SILVER KING
SITE #1
MINFILE 105M 001ba

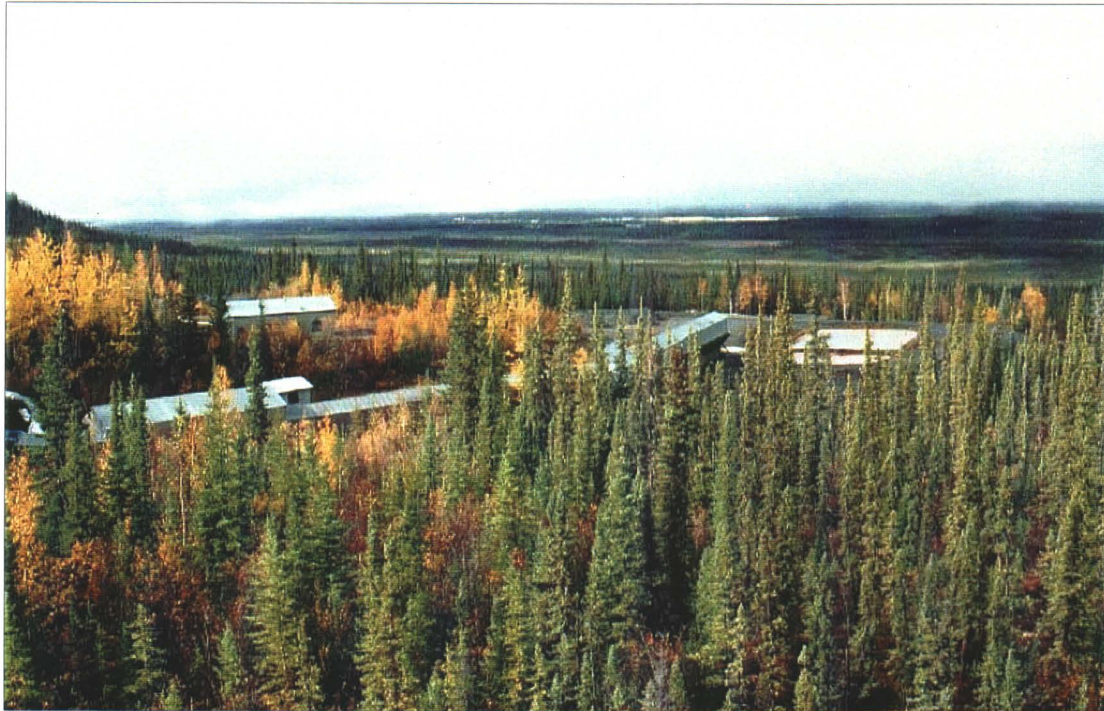
Silver King 100 Level Adit – Under Care and Maintenance (photo 1-1)

Description: This portal is currently under care and maintenance; access is maintained for pumping and treatment of mine water. There is a long (about 100m) galvanized shed that extends from the portal, covering the ore dump tracks.

Condition: Appears to be stable.

Waste Rock Pile WR-02 - 100 Level Adit Waste Dump (photo 1-1)

General Description: Quartzite and phyllite from underground development is distributed in front of the portal, and was used to construct the roads and settling ponds. The material is grey, fine-grained and clay-rich. This material retains water due to the fine-grained nature. The waste averages about 1% pyrite. Some calcite and siderite were noted. Natural revegetation is sparse, however there is little staining due to oxidation.

5.4 Minesite Water Treatment (photo 1-1)

Description and type: Mine wastewater from the 100 Level portal is treated by mixing with lime, and settling in two ponds connected in series. The lime mixer is in an insulated part of the portal shed at the end of the tracks.

Impacted vegetation: There is some rusty precipitate deposited in the outflow area. Vegetation may be impacted in an area about 10m by 20m.

1A - Silver King 100 Level Portal Shed (photo 1-1)

1B - Silver King 100 Level Shifters Office/ Lunch Room (photo 1-1)

1C - Compressor Building (photo 1-1)

Photo 1-1 : Silver King. Silver King 100 Level Portal site, showing buildings (1A, 1B & 1C) and settling ponds. Looking northwest from the open pit waste dump across Galena Creek.

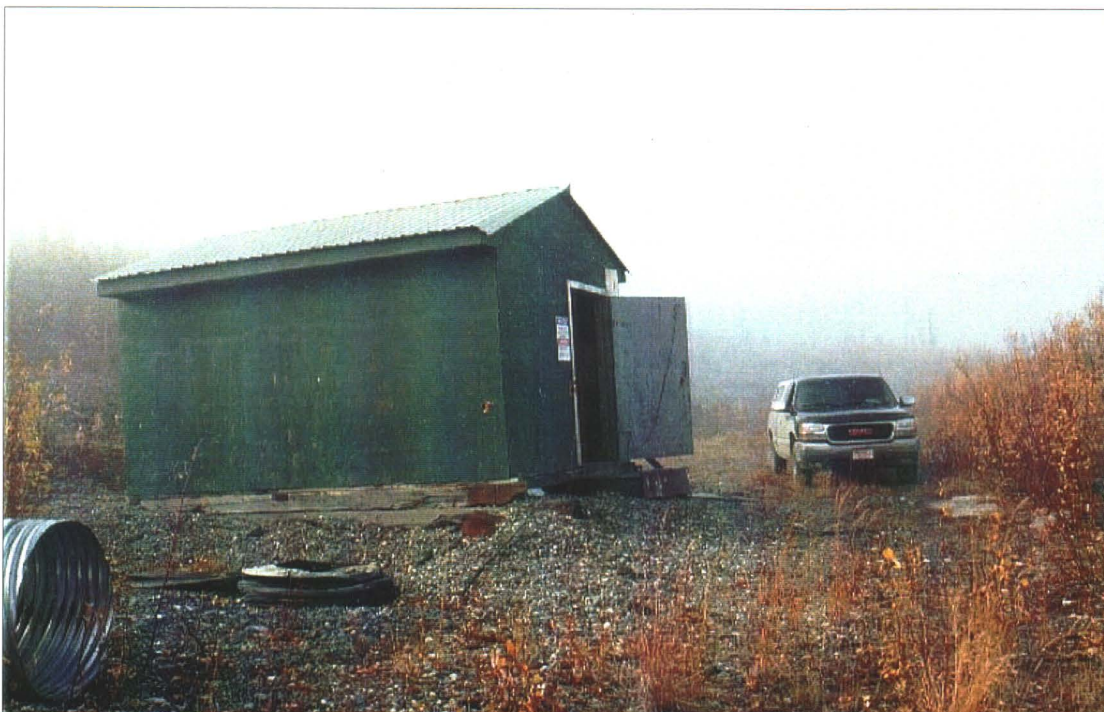
Ventilation Raise – Under care and maintenance (photo 1-2)

Description: A ventilation raise is covered by a wooden shed.

Condition: Appears to be stable.

Accessibility: The shed is kept locked, and steel mesh covers the raise entrance.

1E - Ventilation Raise Building (photo 1-2)

Photo 1-2 : Silver King. Ventilation Raise Building. Looking west, about 100m southeast of the open pit.

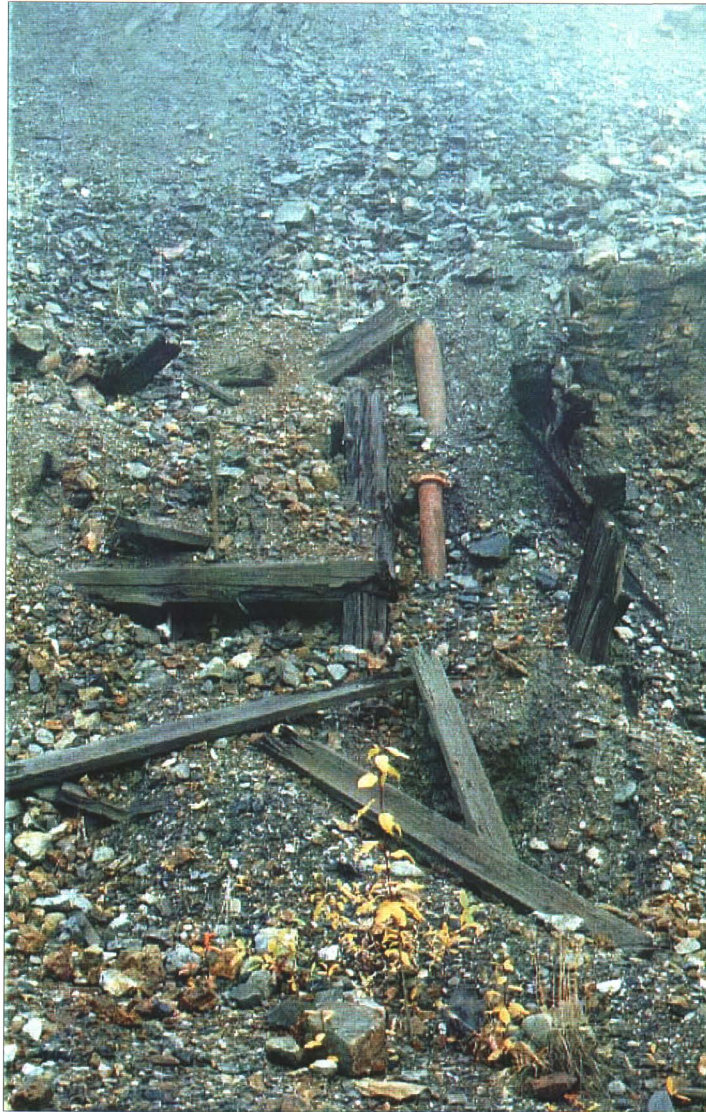
Shaft #1 - Open Pit Shaft (photo 1-2)

Description: Timbers and pipes exposed in the bottom of the open pit identify former shaft, filled with waste rock. This is likely the number 3 shaft, which was the main production shaft for this part of the mine.

Condition: Appears to be stable.

Accessibility: Access to underground is blocked with fill.

Photo 1-3 : Silver King. Timbers and pipe identify a filled-in raise or shaft (Shaft 1). Looking northwest at the bottom northwest corner of the Silver King pit.

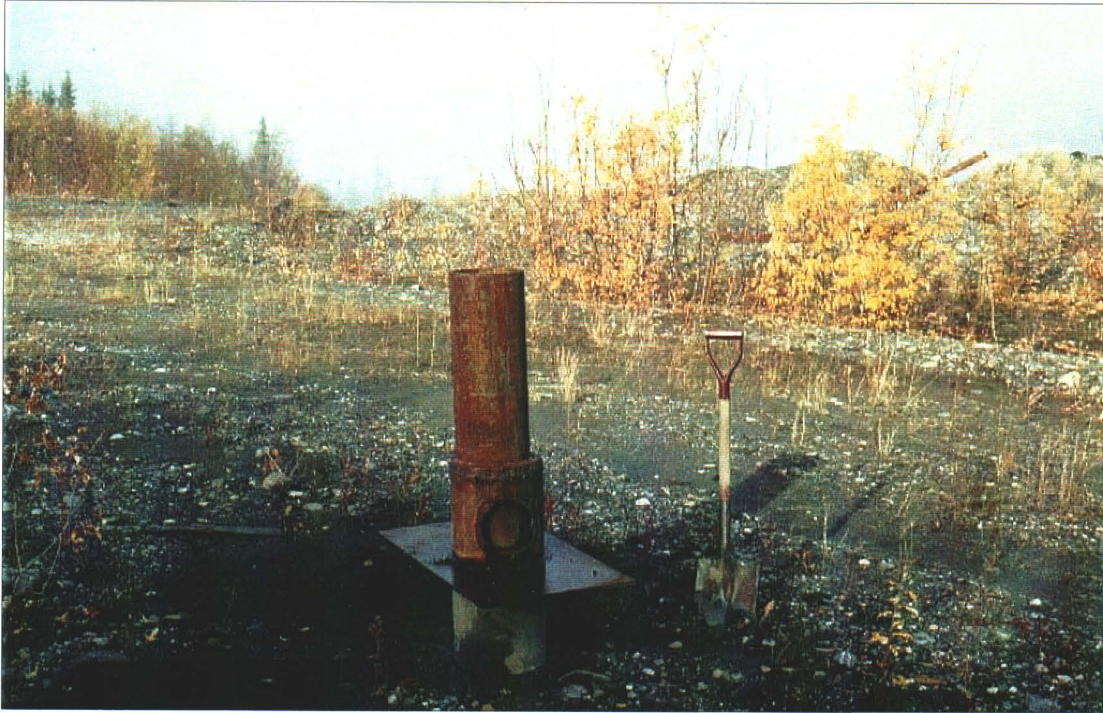
Backfill Pipe (photo 1-4)

Description: Steel pipe that provides access to the recent workings for delivering backfill underground.

Condition: In sound condition.

Accessibility: Not capped. Access to site by road.

No significant hydrocarbons in soil were noted. A small, very shallow (<0.1m) stain from drilling lubricant or hydraulic oil was noted around the Backfill Pipe.

Photo 1-4 : Silver King. Backfill pipe, 100m south of the open pit. Looking northwest.
Note hydrocarbon stain at base of pipe (likely drill lubricant or hydraulic fluid).

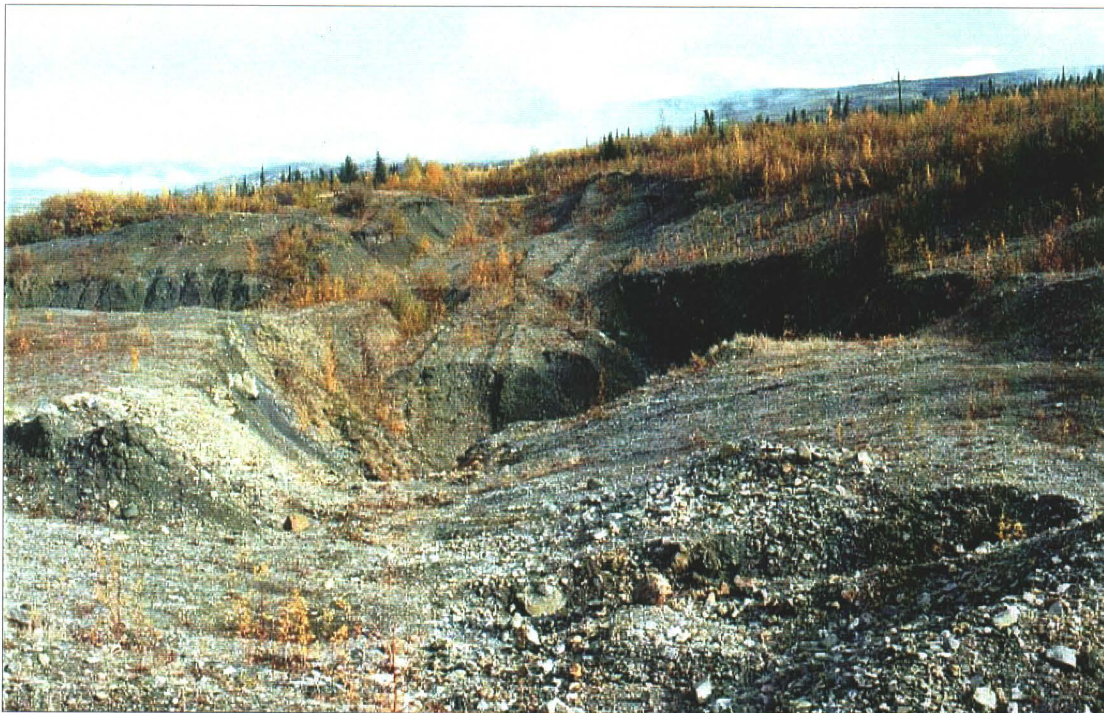
Silver King Open Pit (photo 1-5, 1-6)

Description: The pit was mined to remove a shaft pillar of ore left from the early days of mining. Most of the waste material removed here was overburden (glacial till). The waste was dumped across the highway. Large blocks of concrete that were foundations for shaft hoists are located on the north side of the pit, near the highway. There are reports that one of these blocks covers a shaft, but there was no evidence of subsidence. The pit overlies a zone of underground mining with minimal crown pillar, and there is evidence of subsidence in several places along the vein trend to the northeast of the pit towards the highway (see map). An open slump hole is present along the north-central wall of the pit, at the pit entrance.

Condition: The pit walls are mostly gravel, at a moderate angle of repose, and appear to be stable. There is considerable natural revegetation in and around the pit.

Photo 1-5 : Silver King. Silver King Pit, looking east-northeast. Note moderate pit wall slope, abundance of overburden versus outcrop, and natural revegetation.

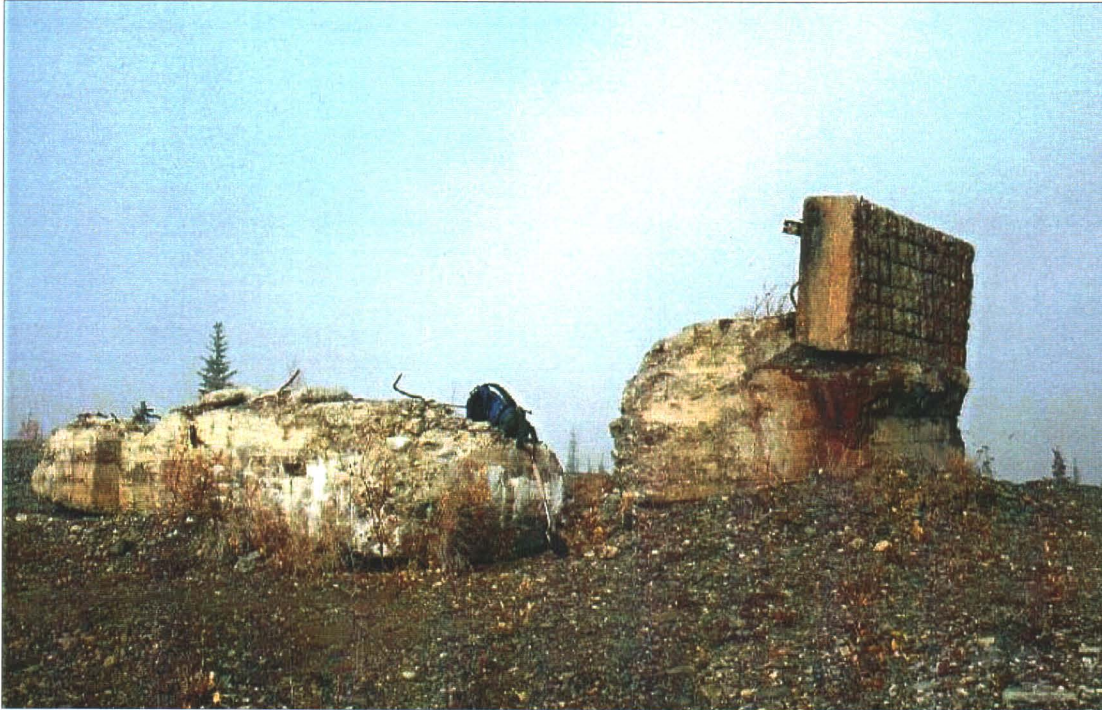
Photo 1-6 : Silver King. Concrete shaft hoist foundations. Looking northwest, northwest of the open pit.

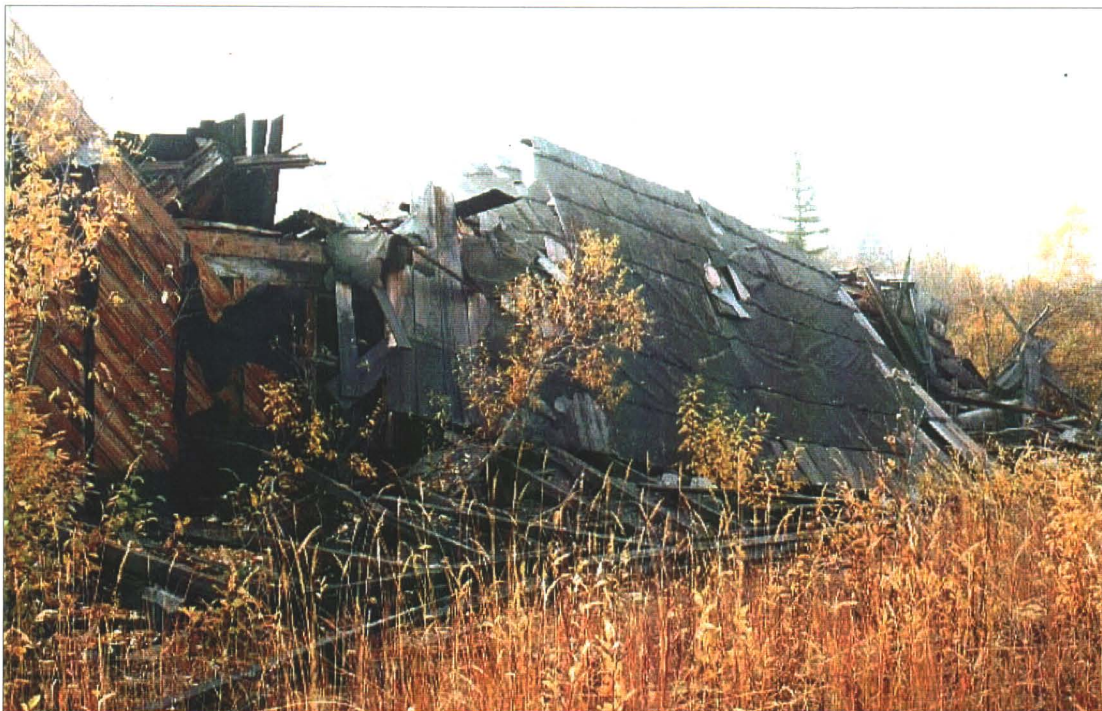
1D - Collapsed Storage Shed (photo 1-7)

Dimensions (L x W x H): About 9m by 5m, was about 6m high before collapse.

Non-Hazardous Contents: Pipe fittings, exploration samples, sample bags, and miscellaneous materials.

Photo 1-7 : Silver King. Large, collapsed storage shed. Looking south, near transformer station south of highway, west of Galena Creek.
