**HUSKY #2**  
**(MINFILE#105M 001bb)**

**HUSKY SOUTHWEST #2**  
**(MINFILE # 105M 001bb)**

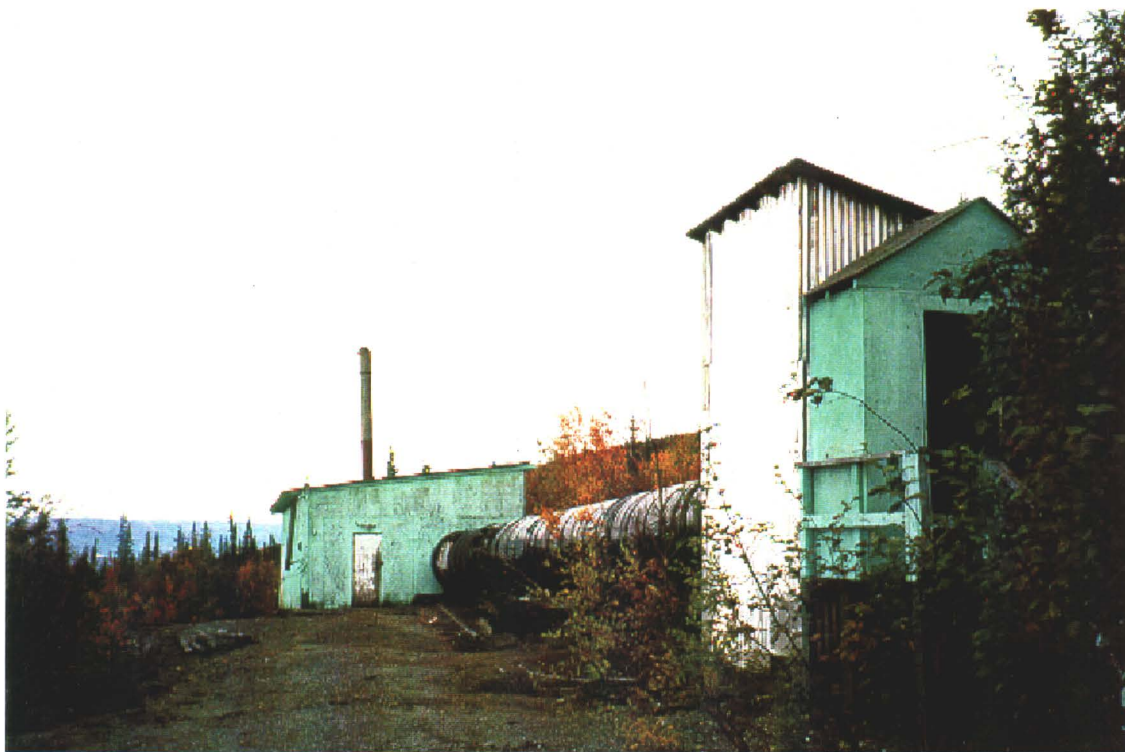
Husky mine is accessed via a shaft. The workings are flooded to surface. There are two raises to the surface. One of the raises was used for ventilation to the underground workings and has a heating furnace and downcast fans at the surface (photo 2-1).

Photo 2-1: Boiler house down draft raise & duct.

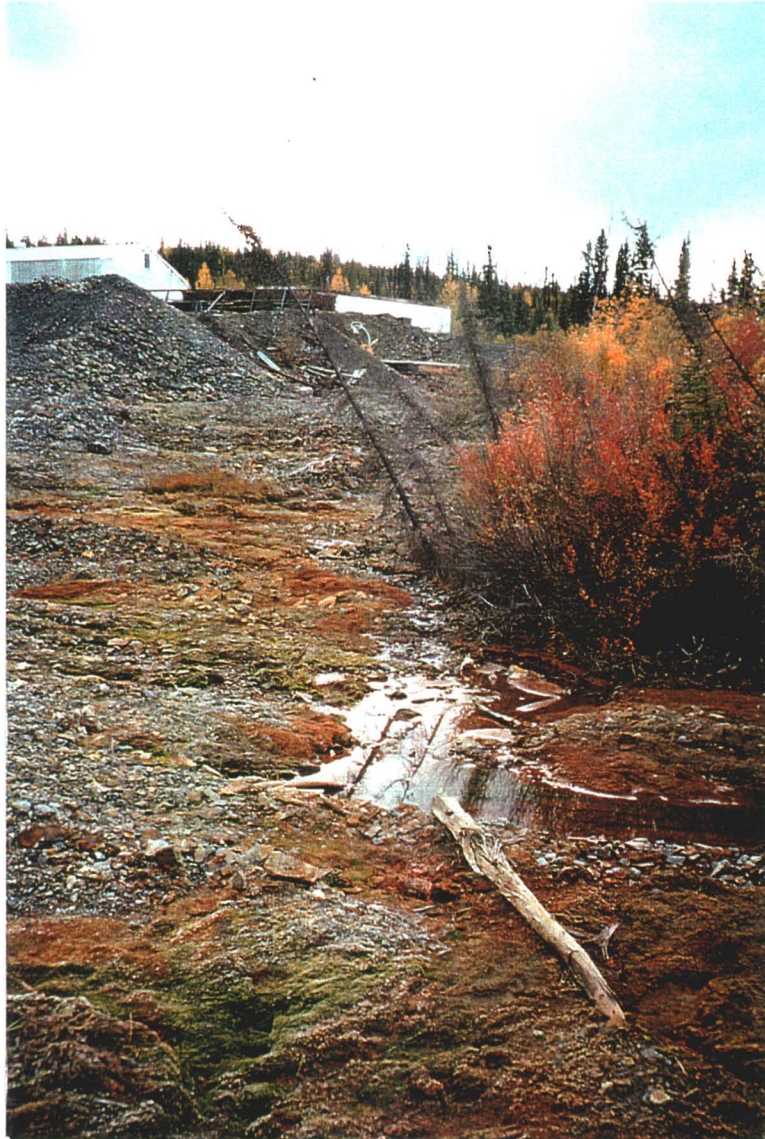
The dump is located on the north side of the shaft pad area. It consists mainly of quartzite with some quartz and minor amounts of schist. The quartzite has disseminated pyrite, arsenopyrite and quartz veinlets. The toe of the dump shows significant iron staining and precipitates. The vegetation near the flow is heavily stressed (photo 2-2).

Two water quality samples were taken at the site. Sample 02-03-water was collected 78m from the headframe building @170° (photo 2-2). The sediments at this location were orange brown with a noticeable sheen on the surface. Water flow rate at the sample location was .3L/s with a pH level of 2.6 and conductivity at 147  $\mu$ S.

Photo 2-2: Sample location 02-03, water taken 98 m from headframe.

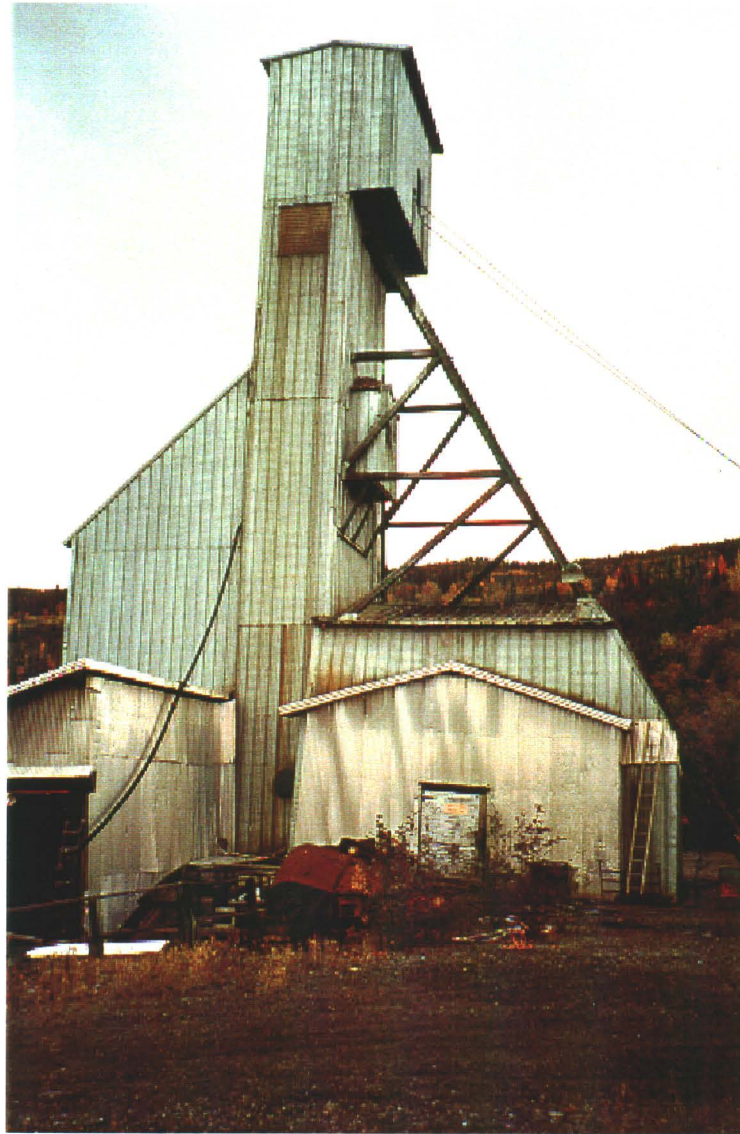
Construction: The building appears to be wood frame with metal sheathing encompassing the structure, roof and headframe. There are timber supports tied into the concrete pads on the southwall and timber supports on the north wall tied into a submerged concrete wall, both were constructed to stabilize the headframe structure.

Hazardous Contents: There was one fuel drum that was not labeled sitting horizontally with a small amount of product having leaked from the bung. Soil staining was very minor.

Photo 2-3: Shaft & headframe.

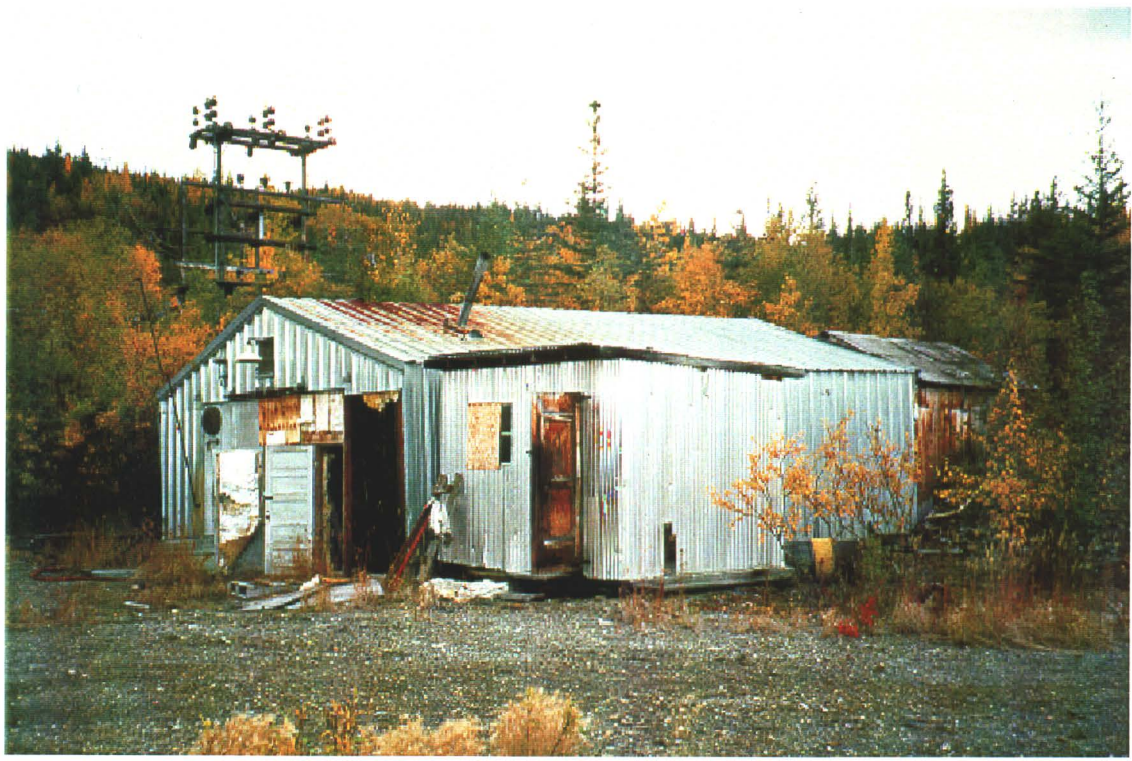
Construction: The structure was wood frame and encased in exterior steel sheathing including the roof. The building had fibreglass insulation. A small wooden porch was located off the west end. The doors were metal. The hoist cable openings were stained with lubricants and tar. There were some tar stains located directly under the cable openings, however, soil staining was minor in nature.

Photo 2-4: Hoist house.

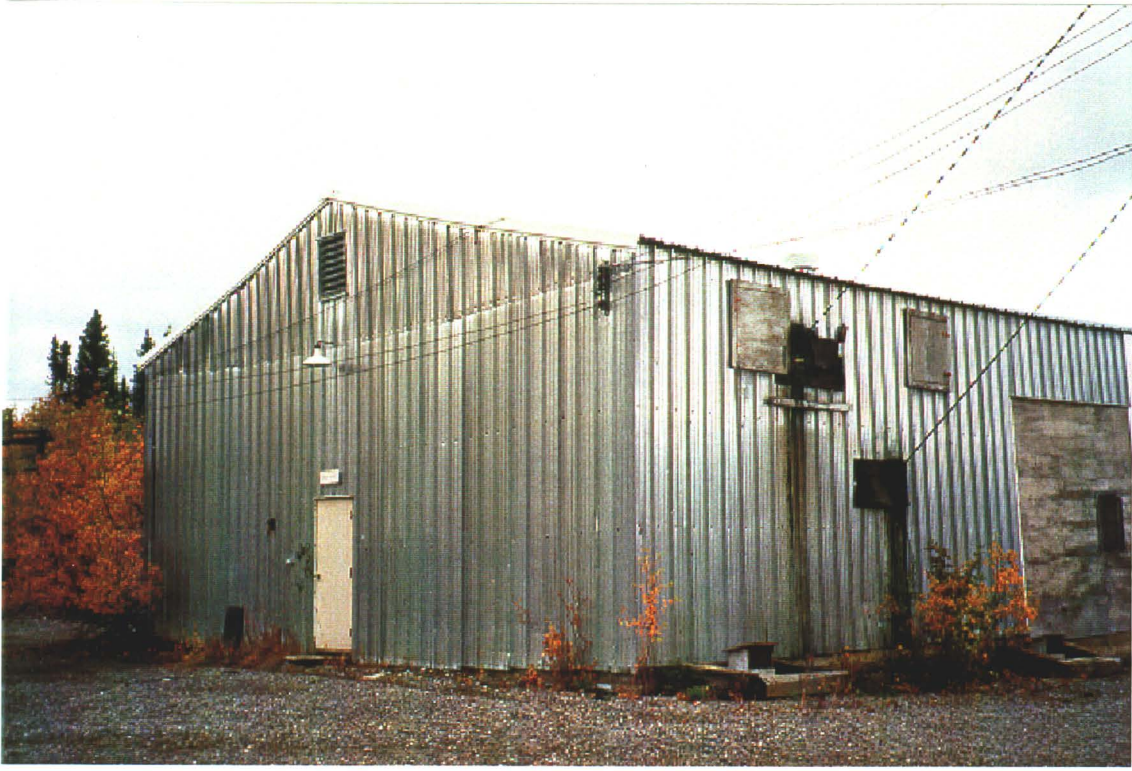
Hazardous Contents: There were two ASTs located in the interior of the building in the northeast corner. There did not appear to be any contents, however, it was difficult to determine as the tanks were encompassed with building debris.

Note: Staining was noted in the exterior of the building on the concrete floor as well as on the exterior of the rear addition. No staining was noted on the surrounding soils. A large vertical AST was located at the rear of the boiler house.

Hazardous Contents: The interior of the structure was heavily stained with both tar and rock drill oil. There was a drip pan under a 200L drum of rock drill oil that contained some product. There was some minor staining at the entrance to the building. 3 - 200L drums were located at the rear of the building and were empty. Minor surficial staining was noted surrounding the drums.

Photo 2-5: Boiler house.

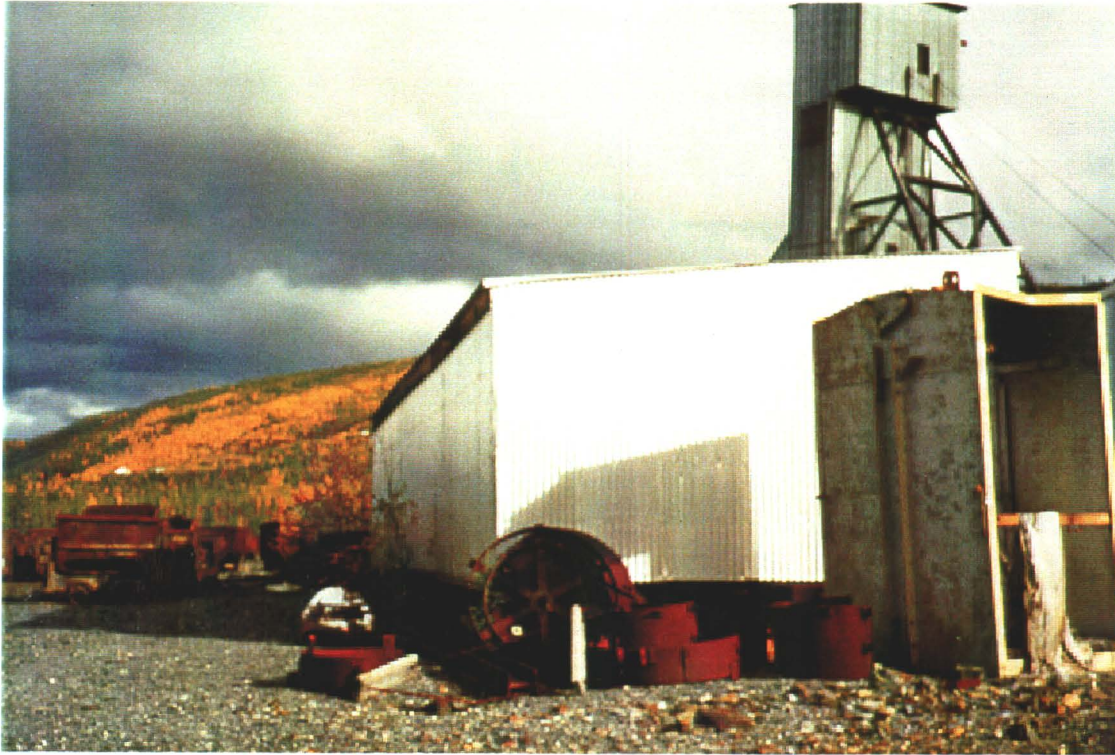
Photo 2-6: Large storage shed.

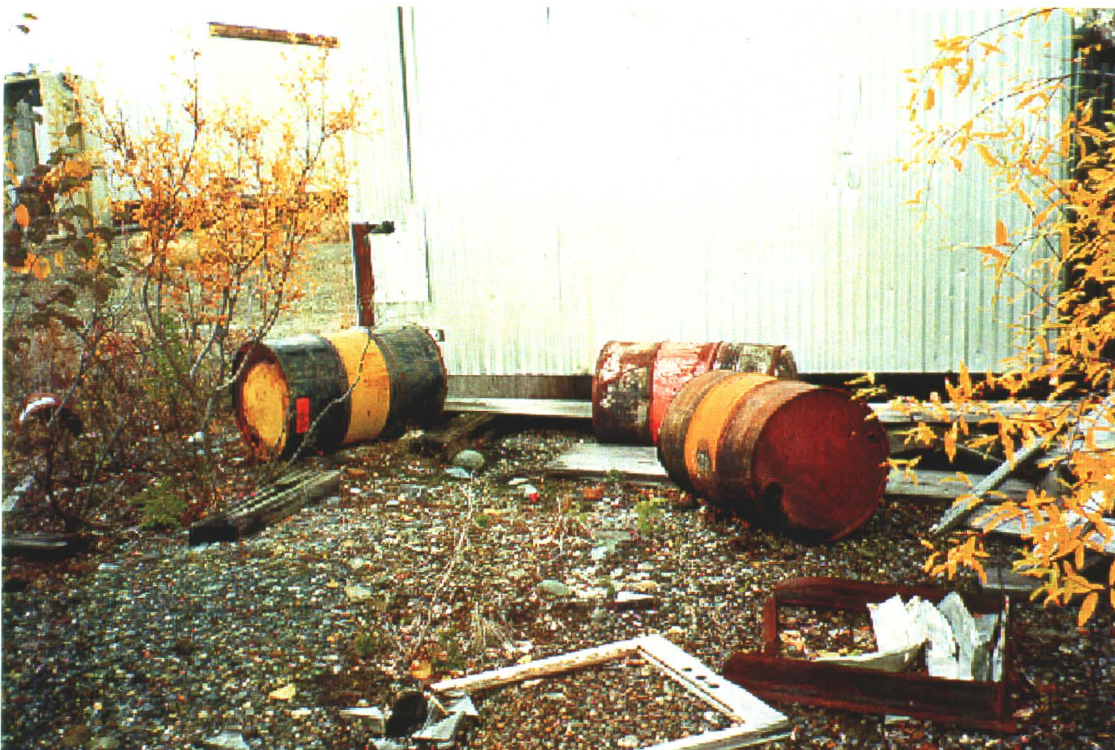
Note: There was some metal debris that was noted along the south side of the building that included empty and rusted out drums (photo 2-7). There was no sign of staining around the perimeter of building 2E.

Photo 2-7: 200L drums at rear of storage shed.

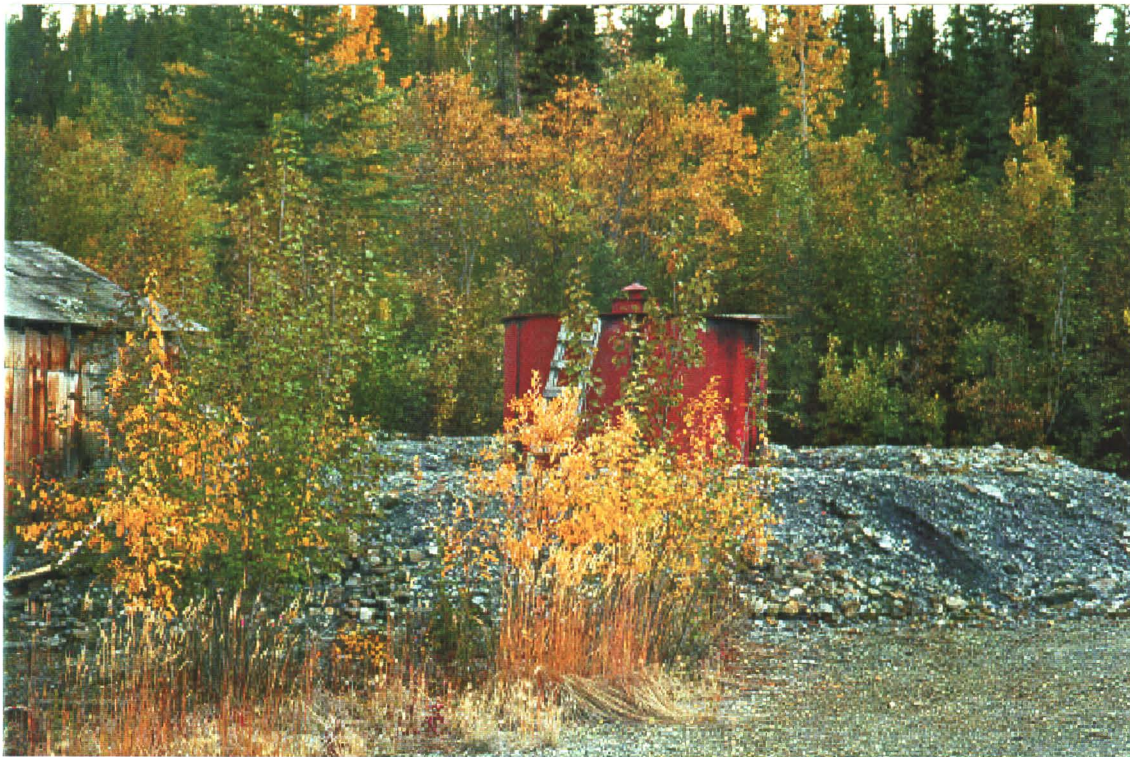
Location: An aboveground storage tank was located behind the boiler house (photo 2-8).

Soil staining was apparent in numerous areas of the site. Most of the areas were surficial in nature and did not appear to be adversely affecting the surrounding environment. The major area of concern noted was the aboveground storage tank. There is staining around the perimeter of the AST and it is difficult to determine the extent of contamination as the AST was placed on top of

Photo 2-8: AST behind boiler.

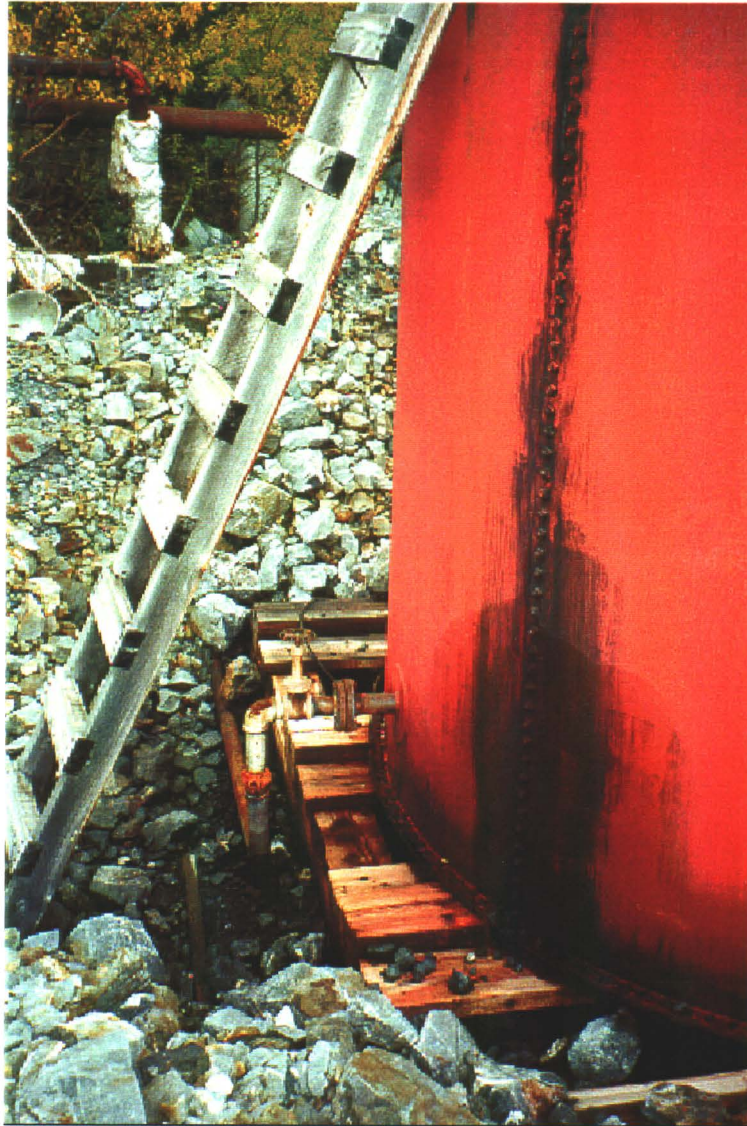
Above Ground Storage Tanks: The AST measured 3m in height and 2 m in diameter and consisted of steel bolted construction. There appeared to be staining along the bolted joints (photo 2-9). Soil staining was evident around the perimeter of the tank. There was heavy staining at the valves. A waste rock berm extends around the perimeter of the AST. Samples were not collected as the area surrounding the AST consisted exclusively of large waste rock.

Photo 2-9: AST & piping.

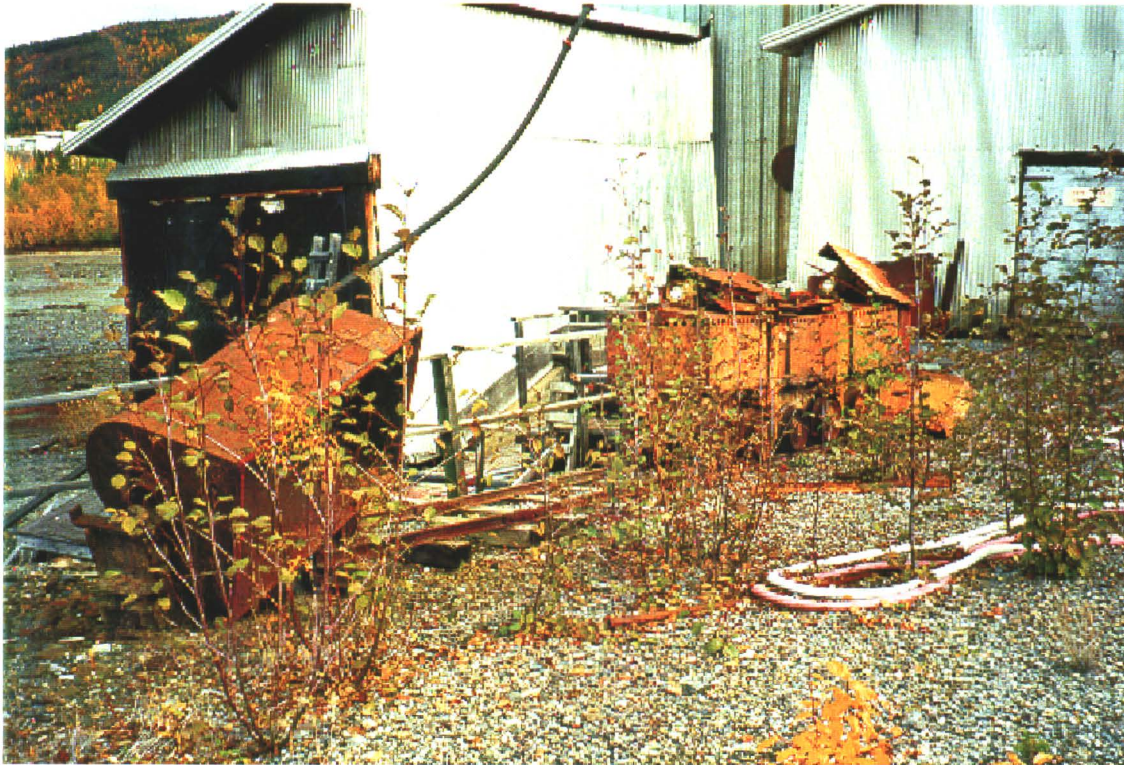
There were rails extending approximately 25m from the shaft house and stopped abruptly, rail debris and cars were abandoned in this area (photo 2-10). Approximately 28 rail cars were located behind building 2E (photo 2-11).

Photo 2-10: West side of headframe.

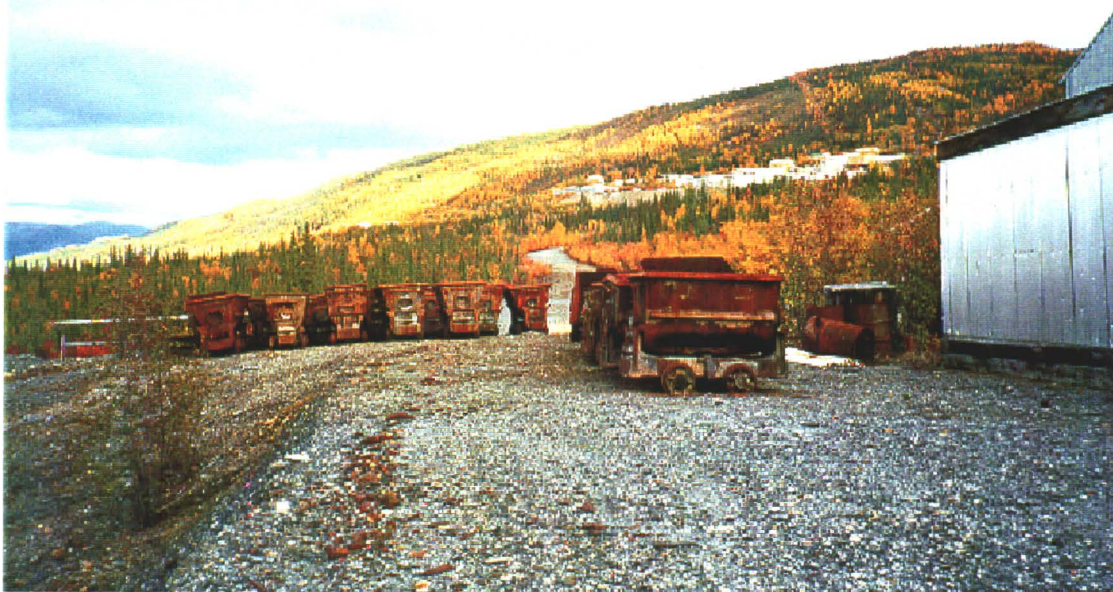
Photo 2-11: 28 Rail cars.

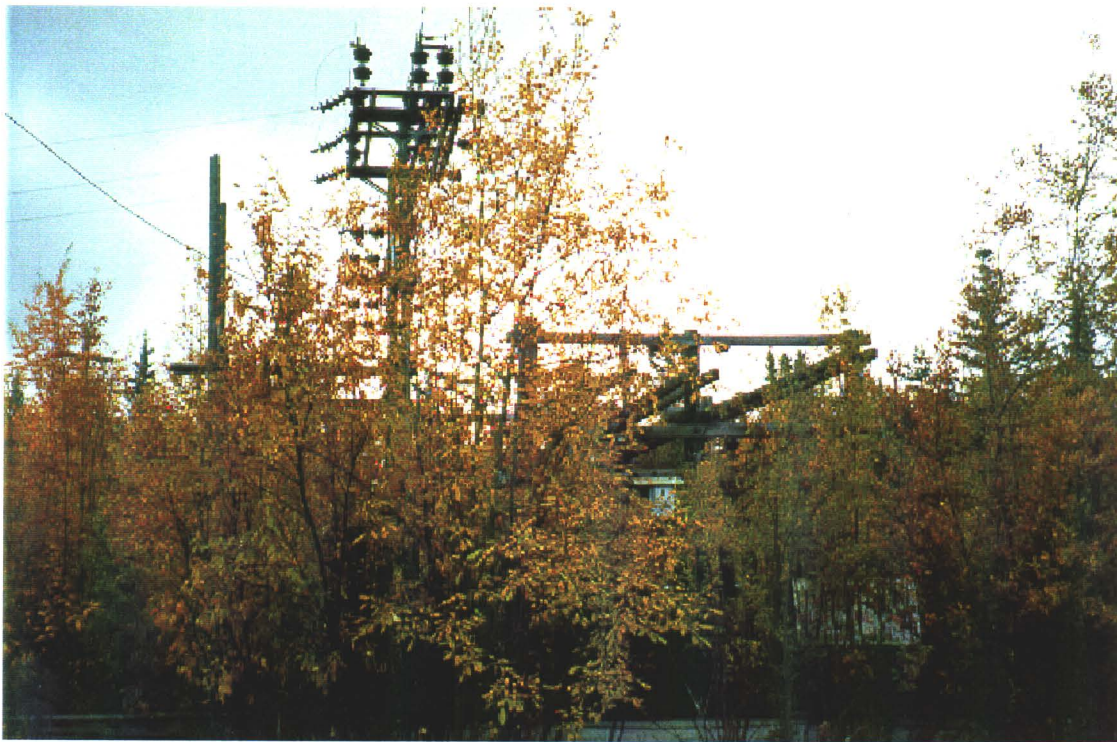
There were three transformers at the site located to the southeast of the boiler house (photo 2-12). No samples were taken as the transformers were still in use and the perimeter was fenced and padlocked.

Photo 2-12: Transformer compound.

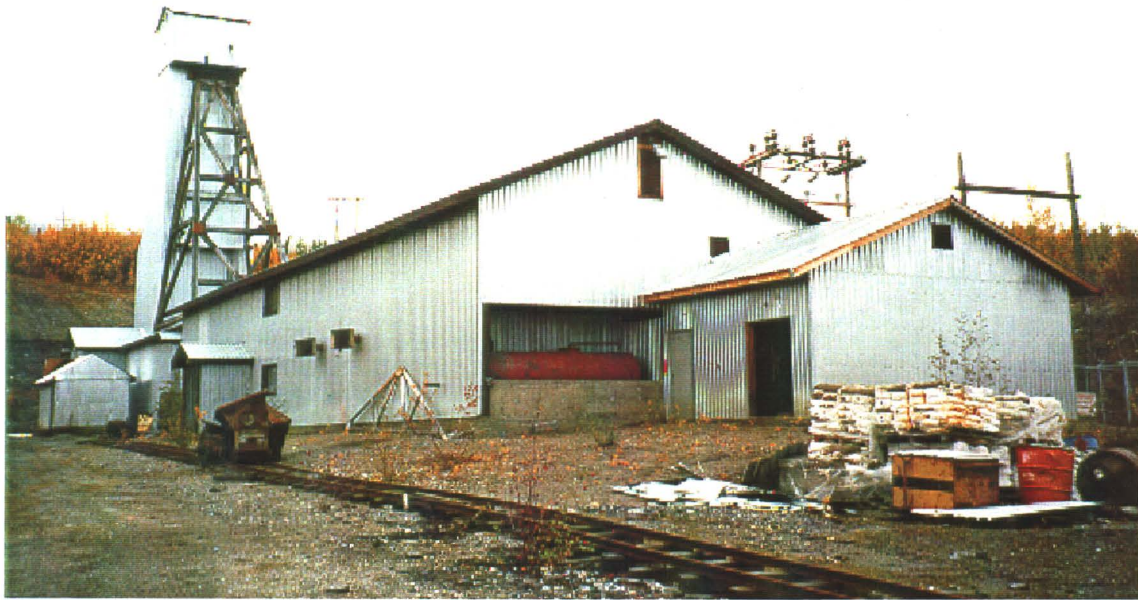
Hazardous Contents: An aboveground storage tank was located on the northwest corner of the building and was incorporated into the structure(photo 2-15). Secondary containment consists of a concrete berm that extends half way up the AST. The tank is open to the elements, however, it is located under a building overhang (photo).

There was one aboveground storage tank (photo 2-15) that was located on the northwest corner of the hoist house. The tank was welded steel and no leaks were noted - no staining was noted in the concrete secondary containment.

Photo 2-15: Structures at site.

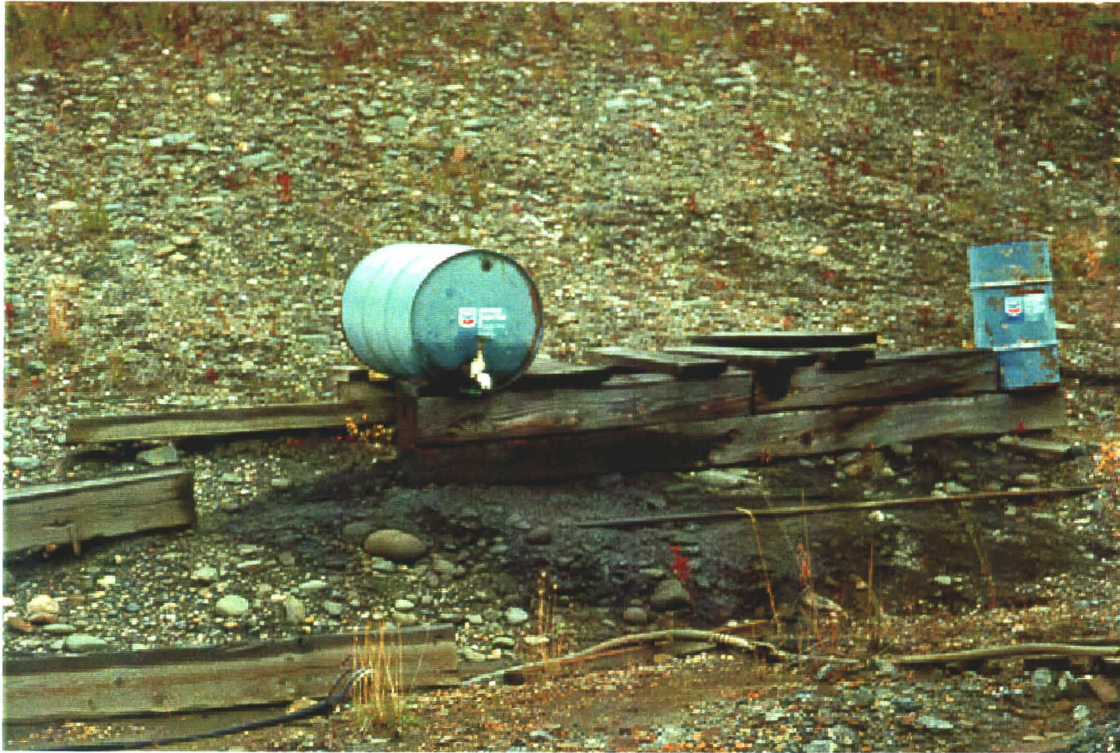
There were two 200L drums labeled as torque fluid. One of the drums was horizontal on a wood platform with a closed bottom valve (photo 2-19). The drums did not contain any product or residue however, the area around the horizontal drum was stained. Intrusive investigation indicated that the contamination was surficial. The area of contamination was estimated at 10m x 8m with an approximate depth of .25m.

Photo 2-19: Torque fluid 200L staining is evident.

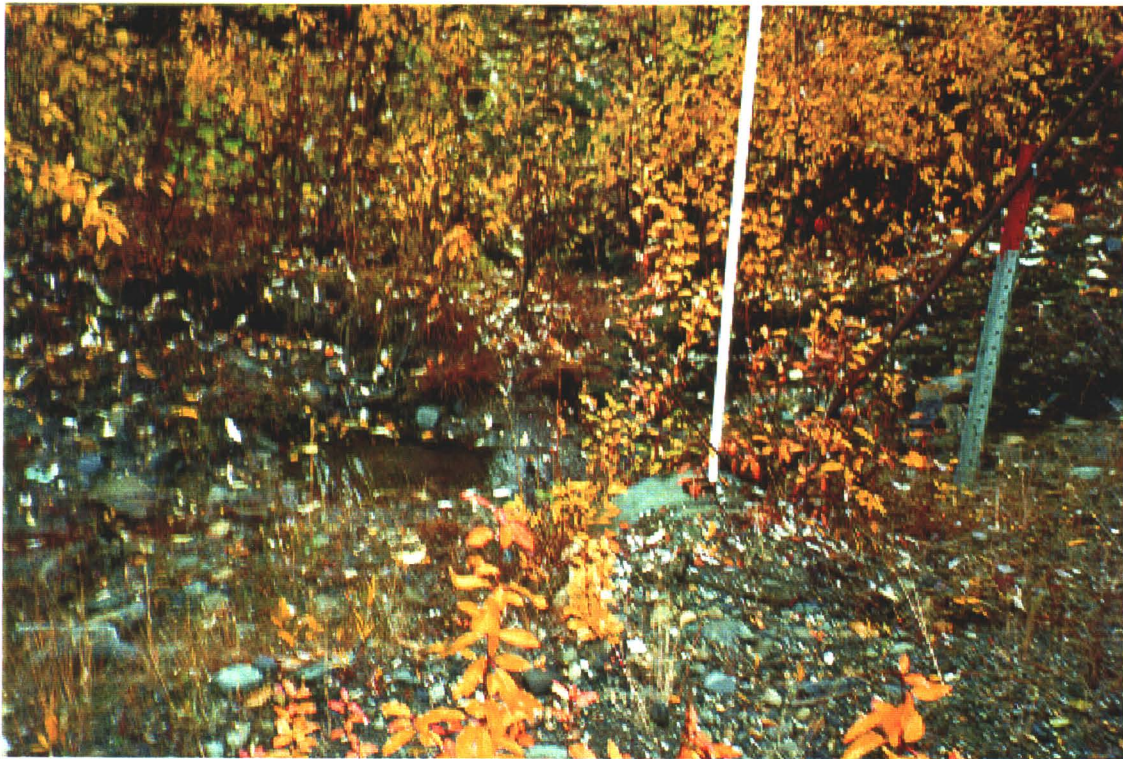
Two samples were taken at the Husky SW mine site. The first sample (02-01-upswater) was taken above the site (photo 2-22). The water was clear and there was abundant mosses and lichens along the rock faces. The sample was taken on the south side of the road at the culvert. Water flow at the sampling location was .75L/s with a field testing of 7.6 pH and conductivity at 18µS. Laboratory sample results can be found in Attachment B.

Photo 2-22: Sample location 02-01 - upstream. Sample location just off Hwy 2 at culvert.
