ELSA MINE
SITE #3
MINFILE #105M OO1a

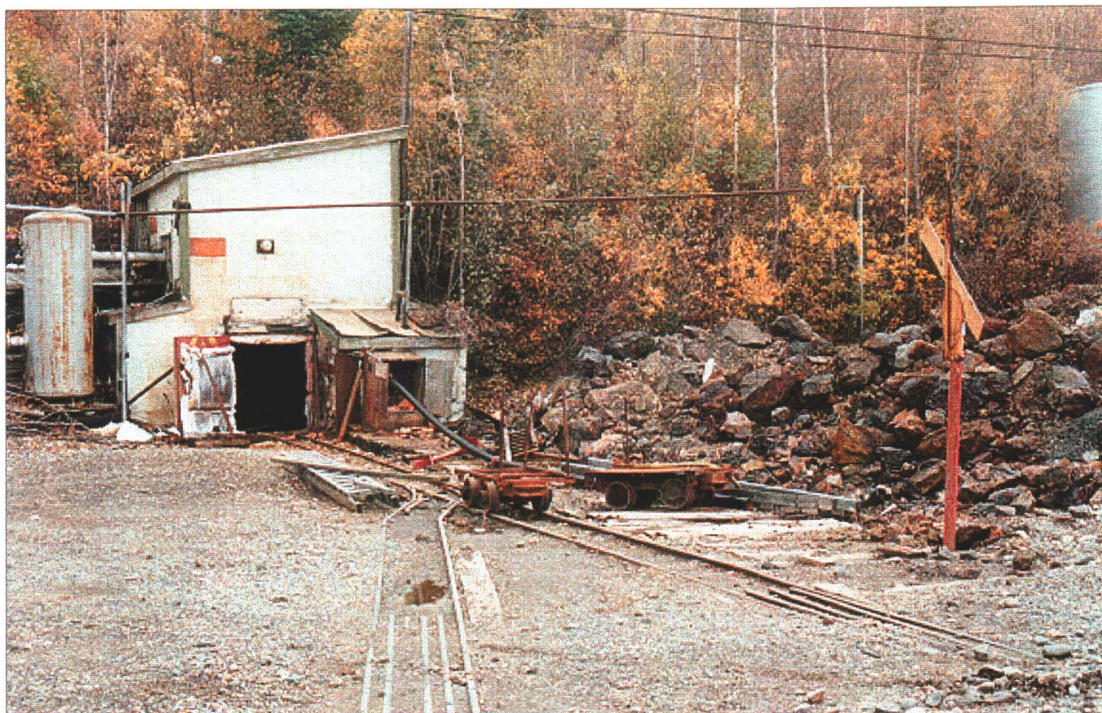
400 Level Portal (Photo 3-1)

Description: The portal is covered with an insulated, asbestos-clad building. Tracks from underground lead across the road to a dump chute and to the mill.

Condition: Appears to be very stable.

There are a few piles of low-grade open pit material (distinguished by larger rock size than from underground) near the 400 portal. This material is highly oxidized, and siderite-rich. The dark boulder pile in photo 3-1 is typical of this material.

The 400 level portal building is an insulated wood frame structure with asbestos siding (photo 3-1).

Condition: Mostly in good condition. The ore dump/ grizzly section is perched at the top of a steep bank, and supporting timbers may be rotting. The ore chute timbers are badly rotted.

Photo 3-1 : Elsa Mine. Elsa 400 Level Portal. Looking southeast. Low grade open pit ore pile to the right of the tracks.

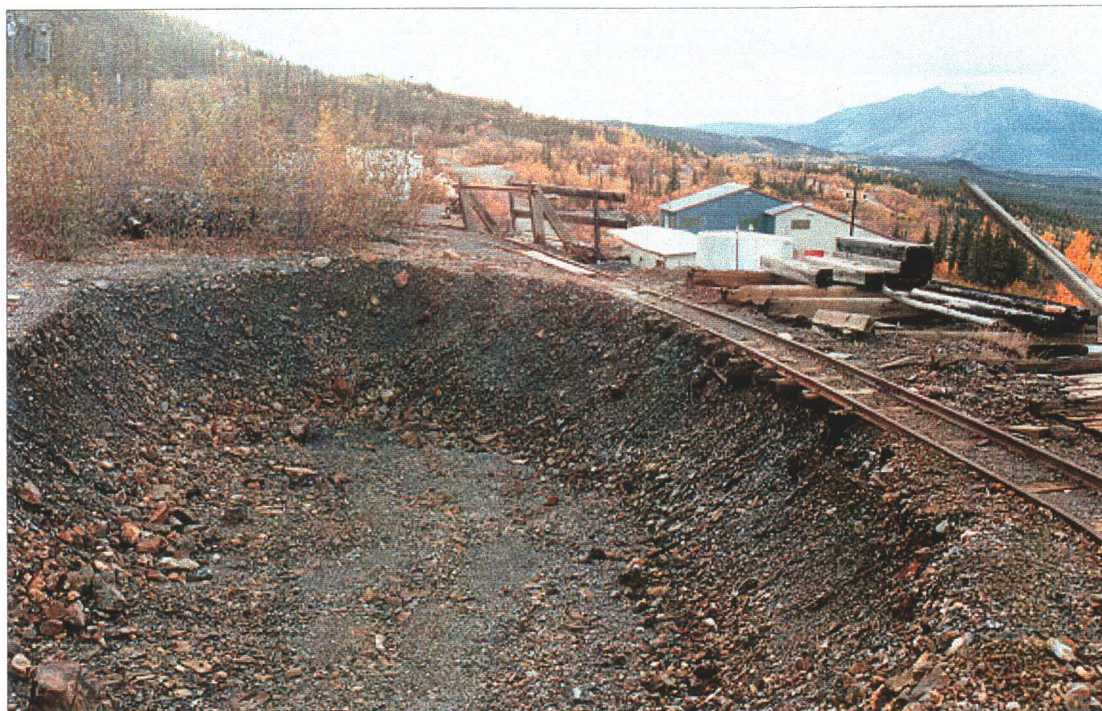
400 Portal Area Waste Rock Pile (Photo 3-2)

General Description: The waste rock sampled is from underground development. It is quartzite and phyllite with quartz-siderite-pyrite vein material. Limonite and manganese oxide staining is very common. The area is quite well drained by ditches and culverts, and the material is quite coarse, with little water-retention capacity. There is minor, local vegetation in the area.

Sample #	Location	Paste pH	Conductivity	Lab Results
3-WR-TPBM-01	400 portal	2.62	2.75 µS/cm	See Table – Attach. 2

SAMPLE	SITE DESCRIPTION	PASTE pH	S(T) %	S(SO4) %	AP	NP	NET NP	NP/AP
3_WR_TPBM_01	400 portal area waste rock pile	3.5	2.05	0.43	50.6	-1.3	-51.9	<0.1

Photo 3-2 : Elsa Mine. Elsa 400 level tracks and grizzly. Looking southwest. Waste rock sample site 3_WR_TPBM_01.

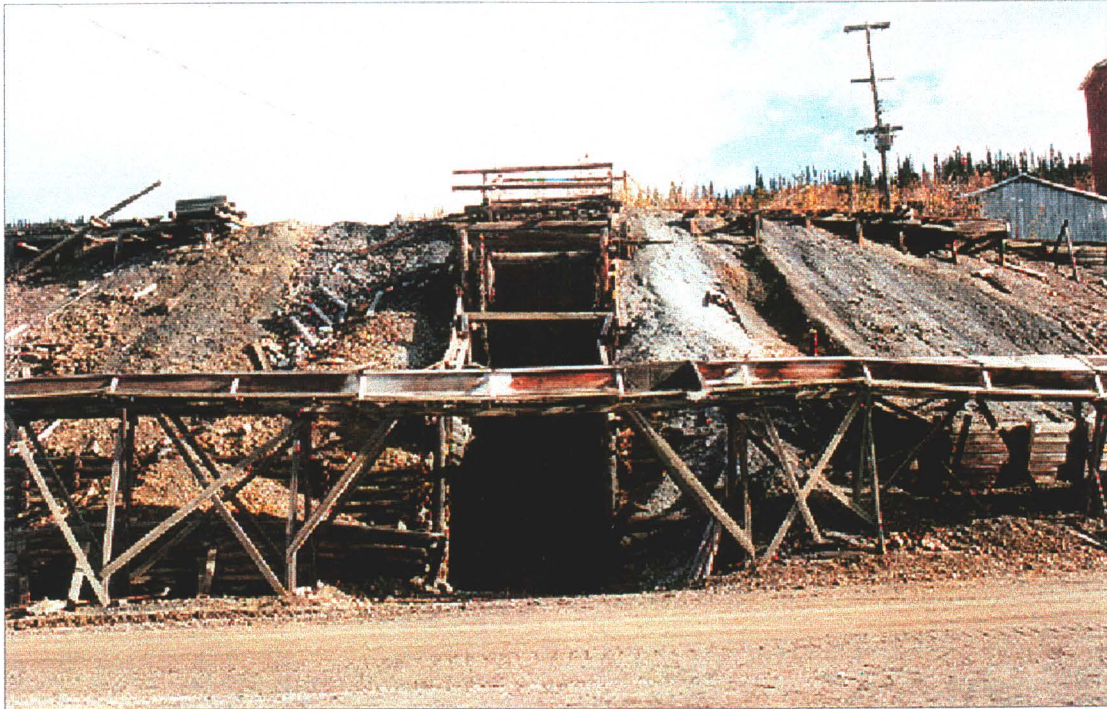
Photo 3-3 : Elsa Mine. Elsa 400 ore chute and grizzly from below. Looking southeast.
Note steep banks of waste rock.

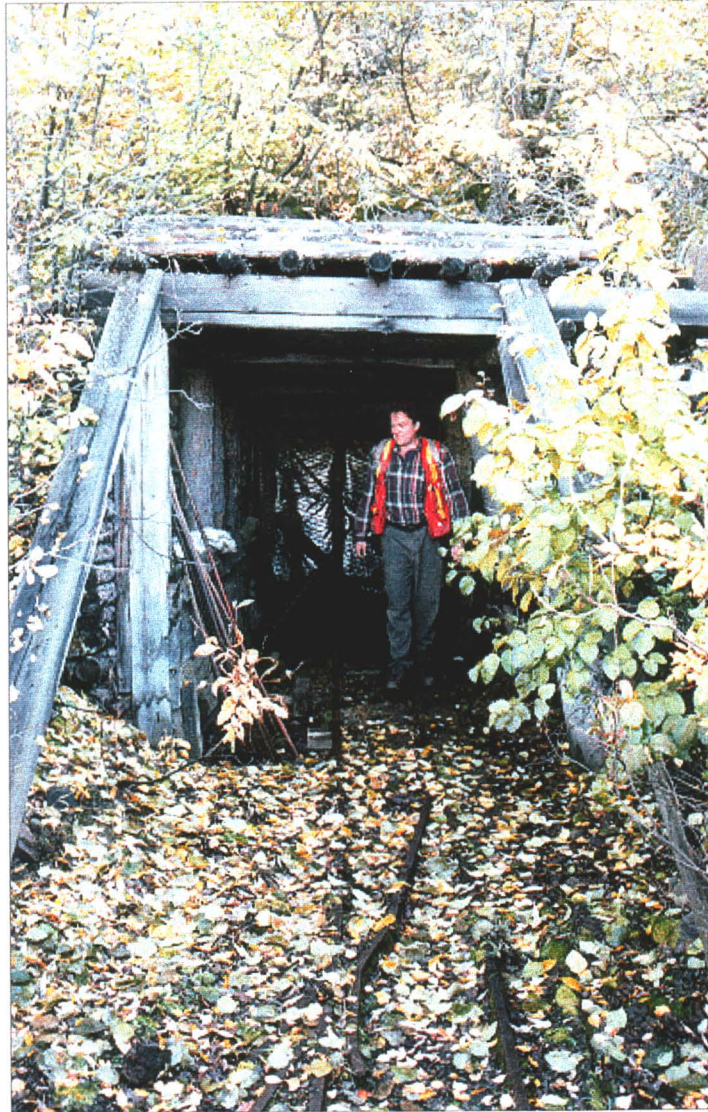
200 Level Portal (Photo 3-4)

Description: This portal was the major production level during the early years of the mine. The portal is in good condition, with a locked steel door. Tracks from underground lead to an ore dump station. Two ore cars are present on the tracks. Virtually all of the ore has been removed from the ore dumpsite.

Condition: The portal appears to be very stable, but the ore dump structure is perched on a steep bank that has been undermined

Note: This mine level is reported by local residents to have high radon levels.

Condition: Good condition, except ore dump trestle has been undermined and may be unstable.

Photo 3-4 : Elsa Mine. Elsa 200 Level Portal. Looking south.

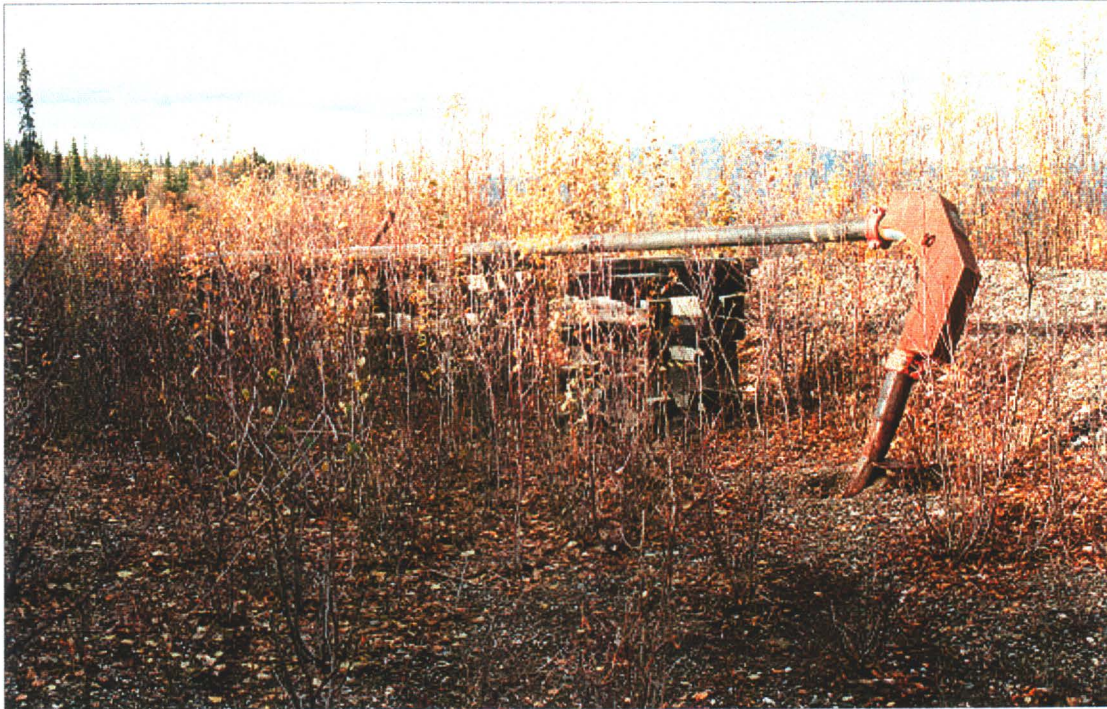
Backfill Site (photo 3-5)

Description: A large-diameter pipe leads underground from surface. Gravel sized rock was delivered underground for use as backfill. Piles of gravel are present, and minor timbers, pipe, and other materials.

Condition: Site appears to be stable.

Photo 3-5 : Elsa Mine. Elsa mine backfill pipe. Looking west.

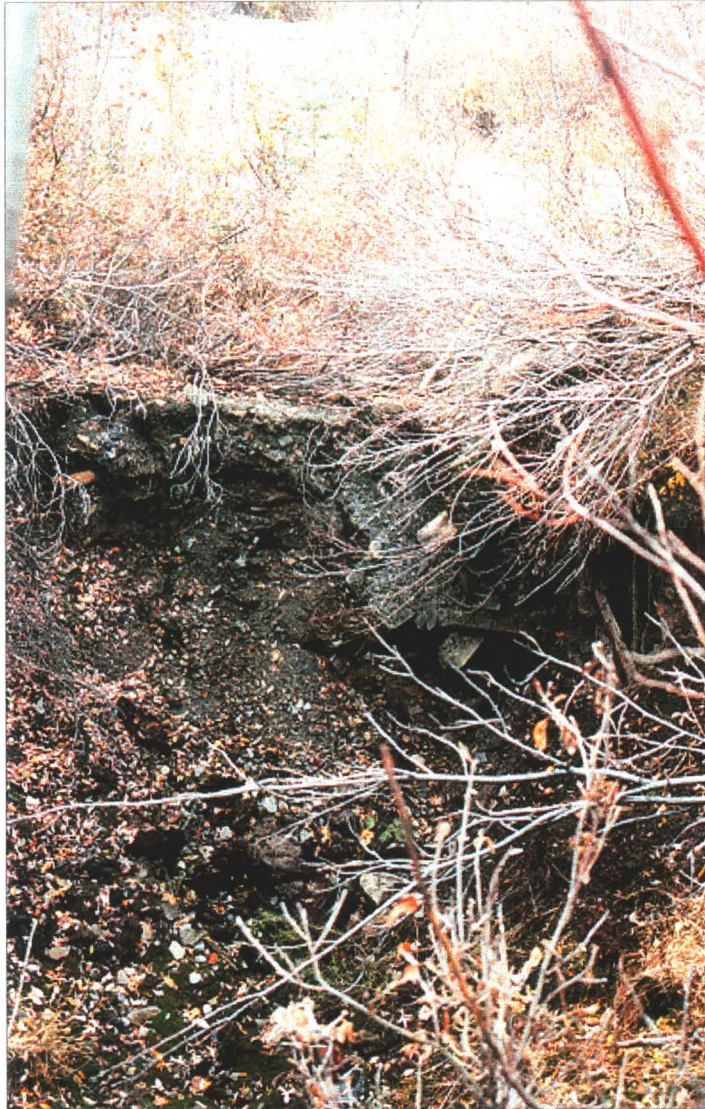
Powderhouse Corner Vent Raise (Photo 3-6)

Description: A vent raise that has been backfilled is subsiding. A hole is present, with minor pipe and timber indicating mine association.

Dimensions (L x W x H): A pit about 10m by 10m wide and 5m deep is present.

Condition: Appears to be unstable.

Note: There is a northeast-trending linear depression evident about 100m uphill from this site. The depression crosses Calumet Drive, and is thought to be due to stope subsidence.

Photo 3-6 : Elsa Mine. Collapsed ventilation raise,
Powderhouse Corner on Calumet Drive. Sink
hole is about 10m by 10m by 5m deep.
Looking north.

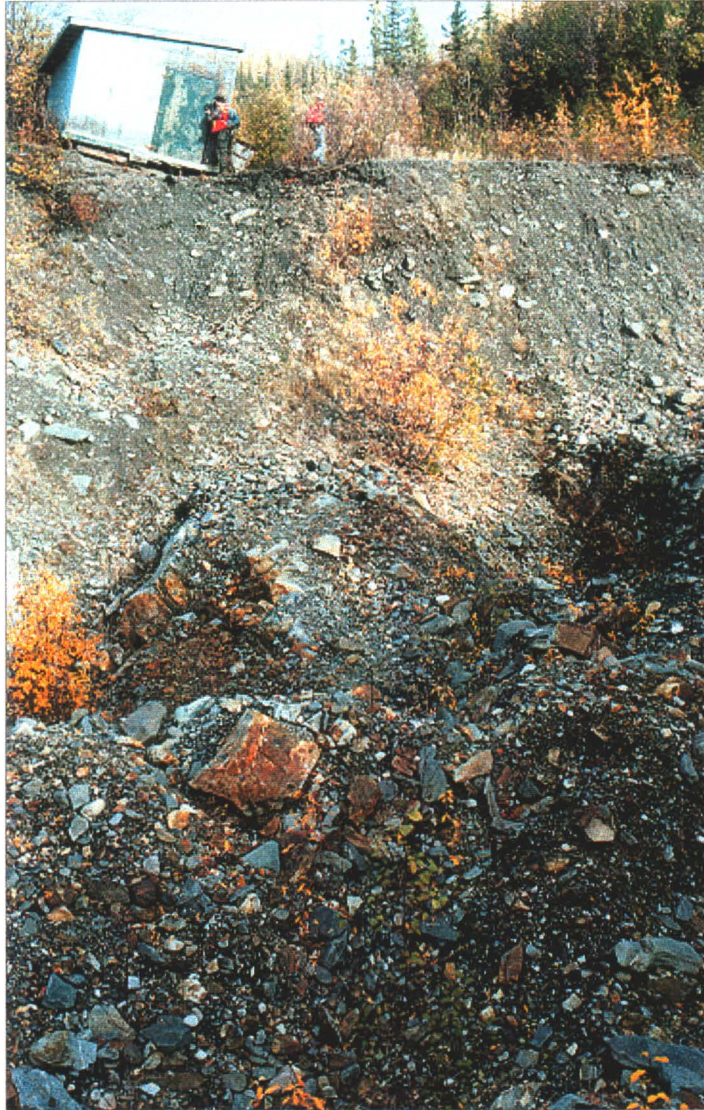
50 Level Portal/ Open Pit Site (Photo 3-7)

Description: A small open pit was mined in the 50 portal area to remove a crown pillar of ore in the late 1980's.

A small shed is present. The portal was not located, and has likely been destroyed by the open pit.

Condition: Site appears to be fairly stable.

Photo 3-7 : Elsa Mine. Elsa 50 Level open pit and mine shack.
Looking southeast.

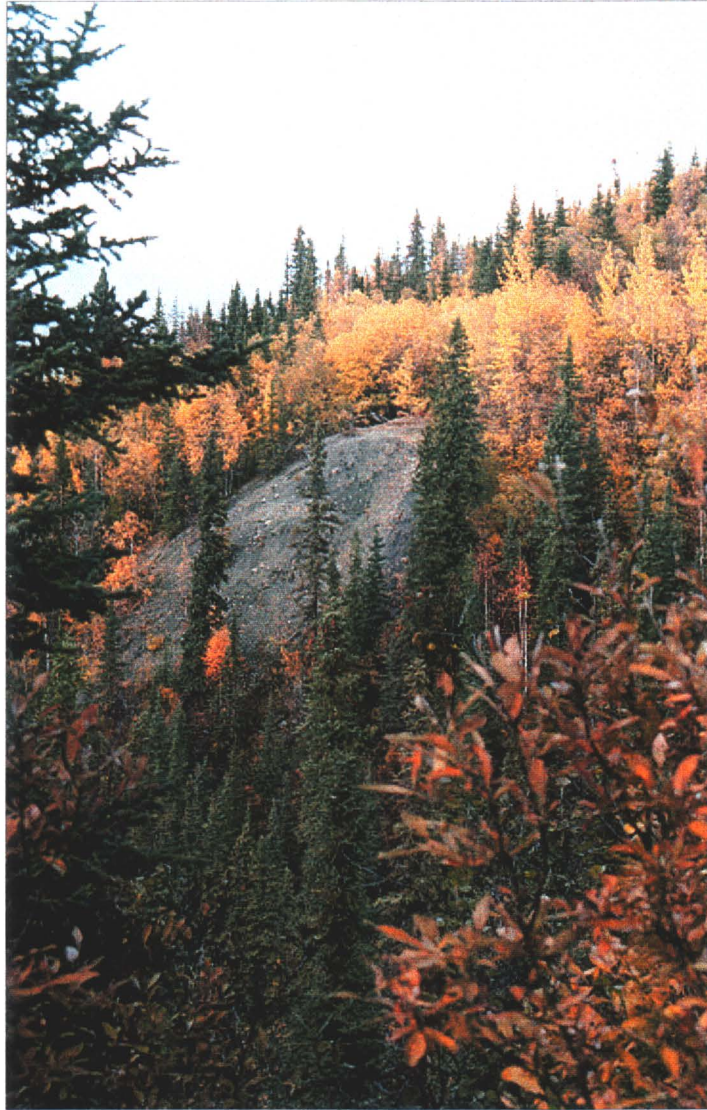
Description: Portal is collapsed. Level part of site is totally overgrown. Steep bank of waste dump is not vegetated, shows some slumping. Two small, collapsed raises were found uphill from the adit.

Condition: Portal is collapsed.

Photo 3-8 : Elsa Mine. Elsa +50 adit waste dump. Photo taken from Calumet Drive, across Porcupine Creek, looking northeast.

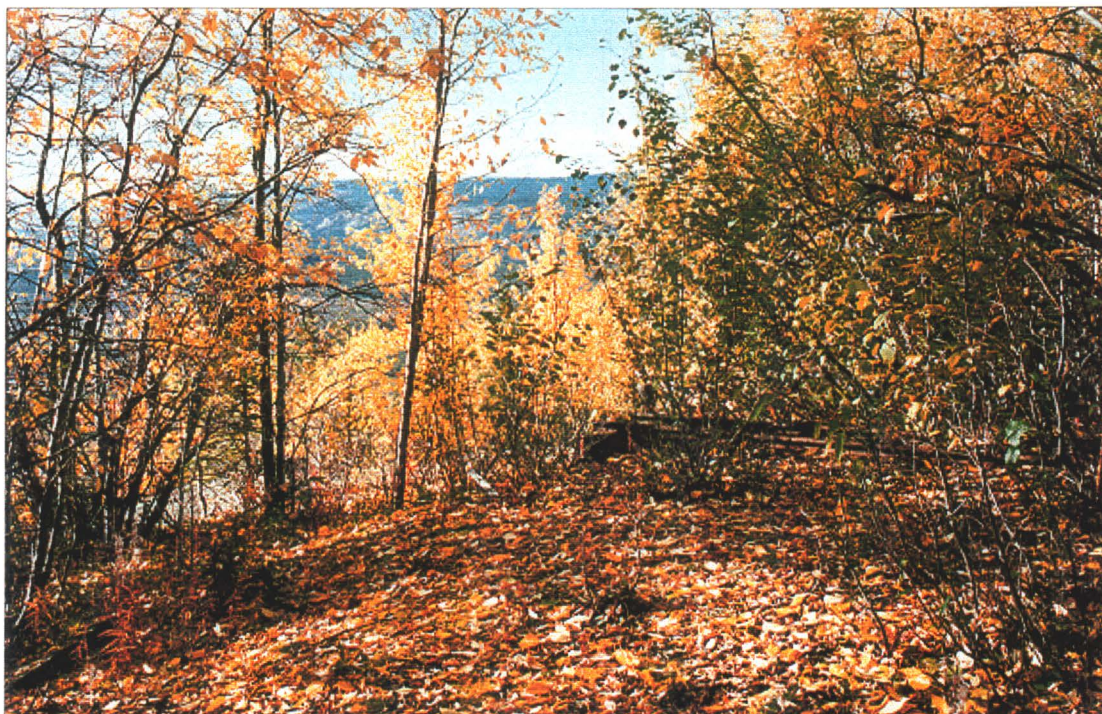
Photo 3-9 : Elsa Mine. Elsa +50 adit dump, showing dense natural revegetation and some slump features. Looking northwest.

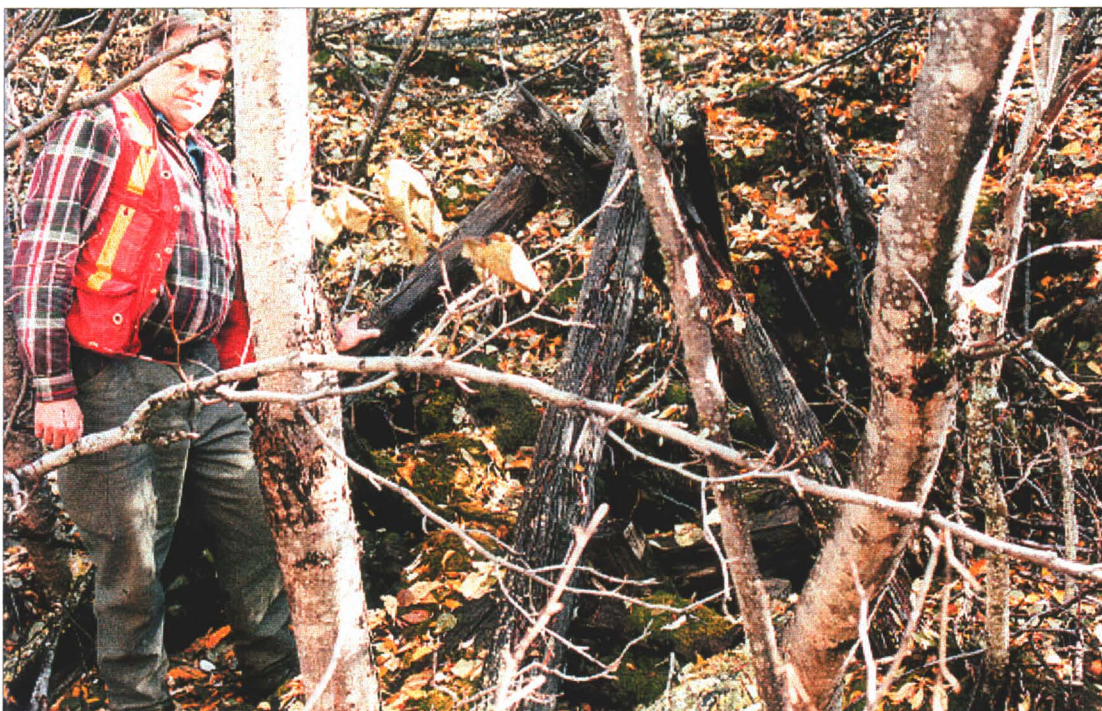
Tick Shaft (photo 3-10)

Description: A small, collapsed inclined shaft with small timber hoist frame mounted above. Note that this shaft is not connected to the main Elsa mine.

Supports: Some rotten timbers present.

Condition: Collapsed.

Photo 3-10 : Elsa Mine. Tick shaft. Rotting timberframe, collapsed adit. Looking south.
