**DIXIE #4**  
**(MINFILE# 105M 001b)**

Public Works And Government Services Canada	Travaux publics et Services gouvernementaux Canada	designed by:	date:
		drawn by:	
Architectural & Engineering Services Western Region		designer par:	C.S. Nov. /99
		approved by:	
Drawing title:		Titre du dessin:	
Dixie Site #4 Site Assessment Yukon Territory		project no. no. du projet:	dwg. no. dessin no.:
		125-12.01	1 of 1

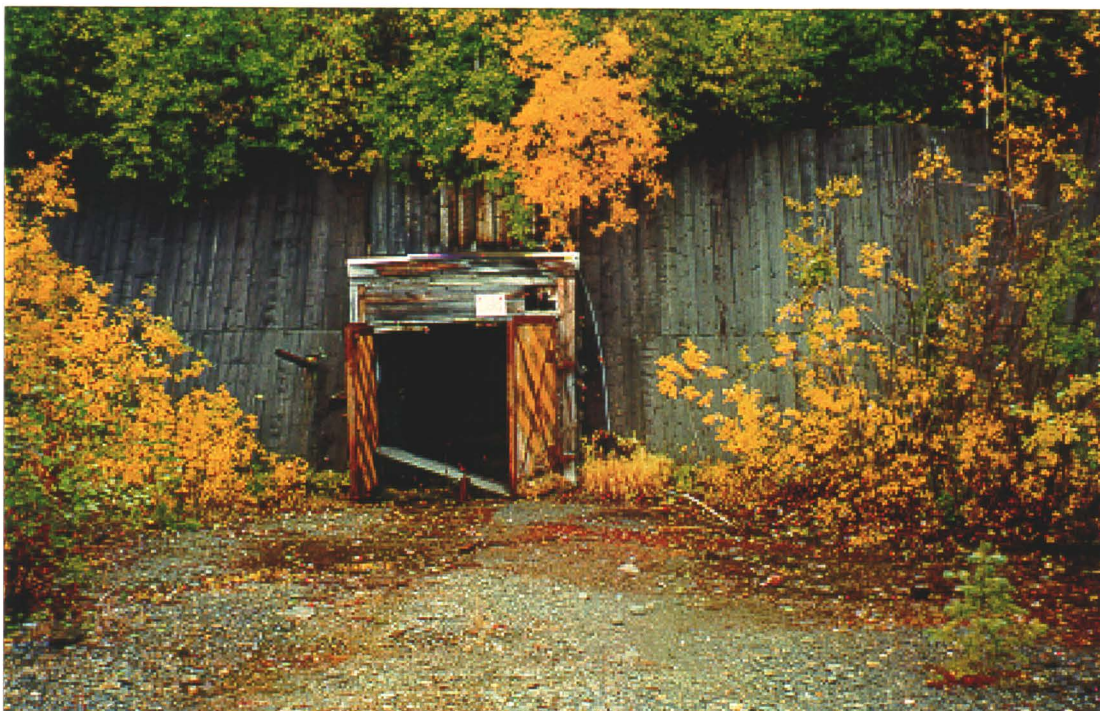
200 Level Adit (Photo 4-1)

The adit has dimensions of 2.5 m x 2.5 m; mine drawings show the adit to be 300 meters long with 960 m of drifting off it. The portal is wood frame construction with timber cribbing blocking any access into the mine. The talus around the portal is retained by 5 m high wood frame walls. The construction appears stable. The rails and any mine services have been removed.

Photo 4-1: Photograph of the adit at Dixie Mine, note the portal entrance has been blocked off with timber cribbing. (Azimuth 145°)

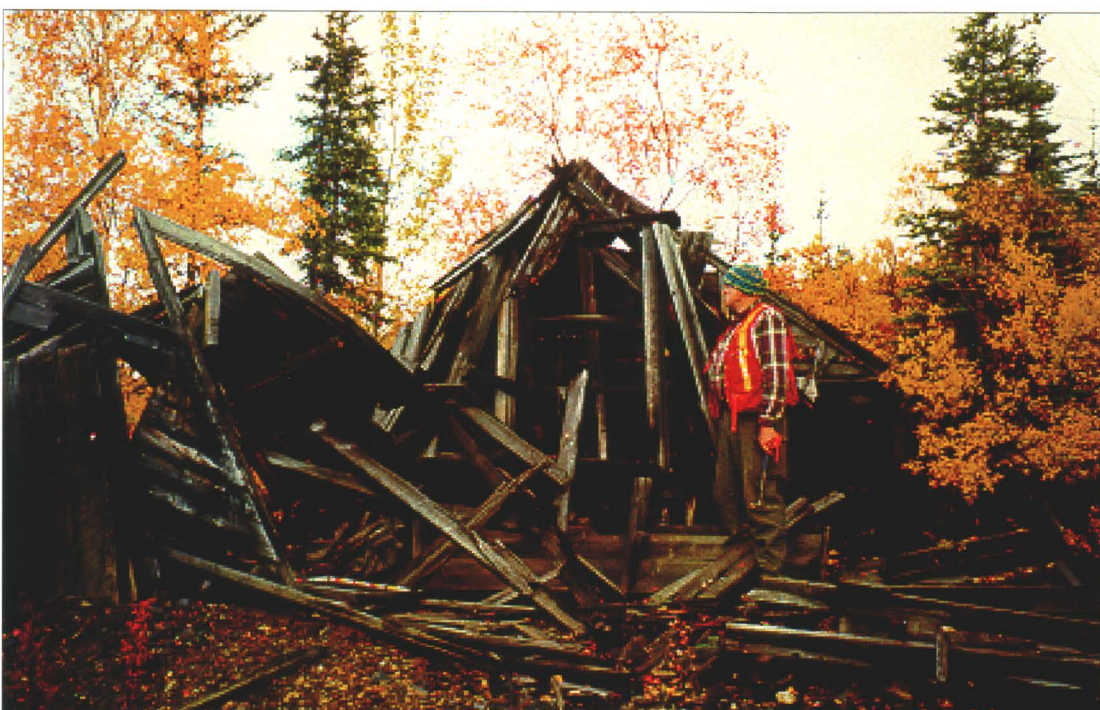
#### Dixie Shaft (Photo 4-2)

The shafthouse (4 m x 5 m) is wood frame construction and has collapsed. The shaft dimensions are 1.2 m x 2 m, the lagging has partially collapsed and the shaft appears to be filled with water and soil ~3 m below ground level. This site should be considered a hazardous area.

Photo 4-2: Collapsed structure above raise. The raise is located at the intersection of the powerline and roadway approximately 500m above the main Dixie site. (Azimuth 95°)

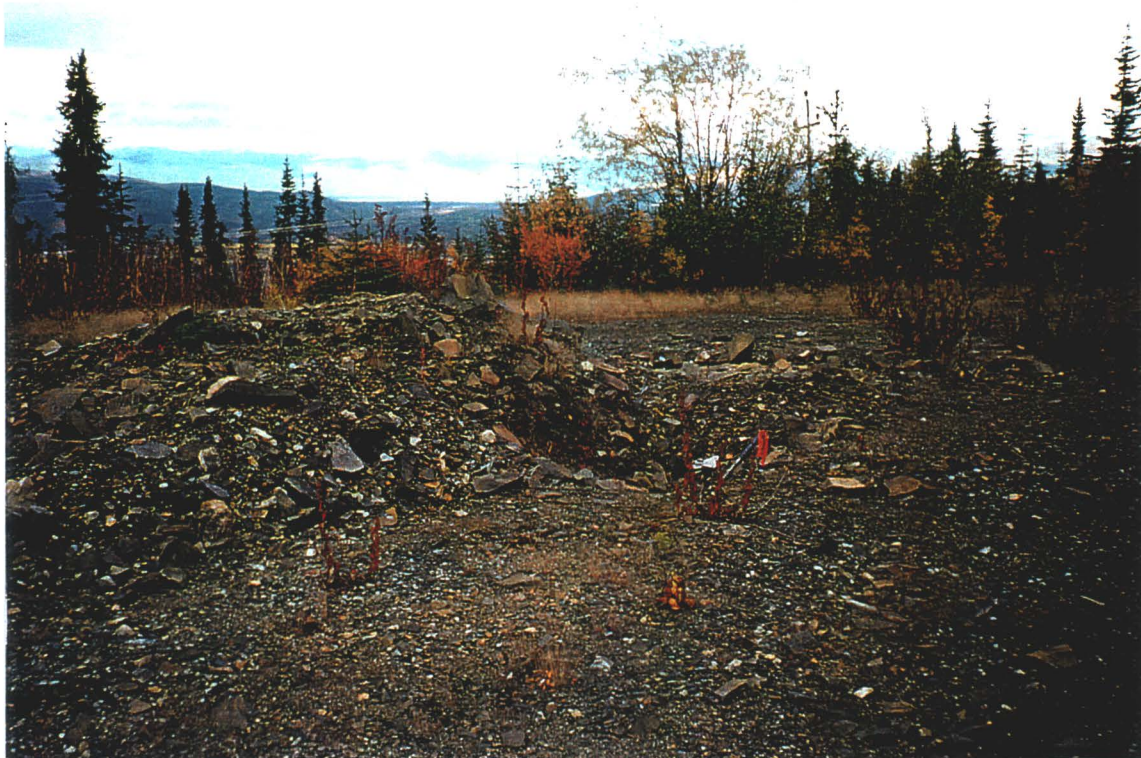
##### Eastern Raise (Photo 4-3)

The raise has been backfilled and any surface installations removed. The level pad area is 50 m x 30 m.

There is minor subsidence 2.5 m in diameter by 1 m deep. The raise poses a minimal hazard.

Photo 4-3: Eastern raise of the Dixie mine site. Magnesium staining is evident on the vein rocks. (Azimuth 25°)

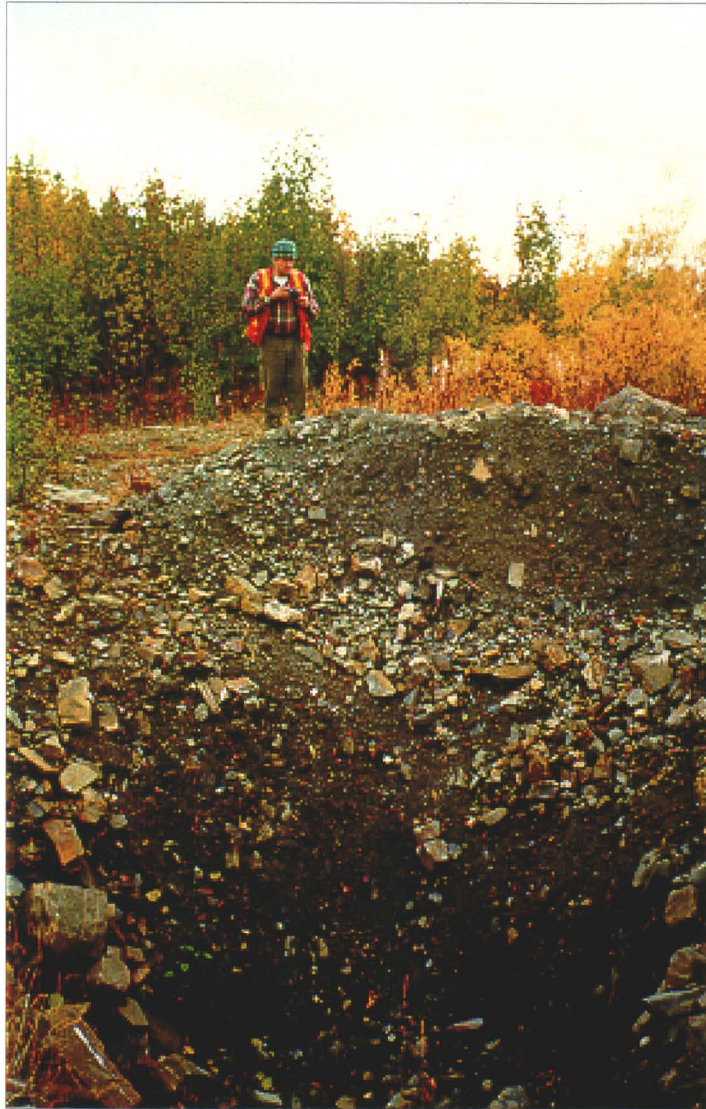
##### Western Raise (Photo 4-4)

The raise has been backfilled and any surface installations removed. The level pad area is 50 m x 50 m.

There is an area of subsidence 5 m in diameter by 3 m in depth. The raise poses a minor hazard.

Photo 4-4: Photo of the collapsed western raise located directly above the main Dixie site. (Azimuth 210°)

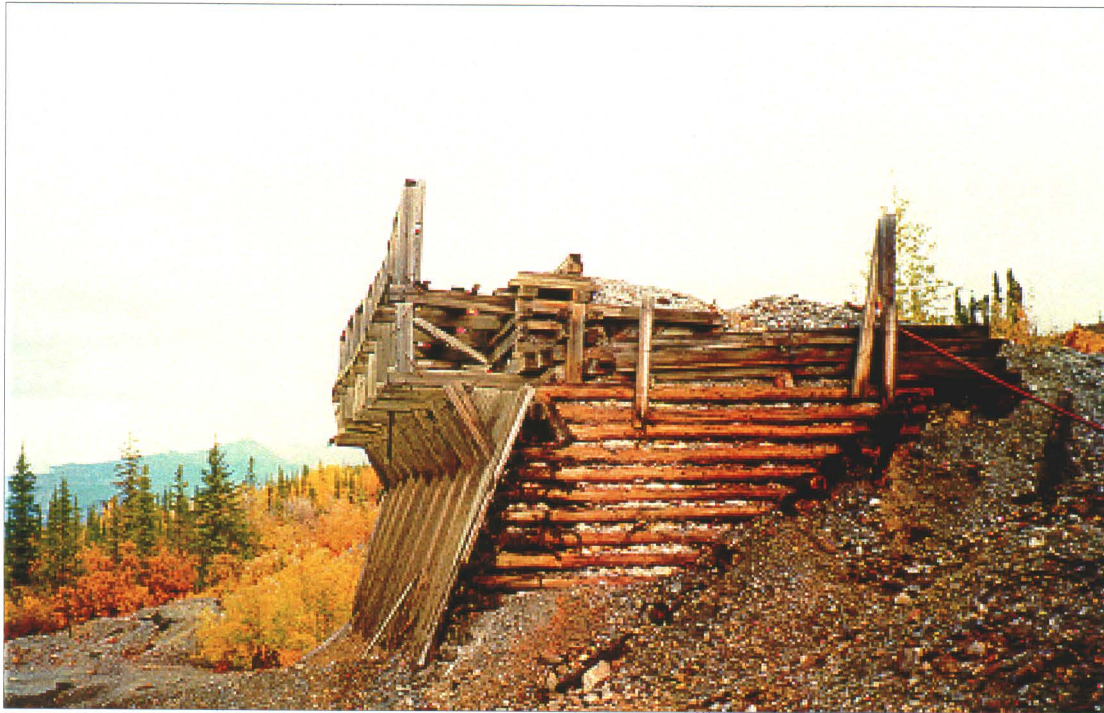
There were two buildings located on the Dixie mine site. One of the structures was used as a garage and office and the other structure was the portal to the mine. A loading area is located on the Dixie mine site and is constructed of timber cribbing and a timber reinforcement wall (photo 4-5).

Photo 4-5: The loading area at the main Dixie mine site. (Azimuth 80°)

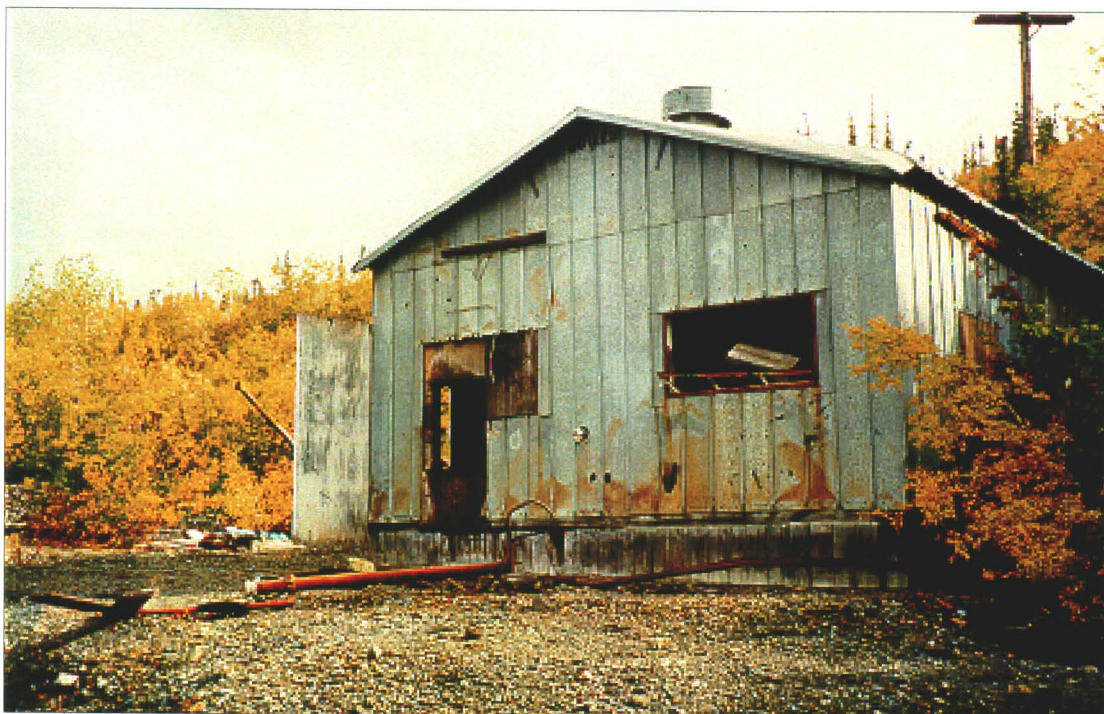
Construction: The building is of wood frame construction with metal sheathing on the exterior and roof. Tile flooring is located throughout the office. The garage area has a soil and gravel base with some areas stained with hydrocarbons.

Paint: The interior was painted white, however, the paint has faded and flaked off over the years and there are only small areas that remain adhered.

Asbestos: There is asbestos board in the office area of the structure. A sample of the floor tile was taken to determine potential asbestos content. The analysis is shown in the table below.

Photo 4-6: Building 4A (garage/office) facing NE. (Azimuth 75°)

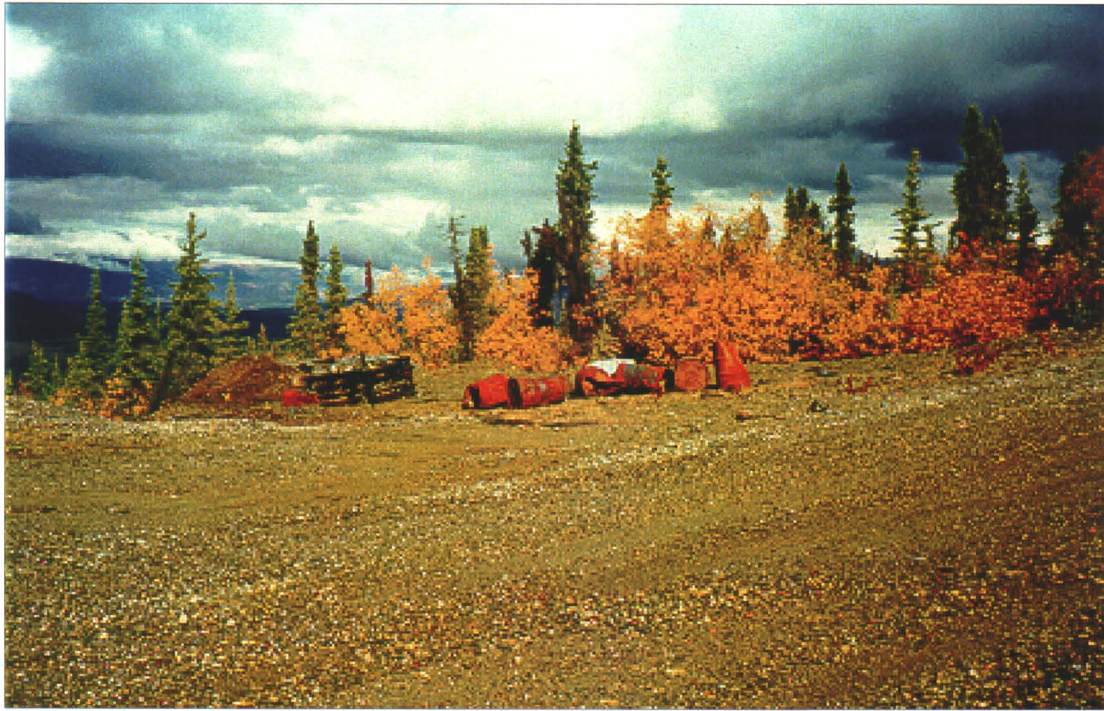
There is a small dump area that consists mostly of waste rock, however, there is also miscellaneous debris that has been deposited at the site. Most of the materials appear to be from the dismantling of equipment at the site such as rails and ties from the tracks and old fuel drums. The drums were inspected and all were empty, rusted and void of any interior residues (photo 4-7).

Photo 4-7: Empty barrels at the solid waste dump site. (Azimuth 25°)

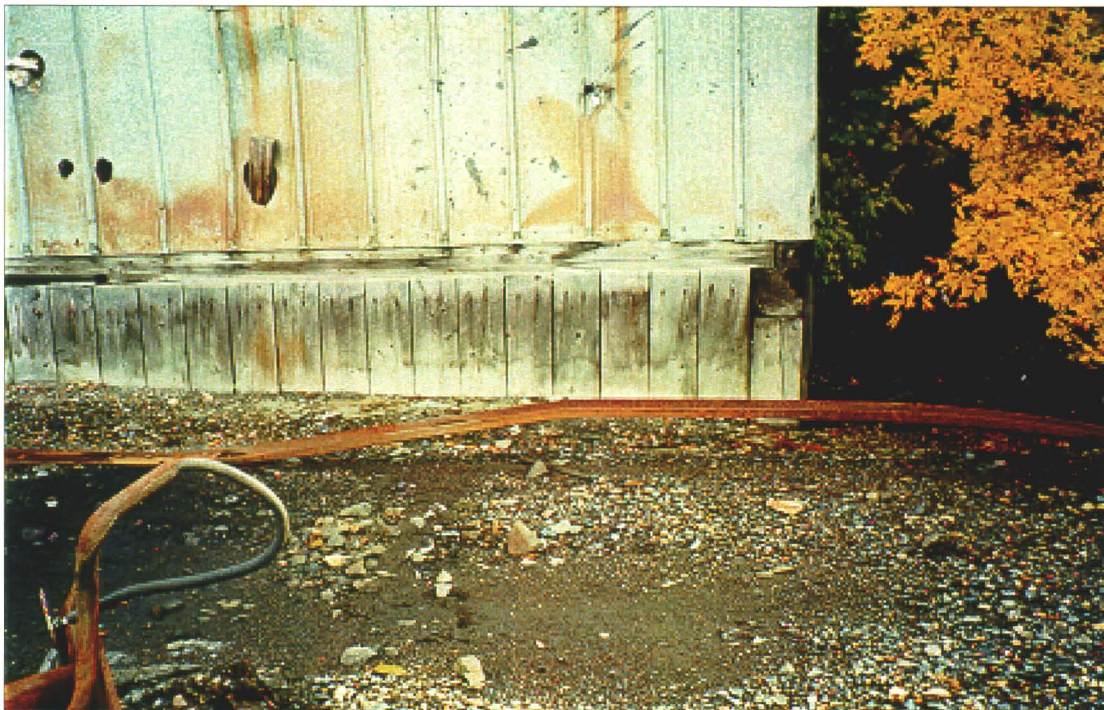
Soil staining was visible at the site both in the garage and around the exterior of the garage. The largest area of staining was located along the north wall of the garage and measured 5m in wide and 2m in length. Another smaller area of staining was noted on the west side of the building. Both areas appeared to be limited to surficial soils and were caused by heavy machinery maintenance procedures (photo 4-8).

Photo 4-8: Stained soil on the west side of building 4A. (Azimuth 135°)

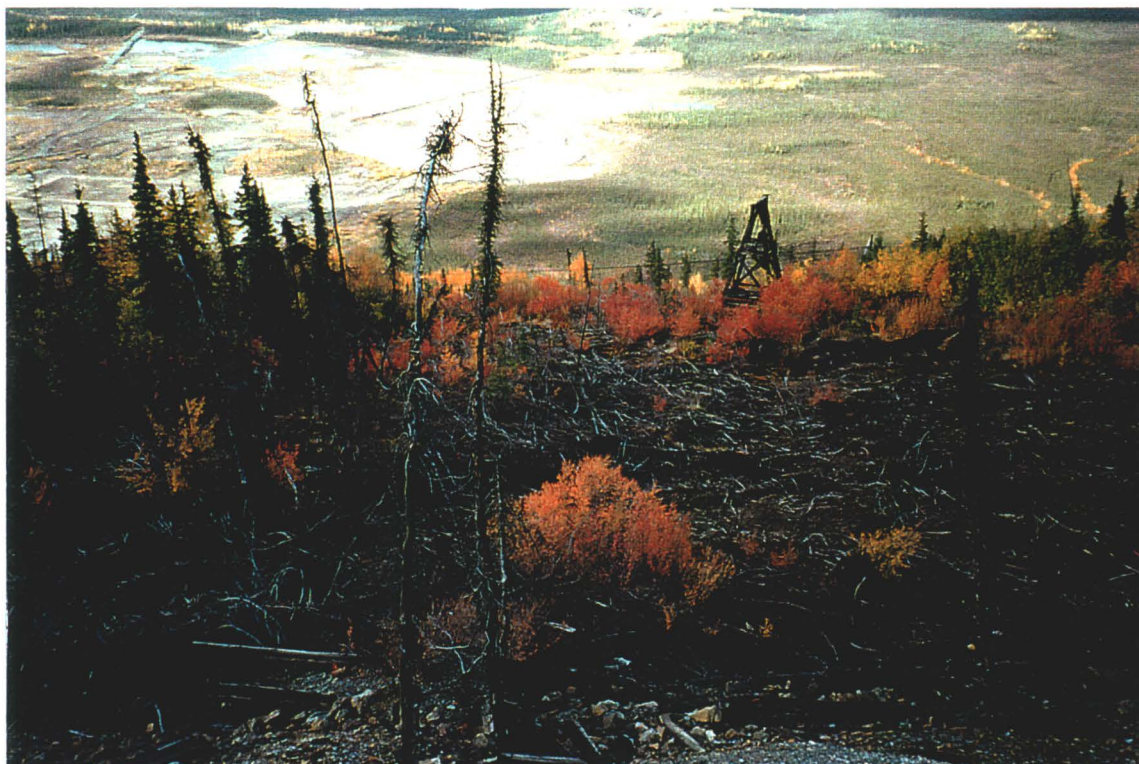
Comprised of vein material overlying development waste rock and the quartzite excavated to collar the portal. (~18,000 tonnes). The vein material consists of brecciated quartzite, quartz stringers with disseminated pyrite and minor amounts of galena. There is no sign of any significant water flow through the dump. There is a significant kill zone below the toe of the dump. It comprises an area

of 50 m wide x 80 m downslope, it has been bulldozed in the past (Sept. 14 F04-P22A). Minimal revegetation has occurred.

There was sparse revegetation at the site, however, the waste rock dump site has had no revegetation. A large kill zone exists below the waste rock dump site and only sparse vegetation re-growth has occurred (photo 4-9).

Photo 4-9: The kill zone associated with the waste rock dump site. (Azimuth 320°)
