**CORAL WIGWAM #5**  
**(MINFILE# 105M 001C)**

Public Works And Government Services Canada Travaux publics et Services gouvernementaux Canada Architectural & Engineering Services Western Region	designed by: conçu par: drawn by: C.S.	date: Nov. / 99
	approved by: approuvé par:	revisions:
Drawing title: <b>Coral &amp; Wigwam Site #5 Site Assessment</b> Yukon Territory	Titre du dessin:	project no. no. du projet: 125-12.01
		desig. no. dessin no.: 1 of 1

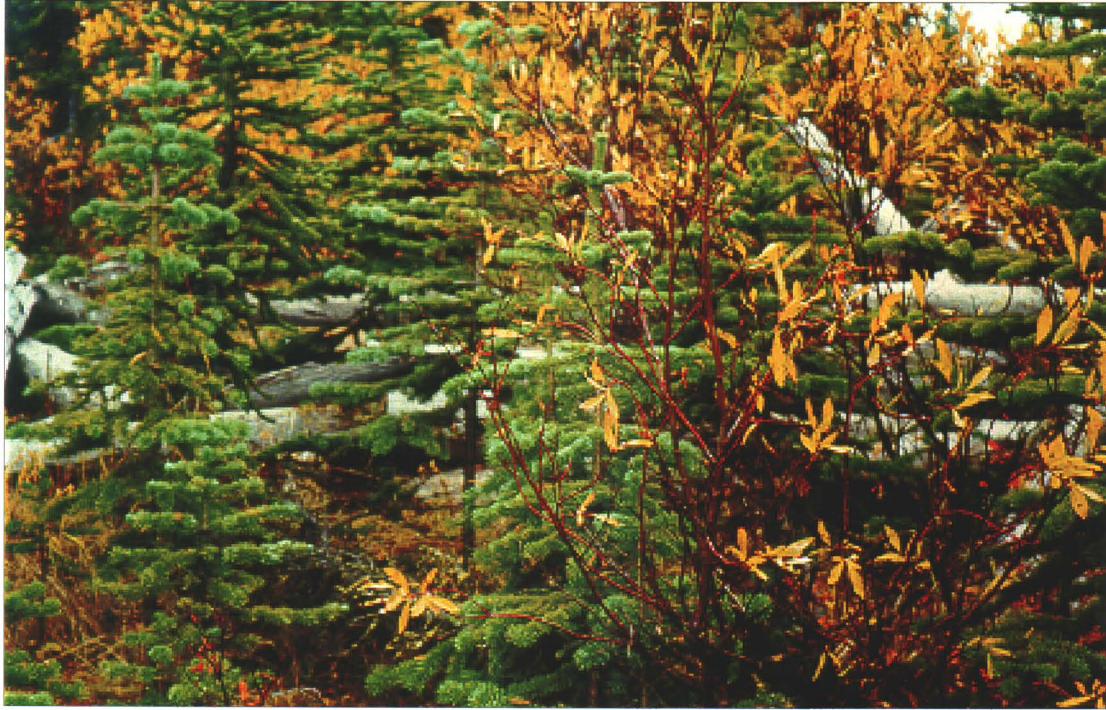
Building 5A – Residential (collapsed)

Building has collapsed and deteriorated.

Photo 5-1: Building 5A - Building was of log construction has deteriorated and collapsed.

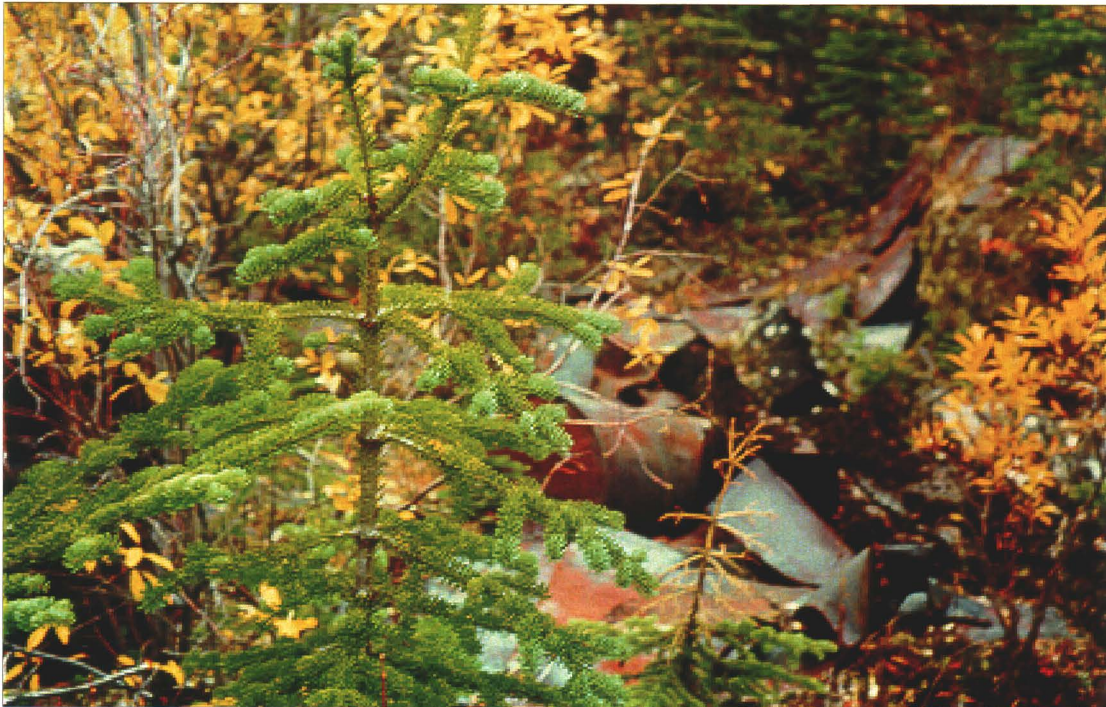
Building 5B

Building has burnt and collapsed.

Photo 5-2: Building 5B - Building had collapsed and burnt - metal debris appeared to be burnt.

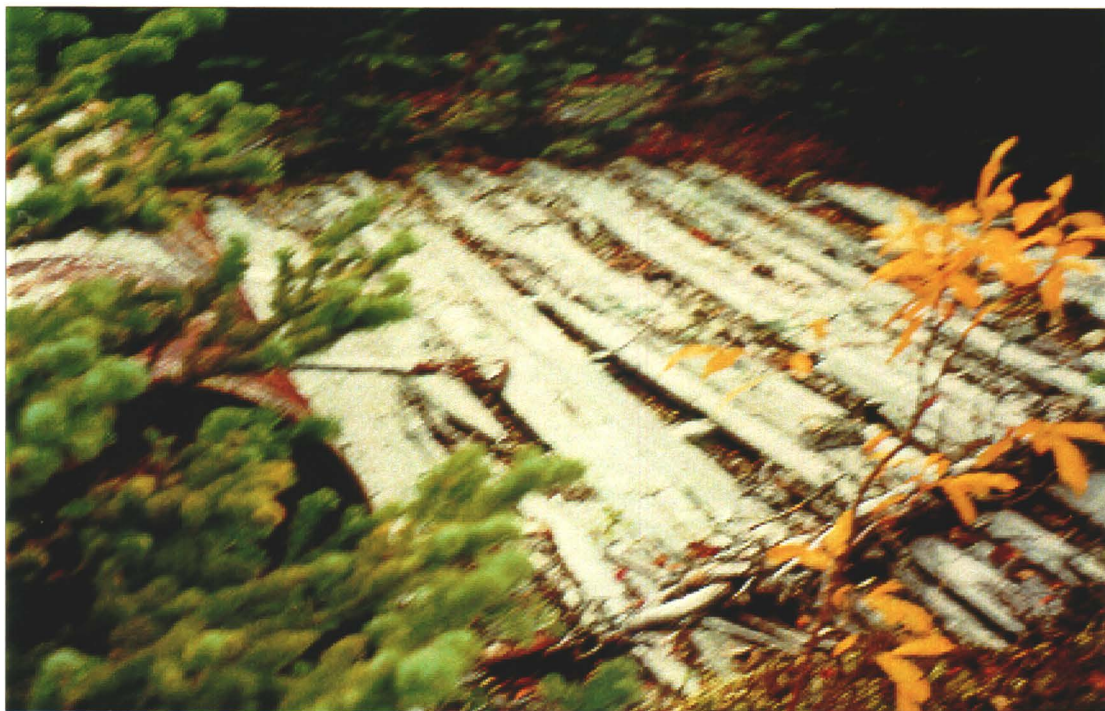
There is only wood plank floor remnants left at the site. A drum utilized as a stove was situated in the corner of the building site.

Photo 5-3: Building 5C - Building has collapsed and only plank flooring is evident.

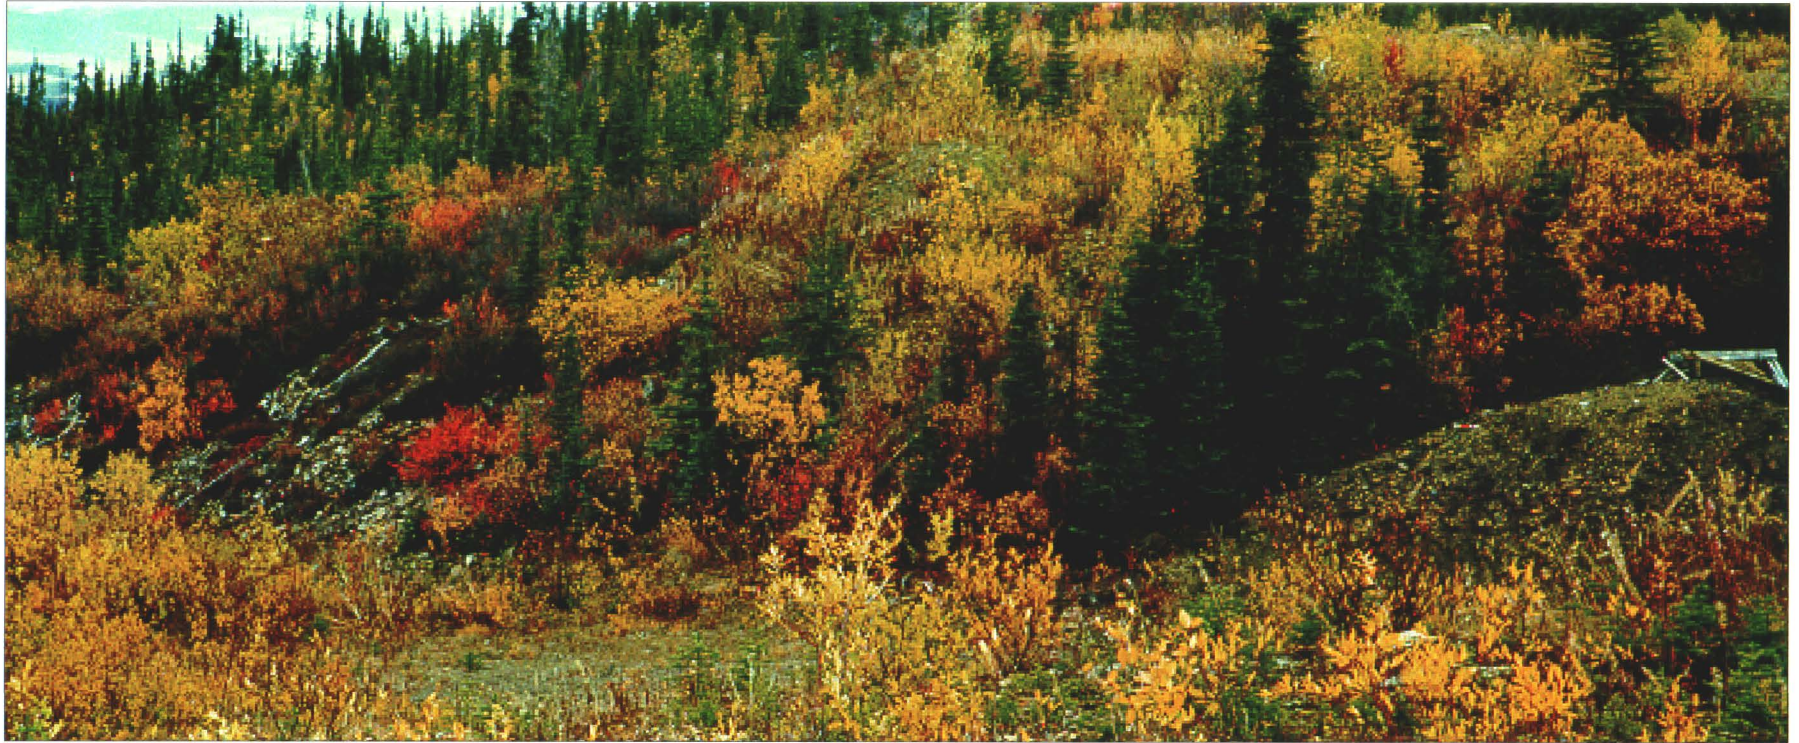
The structure was utilized as a shaft house, however, it has collapsed and deteriorated and is a safety hazard.

Photo 5-4: Trenched area below the collapsed shafthouse (shafthouse debris can be seen on the far right of photo).

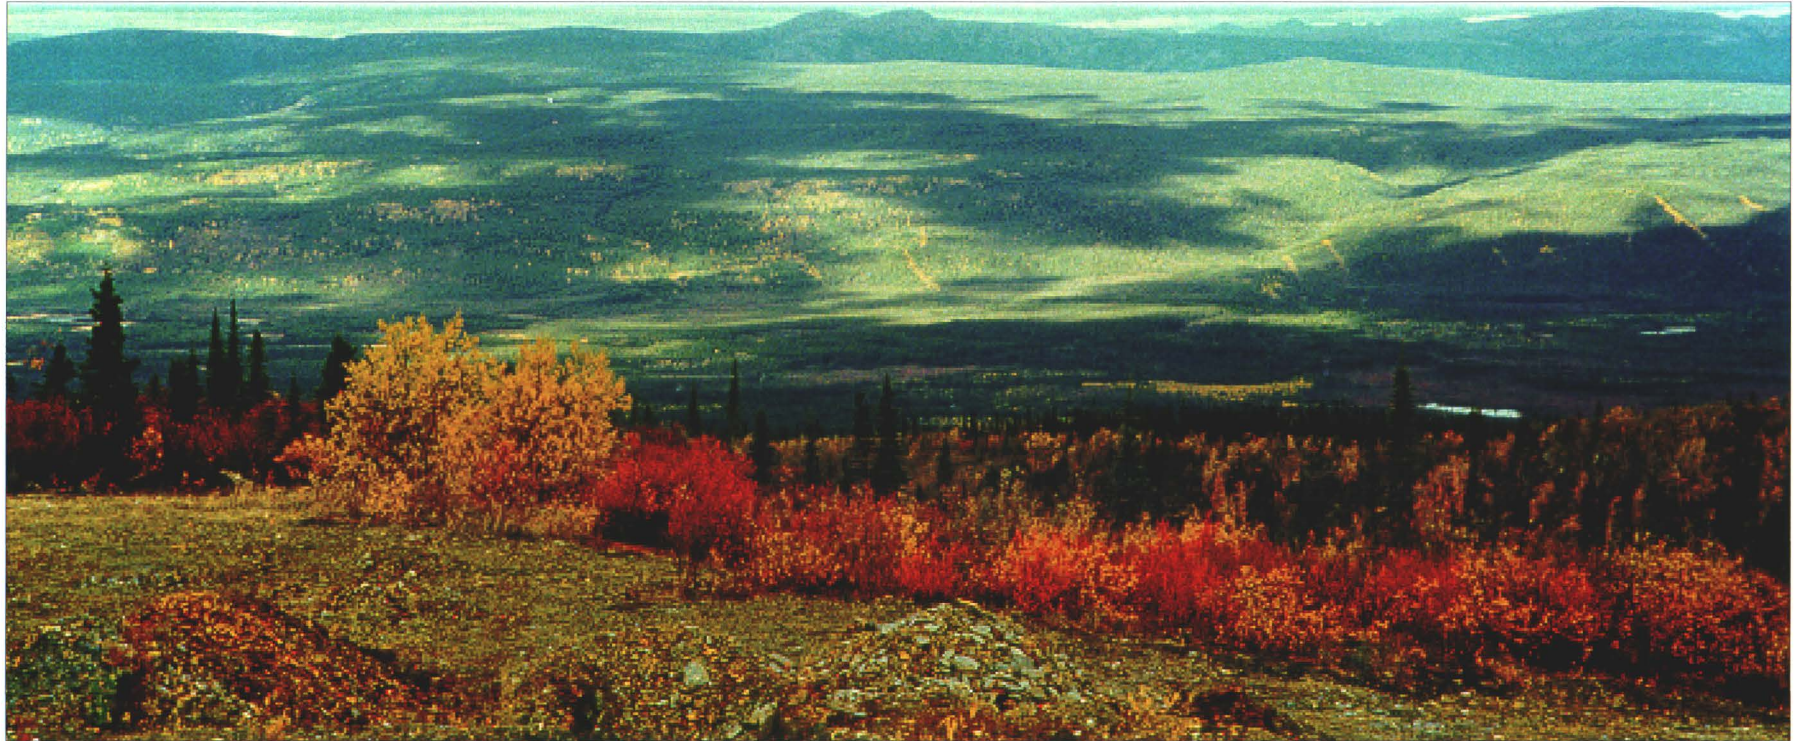
There are seven backhoe trenches in the stripped area. They are 1.5 to 2 m deep by 2 to 3 m wide and from 10 to 15 m long. The material taken from the cuts is piled alongside the trenches. The trenches present a minor hazard.

Photo 5-5: Small trenched areas can be noted in the foreground of the photo within the leveled area of the waste rock dump.

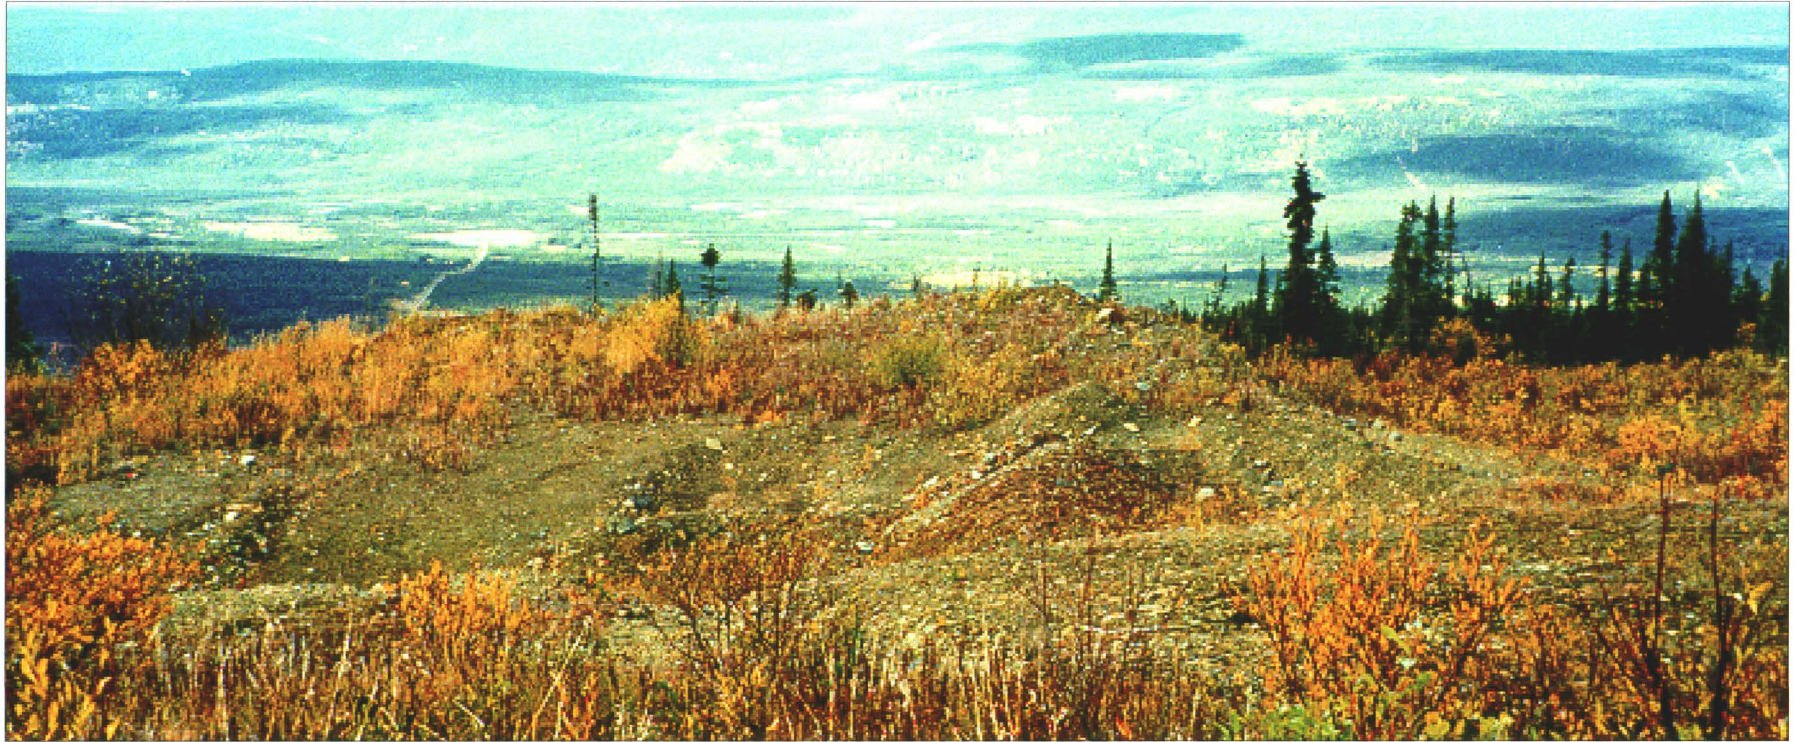
Photo 5-6: Trenched area is on the southwest portion of the Coral and Wigwam site.
