BERMINGHAM (# 6)
(MINFILE# 105M 001,d,e)

RUBY 400 #6
(MINFILE # 105M 001 d,e)

Public Works And Government Services Canada Travaux publics et Services gouvernementaux Canada Architectural & Engineering Services Western Region	designed by: conçu par: drawn by: dessiné par:	C.S. Nov. / 99	date:
	approved by: approuvé par:	revisions:	project no. no. du projet:
Drawing title: Birmingham & Ruby (Arctic & Mastiff) Site #6 Site Assessment Yukon Territory	Titre du dessin:	125-12.01	dwg. no. dessin no. 2 of 2

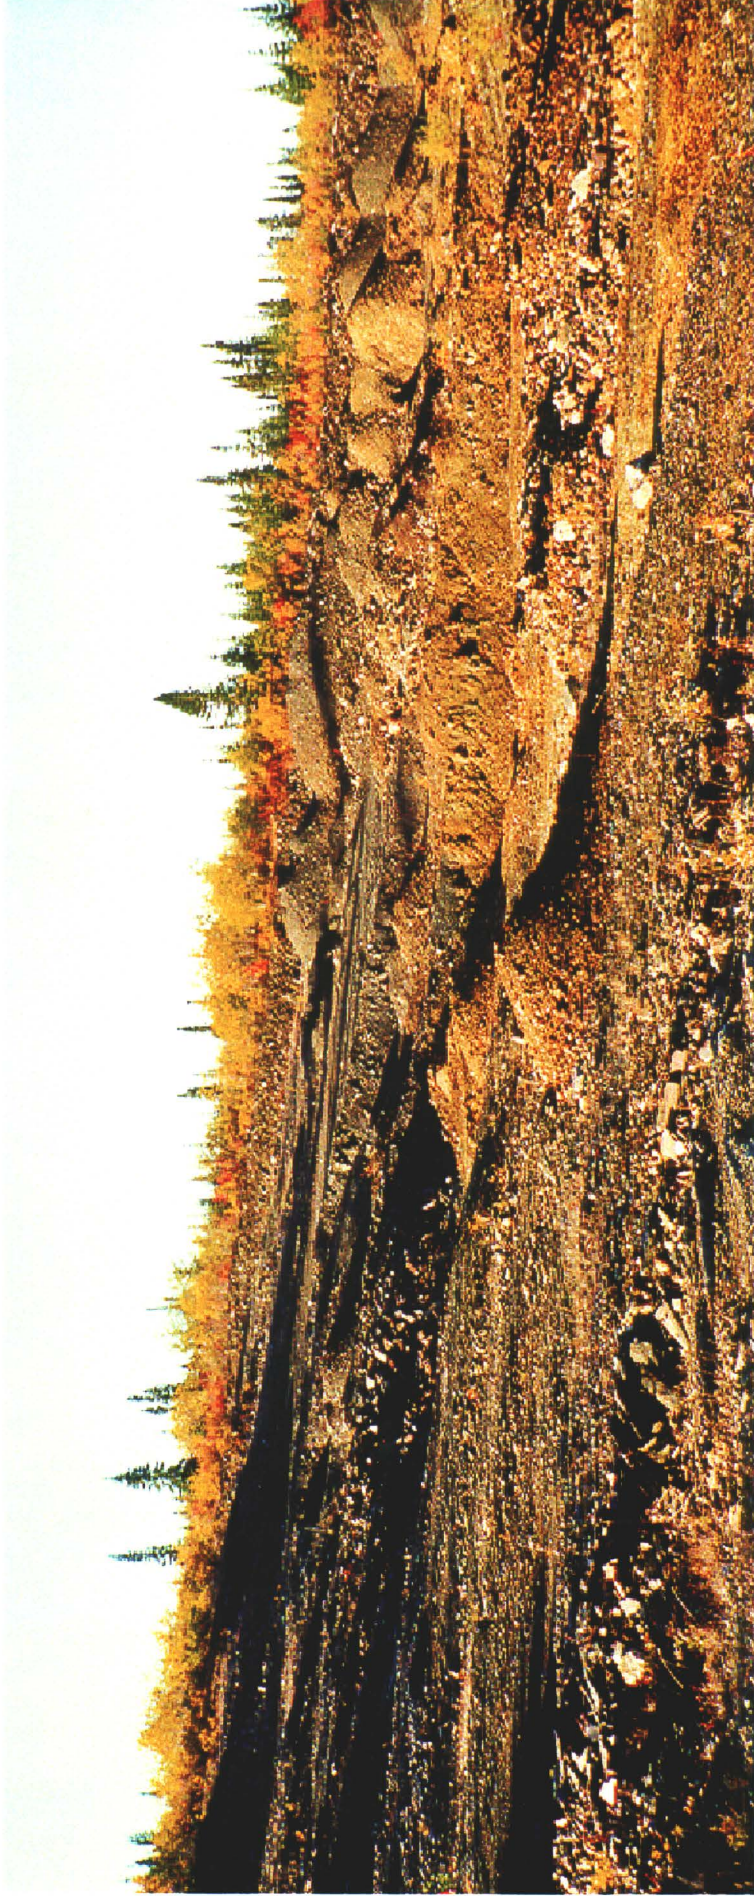
Stripped area (100 m x 250 m) located ~150 m southwest of the Birmingham SW pit, contains 6 backhoe trenches with exposed veins.

Photo 6-1 : Panoramic view of trenching at Bermingham Pit. (Azimuth 210^o)

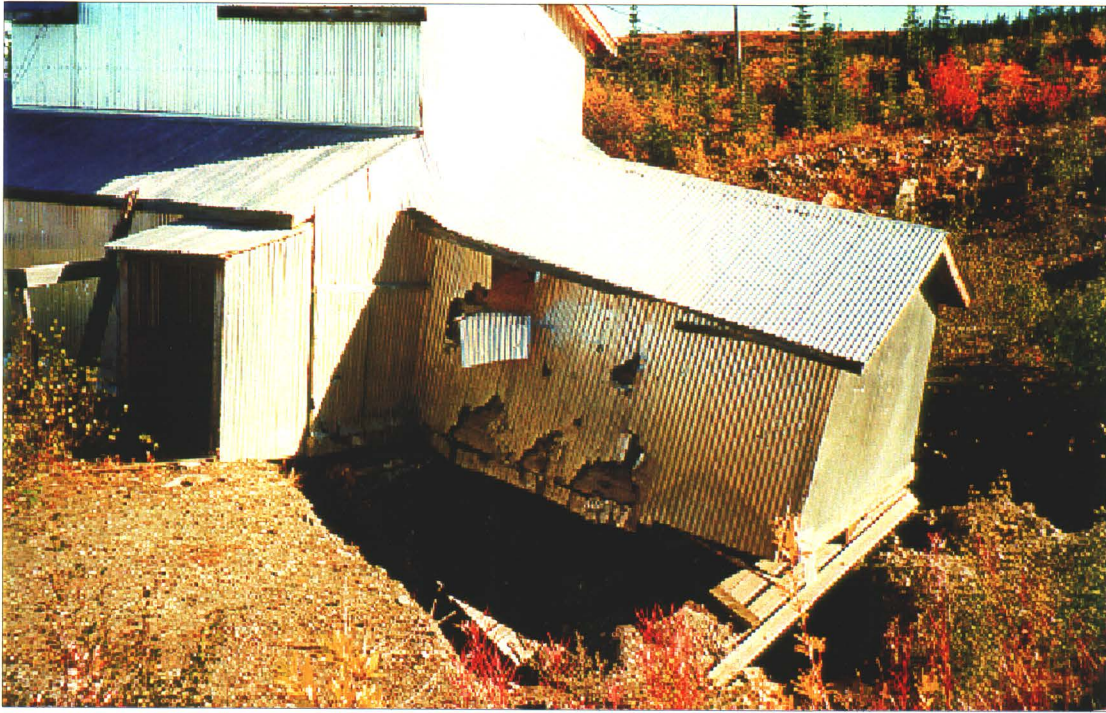
The building is a shafthouse that has partially collapsed over the shaft.

Hazardous Contents: There were two barrels with lubricant labels, however, it is not known if the barrels contained any product as the building has become a safety hazard and was not entered during the site investigation. Some rags stored in pails appeared to be stained with hydrocarbon product.

Photo 6-2 : Ruby Shaft. South portion of shaft house over opening has collapsed.

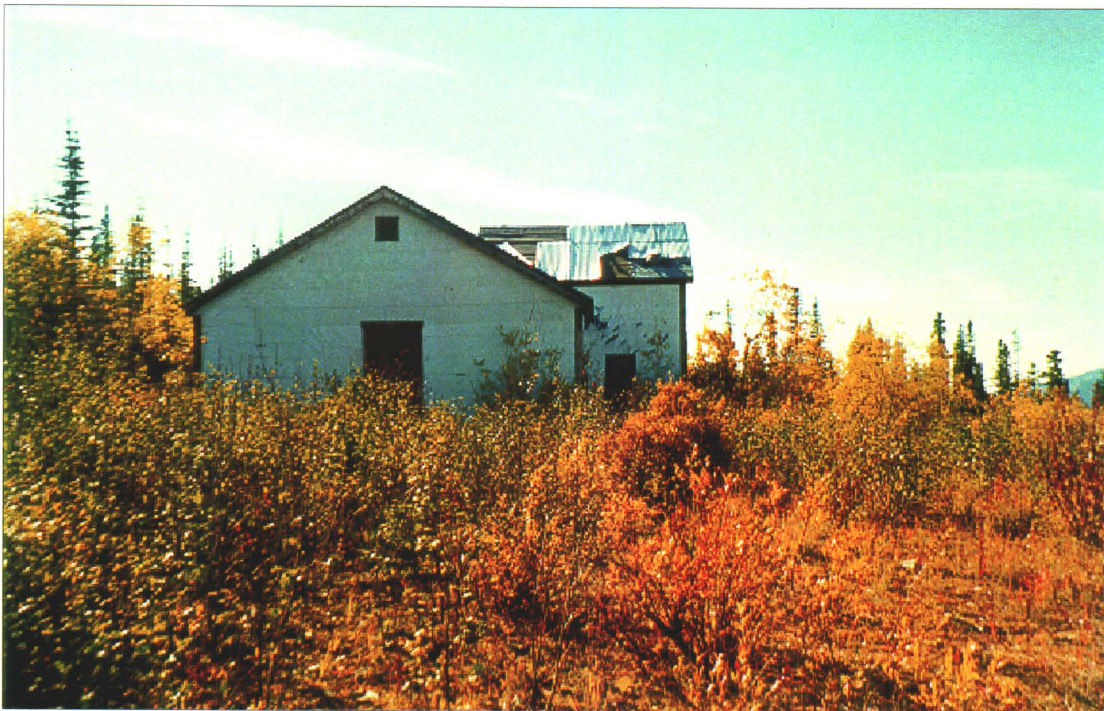
This structure served as the explosives magazine and the detonator house. The detonator house appeared to be of newer construction than the adjoining explosives magazine. The timber plank walls had been partially removed in both buildings.

Photo 6-3 : Bermingham Pit. Building 1. Explosives magazine. (Azimuth 235°)

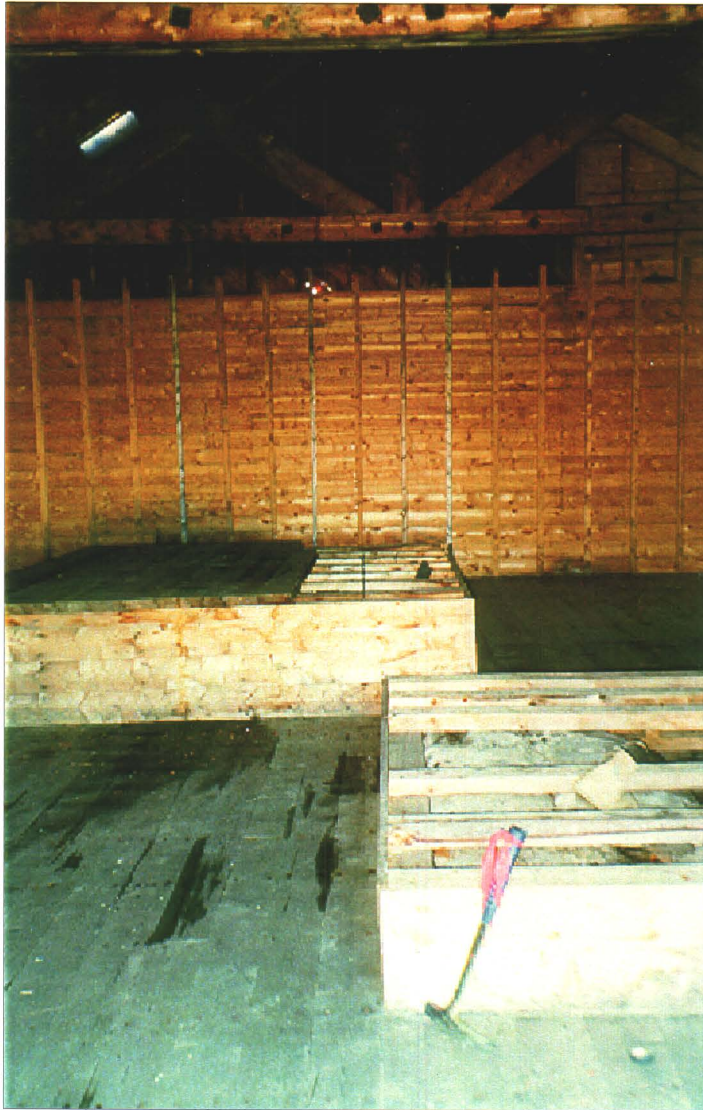
Construction: The building is wood frame construction and the interior walls are fortified with sand (photo 6- 4).

Photo 6-4 : Bermingham Pit. Building 1. Interior of explosives magazine. (Azimuth 225°)

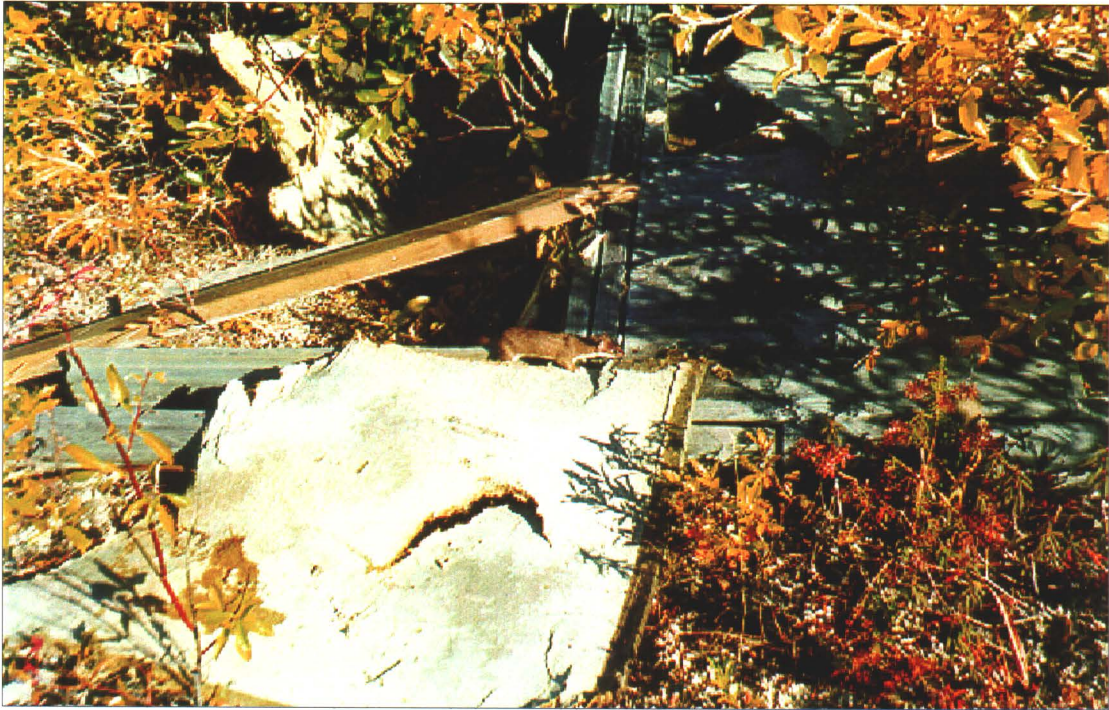
The structure appears to have been residential.

Dimensions (L x W x H): The building has collapsed.

Photo 6-5 : Bermingham Adit.

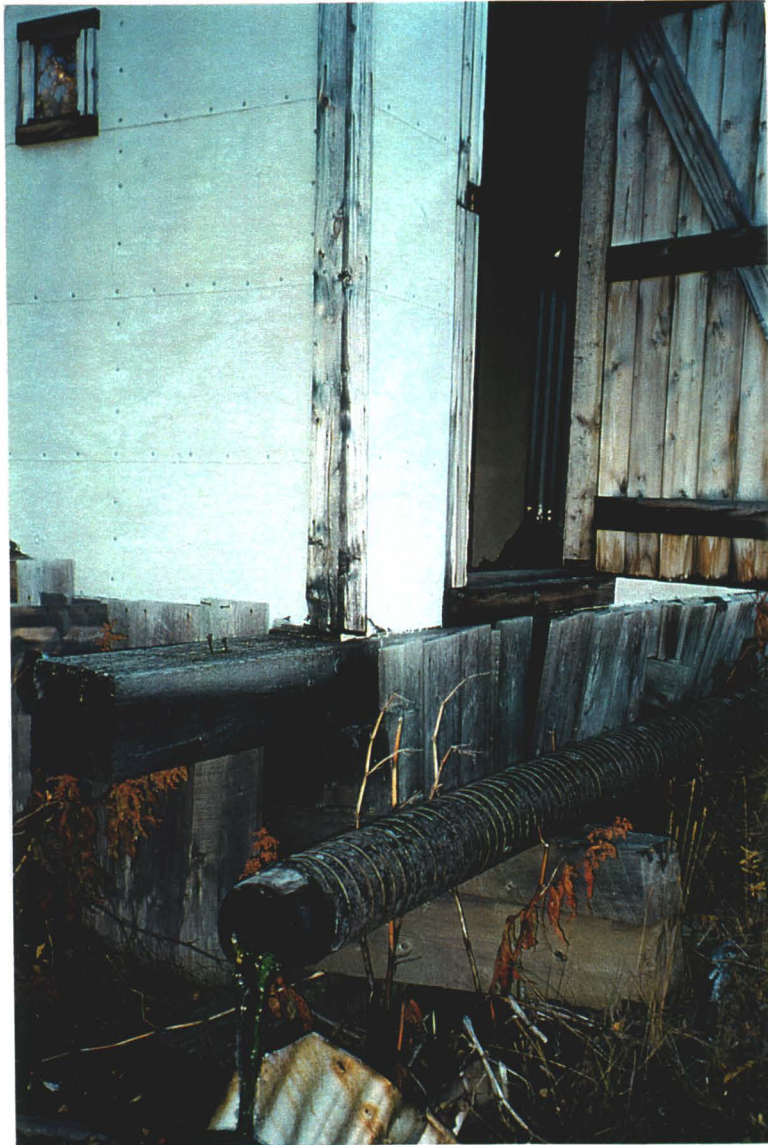
The function of the building was to heat water and pipe it down gradient to avoid ice build up.

Photo 6-6 : Bermingham Adit. Wooden pipe extending from Building #3. (Azimuth 160°)

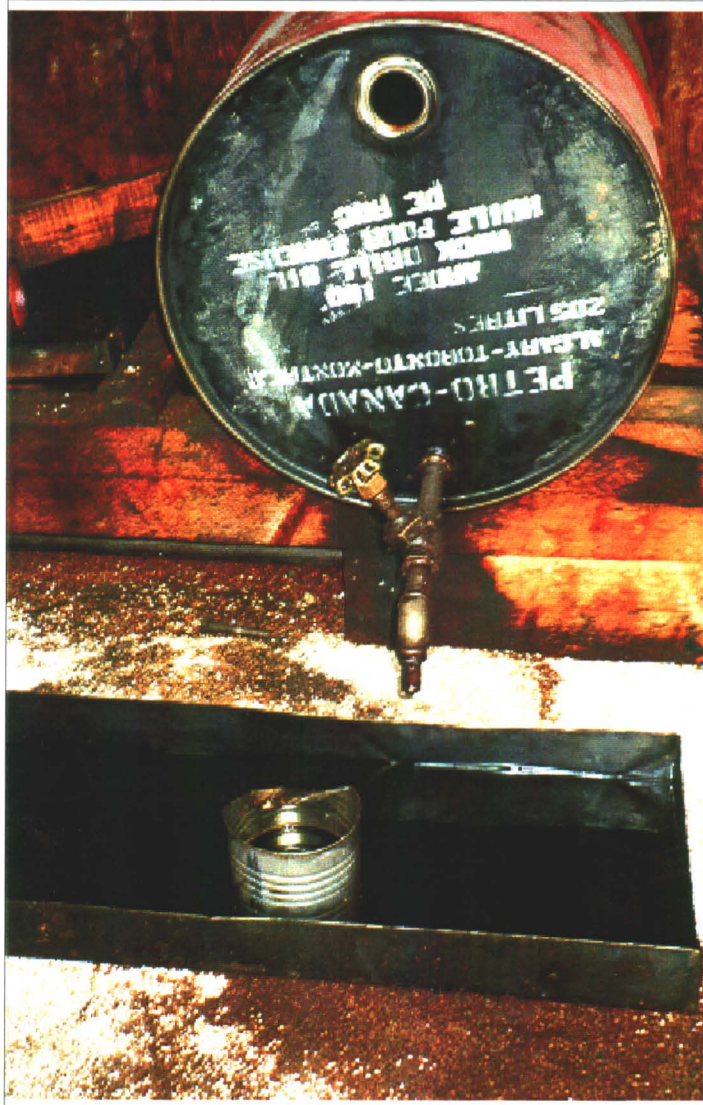
Non-Hazardous Contents: There were two barrels inside the shack. One of the barrels was utilized for heating the water and the other barrel was empty (photo 6-7).

Photo 6-7 : Bermingham Adit. Interior of Building #3.

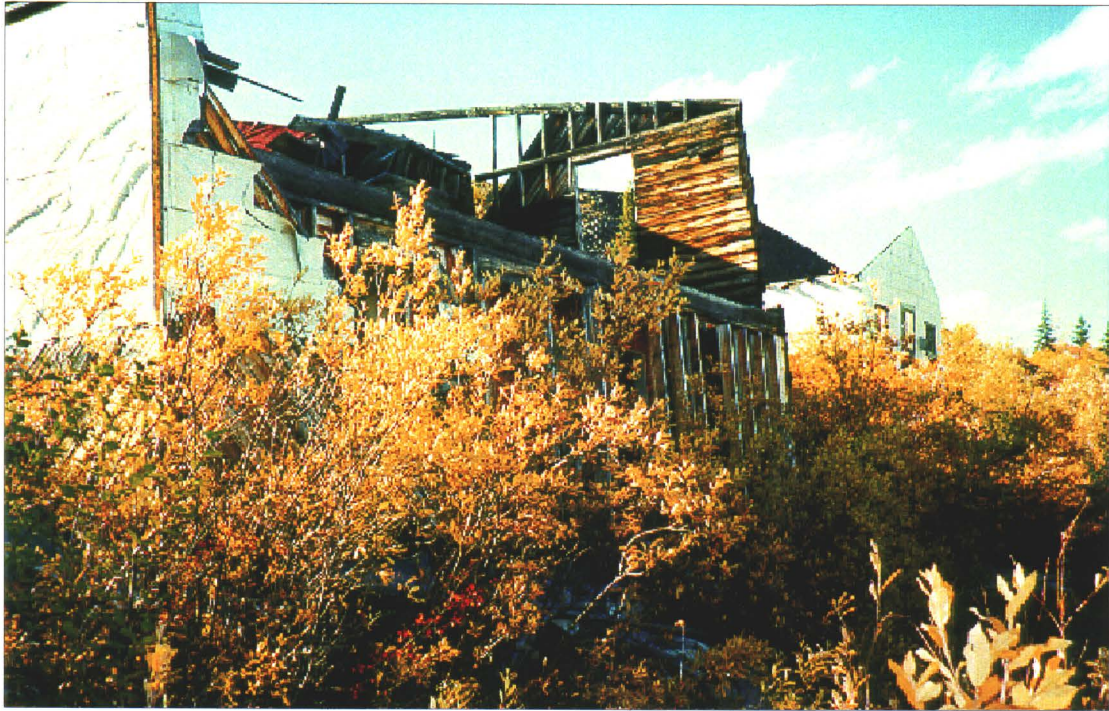
Note: Both building 6E and 6F have deteriorated and were unsafe to enter during the site investigation.

Photo 6-8 : Bermingham Adit. Buildings 4 & 5. Wood frame asphalt shingles - tar paper exterior. (Azimuth 195°)

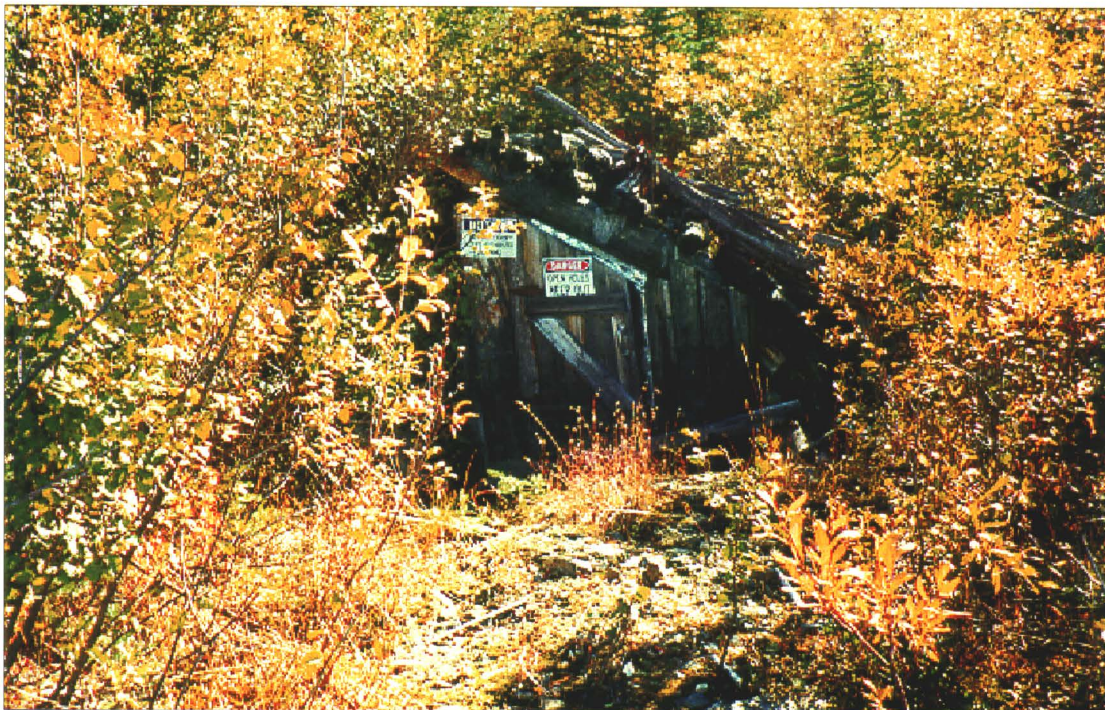
Note: The structure has deteriorated to the point that it has become a safety hazard. It appears that the shaft has collapsed into itself and there are danger signs posted on the wooden doors.

Photo 6-9 : Bermingham Adit. Portal at Bermingham Adit. (Azimuth 170°)

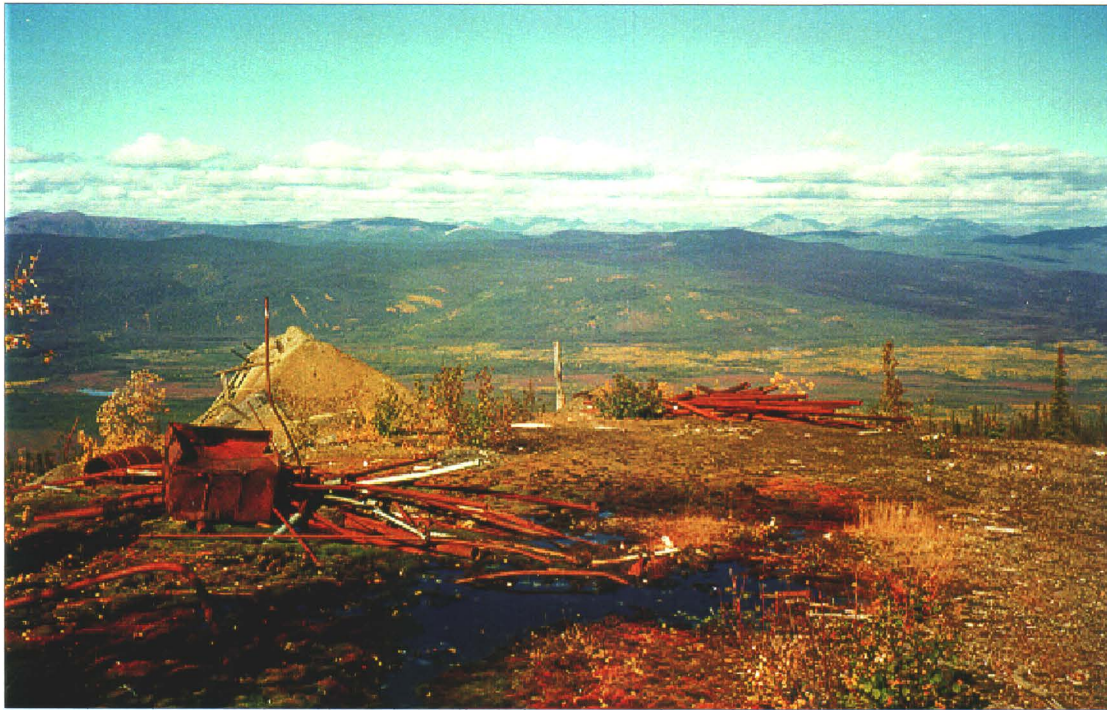
There were no rail or trestle structures at the site. There were metal tracks and associated debris piled at the site near building 6C (photo 6-10). The tramway structure is directly below the site, however, there is no indication that it was used by the Birmingham mine site.

Photo 6-10 : Bermingham Adit. Metal debris on dump. (Azimuth 325°)

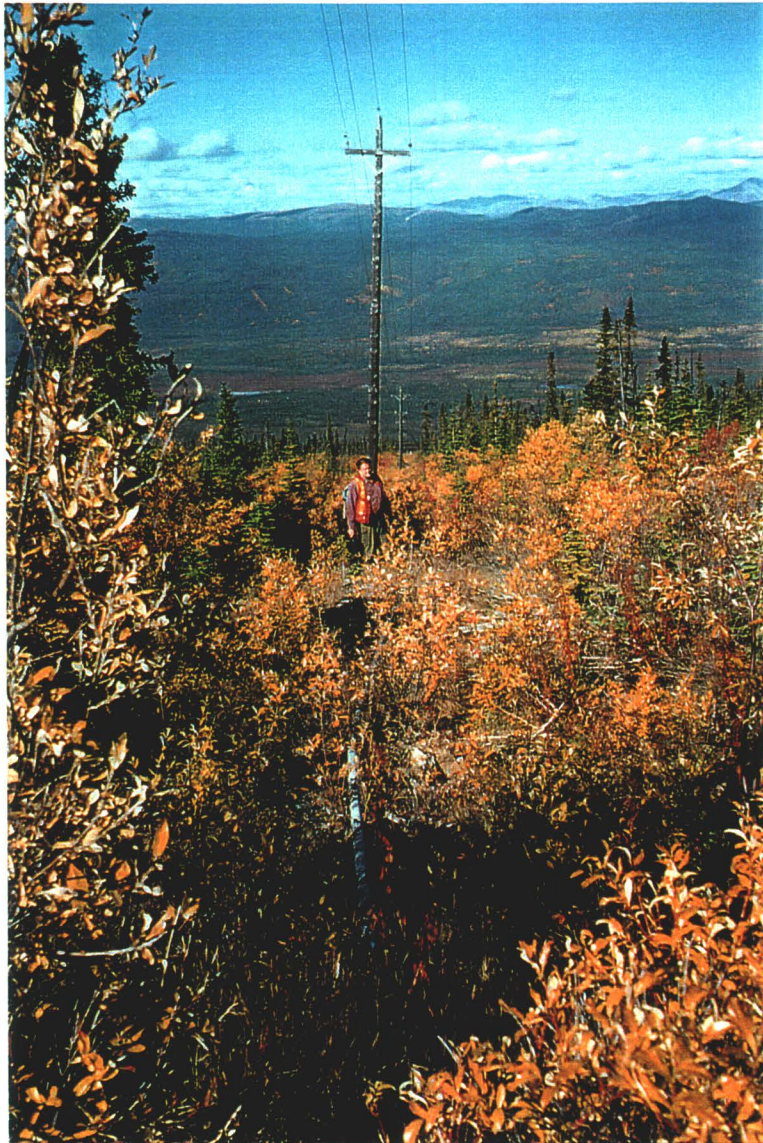
A power line extends from Ruby 400 to Birmingham and Ruby Shaft areas and is still in existence (photo 6-11).

Photo 6-11 : Bermingham Adit. Powerlines from Adit.
Also note wooden pipe extends down
along powerline.

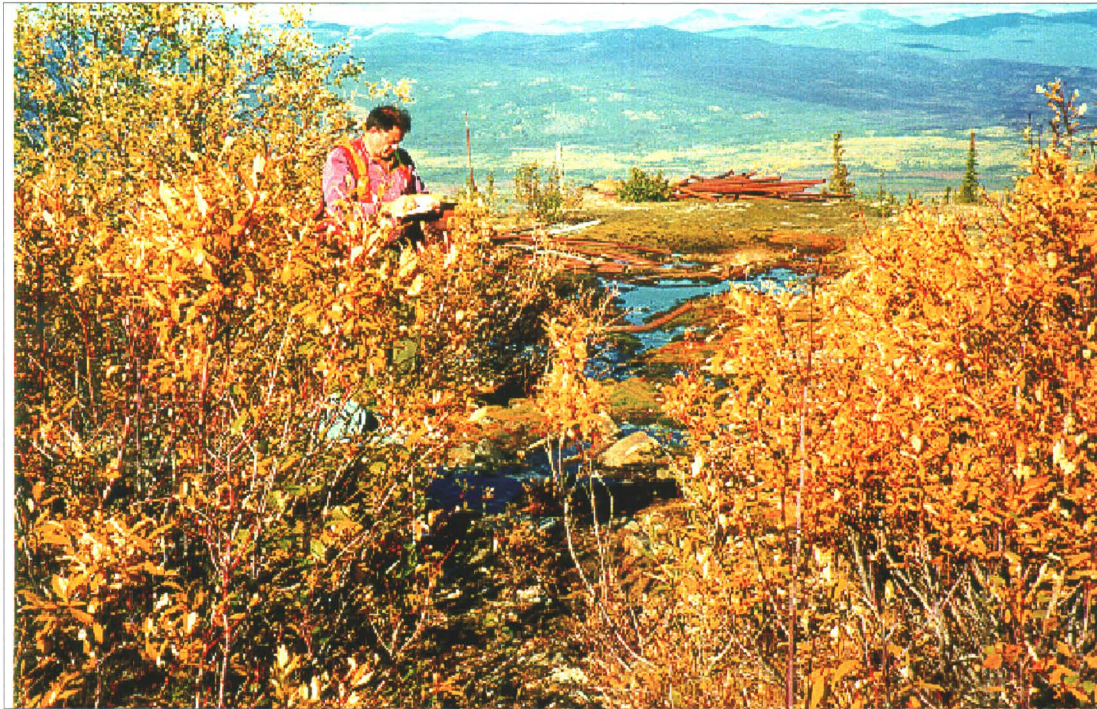
One water sample (06-01-water) was collected at the Bermingham pit from the eastern pit surface water. The second sample (06-02-water) was taken at the Bermingham adit site of discharge water from the adit (photo 6-12). The sample results can be found in Attachment B.

Photo 6-12 : Bermingham Adit. Water sample location. (Azimuth 348^o)

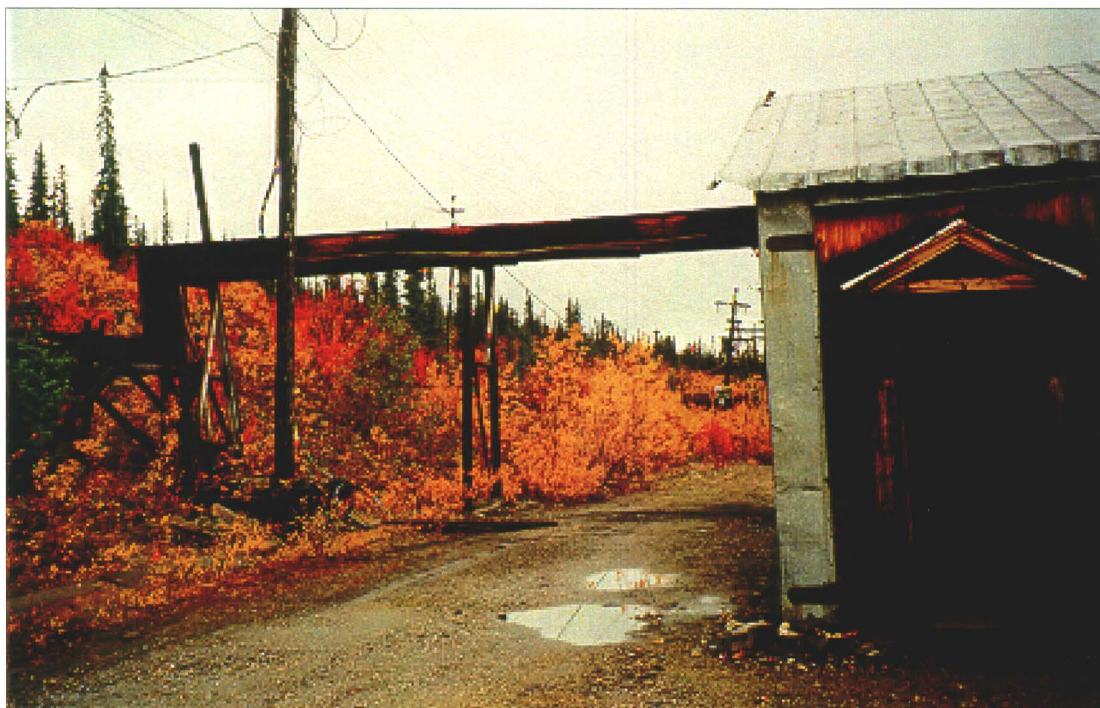
There are intact power lines at the site and it was not know if they were still in service (photo 6- 14). An old electricity-driven compressor was located at the site near the northwest corner of the dump (photo 6- 21). There is some surficial staining under the machine, possibly from remaining product residues left in the engine at the time of abandonment. Information listed on the equipment is as follows.

Photo 6-14 : Ruby 400. Utildor from adit structure to garage. Transformer compound is in the background.

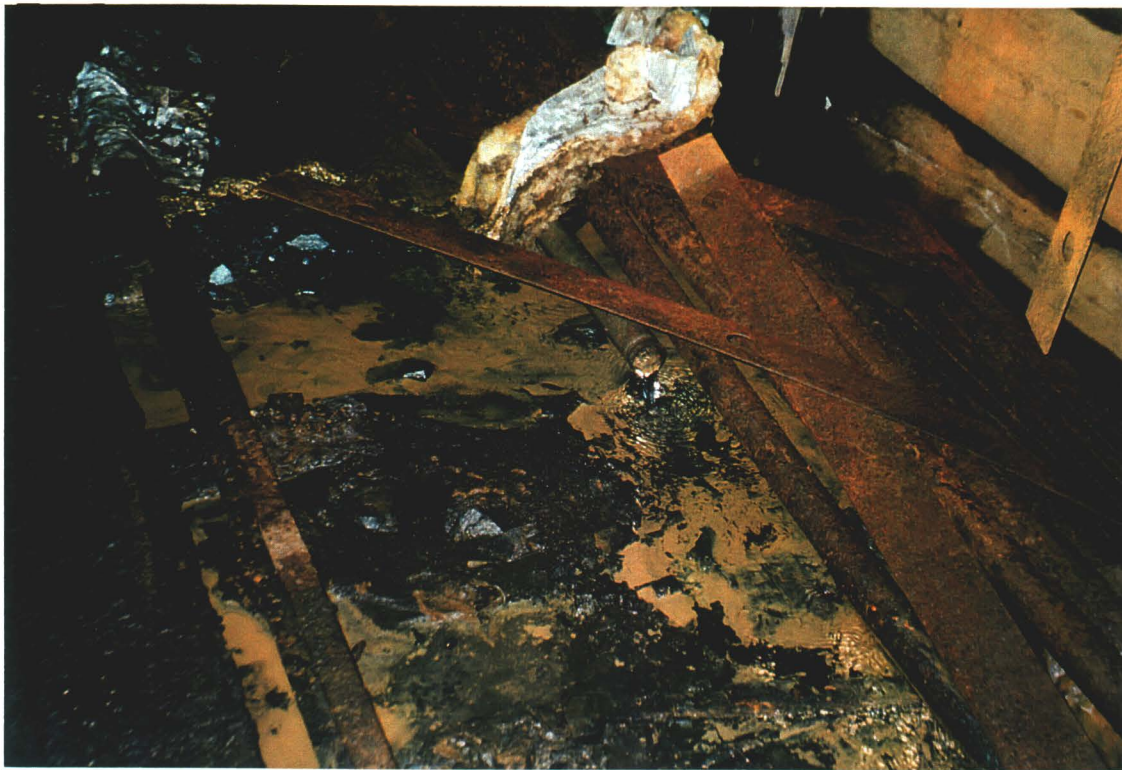
Samples: Water sample 06-03-water was taken 12m inside the adit from a pipe (photo 6-17). The sample analyses can be found in this report under Section 9. Water Quality.

Water sample 06-03-water was taken approximately 12m horizontally inside the portal. There was a discharge pipe at the sample location. Water flow at the sample location was 1.5L/s. The pH levels were 7.6 and conductivity was 43 μ S. The soils in the portal were generally silts and were stained with bright orange by precipitate. Approximately 5 cm of mud was located on the floor of the portal partially due to the melt water from an ice plug.

Photo 6-17 : Ruby 400. 12 metres into the interior of adit at sampling location.

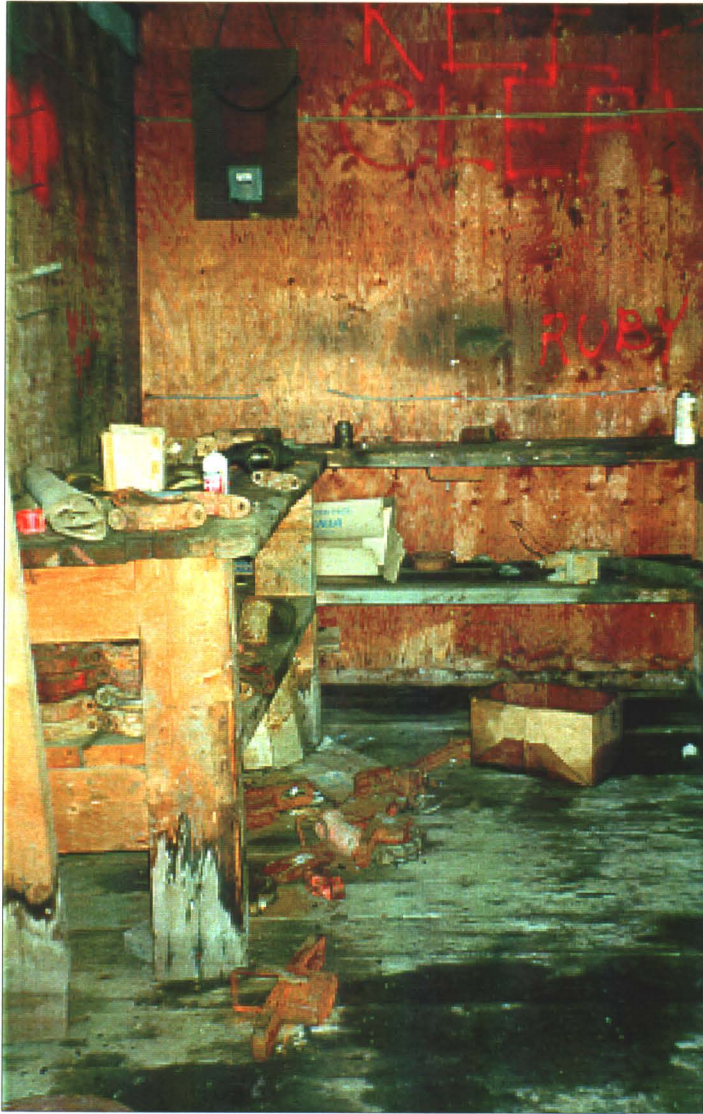
Non-Hazardous Contents: A furnace was located in the workshop with some staining evident around the base. Wood shelving with metal debris was located on two walls (photo 6-19).

Photo 6-19 : Ruby 400. Interior of the shop area of the garage.

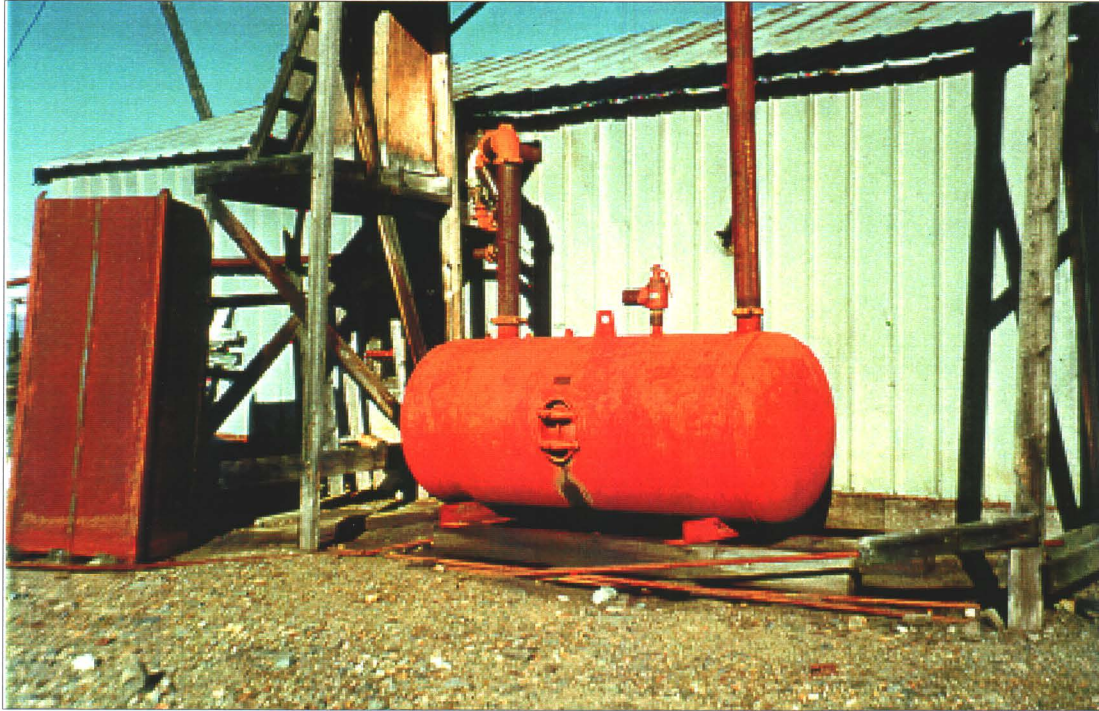
Samples: Sample 06-01-soils was taken at the north west corner of the receiving tank (photo 6-20). Sample analyses results can be found in the table listed in *6.2 Fuel Storage*.

Above Ground Storage Tanks: The tank appears to be empty, however, there may be some residue inside the tank. The tank appears to be in good condition, however, there is no secondary containment associated with the AST. There is some leakage that has occurred and the soils surrounding the tank have been stained. Sample 06-01-soils was taken to the northwest of the AST and consisted of a soil sample taken at a depth of 5 cm. Soils in the area consisted of dense, compacted fines and gravel materials. Table 1 in Attachment B indicates the sample analyses results.

Photo 6-20 : Ruby 400. Receiving tank located on the exterior wall of the boiler house.

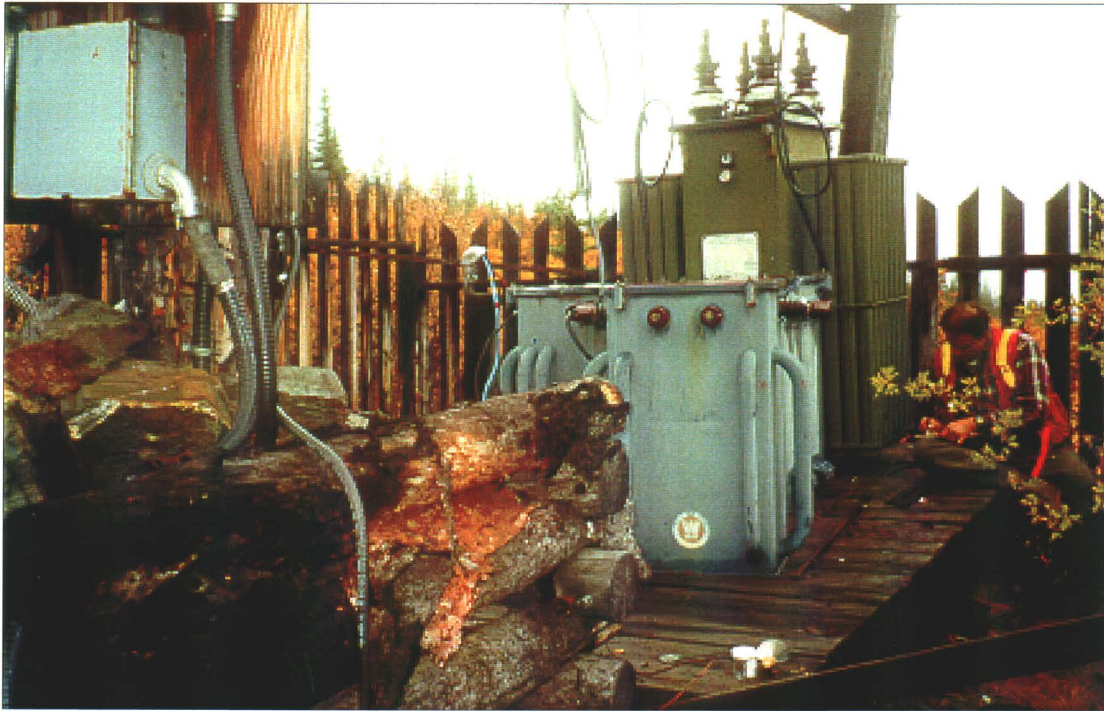
The following transformers and associated electrical panels were located in a collapsed wood fence enclosure (photo 6-22). There were no signs of any leakage from the transformers.

Photo 6-22 : Ruby 400. Transformer compound located at the mine site.
