**NO CASH 100 #7**  
**(MINFILE # 105M 001f)**

**NO CASH 500 #7**  
**(MINFILE# 105M 001f)**

Public Works And Government Services Canada  Travaux publics et Services gouvernementaux Canada  Architectural & Engineering Services Western Region	designed by: conçu par: drawn by: dessiné par:	C.S. Nov. / 99	date:
	approved by: approuvé par: revisions:	project no. no. du projet:  125-12.01	dwg. no. dessin no.:  2 of 2
Drawing title:		Titre du dessin:	
<b>No Cash-500 Site #7 Site Assessment Yukon Territory</b>

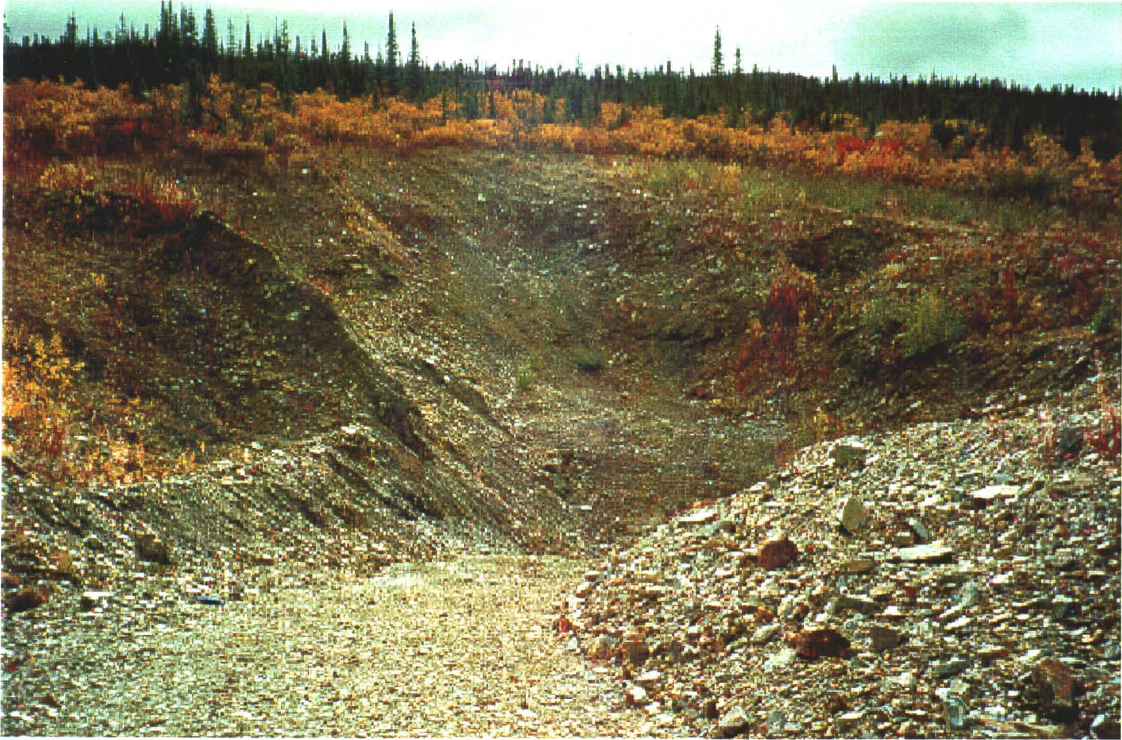
Eastern trench

Dimensions (L x W x H): 40 m x 20 m x 6 m.

Wall rock: interbedded schists and quartzites

Near vein: quartzite flooded with quartz veinlets

Photo 7-1: Eastern trench of the No Cash 100 mine site

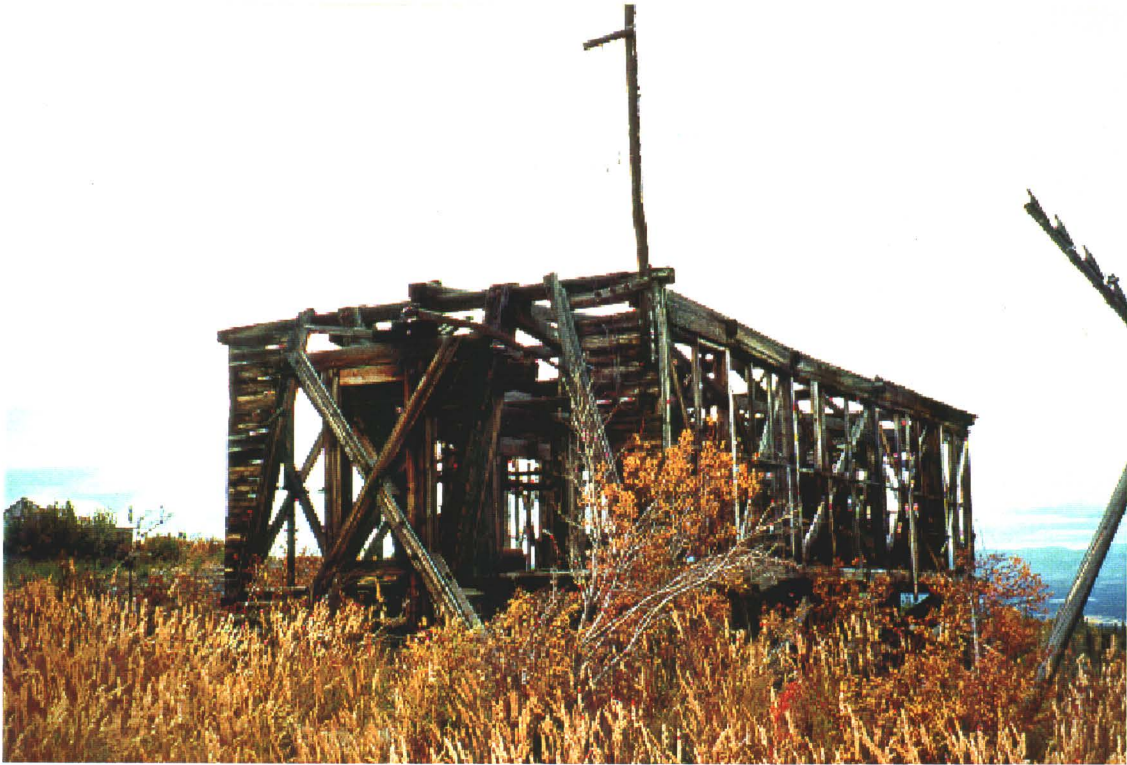
#### Building 7A – Tramway Mid-station (photo 6-3)

Foundation: There was no foundation as the tramway was constructed on timber piles with wood bracing.

Non-Hazardous Contents: Some steel cables were located under the tramway.

Photo 7-3: Tramway midstation structure.

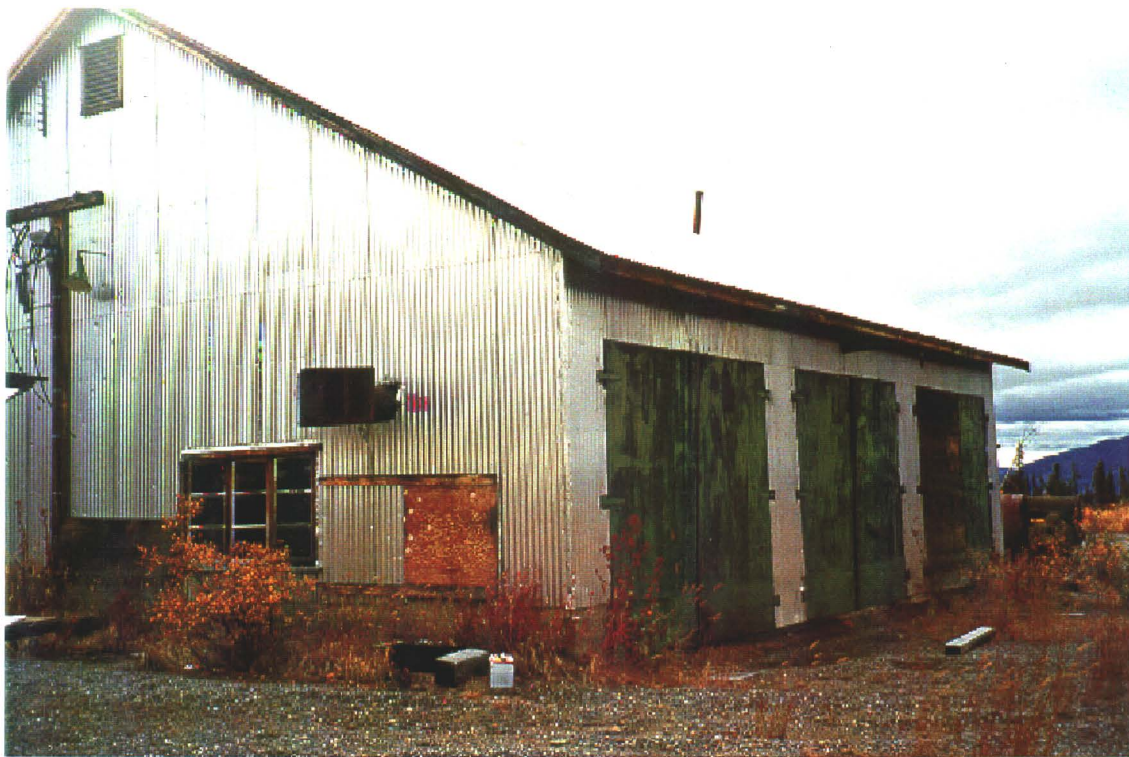
#### Building 7B – Garage(Photo 6-4)

Construction: The structure consists of wood frame construction with metal sheathing on exterior walls and roof. The garage has 3 bays with painted double wooden doors on each bay.

Hazardous Contents: A sample was taken of product labeled as 350 Chevron, from a 23L drum located immediately inside the garage (07-03-drum). There are no hazardous wastes associated with building 7B other than hydrocarbon products potentially contained within the on-site equipment. There was evidence that the equipment in the boiler room had been leaking product onto the surrounding concrete floor. A few fuel drums around the exterior of the garage were found to be empty. Soils surrounding the fuel drums were not stained. Soil staining was evident along the north side fronting the 3 bays, however, the staining was weathered and did not appear to have penetrated deeply into the surrounding soils.

Photo 7-4: Garage structure located adjacent to the shafthouse. Note the batteries in the foreground.

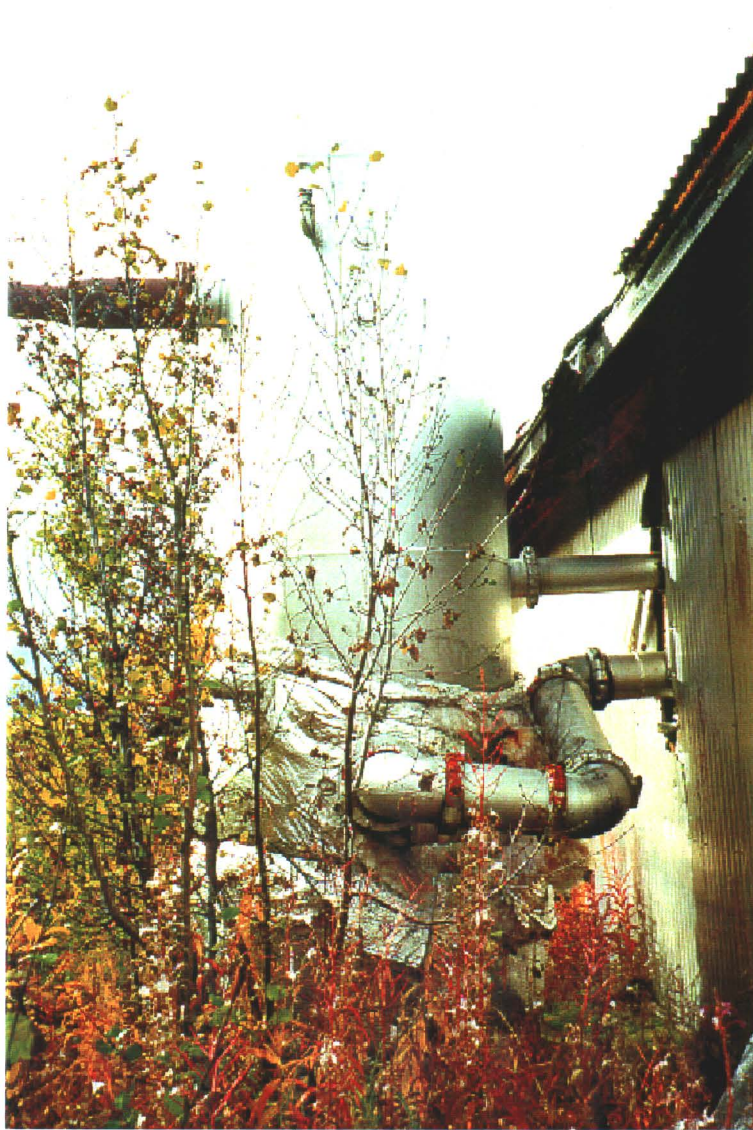
Photo 7-5: Receiving tank located on the outside of the garage structure. Tank was insulated with fibreglass.

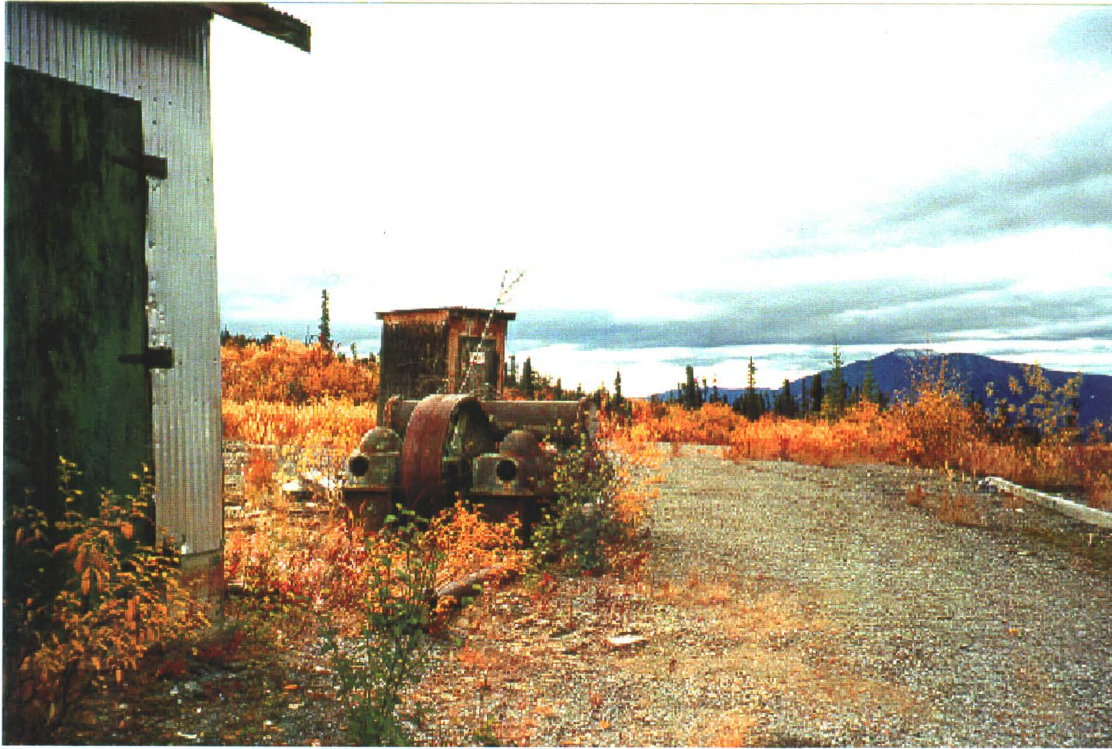
Photo 7-6: Abandoned compressor located on the northwest corner of the garage.

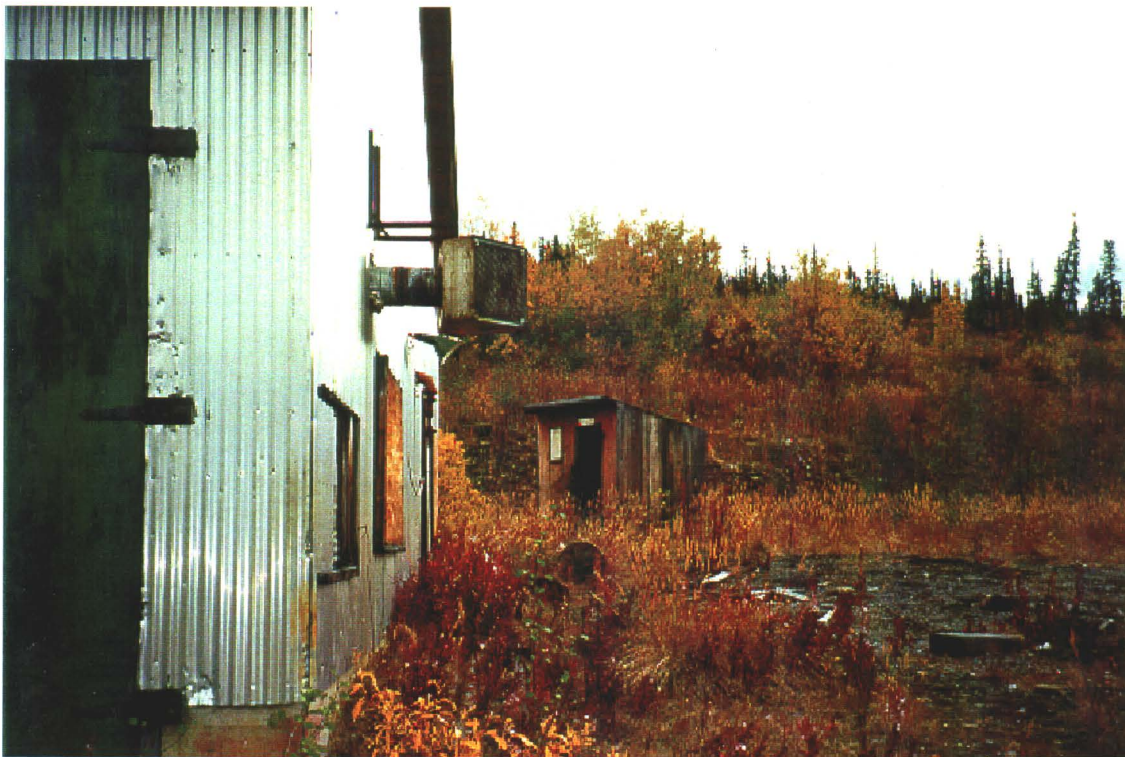
Note: a small wood frame structure (photo 6-7) was located adjacent to the southeast corner of the garage. The structure measured 2.5m x 2.5m x 2.5m. There was one drum within the structure that

was ¾ full of an unknown viscous product. A sample was conducted on the drum to determine content (07-04-drum).

<u>Sample #</u>	<u>Sample Medium</u>	<u>Location</u>	<u>Lab Results</u>
07-03-drum	liquid	garage	PCB Content - <0.1 ppm
07-04-drum	liquid	shed behind garage	PCB Content – 2.69 ppm

Photo 7-7: Shed on the southwest corner of garage that housed unknown product (samples taken).

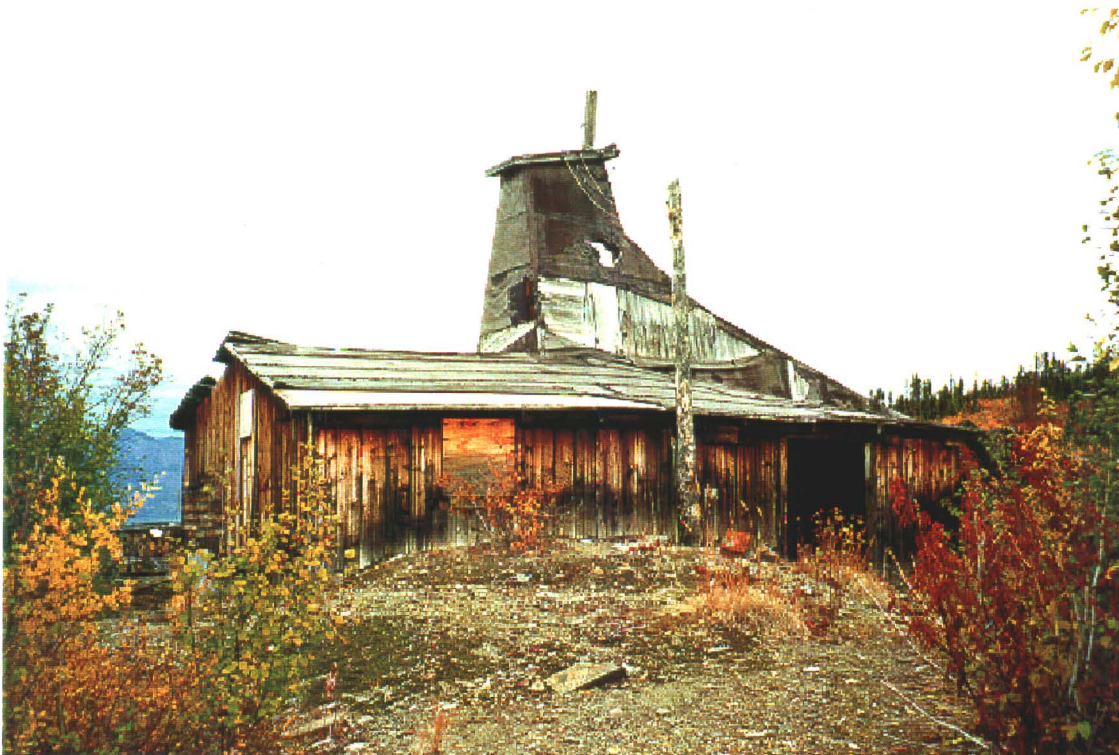
Building 7C - Shaft House (Photo 6-8)

Construction: The shaft house is of wood frame construction with timber clad sheathing. Tarpaper has been utilized on the shaft housing and on the roof. Tarpaper was also used on the wood exterior.

Non-Hazardous Contents: The shaft house has been insulated with fibreglass insulation and there is some wood debris scattered due to deterioration of the structure. The structure should be considered a safety hazard.

Photo 7-8: Shafthouse located to the east of the garage.

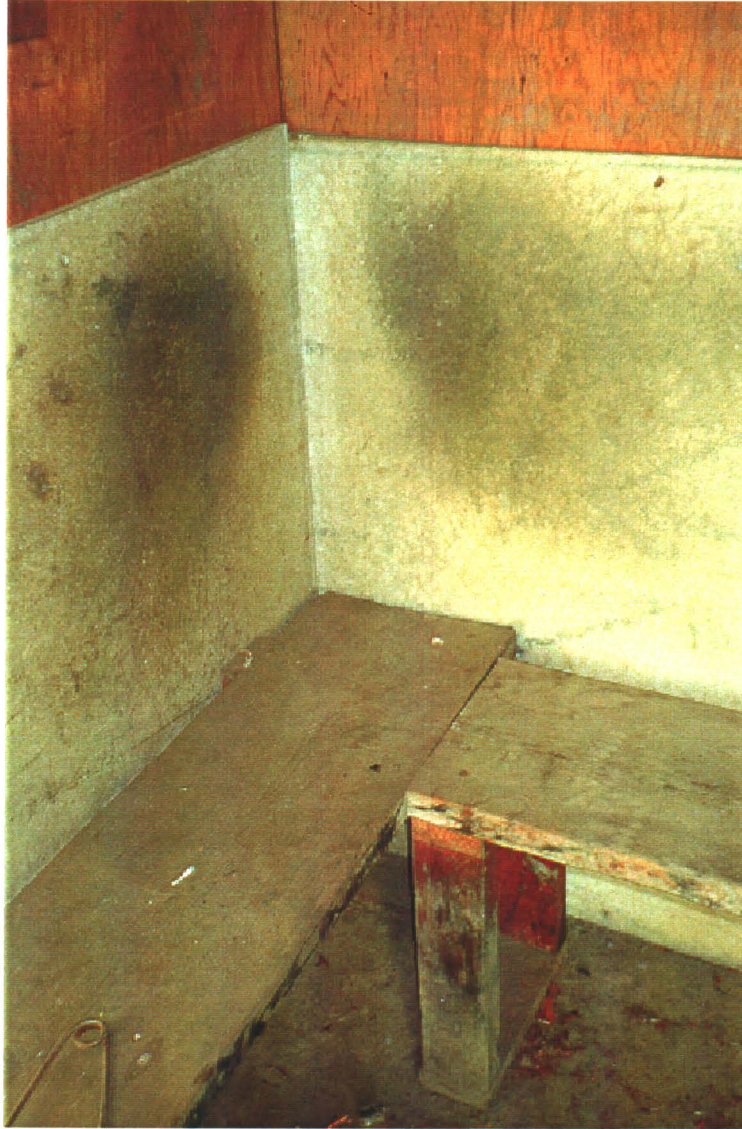
Asbestos: The floor and partial wall (1m in height) is sheathed with 2 cm-thick asbestos board (photo 6-9).

Foundation: The foundation consists of wood plank flooring on grade covered with asbestos board.

Photo 7-9: Interior of the lunchroom. Note the asbestos board on the walls.

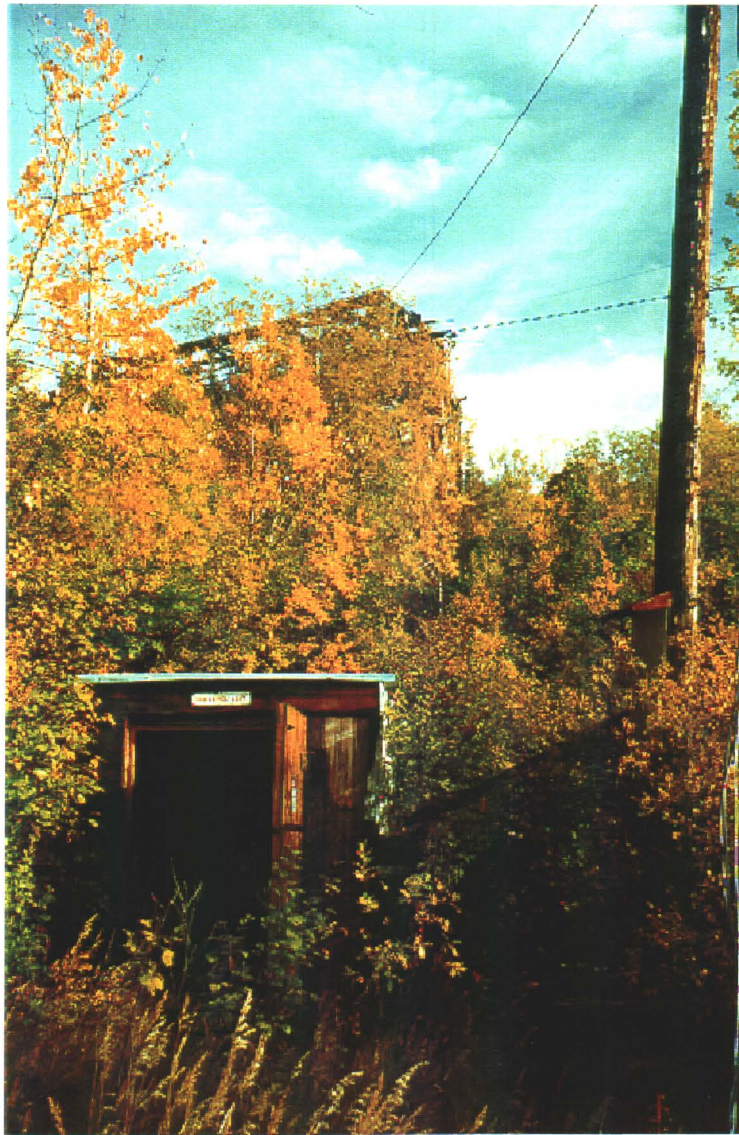
Building 7E – Adit (photo 6-10)

Non-Hazardous Contents: The adit contained no material other than a retaining wall of chain link fencing as an entry restriction.

Photo 7-10: Adit to the No Cash 100 level. Note the tramway in the background.

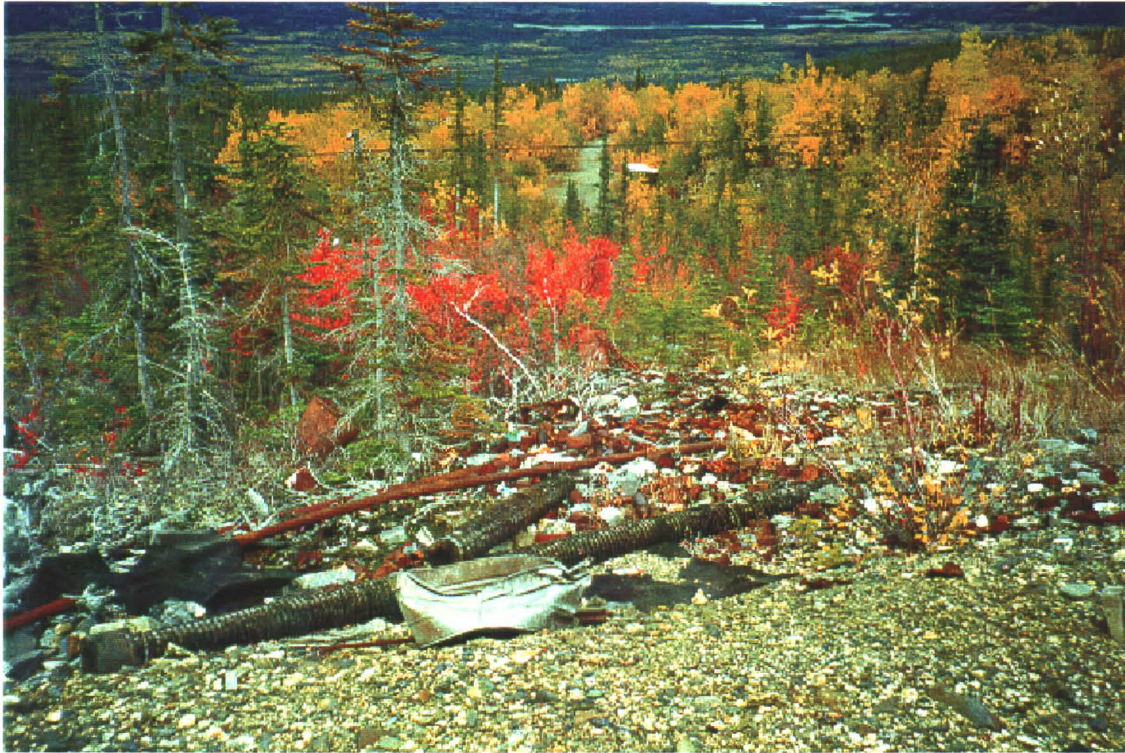
There are two solid waste dumps adjacent to each other located at the site (photo 6-11). One of the dumps is very minor and consists of some metals but mostly household garbage. The other site consists of metal debris that has rusted and corroded. No product was noted in any of the fuel drums or containers observed in the dump. Both dumps were located on waste rock sites and it is

Photo 7-11: Dump site that contained miscellaneous metal debris. Wooden pipe can be seen in the foreground.

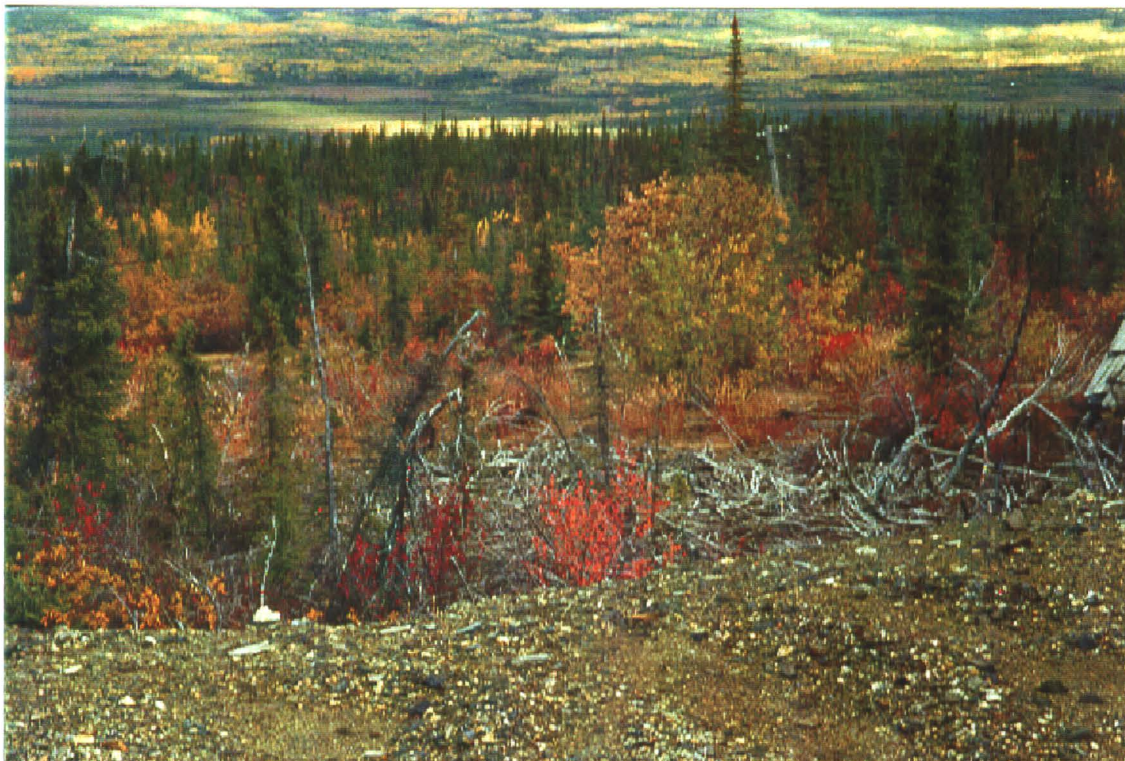
difficult to determine if the kill zones (photo 6-12) adjacent to the dumps were from historical products dumped at the site, or if the impacted vegetation is a result of the existing/past impact from waste rock drainage.

There are four kill zones at the No Cash 100 site. These areas are down gradient of the mine waste dump sites. The area has moderate revegetation (between 10 to 50%) which has occurred naturally with mosses and lichens. Further down the kill zone, low shrubs have re-colonized the area.

Photo 7-12: Kill zone below the waste rock dump.

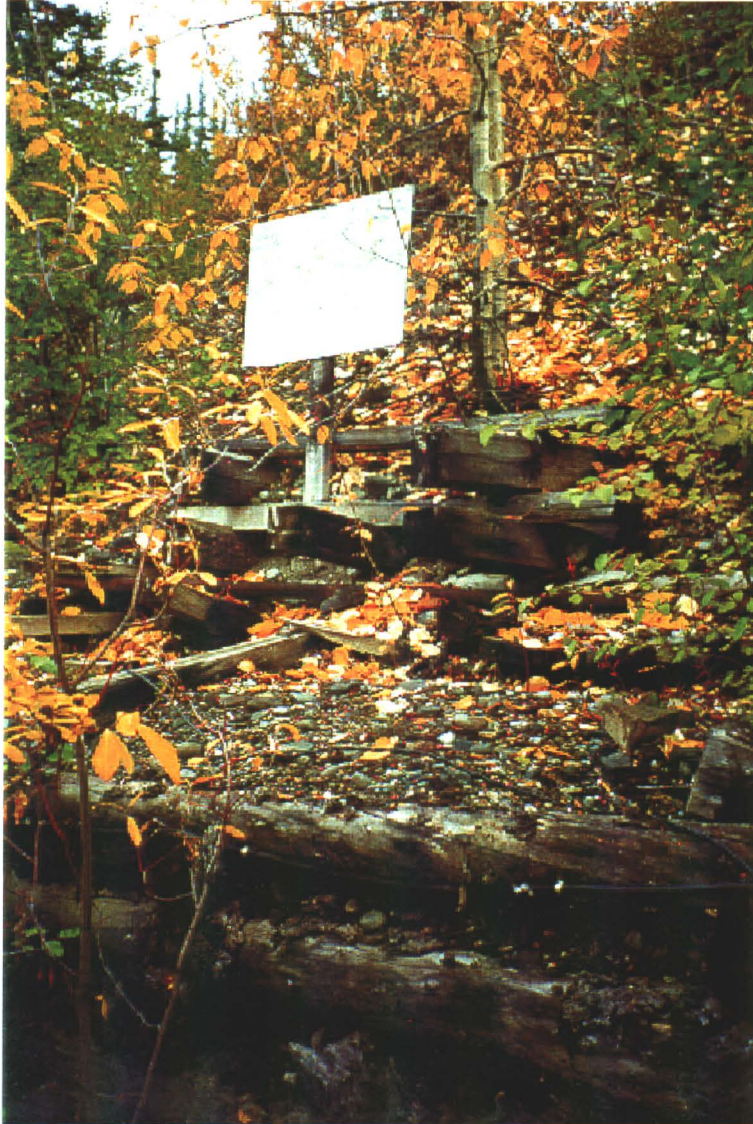
Photo 7-13: Old adit structure that has collapsed and caved in.

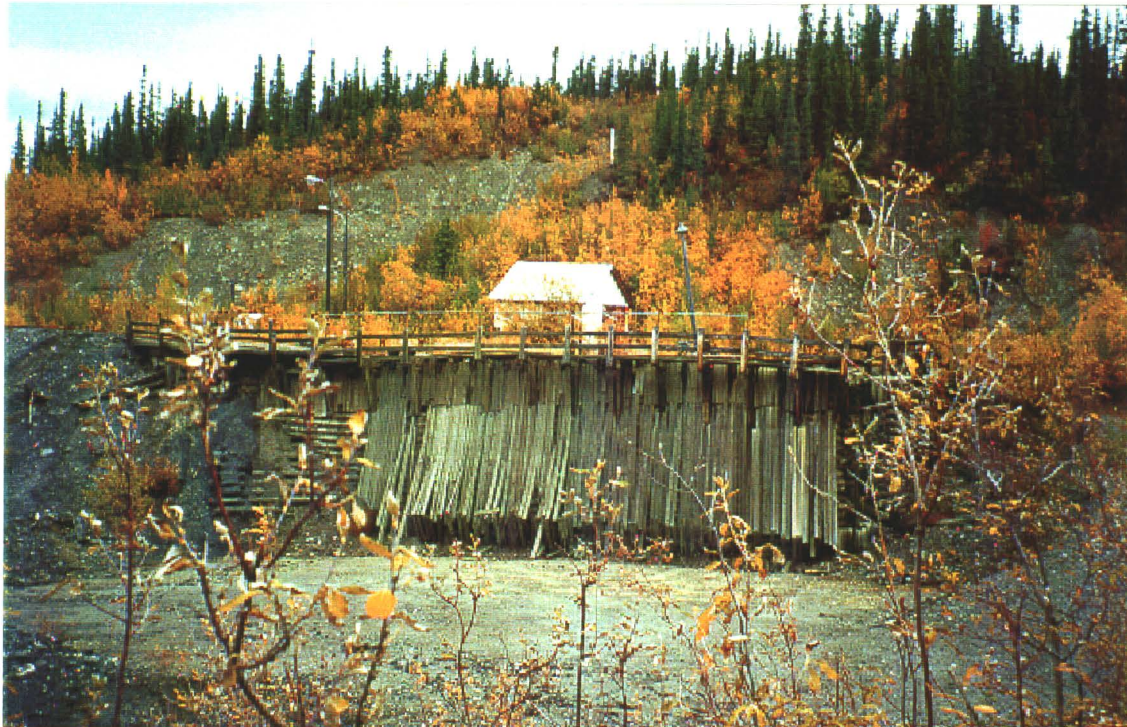
constructed for the loading area is 30m in length and 15m in depth, consisting of both timber crib works and timber sheathing (photo 6-14). The access road, building site, and parking area are constructed of waste rock materials.

Condition: Track is in good condition, however, the loading area is a safety hazard due to loss of fill in some areas. The timber retaining wall and crib have also deteriorated.

Photo 7-14: Timber retaining wall for the loading dock.

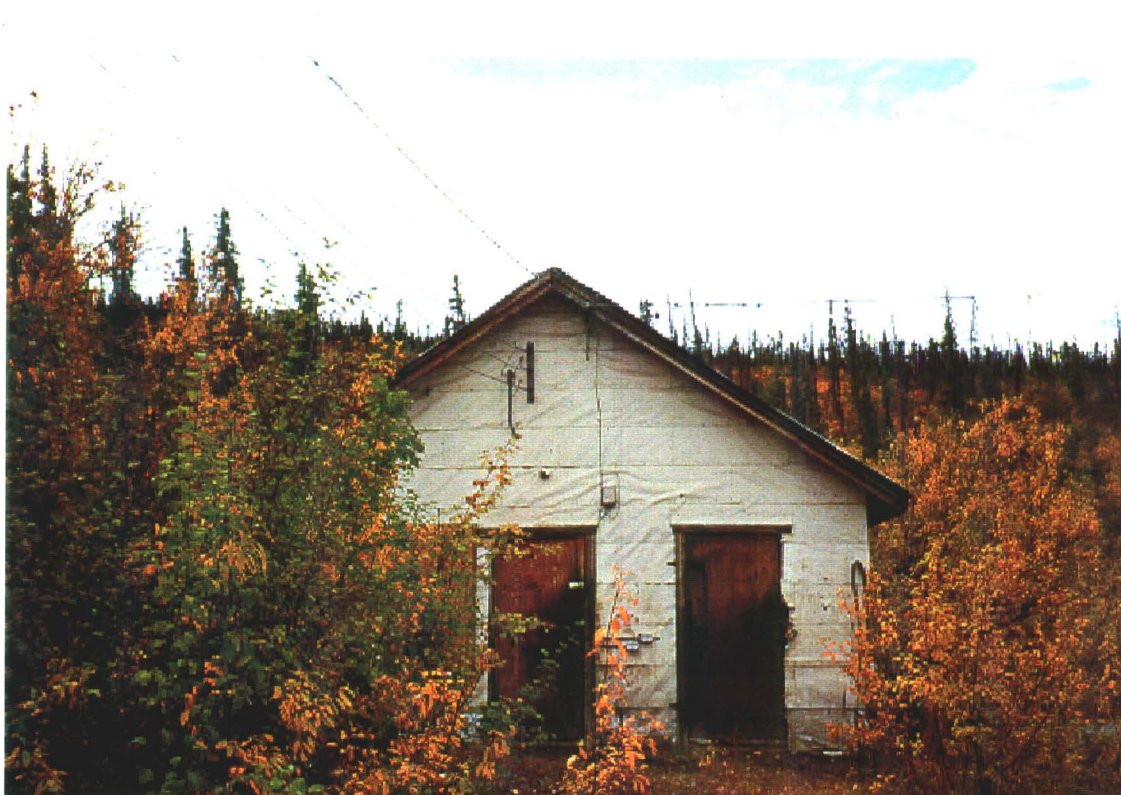
#### Building 7F – Garage (photo 6-15)

Construction: The garage consists of a wood frame structure overlaid with tarpaper and metal sheathing on the east wall approximately .75 m in height from the foundation and metal sheathing on the roof. The interior of the structure is insulated with fibreglass.

Photo 7-15: Garage structure located to the south of the adit.

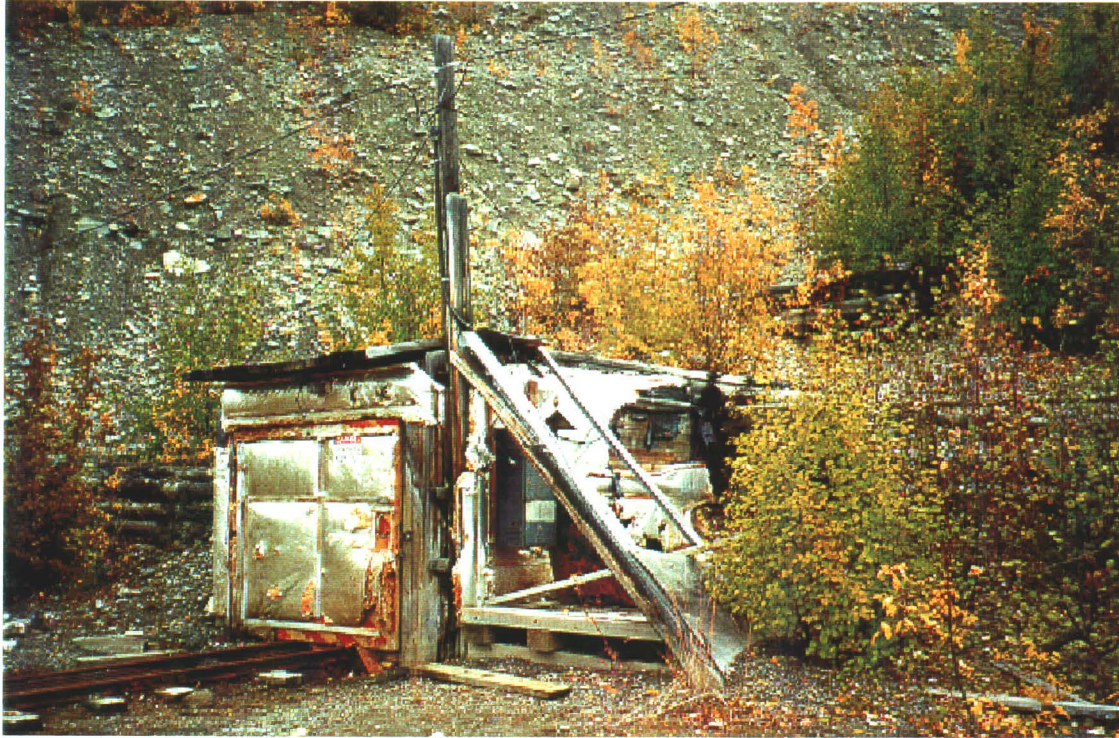
#### Building 7G – Adit (photo 6-16)

Construction: The structure is wood frame with wood sheathing on the exterior. The exterior frame is insulated with fibreglass insulation.

Photo 7-16: Adit structure leading to the 500 level..

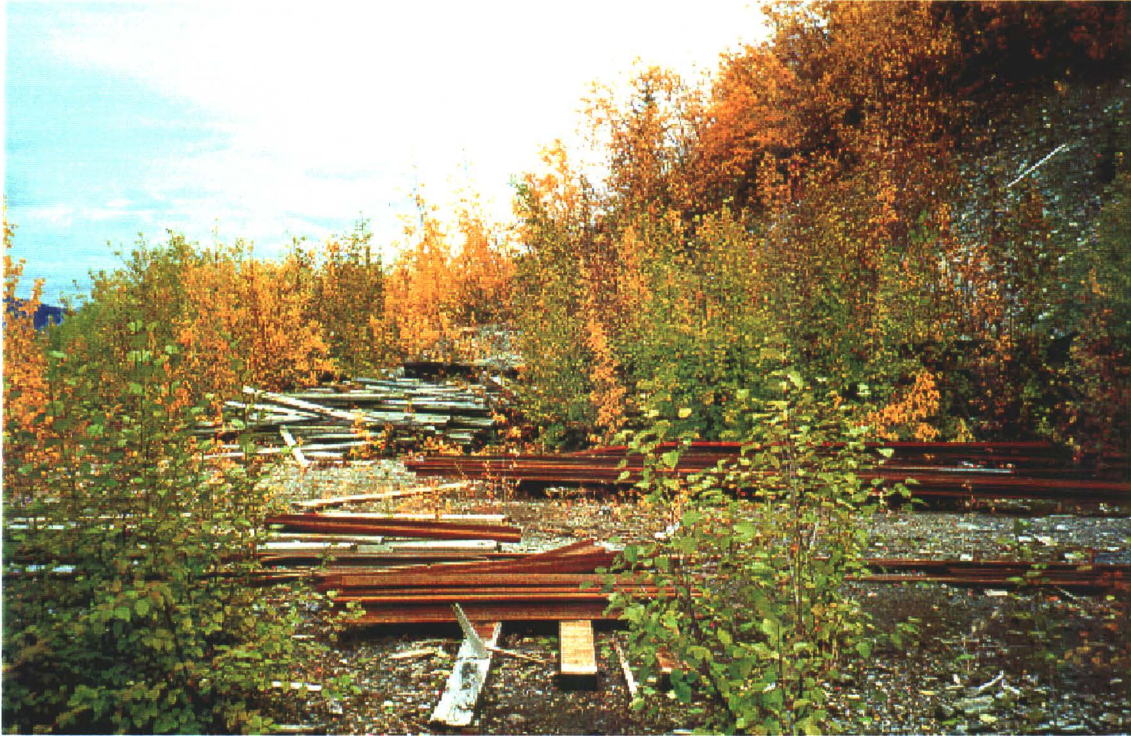
No solid waste dumps were noted at the No Cash 500 mine site. There was some metal debris that had been deposited over the edge of the mine waste dump and stored near the adit (photo 6-18), however, only minor quantities of non-hazardous material are present. No sampling was performed at this site.

Photo 7-18: Wood and metal track debris located near the adit.

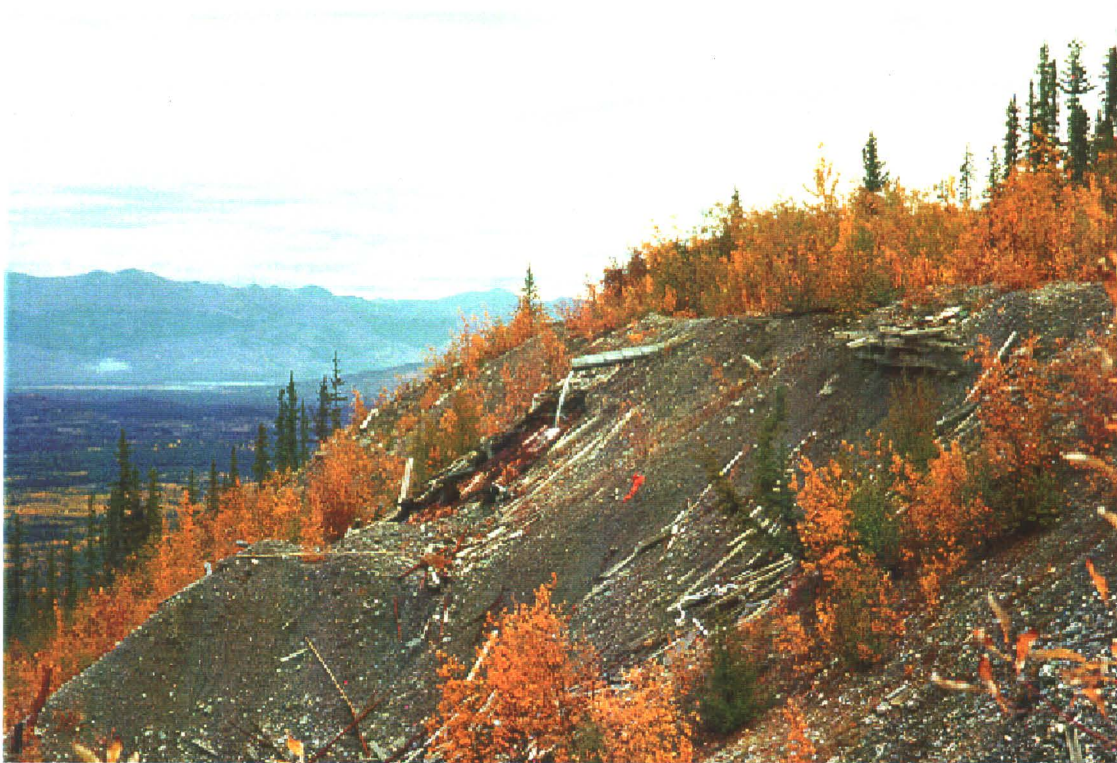
there has been some growth in localized areas. An outfall structure is located to the west of the adit and appears to have impacted down gradient vegetation. Bright orange staining is apparent along the water drainage route from the site.

Photo 7-19: Waste rock dump with pipe in the background providing drainage from the underground workings.
