HECTOR-CALUMET

Site No. 9

MINFILE: 105M 001h,i

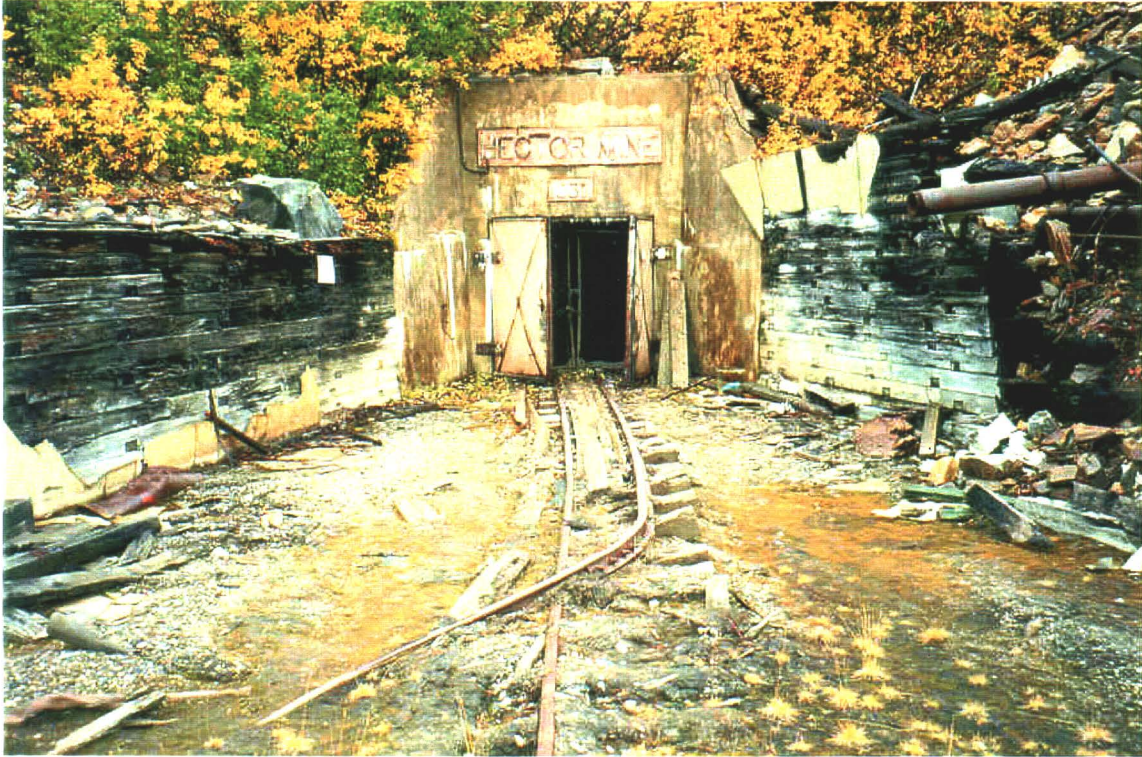
Hector Adit (Photo 9-1)

Condition: The adit appears to be stable but could only see to about 5 m.

Supports: Cement portal with wood retaining walls and metal doors. Adit entrance is constructed with wooden beams. There is a metal column has been placed about 1 m into adit, in the center, to support the beams.

Accessibility: The lock is off the doors. Approximately 3 m into the adit, most of the adit is blocked with rock debris to about 0.5 m of the roof.

Photo 9-1. Hector Adit, showing the buttressing, old rails and debris.

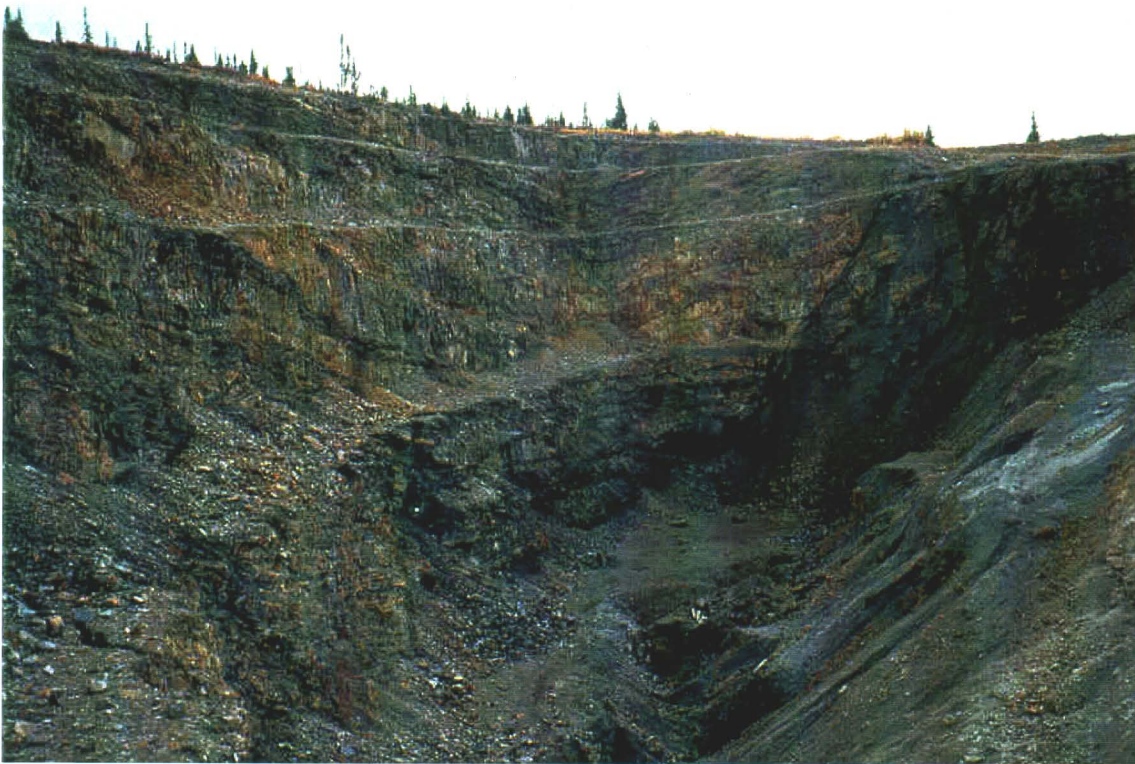
Calumet 1-15 Pit (Photo 9-2)

Condition: The pit has very steep, relatively stable walls, although rock fall is a concern. The pit was dry at the time of the visit.

Accessibility: Can drive to pit and access by foot. There are no fences to limit access to the pit.

Photo 9-2. Calumet 1-15 Pit, looking southwest.

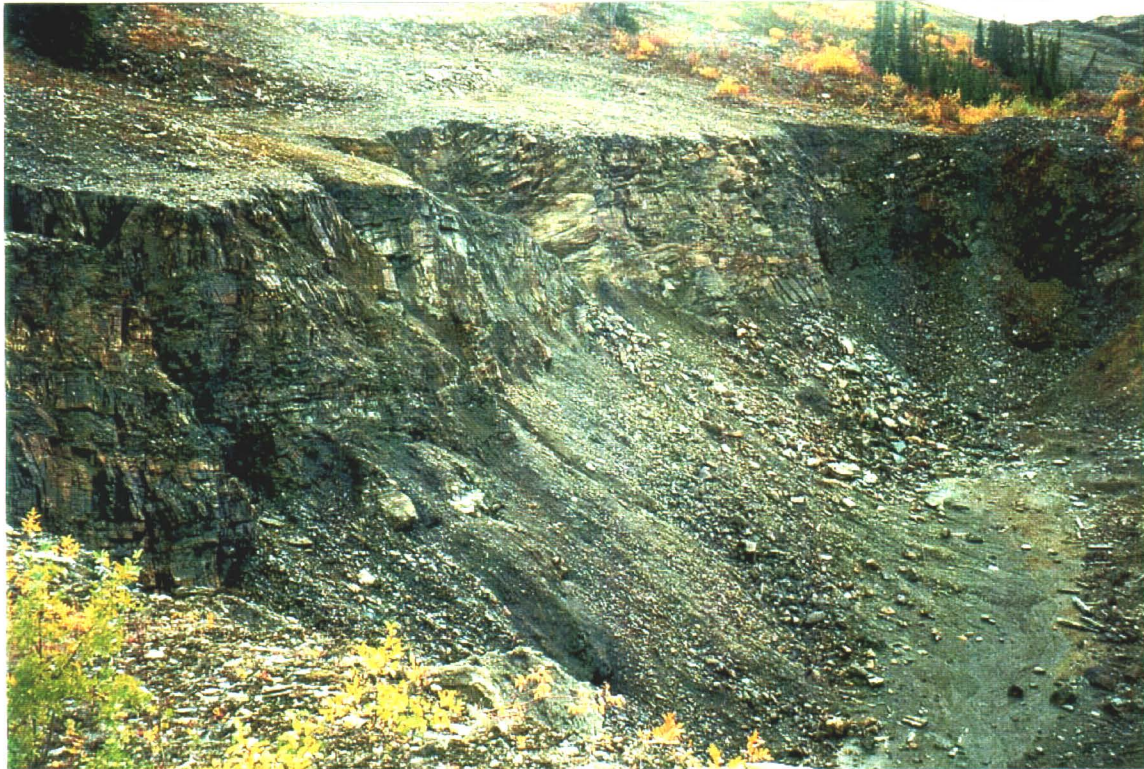
Hector Open Pit (Photo 9-3)

Condition: The pit walls are steep and relatively stable. Rock fall is a hazard, however. The pit was dry at the time of the visit.

Accessibility: Can drive to pit and access by foot. There are no fences to limit access to the pit.

Photo 9-3. Hector Open Pit, looking southwest.

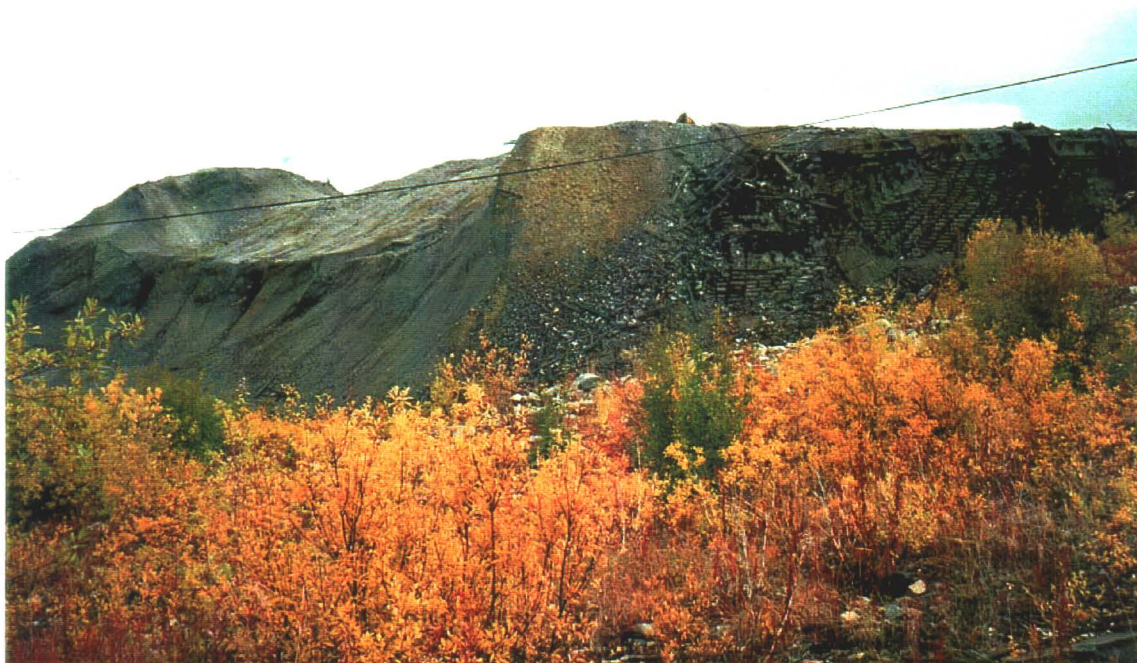
General Description: The waste rock was produced from the Hector adit. Surface material is composed primarily of mineralized and unmineralized quartzite vein, abundant siderite, pyrite, galena, and sphalerite. Much of this material shows abundant iron and manganese oxides. There are a couple small puddles of standing water on top of pile. The pile has not begun to revegetate.

There are two loading facilities at the road outside the adit, to either side of the Hector dump. The west side of the dump has been buttressed to form a gully (Photo 9-4) where an old tram for transporting ore from the Hector mine to Elsa for processing. The tram towers are wooden and the cable is reportedly lying below the towers (Photo 9-15). The gully contains metal and wood debris (Photo 9-16).

Photo 9-4. Hector dump, looking northwest. Note old wooden buttresses and debris.

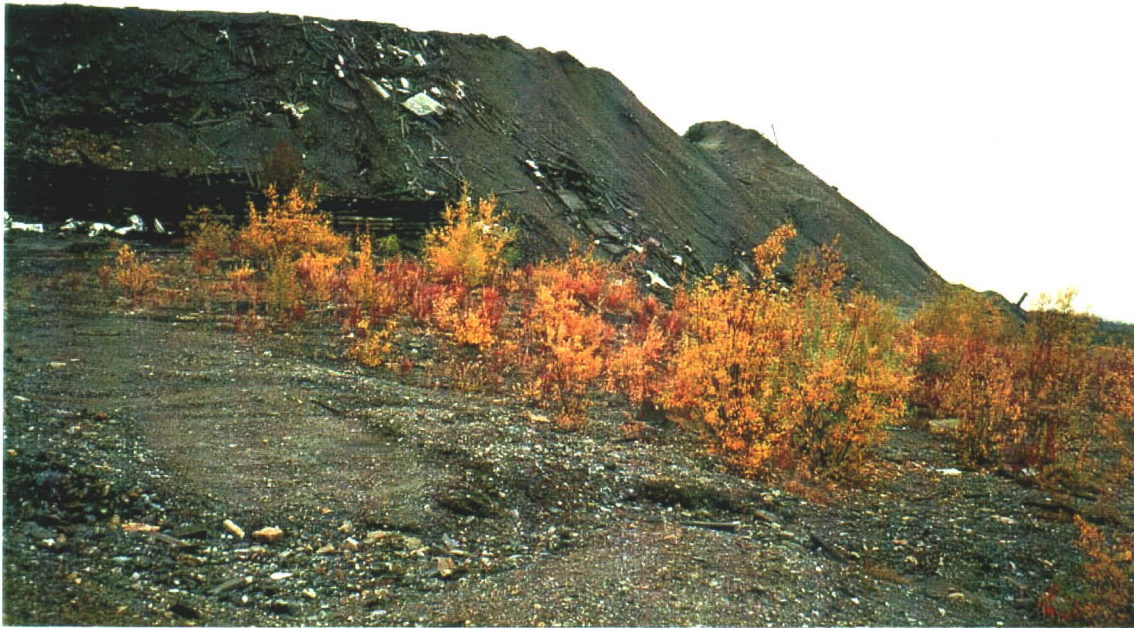
Photo 9-5. Hector dump, looking southwest. Note wooden buttressed and debris. Old steam plant was located at base of buttresses.

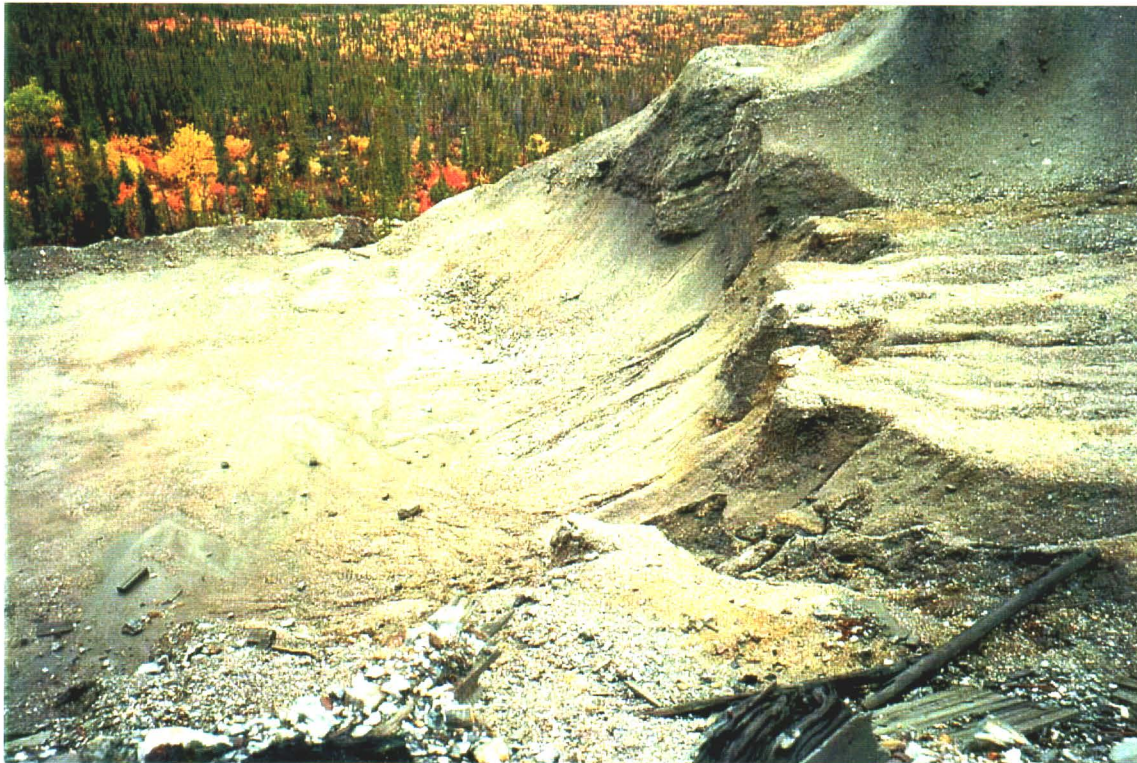
Photo 9-6. Portion of the Hector dump, looking north-northwest. This section of the dump appears to have been used as a loading point, or perhaps the waste was quarried at one time to be used as fill.

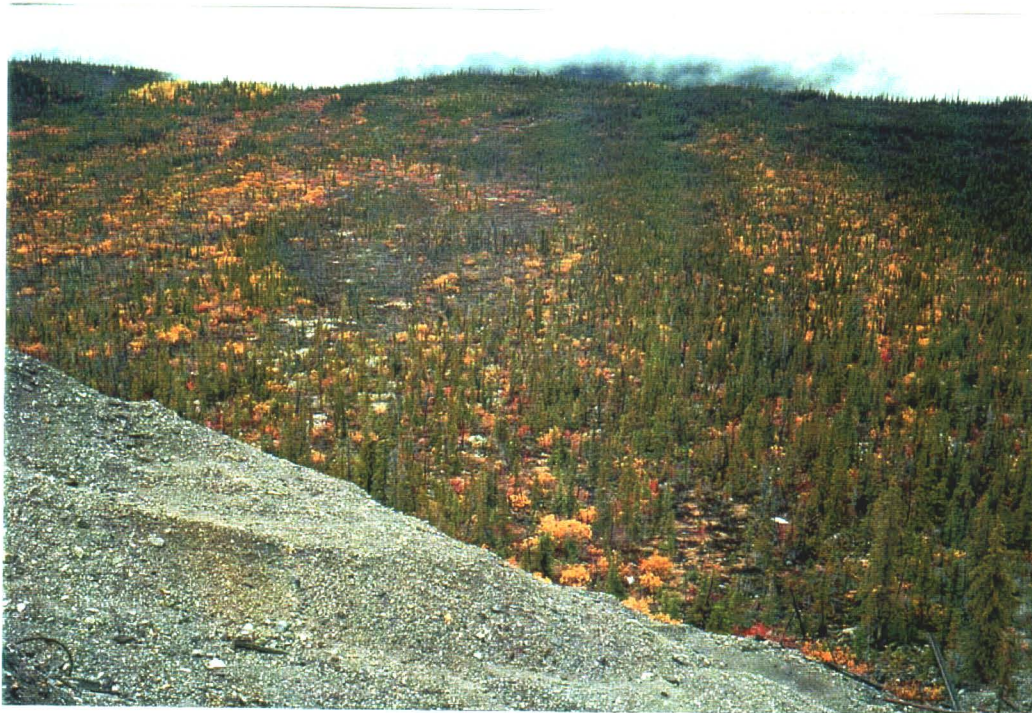
There is a zone of impacted vegetation beneath the dump (Photo 9-7) . According to UKHM (1996) this zone results from deposition of silt from mine water released during operation. The report states that there has been no drainage from the Hector 400 adit since mining ceased in October 1972.

Photo 9-7. Looking downhill (northwestward) at the vegetation below the Hector dump. Note the impacted vegetation (grey patch left of center in photograph). Whether this results from high sediment content in water discharged during mining, or from runoff and seepage from the waste rock dump, is unclear.

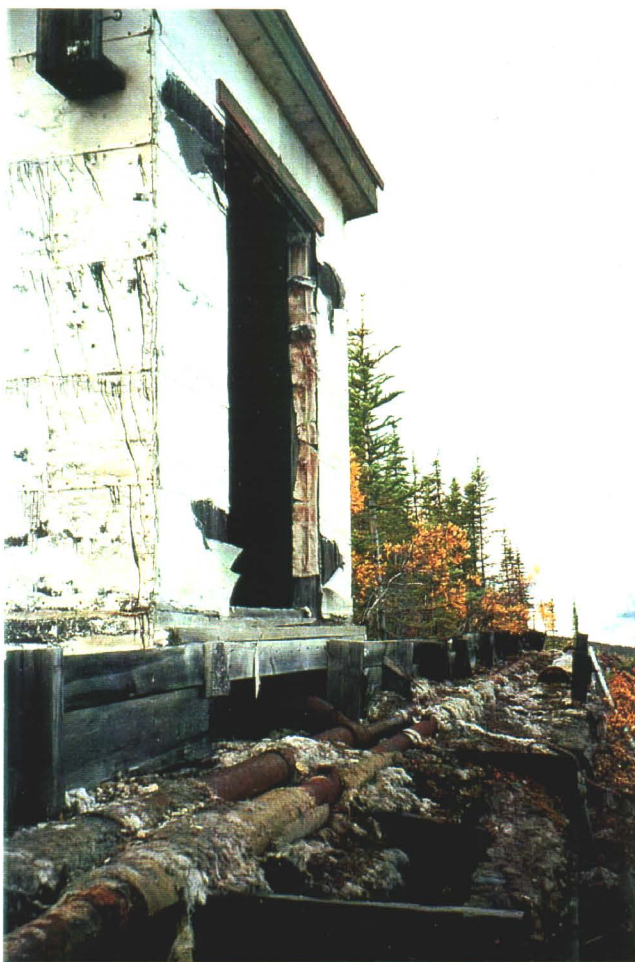
Location: Building 9A is approximately 100 m west of the Hector adit and above the Calumet Road. Building 9B is approximately 200 m west of the Hector adit and is below the Calumet Road. Both buildings are west of the hector dump. Building 9B is shown in Photo 9-8, along with the remnant utilidor that connects to the structure. Building 9A is identical.

Photo 9-8. Building 9B. Note wooden construction and tar paper siding. Also note metal piping and remnants of insulation that comprises the utilidors.

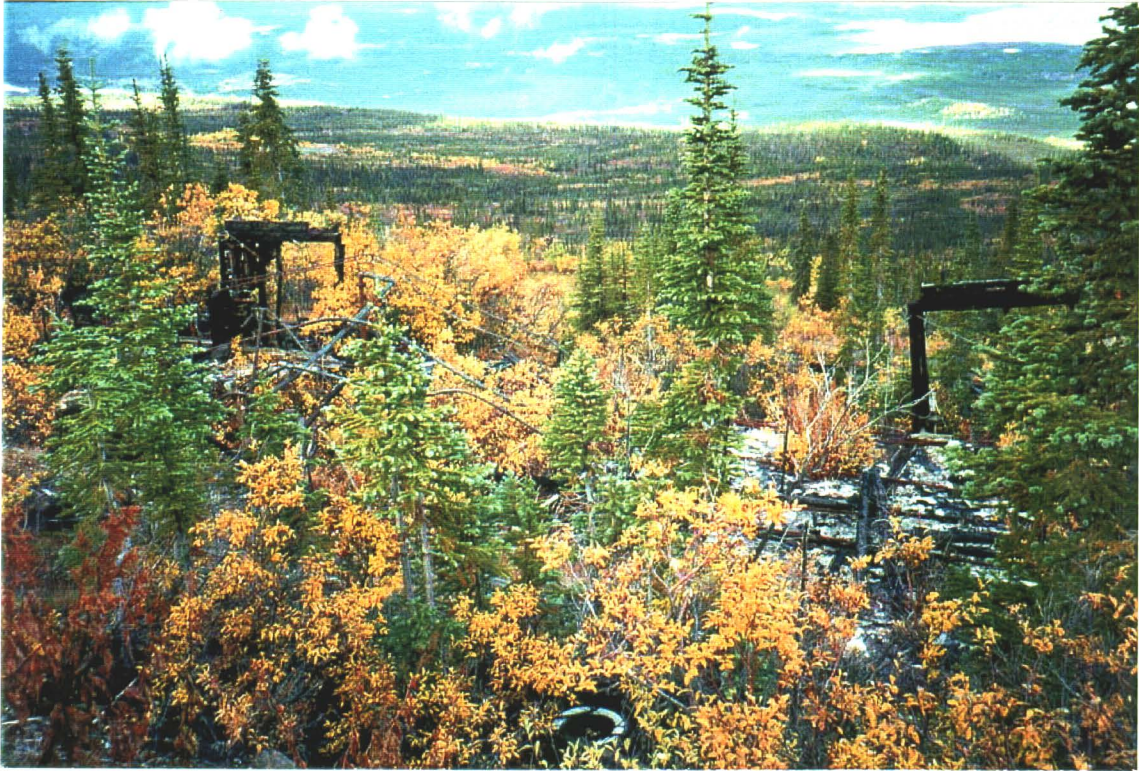
Buildings 9C - Bunk House (burned) (Photo 9-9)

Photo 9-9. Burned out bunkhouse and wash house.

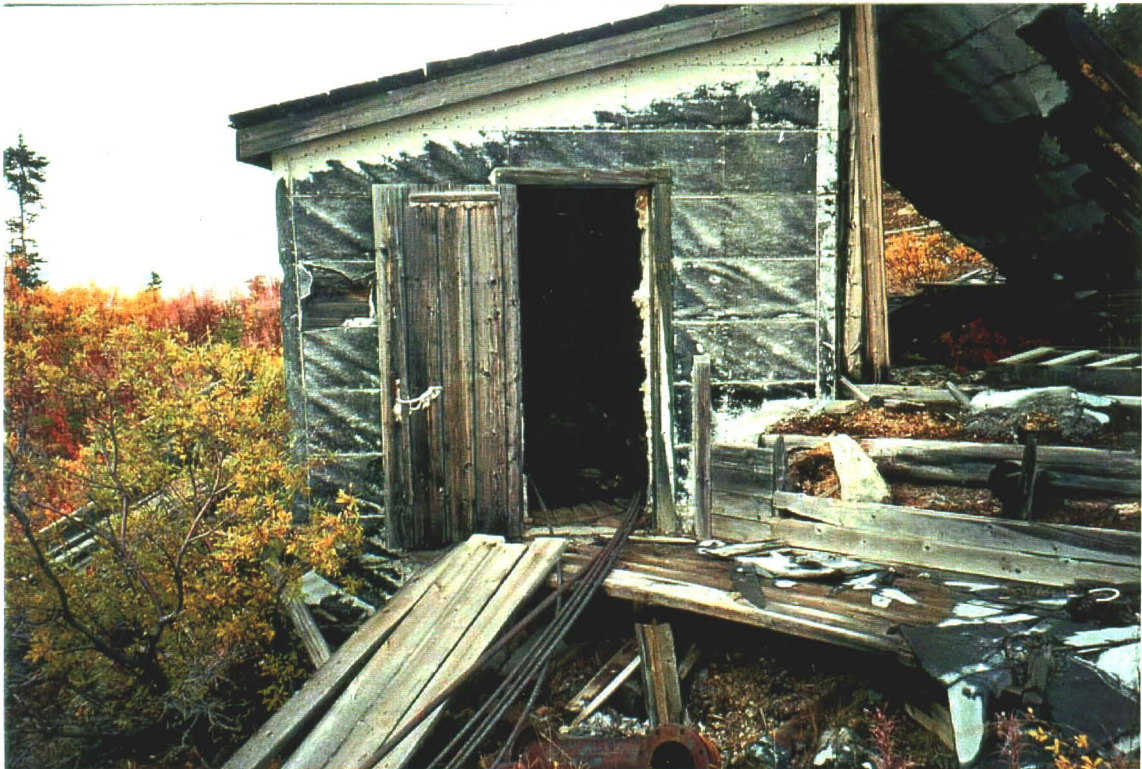
Building 9D - Water Storage Tank and Building (Photo 9-10)

Construction: Wood and concrete with metals ties for water tank. Building has tar paper siding and what appears to be fiberglass insulation.

Photo 9-10. Building adjacent to the water storage tank.

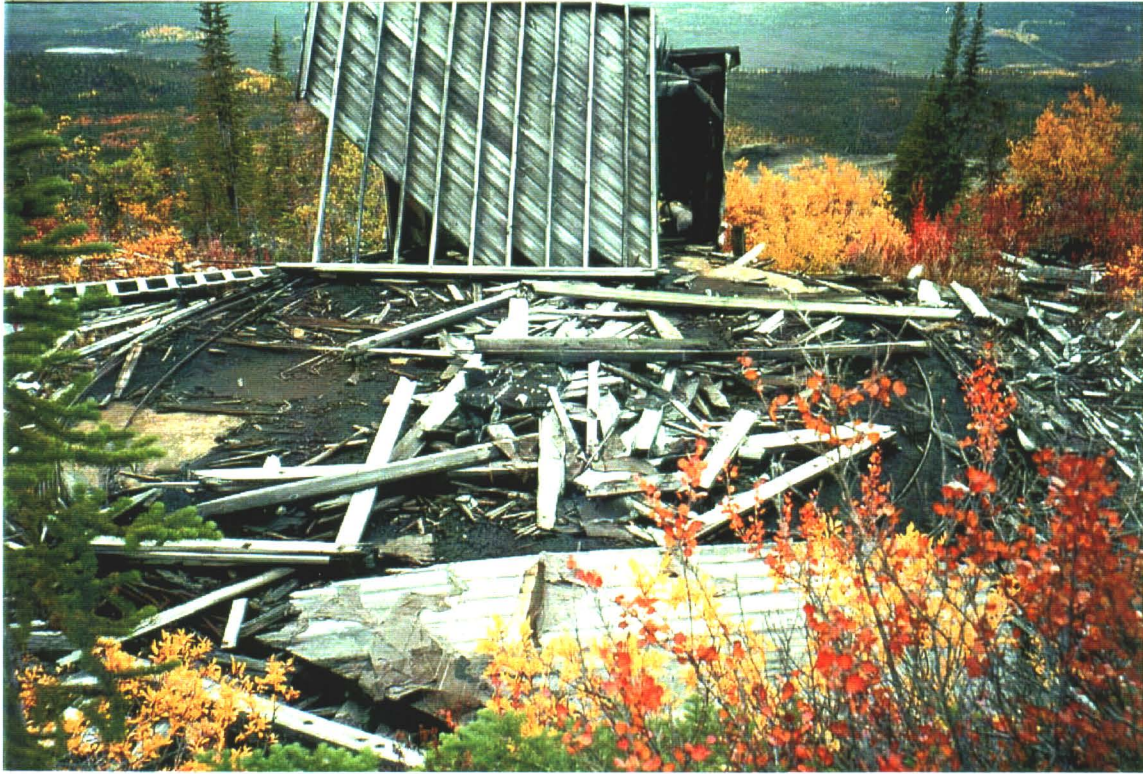
Non-Hazardous Contents: Associated with the building are the remnants of a large water storage tank. Behind and uphill from the building is a large (5 m diameter) round concrete foundation (Photo 9-11). Upon the concrete and to adjacent to it are approximately 400 m of 3 cm thick steel cable, in segments of about 10 m lengths. These are the stays that held the wooden storage tank together. There is also some wood debris from the collapsed tank and part of the building.

Photo 9-11. Concrete foundation of storage tank with debris from storage tank. Building in the background.

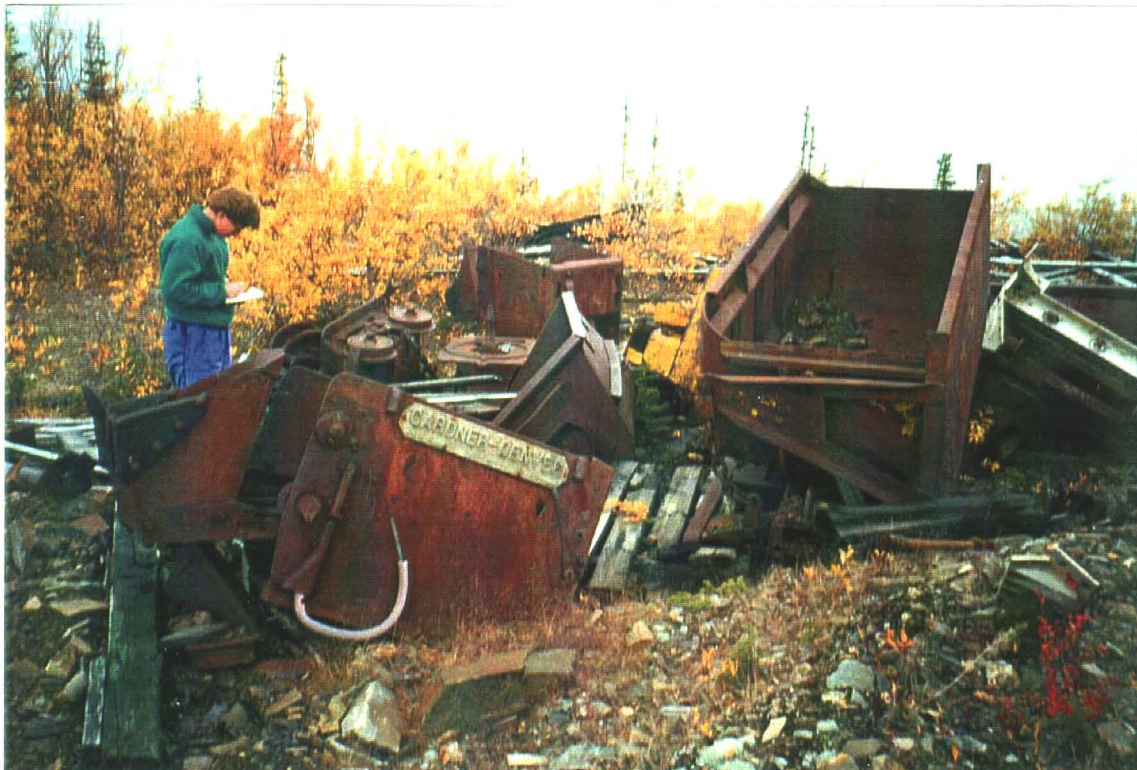
Between the tank and the road are 6 small (1 m x 0.5 m x 0.5 m) ore carriers and 3 ore cart transport bases, and one very large ore bucket (1 m x 1.5 m x 1 m) (Photo 9-12).

Photo 9-12. Old ore carts located near the water storage tank.

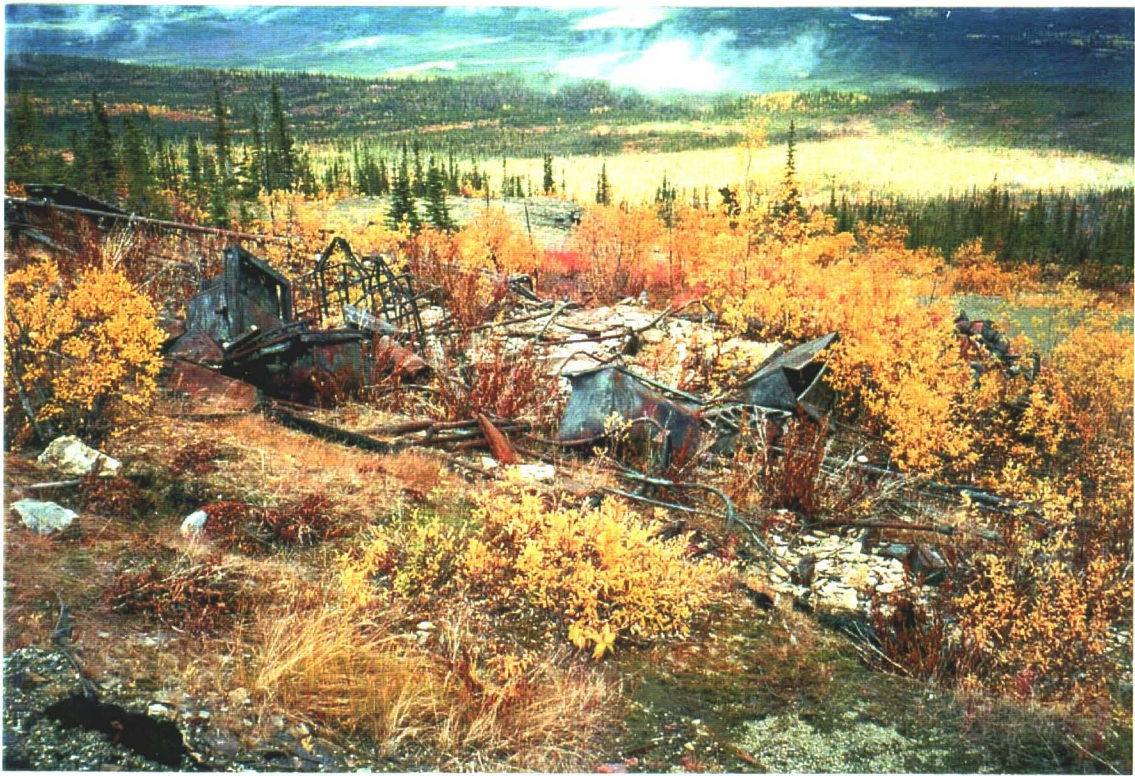
Assay lab: Located to the east of Building 9B. Dimensions (L x W x H): 2 m x 3 m (collapsed). Brick construction. Metal pipes and rusted ovens remaining (Photo 9-13). No hazardous contents observed.

Photo 9-13. Remnants of assay laboratory. Note metal debris and concrete foundation.

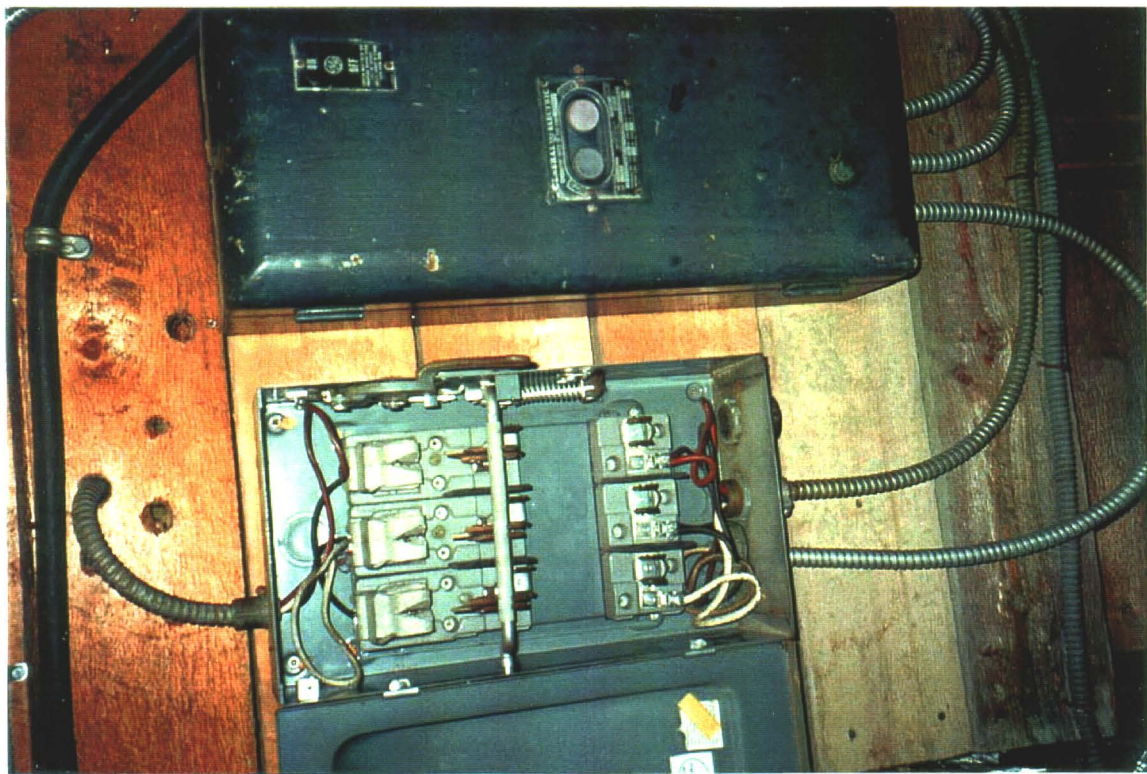
Two electrical boxes are located at the loading facility at the Hector Adit. One is probably pre-1930 and the other is more recent. Also, some electrical equipment is associated with the loading facility at the Calumet 1-15 dump (Photo 9-14).

Photo 9-14. Electrical boxes in small shed near loading facility on Calumet 1-15 dump.

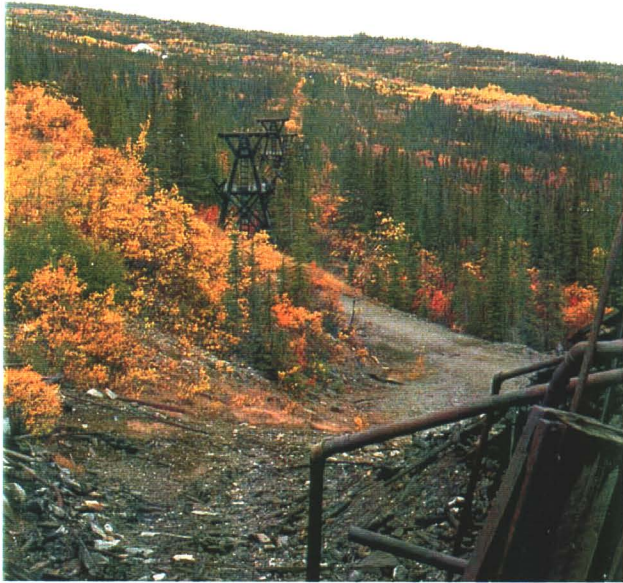
Photo 9-15. Old wooden tram towers. Looking west from the Hector dump.

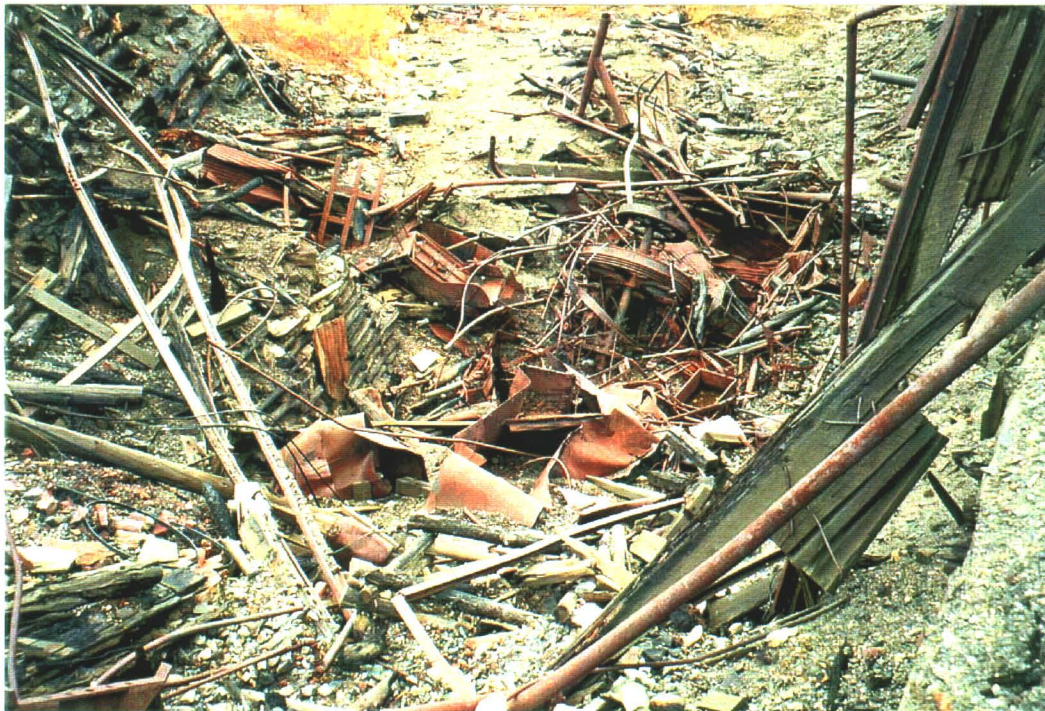
Photo 9-16. Debris in gully adjacent to the Hector dump.

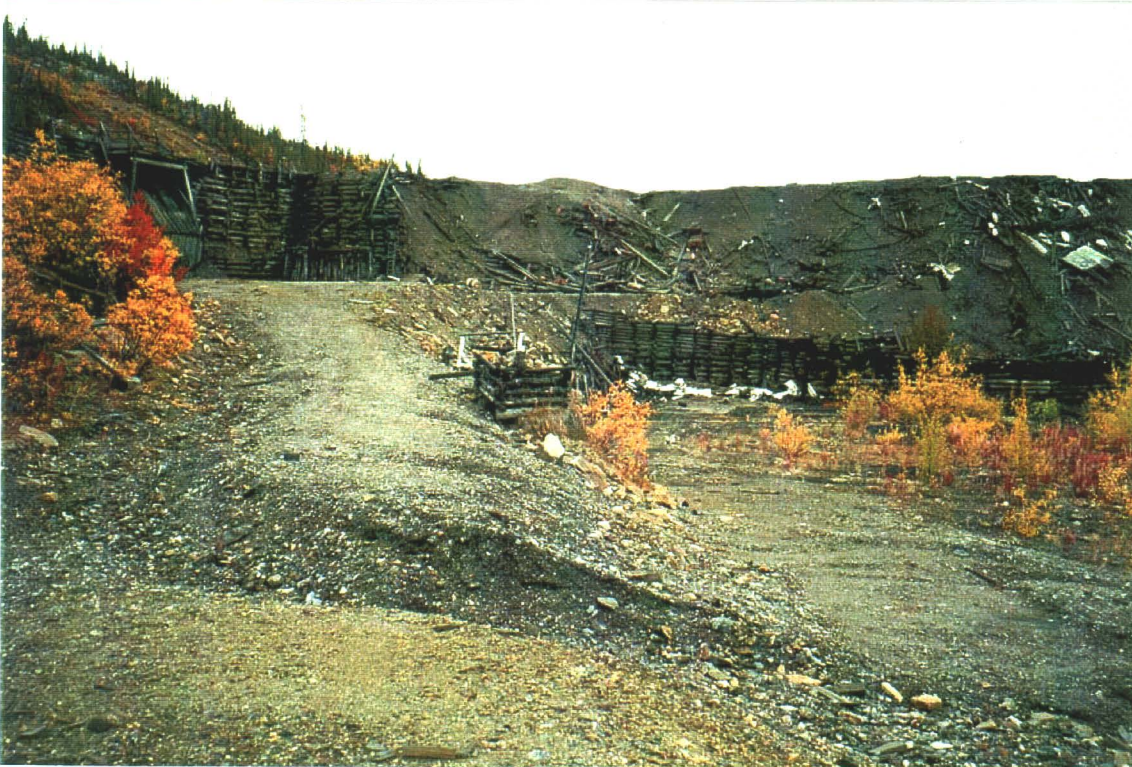
On the east side of the dump, are larger loading structures with more buttressing (Photo 9-17). A coal-fired steam plant built at the loading facility at the Hector adit was used to heat the mine buildings. The concrete foundation for the plant and small pile are still on site, but the building has been removed (Photo 9-18). There is abundant metal and wood debris in this area (Photo 9-19).

The Calumet road shows signs of subsidence near the loading facility. In places, the road material has fallen through the timbers that comprise the loading facility.

Photo 9-17. Hector dump and loading facility, looking southwest.

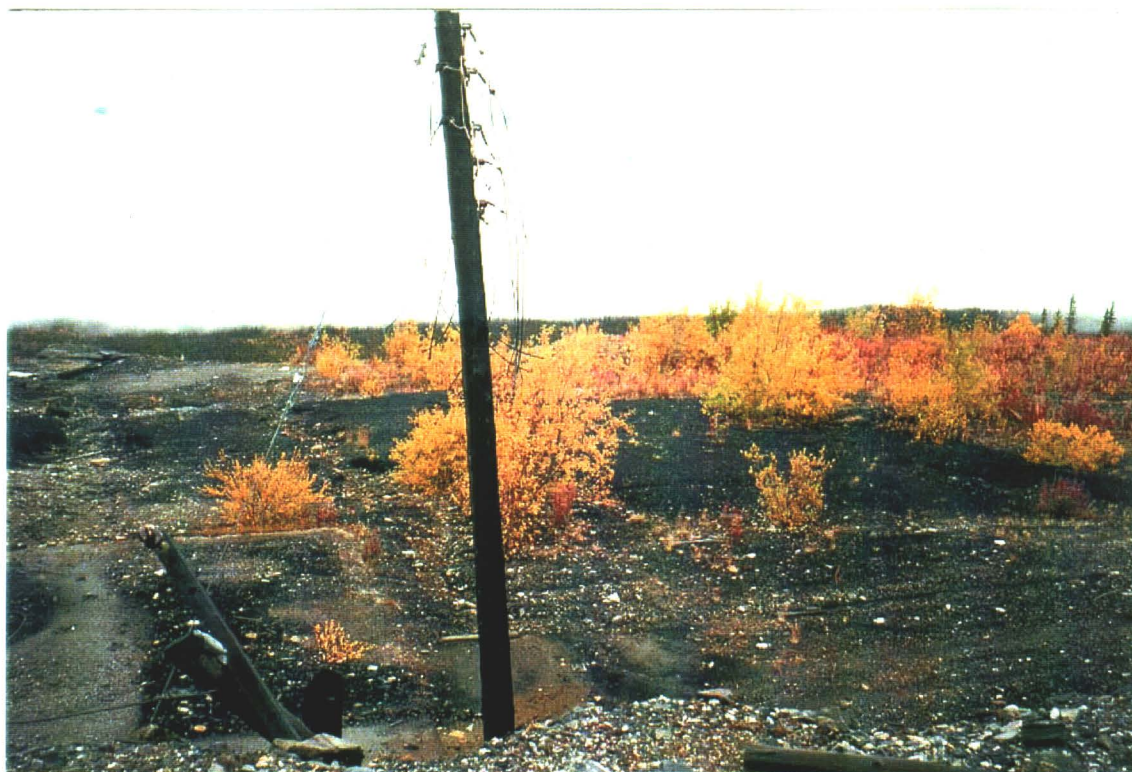
Photo 9-18. Coal piles at site of old steam plant. An edge of the concrete foundation of the plant can be seen on the left side of the photograph.

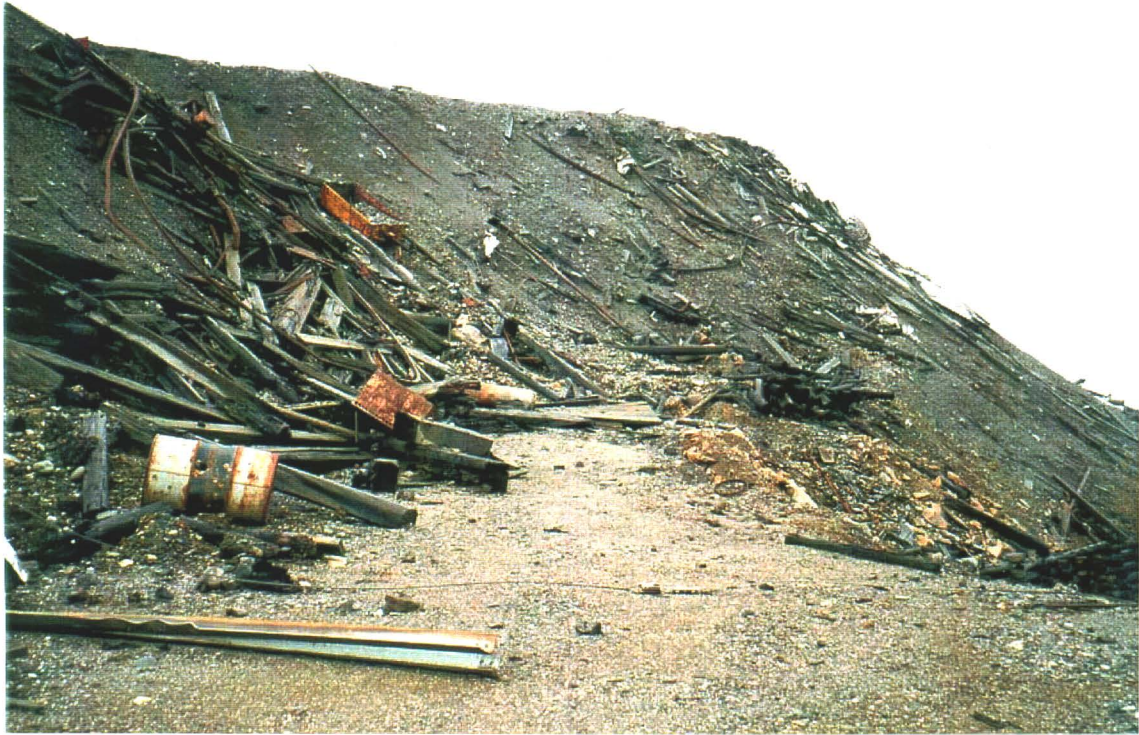
There is abundant metal and wood debris on and adjacent to the dump (Photo 9-19). This material is described in Section 6.6 Loading Facilities.

Photo 9-19. Metal and wood debris on the side of the Hector dump.

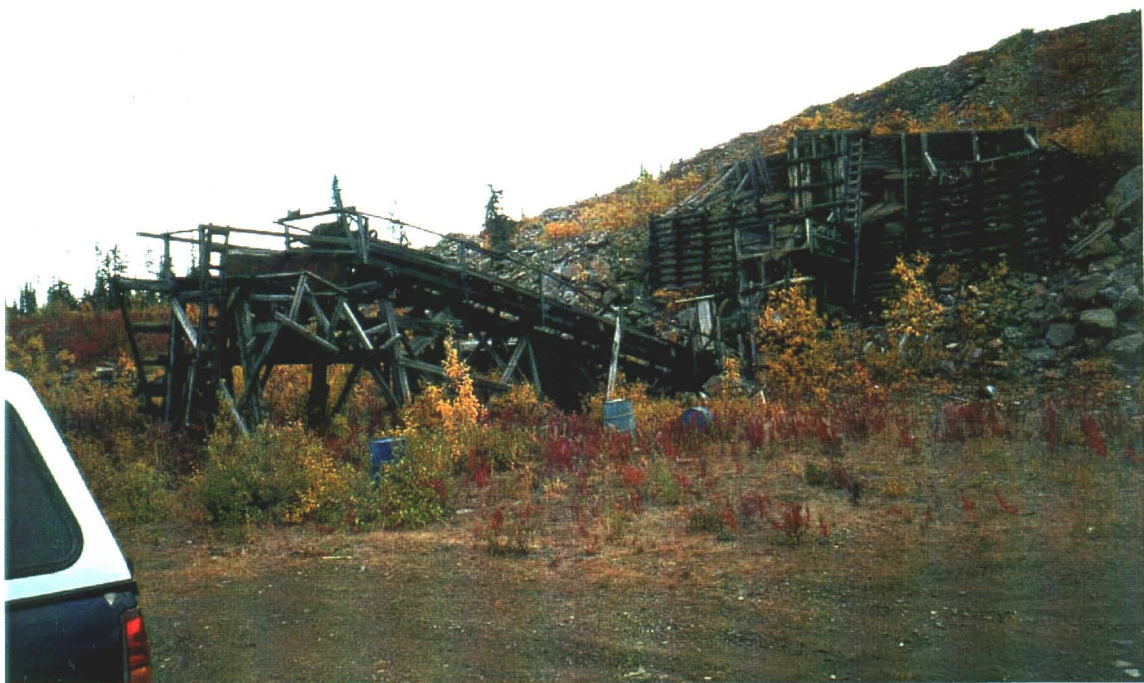
The Calumet 1-15 loading facility includes a wooden buttress, an ore chute, a holding bin, and a conveyor-type structure, and a loading dock.(Photo 9-20). The structure is made of wood, except for some iron cogs that likely ran the conveyor. A small building adjacent to the conveyor holds some electrical equipment (Photo 9-14) and some fiberglass insulation (Photo

Photo 9-20. Loading facility on the Calumet 1-15 dump. Note the three barrels

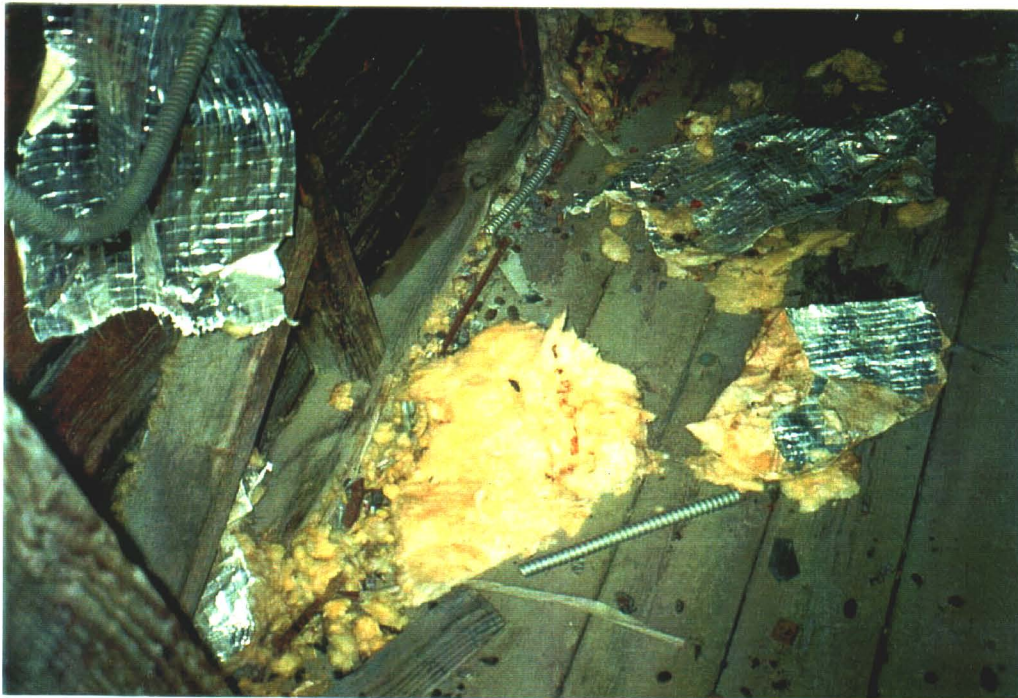
Photo 9-21. Insulation in the electricity shed, adjacent to the conveyor structure at the Loading Facility at the Calumet 1-15 dump.

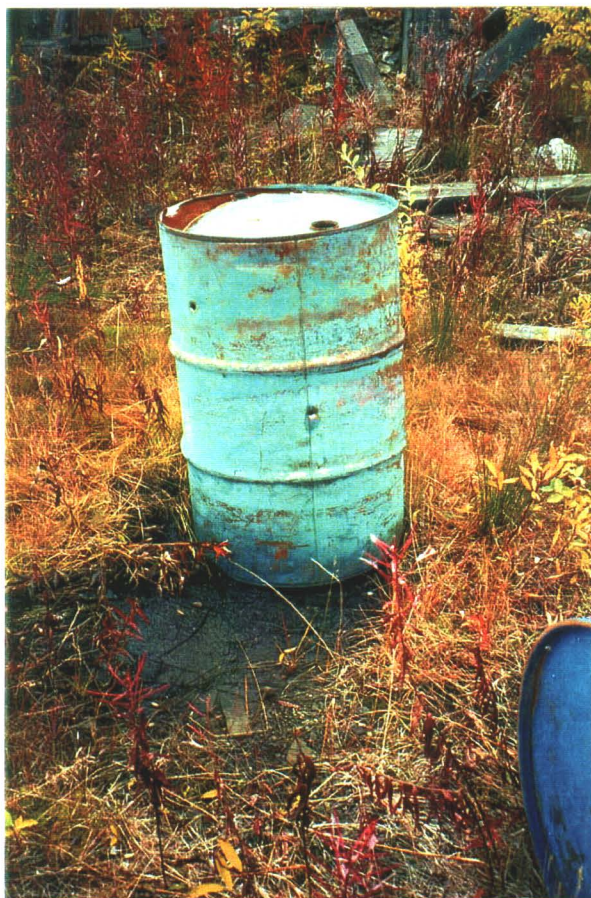
Hazardous contents include three metal oil barrels are adjacent to the conveyor section of the facility (Photo 9-22). Two are empty and the third is half full of oil and water. There is a small 0.5m²) stain on the ground near the barrels. Also present are 20 empty cans (each 10 cm tall) of Quick Start Fluid on the ground.

Potential contaminants of concern at the Hector-Calumet site include metals washing from the waste rock piles, and one barrel of oil (half full) located at the loading facility at the top of the site.

Photo 9-22. Oil spillage from barrel that is half full of oils and water. The other tow barrels are empty.

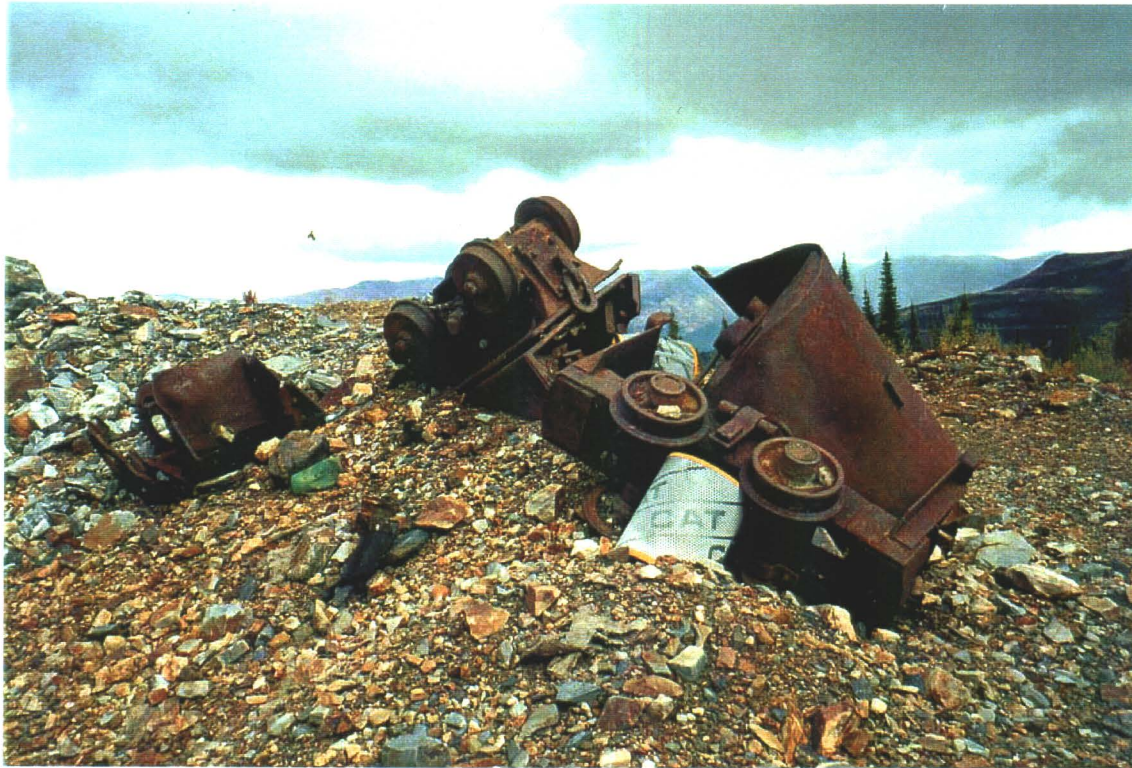
Non-hazardous material includes approximately 10 m of metal pipe or rail; small amount of wood, 3 ore carts (1m x 0.5 m x 0.5 m) located on the rock dump (Photo 9-23).

Photo 9-23. Old ore carts and debris at the upper loading facility on Calumet 1-15 dump.
