## DRAGON (UN) & MILLER

### Site No. 10

### MINFILE: 105M 001j

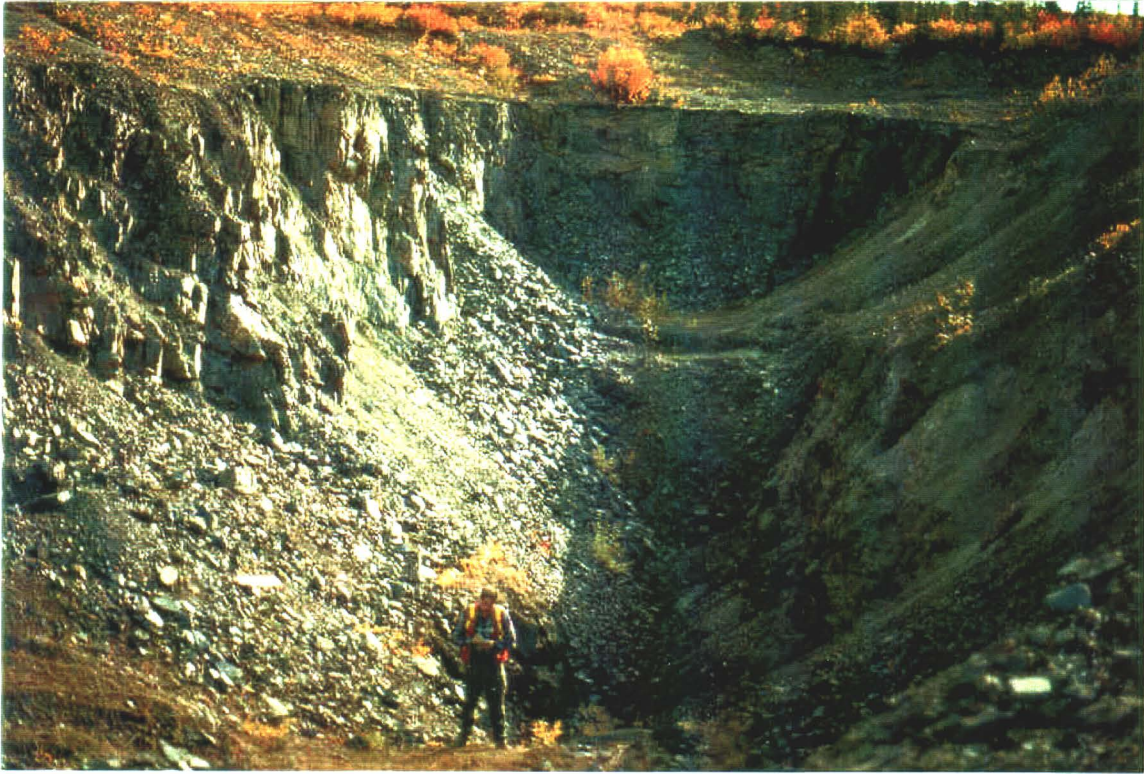
The walls of the Miller Pit are composed of thick beds of resistant quartzite (Photo 10-1). The walls show no mineralization but manganese oxide staining is common. The western wall of the pit has a strong manganese oxide stain, some clay alteration and a small amount of siderite, indicating the end of the mineralized vein. There is no outcrop outside the adit; the adit was not entered.

The Miller Pit is approximately 90 m long, 10 m wide and 15 m deep (Photo 10-1). The walls are composed of quartzite, and the north and east walls are both steep and thick-bedded quartzite beds can be seen. In contrast, the west wall of the pit, which is more altered, has more erosion.

There is a moderate amount of manganese alteration on the pit wall rocks and on the waste rock. There was no water in the pit at the time of the site visit.

Photo 10-1. Miller Pit looking south.

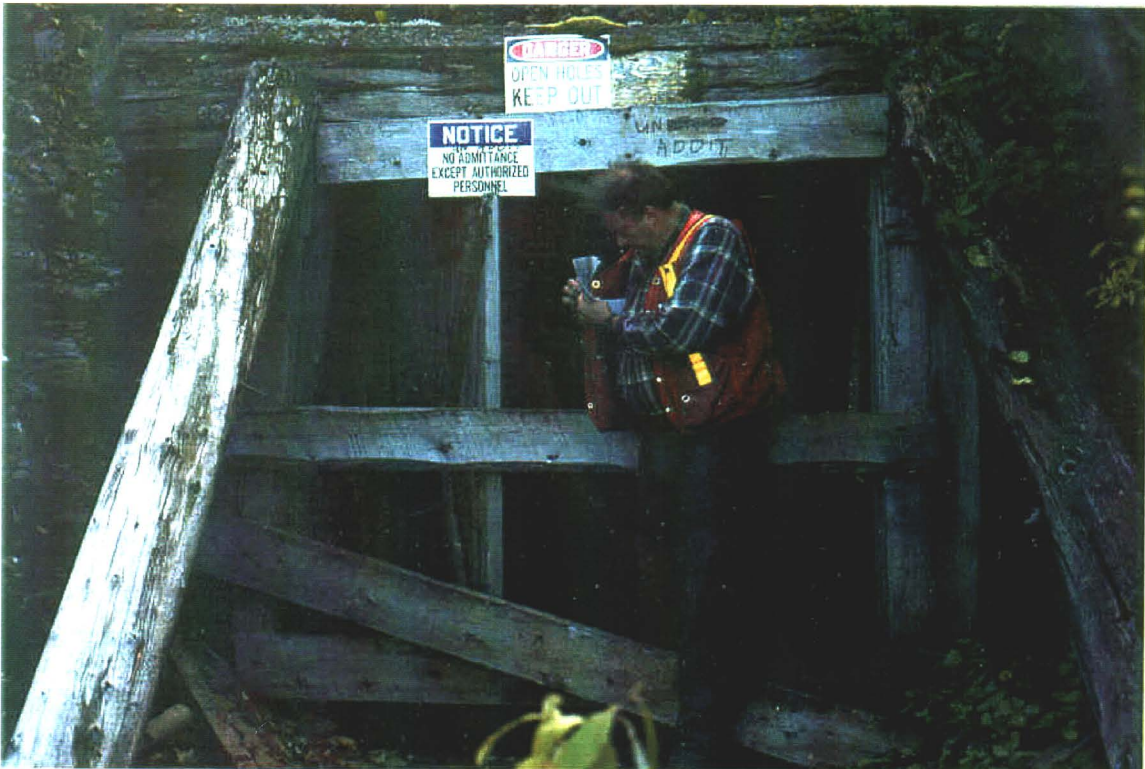
The UN portal is 2 m high and constructed with wood beams (Photo 10-2). The adit has a wooden door to the adit was open at the time of the site visit. The adit is blocked by ice that extends to the sides of the adit, and comes to within 20 cm of the roof. The ice block is reportedly present year round, but has never fully blocked the water flow (B.Dunn, pers. comm).

Photo 10-2. UN portal showing wooden debris and open door.

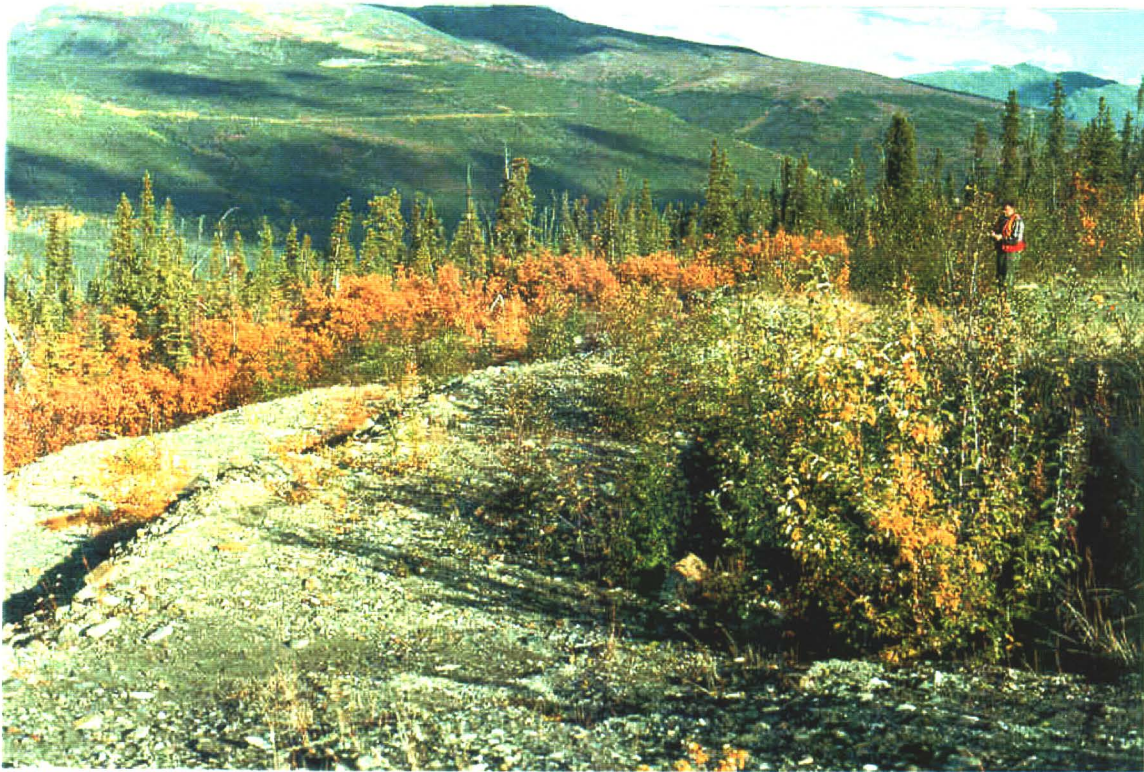
There are waste disposal areas associated with both the Dragon (UN) adit and the Miller open pit. The adit dump contains approximately 8,000 m<sup>3</sup> of waste, and consists mainly of schists and quartzite with little staining or alteration. The surrounding vegetation has not been impacted by the dump, and has begun to encroach on the dump material (Photo 10-3).

Photo 10-3. Waste rock pile outside the UN adit, showing natural revegetation.

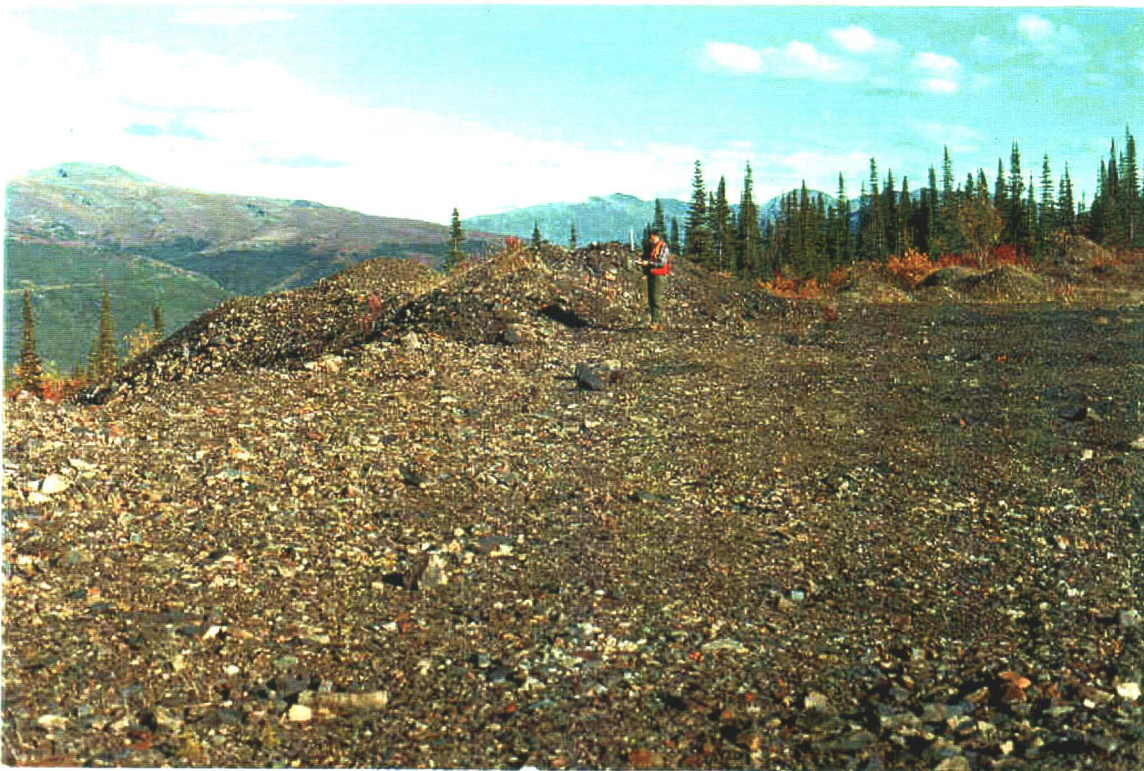
The estimated volume of material in the dump at the Miller pit is 80,000 m<sup>3</sup> (Photo 10-4). The waste rock consists primarily of quartzite with some schist. There is little vein material and some manganese staining.

Photo 10-4. Miller waste rock pile.

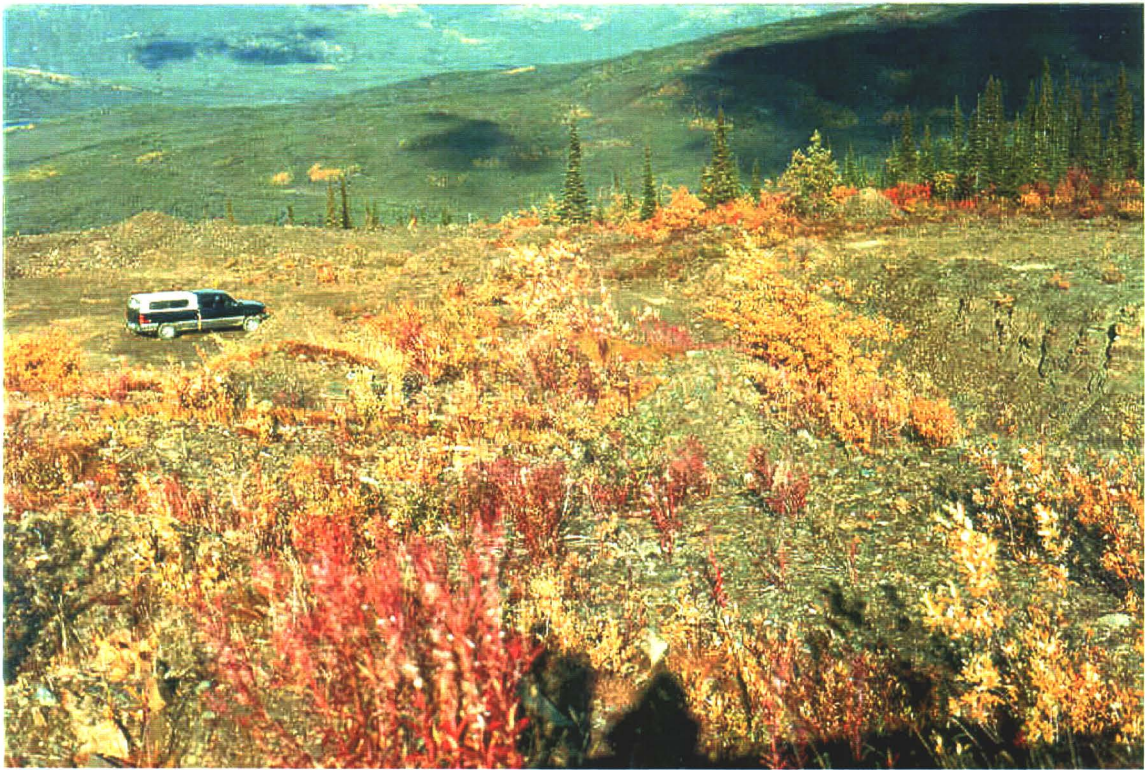
The waste rock pile at the UN adit and the disturbed areas surrounding the Miller Pit are beginning to revegetate (Photo 10-5). This will likely take a long time as there is mostly barren rock in these areas, and little water. Some revegetation of the waste rock dump is also beginning (Photo 10-4).

Photo 10-5. Natural revegetation of area adjacent to the Miller Pit that was cleared during mining.
