GALKENO MINE
(Including Sime, Mcleod, And Sugiyama)
Site No. 11
MINEFILE: 105M 0011,m

| | Public Works And Government Services Canada | Travaux publics et Services gouvernementaux Canada | designed by: _____ | date: _____ |
| | | | project no. no. du projet: 125-12.01 | dwg. no. dessin no.: 1 of 1 |

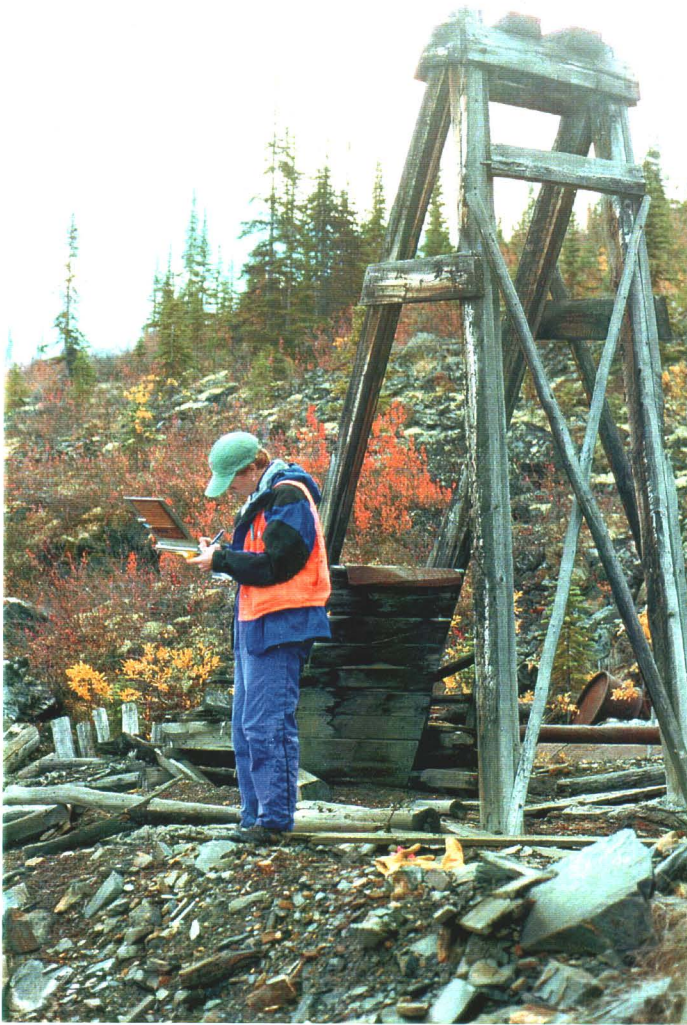
Condition: The wood of which the shaft is constructed is rotting.

Supports: There is a wooden A-frame above the shaft that likely once held a pulley. The wooden supports around the shaft are in poor condition, and the ground to the NNE of the shaft is subsiding due to collapsing workings below (Photo 11-2).

Accessibility: Shaft is partially collapsed and blocked by wood debris.

Photo 11-1. McLeod Shaft, looking southeast.

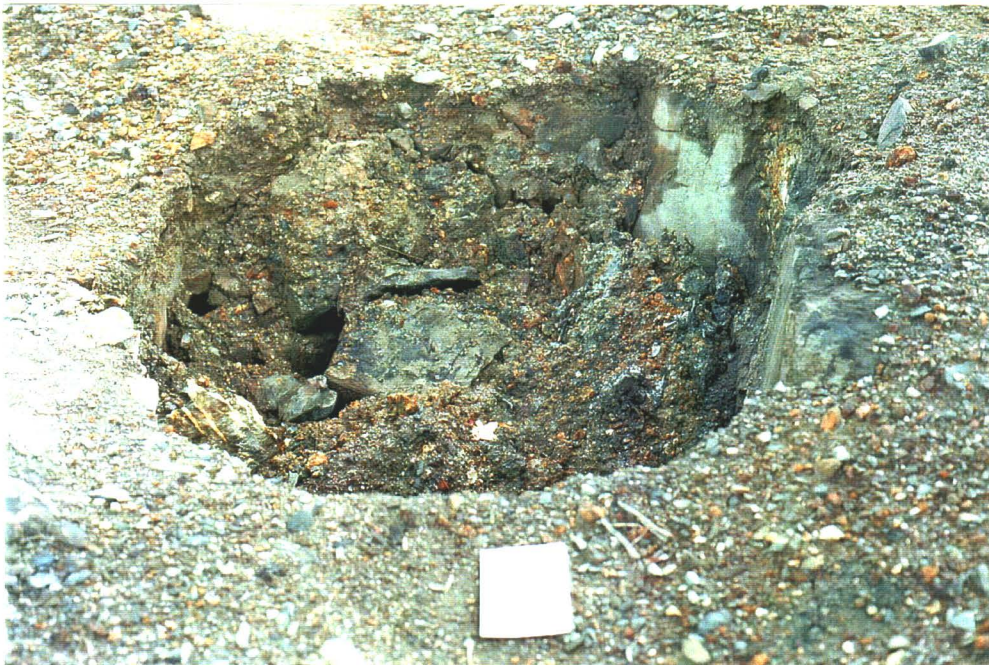
Photo 11-2. Subsidence over adit workings, near the McLeod Shaft. The collapsed area measures approximately one meter across.

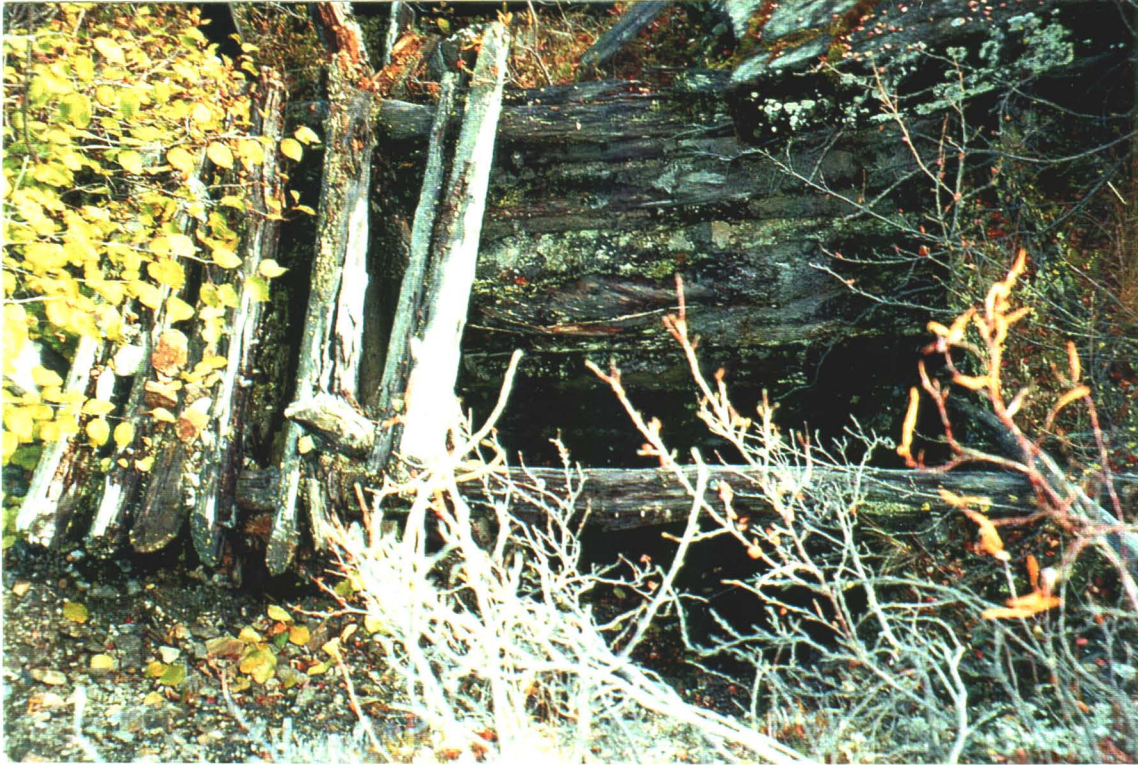
Condition: The bush has grown up around the shaft that is well hidden. The wooden supports for the shaft entrance has collapsed on one side and there are wooden timbers blocking the entrance.

Supports: The wooden supports around the shaft are in poor condition.

Accessibility: The shaft is inaccessible.

Photo 11-3. Unnamed Shaft. The wood constructing the shaft is rotted and unstable, and the area around the shaft is overgrown.

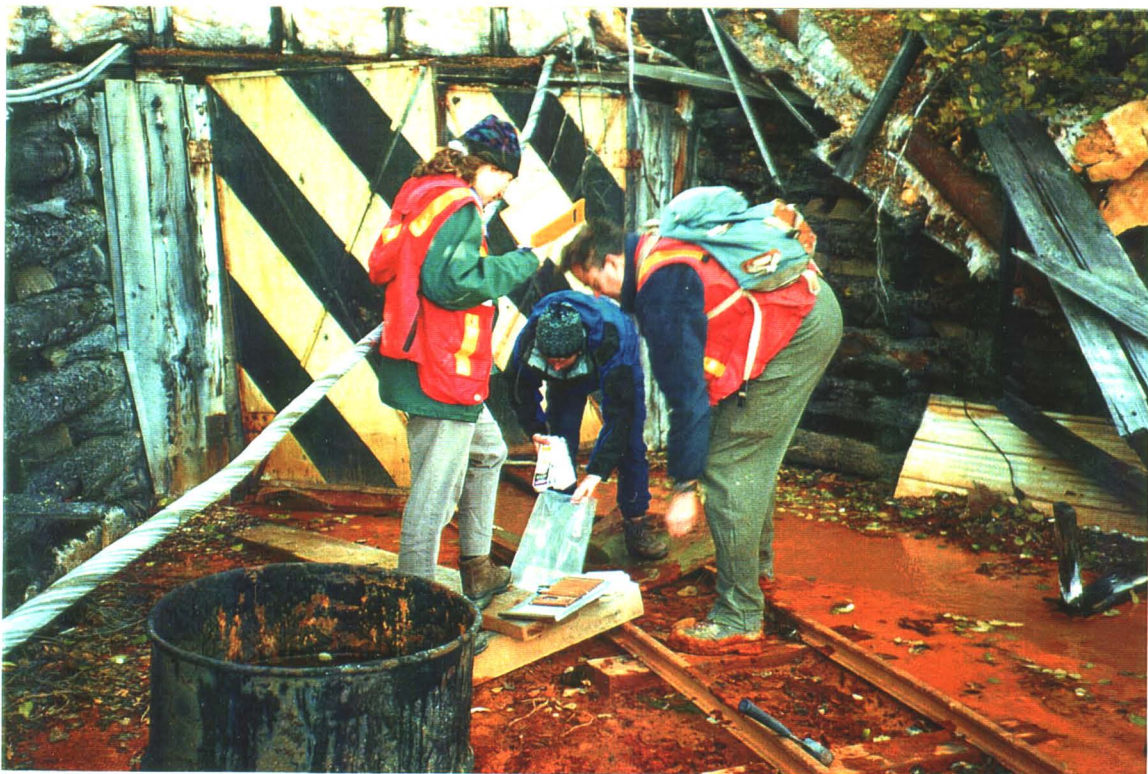
Accessibility: Portal has a wood frame that is in good condition and metal doors that are currently open although there has been an attempt to lock it. Adit is not blocked. There is lots of debris at the adit entrance: wood timbers, metal pipes or rail, insulation (utilidors), 15 m of 5 cm thick cable, retaining wall on either side of adit fairly stable.

A water quality sample was collected at the adit entrance. Flow was approximately 3 L/s and was bright orange (11-4). The pH of the water was 6.7 and the conductivity was 1883 μ S. Approximately 10 cm of bright yellowish-orange precipitate (likely limonite) has been deposited over a 3 m² area outside the adit. The seepage crosses the Duncan Creek to Galkeno 300 road, divides into two streams as it flows down the waste piles near the loading elevator, and then flows into the bush down slope of the mine site (11-20).

Photo 11-4. Galkeno 300 level adit. Note the iron oxidized (orange) laden water and precipitate. Also note the debris in the area.

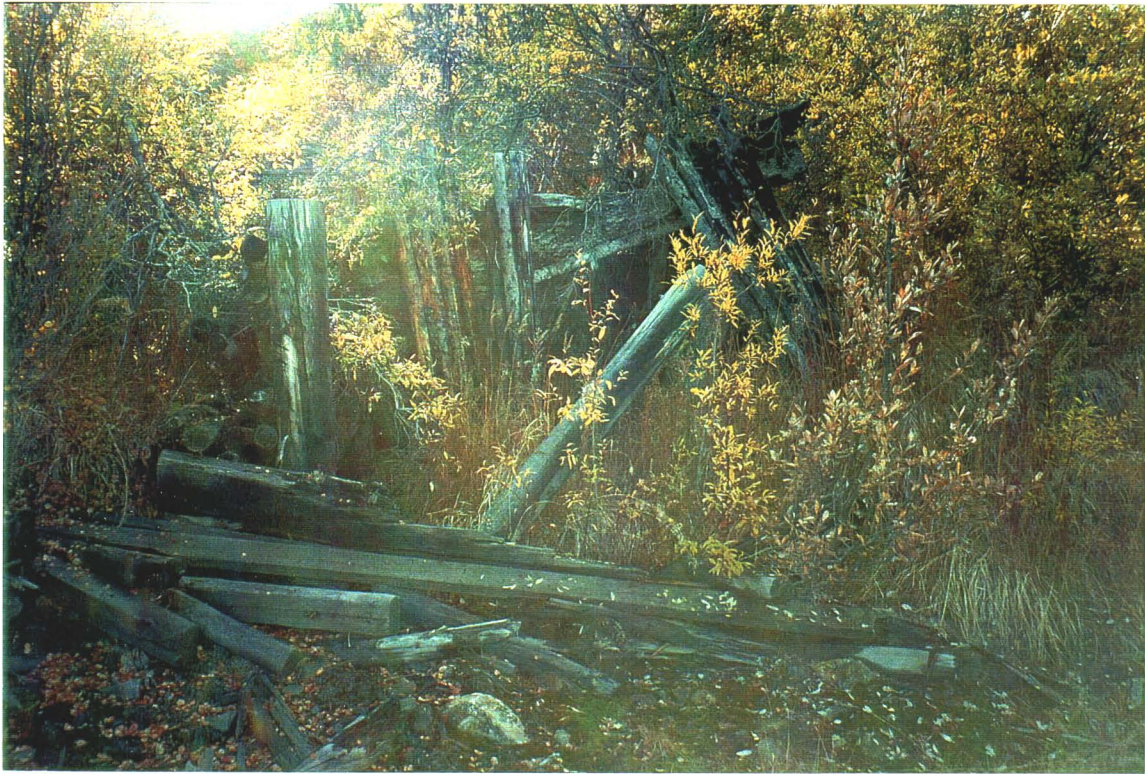
Condition: The portal is in poor condition.

Supports: The wooden supports of the portal have mostly fallen.

Accessibility: The portal is accessible but appears unsafe. It was not entered to determine the depth.

Photo 11-5. Galkeno 200 level adit. Portal is open but is unsafe. The timbers of the portal are collapsing.

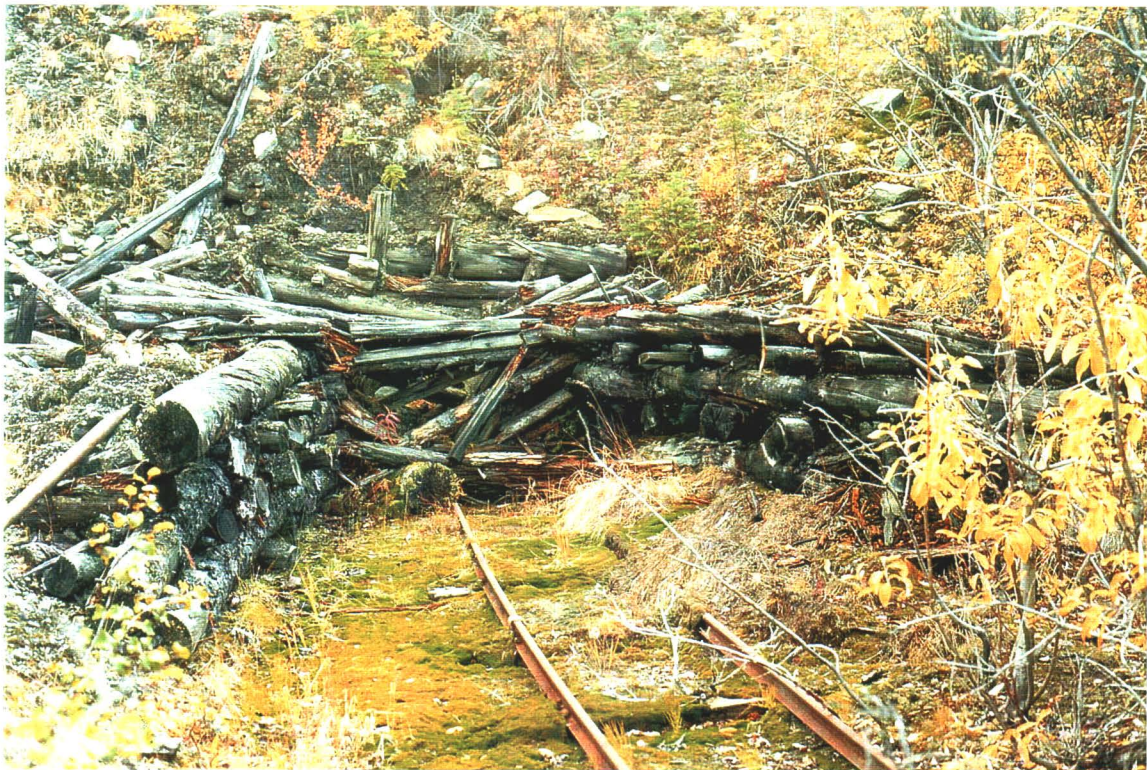
Condition: The portal is in poor condition. A large pile of wooden debris is in a nearby gully (Photo) and there are approximately rails and metal pipe outside the adit.

Supports: The wooden supports around the portal have collapsed. The buttresses to either side are in fair condition.

Accessibility: The portal inaccessible.

Condition: Rail bent and in poor condition.

Photo 11-6. Galkeno 100 level adit. Portal is completely collapsed. Note rails exiting adit.

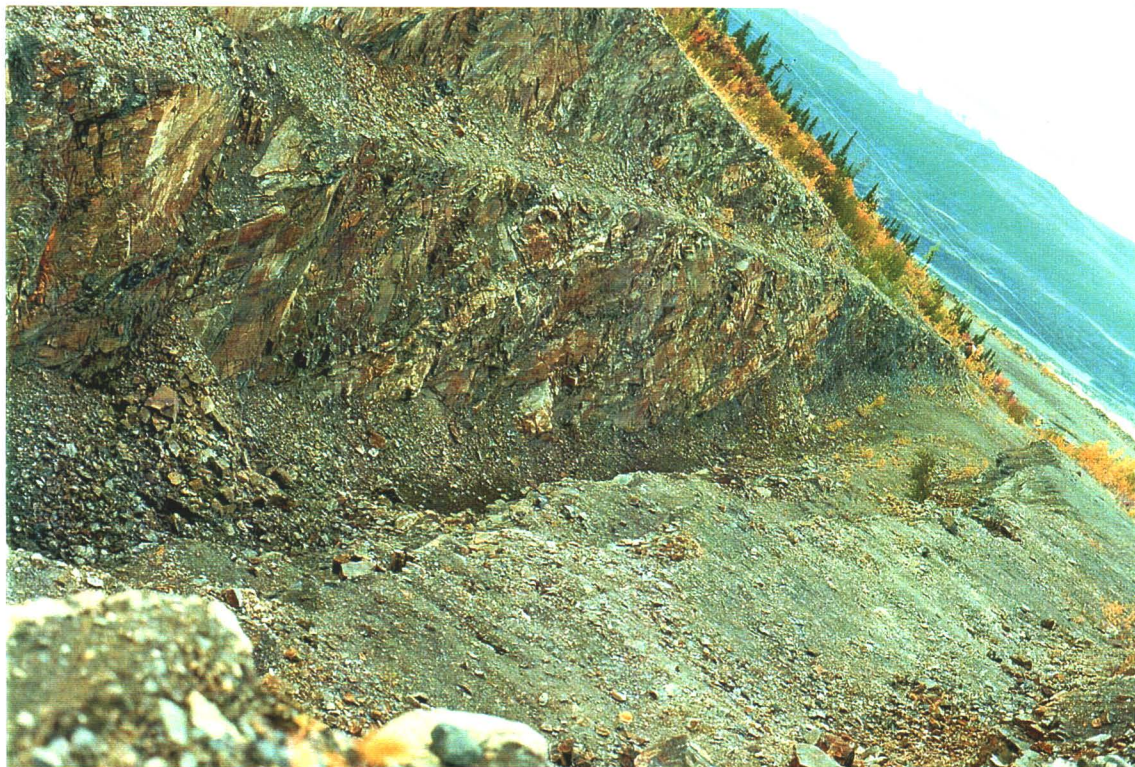
There are three open pits in the Sime area of the Galkeno property. The pits were excavated in thickly bedded, resistant quartzite much of which is moderately iron stained. All of the pits were dry when they were visited in September, and there was no evidence water ponding at any time of the year. The pits are very steep-sided, and walls reach from between 0 and approximately 100 m high. Therefore, they pose a substantial hazard from both the steep drop-offs and rock fall. Each pit is accessible by car and can be entered on foot.

Photo 11-7. #35 Vein Pit. Note steep pit walls.

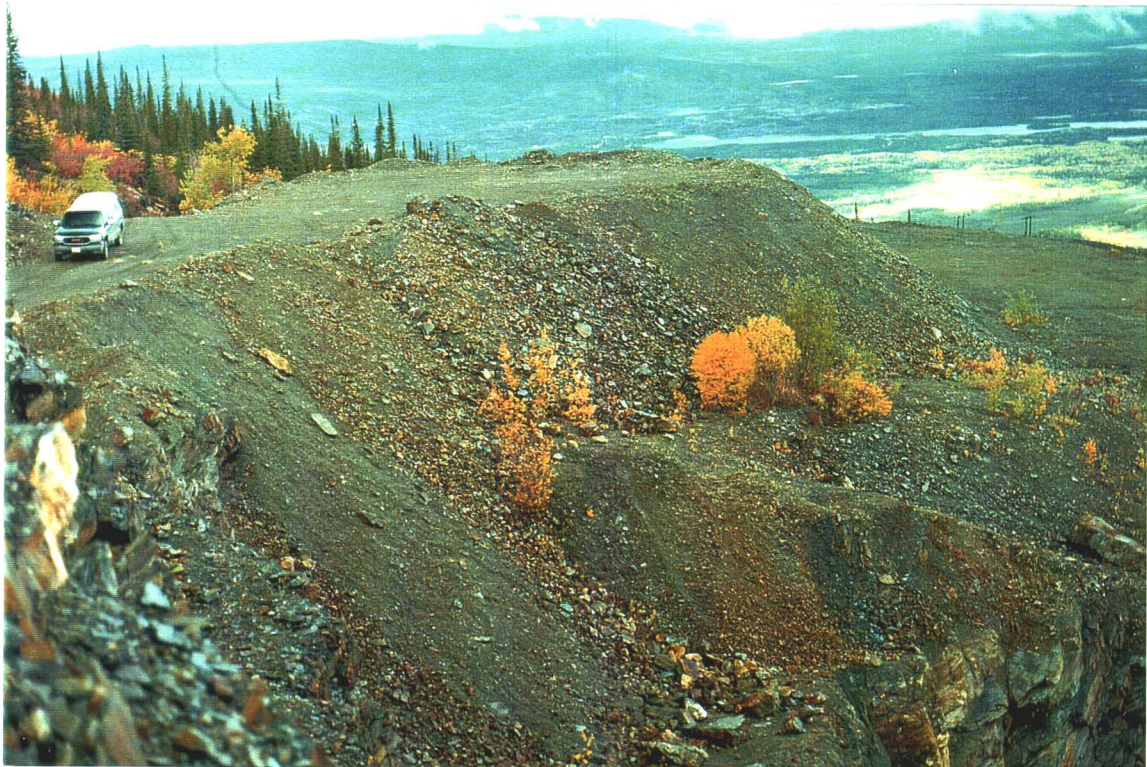
Photo 11-10. Waste rock dump located adjacent to the Sime #4 open pit (lower right-hand corner of photograph).

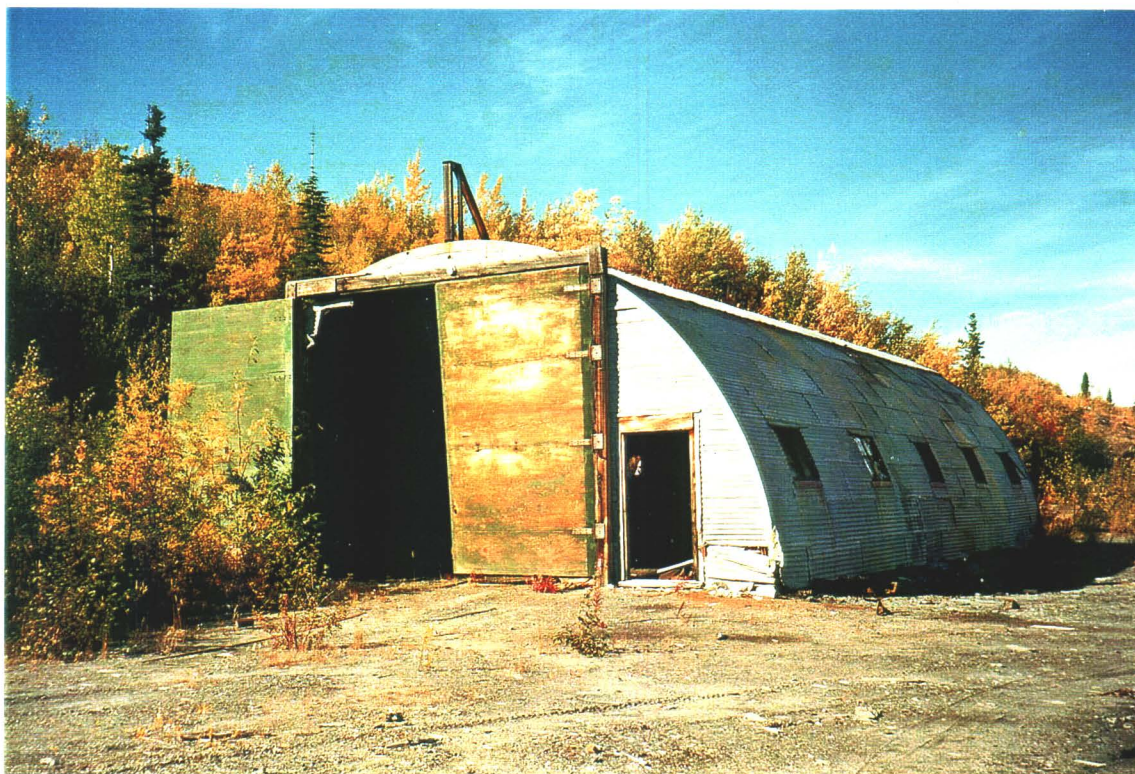
Surrounding area: Hydrocarbon staining was found adjacent to the north and west walls of the building. The northern stain measures 8.5 m x 2 m x 3 cm deep, and the contaminant appears to have leaked from inside between concrete and building frame. The west stain measures 6 m x 3.5 m x 3 cm deep and appears to have leaked from an above ground storage tank.

Photo 11-11. Building 11A - Quonset Warehouse, looking northwest. Located near the 300 level adit.

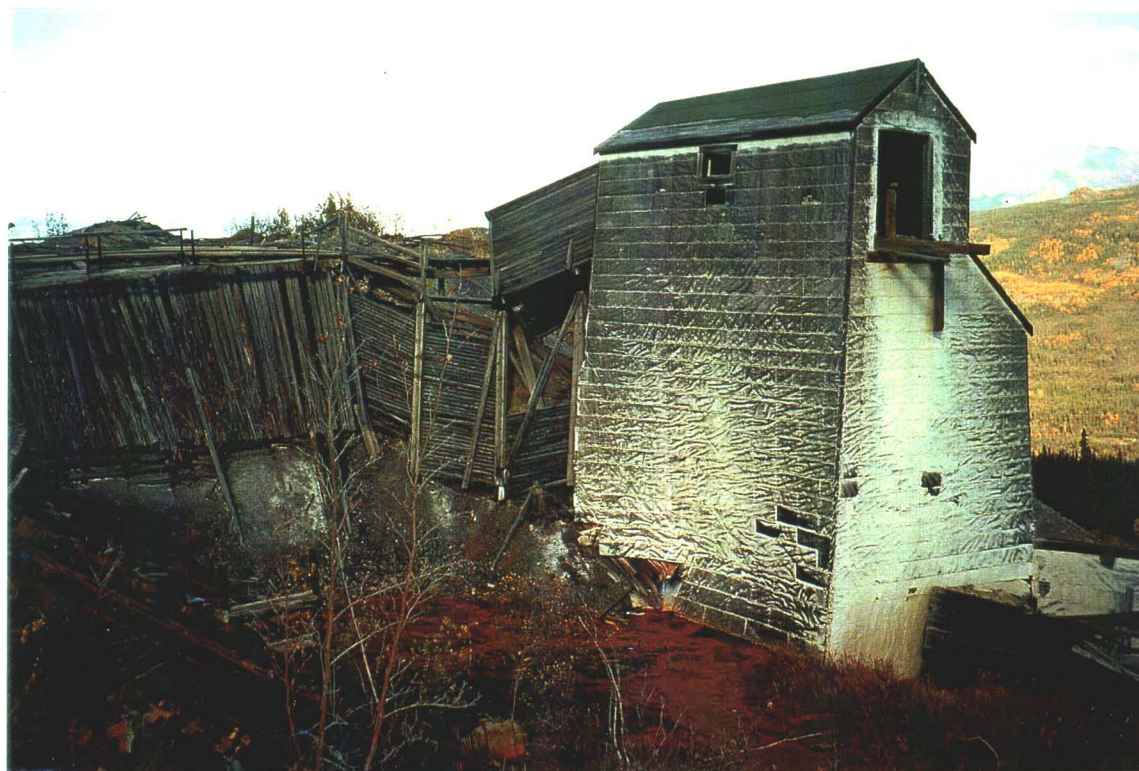
This building is very unstable and poses a hazard, particularly since there is good access to the site.

Condition: Poor. Very unstable as building is leaning downhill.

Photo 11-12. Building 11B - Loading Elevator, looking northwest. The building is located on the waste rock dump outside the 300 level adit. Note how the building is leaning away from the waste dump (also see Photo 11-14).

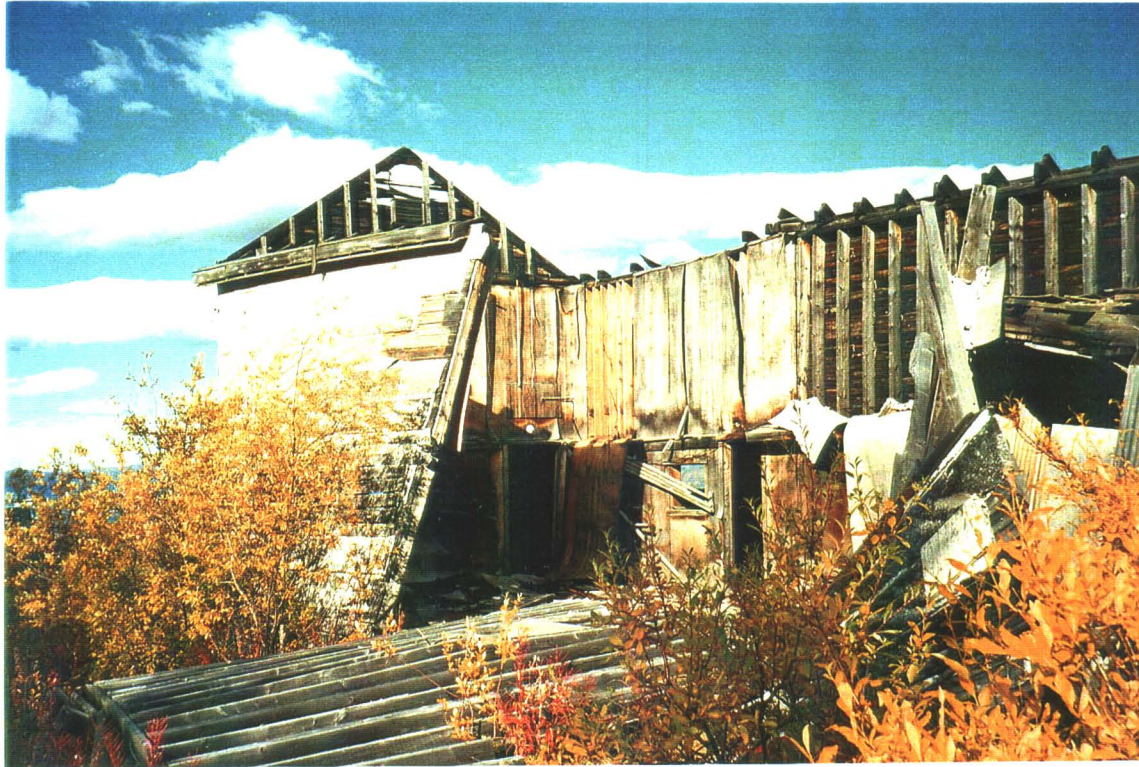
Condition: Poor. Roof has collapsed.

Photo 11-13. Building 11G, showing the remaining walls.

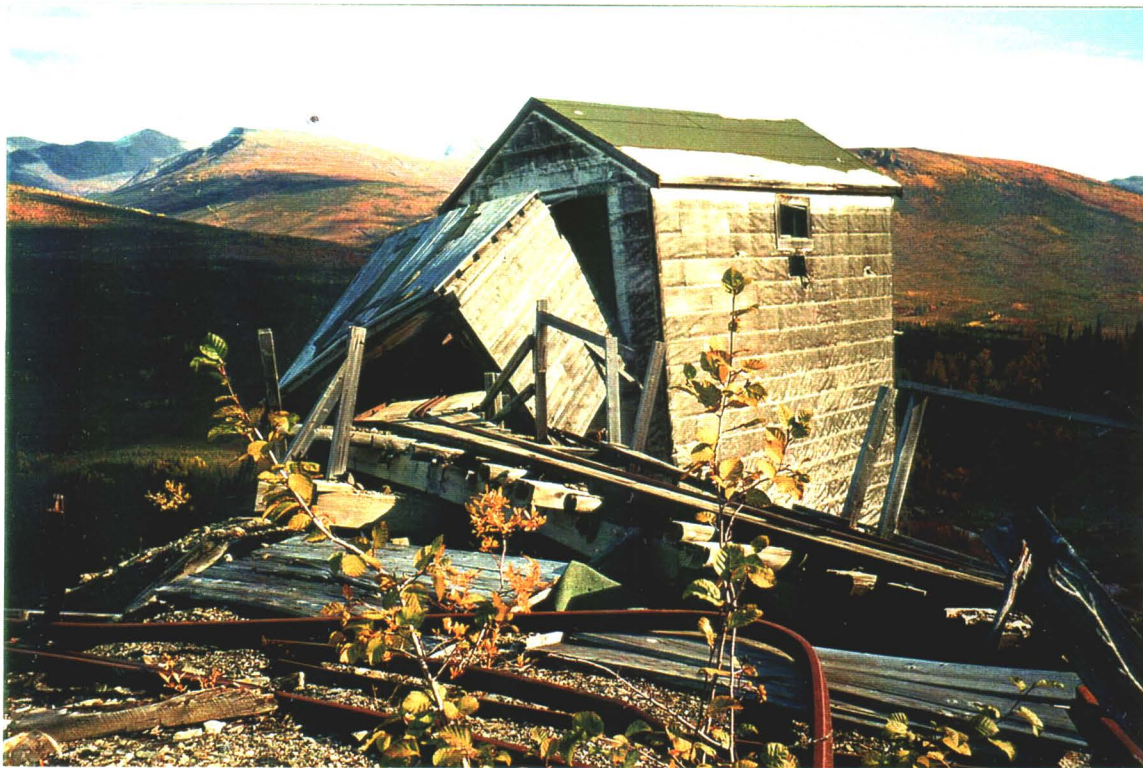
Photo 11-14. The top of the Loading Elevator, looking northeast. There is wooden boards and discarded rails out side this building.

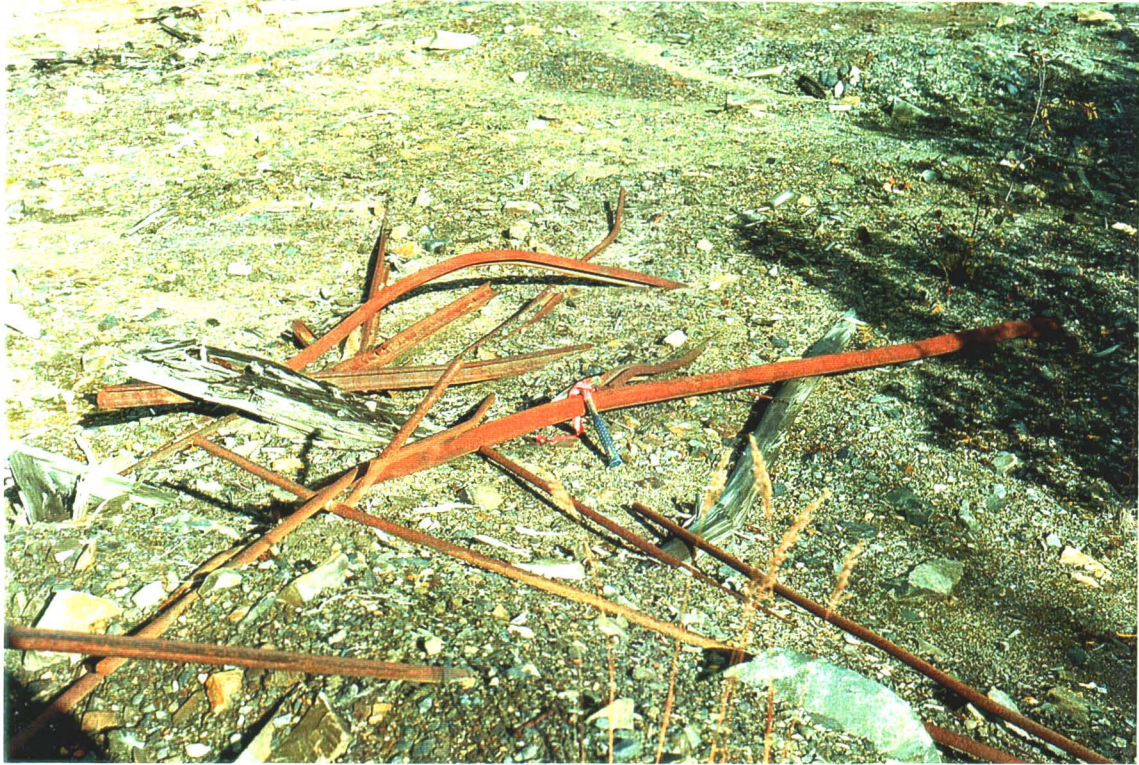
Fabrication: Approximately 30 m of steel rail attached to the wooden ties runs out of adit (Photo 11-6). More rail and other metal and wood debris are deposited on platform outside adit (Photo 11-15).

Photo 11-15. Debris outside the 100 Level adit.

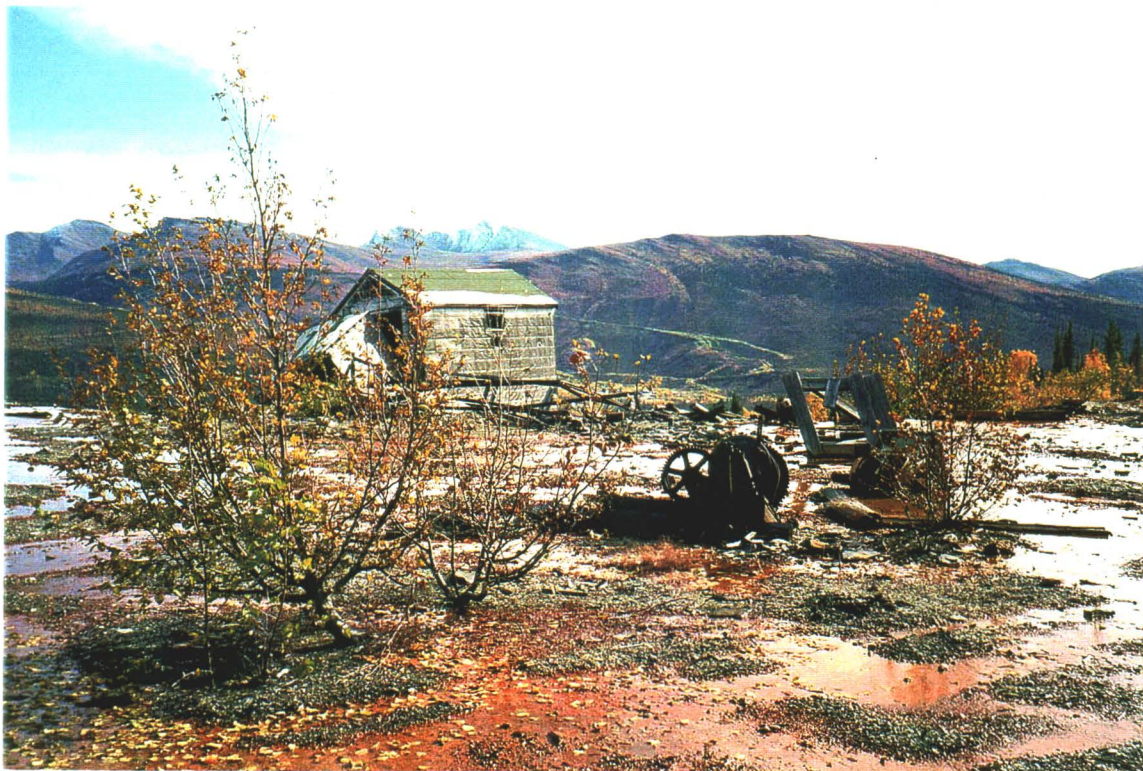
Most debris is at the 300 level adit. There is wood debris as well as rail and track immediately outside the adit (Photo 11-4) and on the top of the waste dump (Photo 11-16).

Photo 11-16. Debris outside the 300 Level adit, on the dump surface.

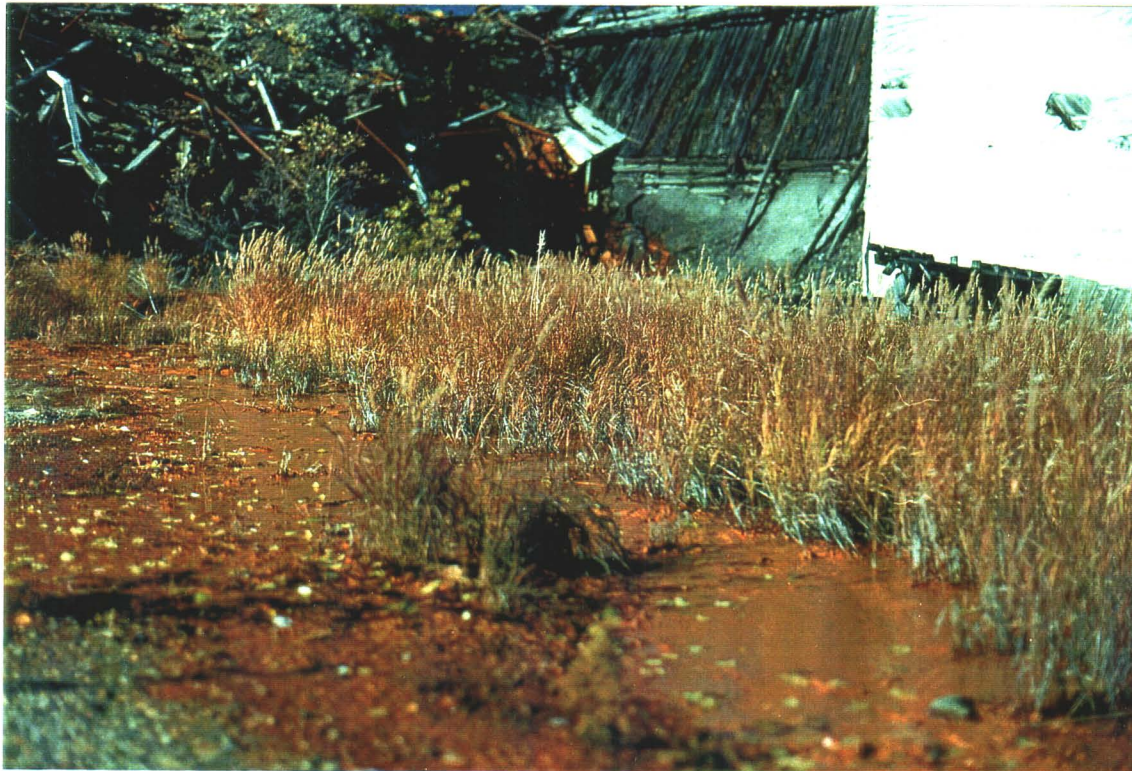
A large pile of mainly metal debris is located adjacent to the loading elevator (Photo 11-17). Additional debris is located below the waste dump at the 300 level adit, consisting of several empty, rusted barrels, miscellaneous metal debris and tar paper from buildings and large wooden cable spools (Photo 11-18).

Photo 11-17. Debris outside the 300 Level adit, adjacent to the Loading Elevator.

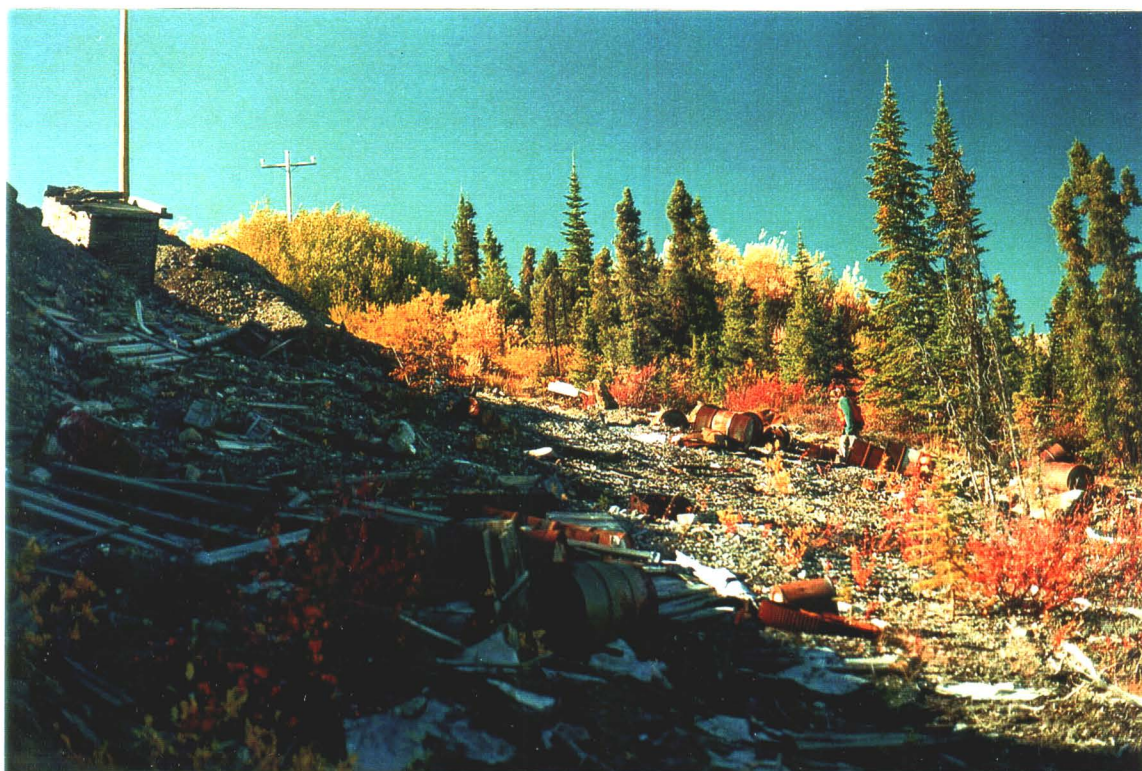
Photo 11-18. Debris at the bottom of the 300 level waste rock

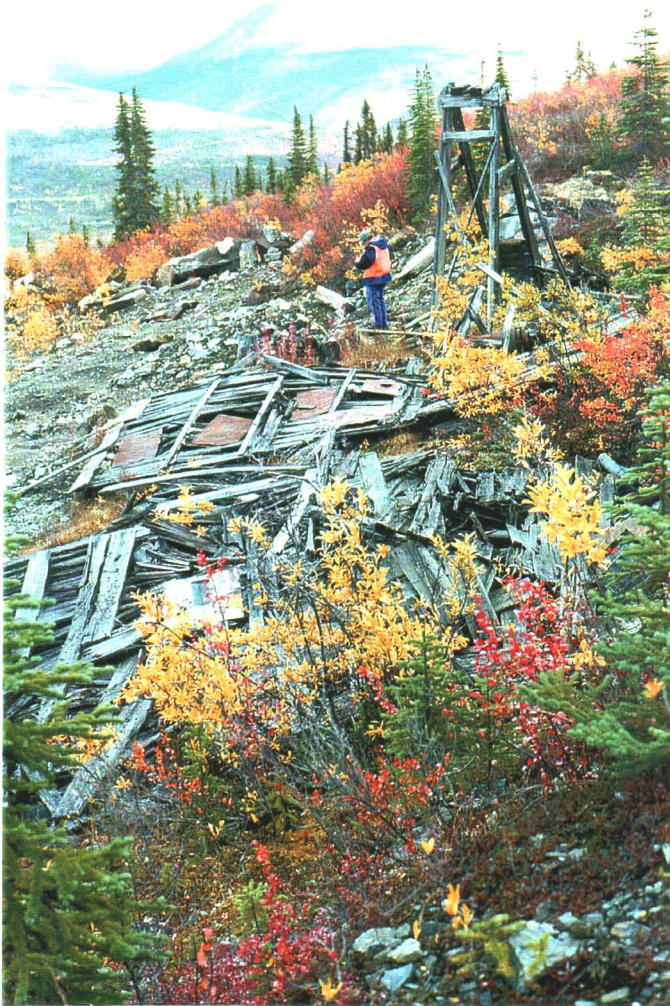
Abundant wood with some metal debris (11-19) surrounds the shaft.

Photo 11-19. Debris around the McLeod Shaft.

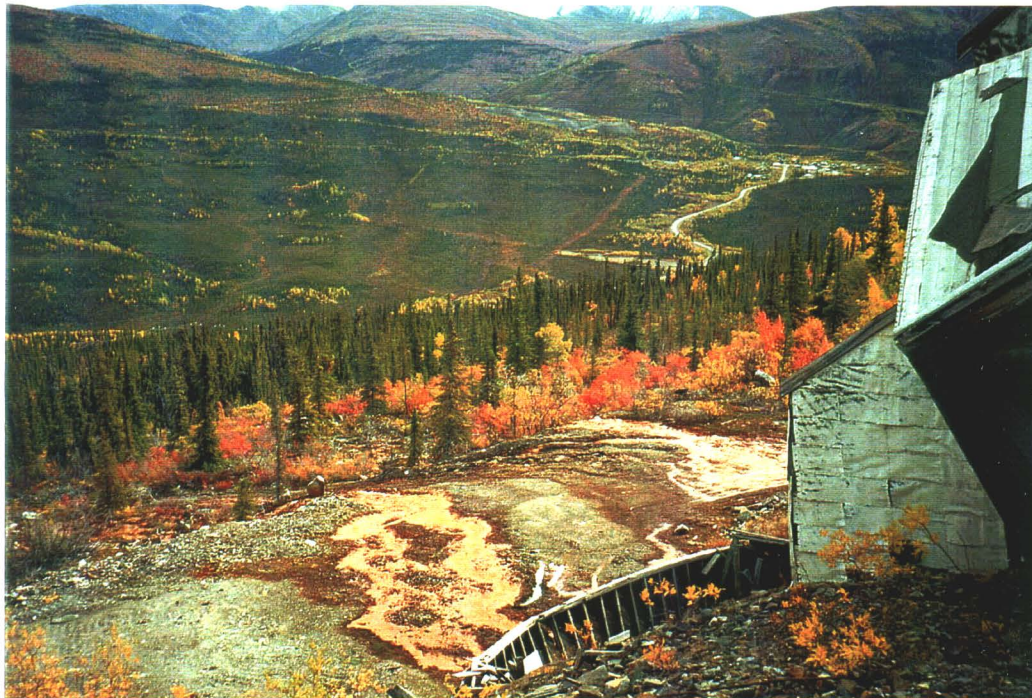
Photo 11-20. Drainage from the 300 level adit as it flows past the Loading Elevator and down below the mine site.

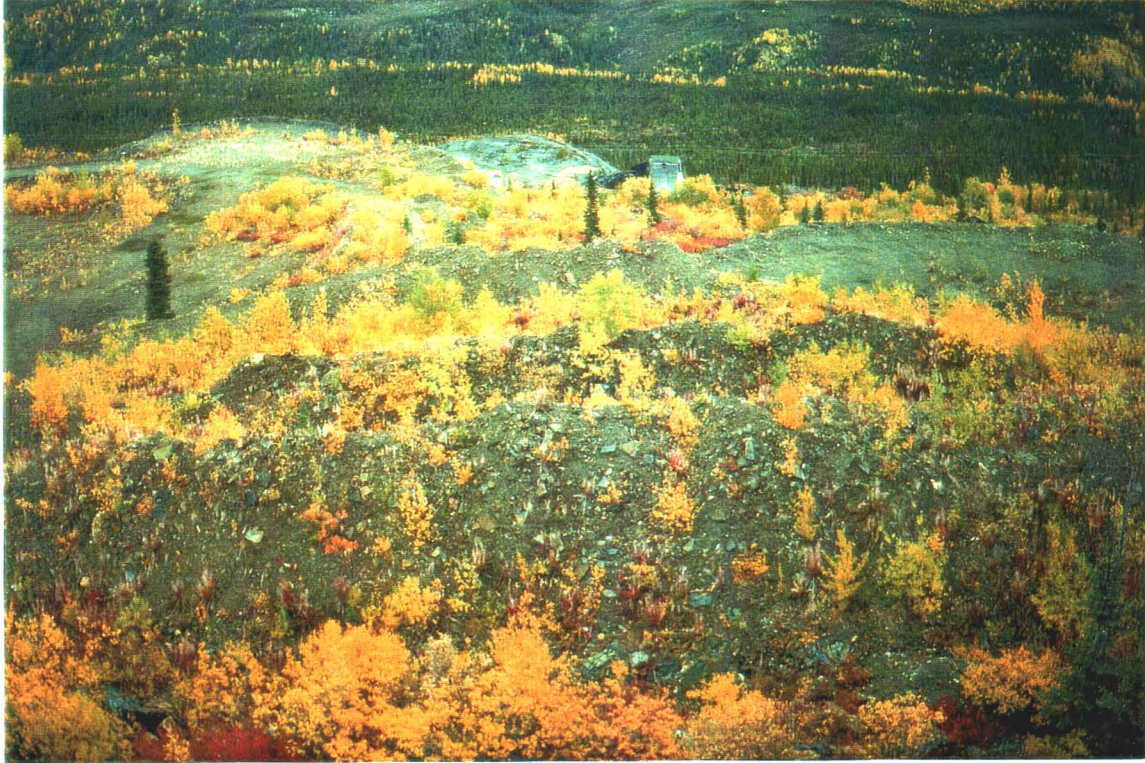
Photo 11-21. Natural revegetation of the some of the waste rock piles. Revegetation is more extensive in areas such as this where the material has a range of grain sizes. Contrast this with Photo 11-10 where there has been less revegetation.
