**FISHER CREEK**  
**SITE #13**  
**MINFILE# 105M001o**

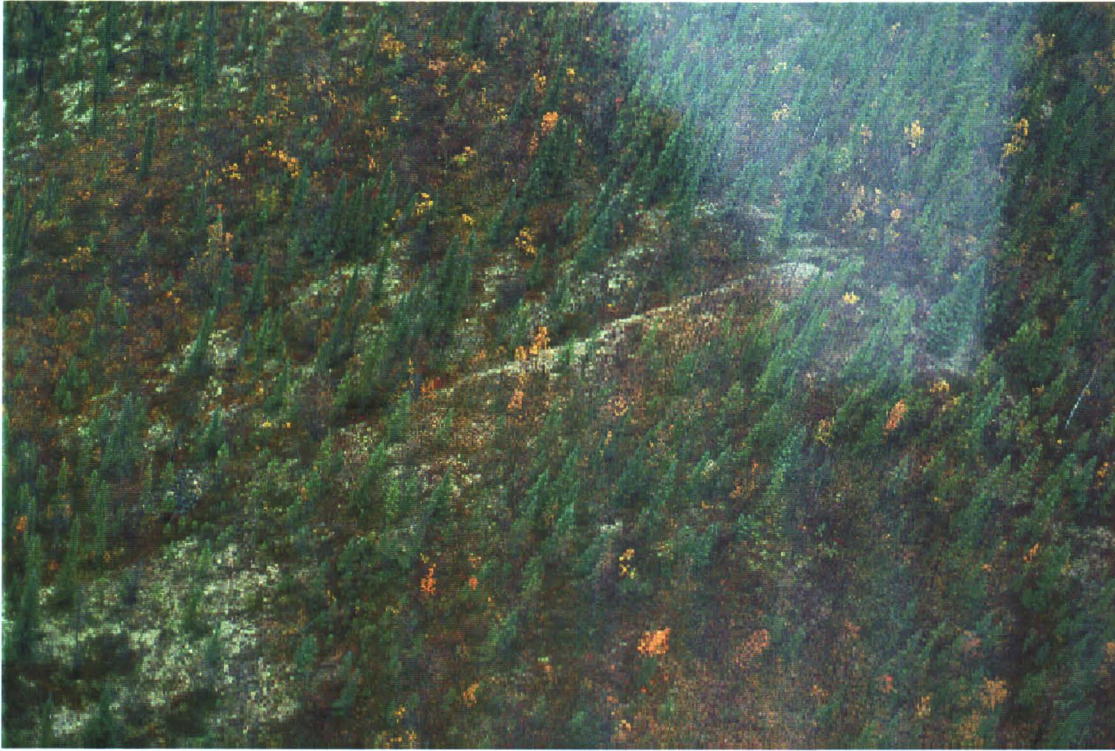
Photo 13-1: Aerial shot of trench #1. (Azimuth 180°)

Trench 1 is has become overgrown with trees and shrubs.

Condition: There is no evidence of slumping of the trench walls, which were stable at the time of the site visit.

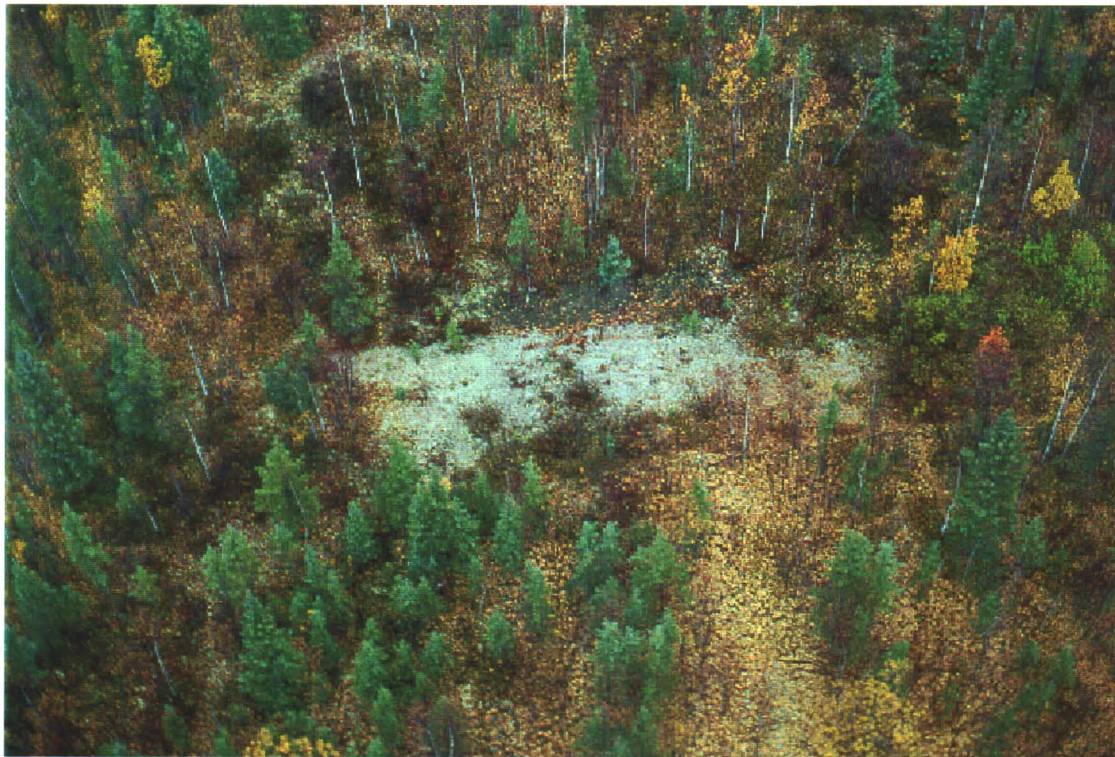
Photo 13-2: Aerial shot of trench #2. (Azimuth 280°)

Trench 2 is shallow but wide. Sparse vegetation is growing within the trench.

Condition: There is no evidence of slumping of the trench walls.

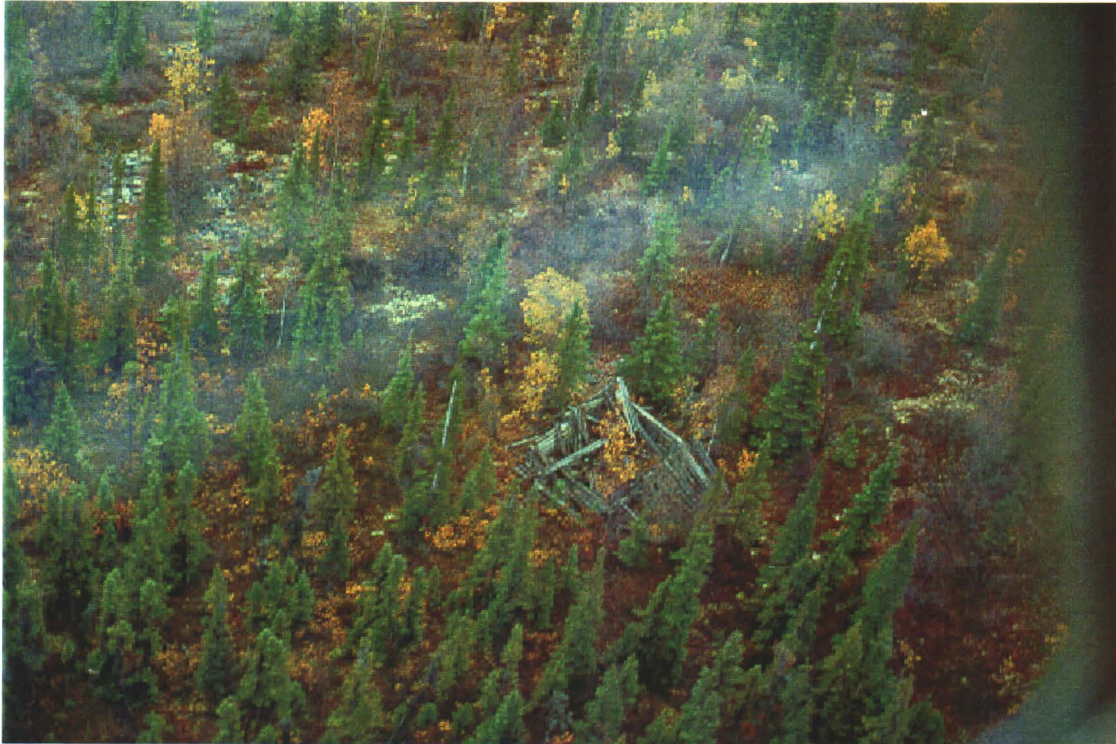
Photo 13-3: Aerial shot of the collapsed log cabin. (Azimuth 260°)

One collapsed log cabin (Building 13A) was encountered.
