BLUEBIRD
SITE NO. 14
105M 001b

Public Works And Government Services Canada Travaux publics et Services gouvernementaux Canada Architectural & Engineering Services Western Region	designed by: _____ date: _____ conçu par: _____ drawn by: C.S. Nov. / 99 dessiné par: _____ approved by: _____ approuvé par: _____
	Drawing title: Bluebird Site #14 Site Assessment Yukon Territory

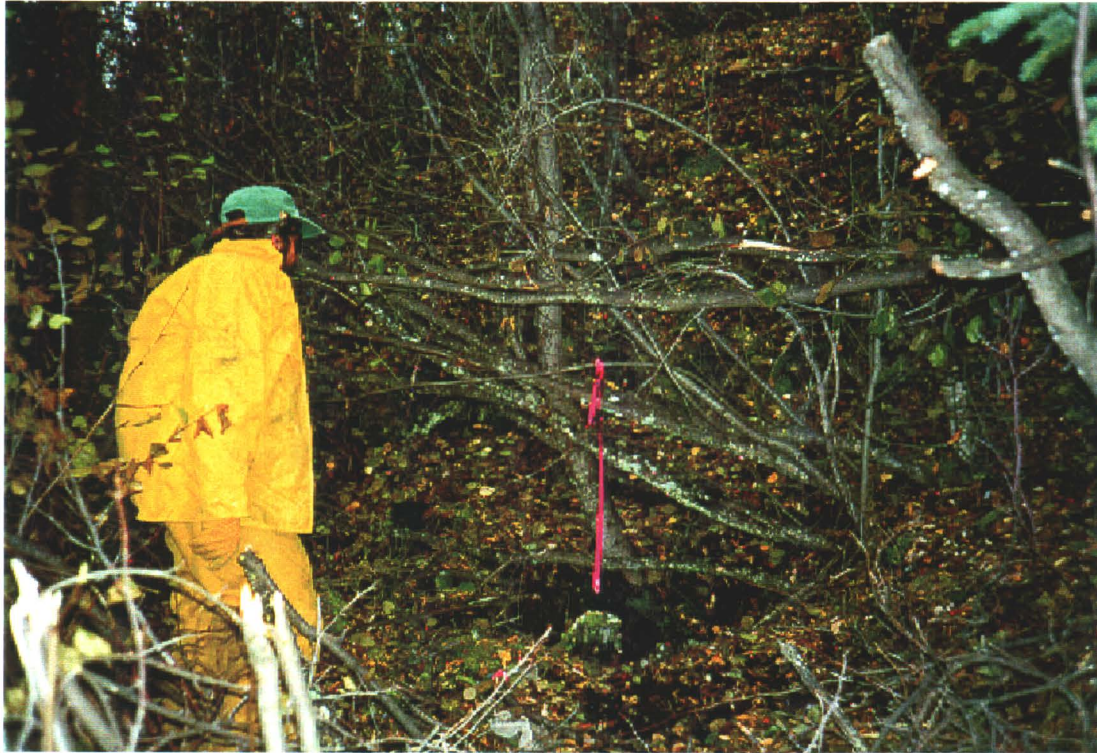
Condition: All of the shafts are partially to completely collapsed, and the northernmost shaft has 40 cm of standing water covering the fill material.

Photo 14-1: Lower shaft; opening located below flagging. (Azimuth 180°)

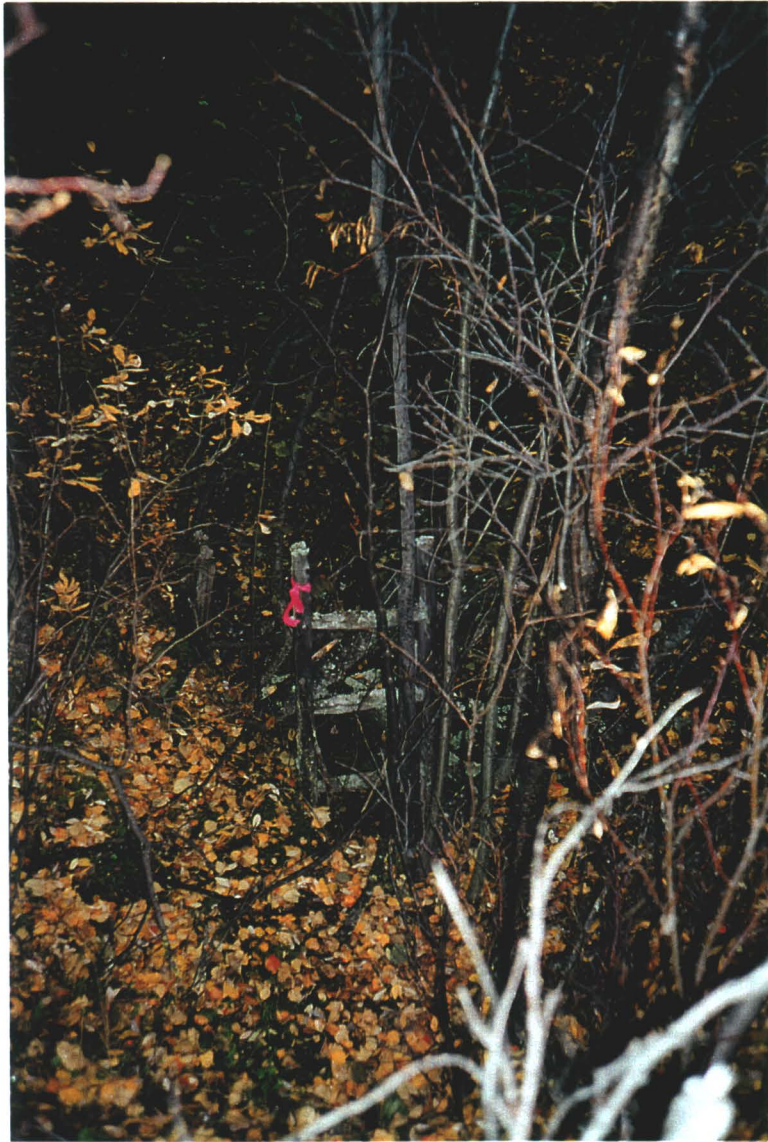
Supports: Some small rotten timbers are visible projecting out of some shafts. Rotten ladders are present at the upper three shafts

Photo 14-2: Lower-middle shaft; note ladder extending out of shaft opening. (Azimuth 040°)

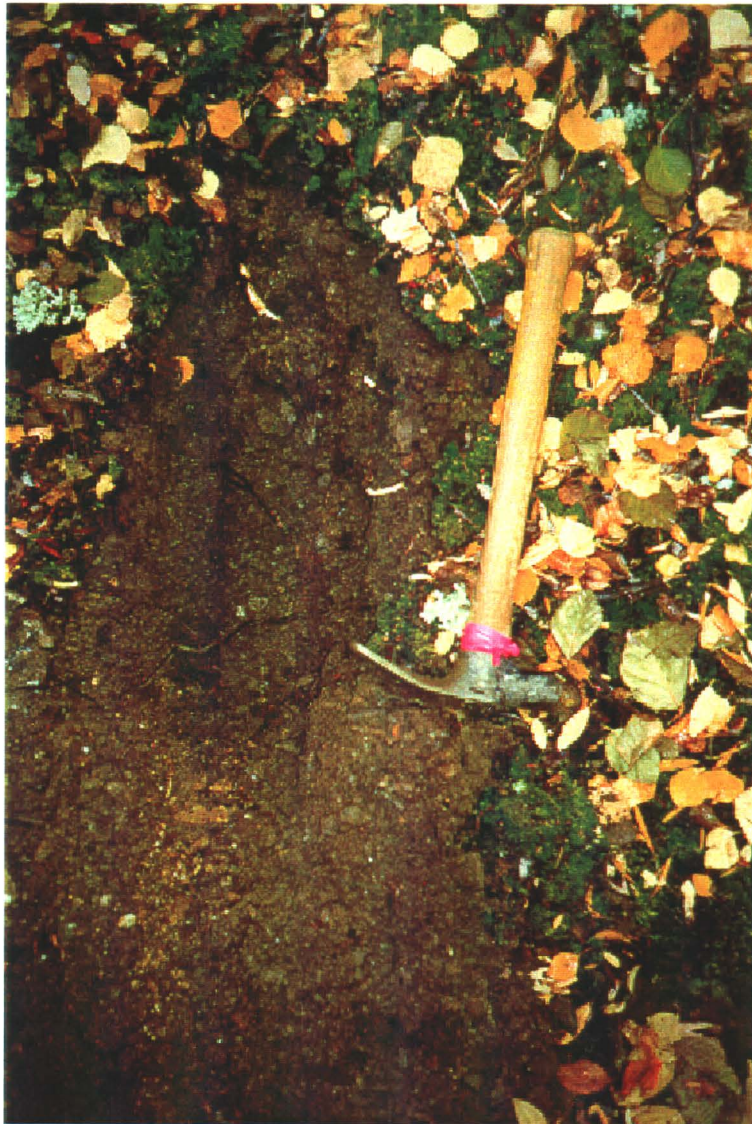
Sampling: No waste rock samples were collected. A 30cm test pit was dug, which revealed fine grey-brown phyllite flakes with 5% bright orange siderite material.

Photo 14-3: Test pit in rock dump for lower-middle shaft.

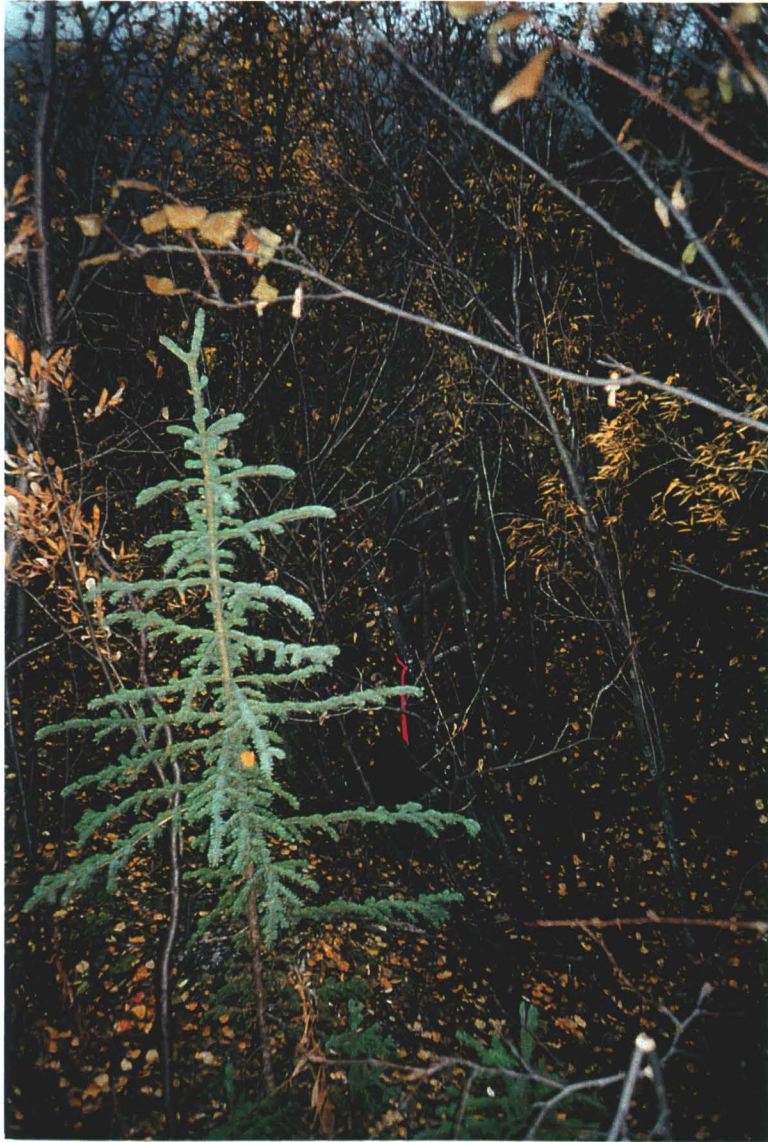
Dimensions: (L x W x H) Maximum size about 12 x 8 x 1m (Upper Middle); difficult to measure due to revegetation.

Photo 14-4: Upper-middle shaft and rock dump area; note flagging on ladder extending from shaft opening and mapper standing at end of rock dump. (Azimuth 120°)

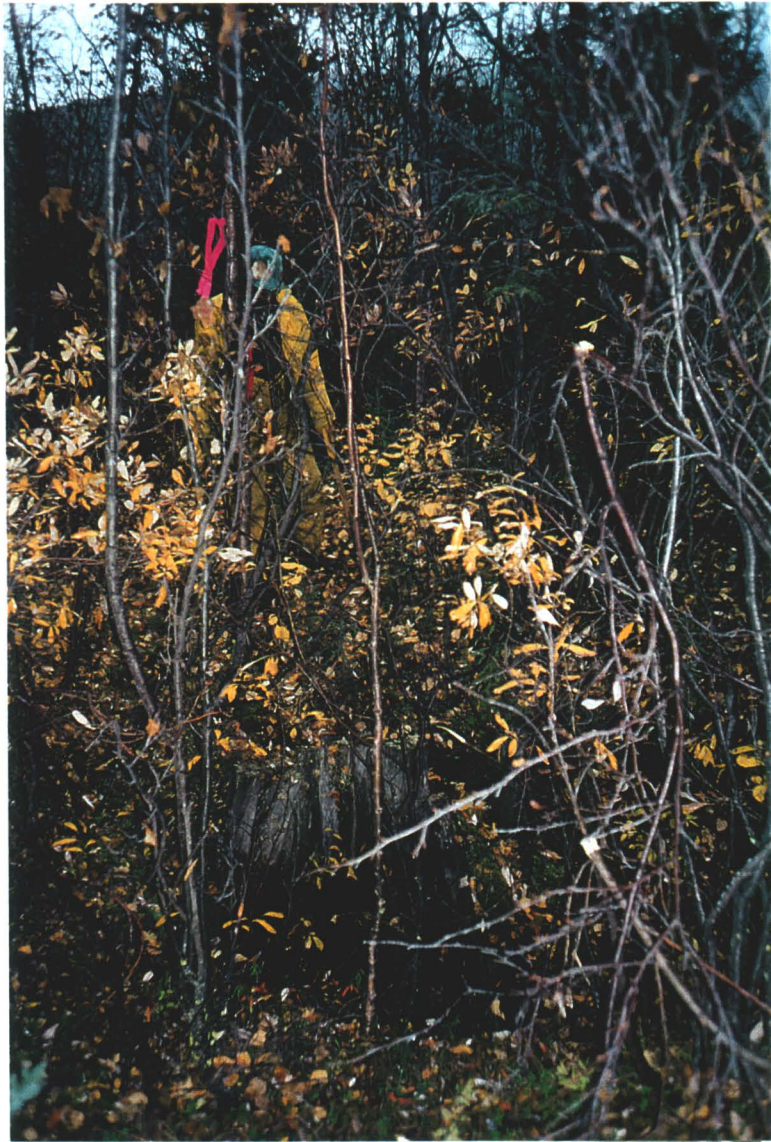
Photo 14-5: Upper shaft site. (Azimuth 050°)

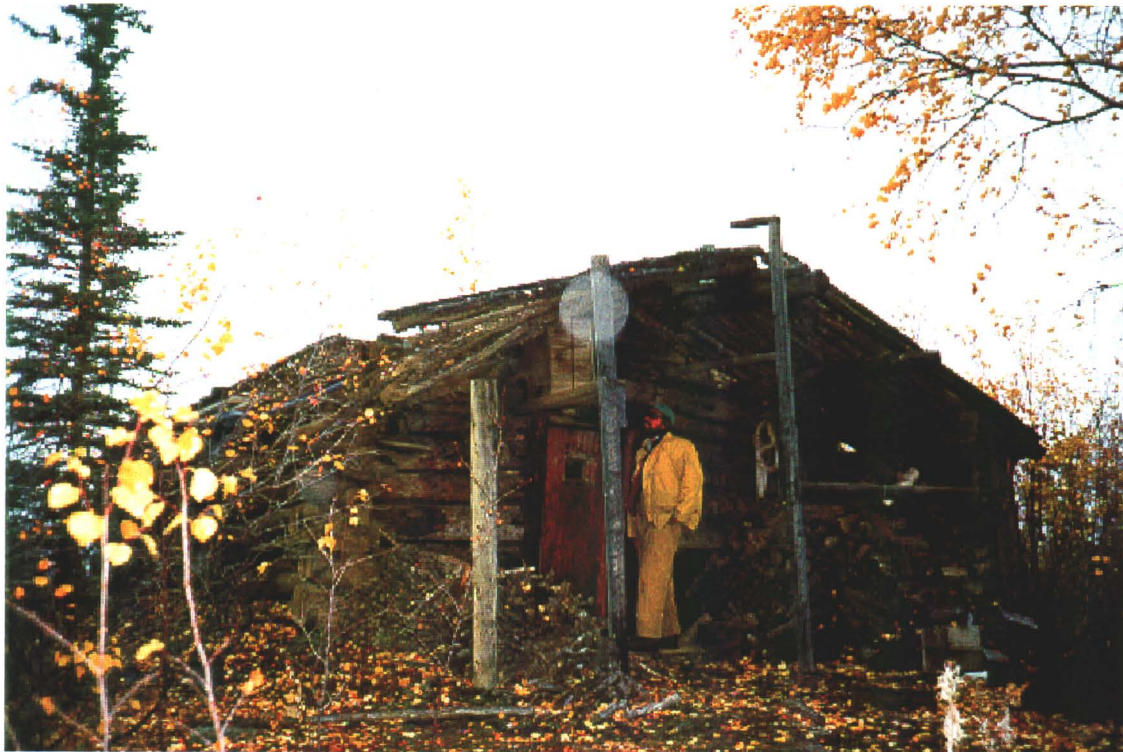
Building 14-A - Cabin (Photo 14-6)

Description and type: Log cabin with a log and sod roof.

Asbestos: None observed.

Hazardous Contents: No hazardous materials observed.

Photo 14-6: Recent cabin (early 1980's); note collapsed sod roof structure. (Azimuth 340°)
