TIN CAN (#15)
MINFILE# 105M 001q

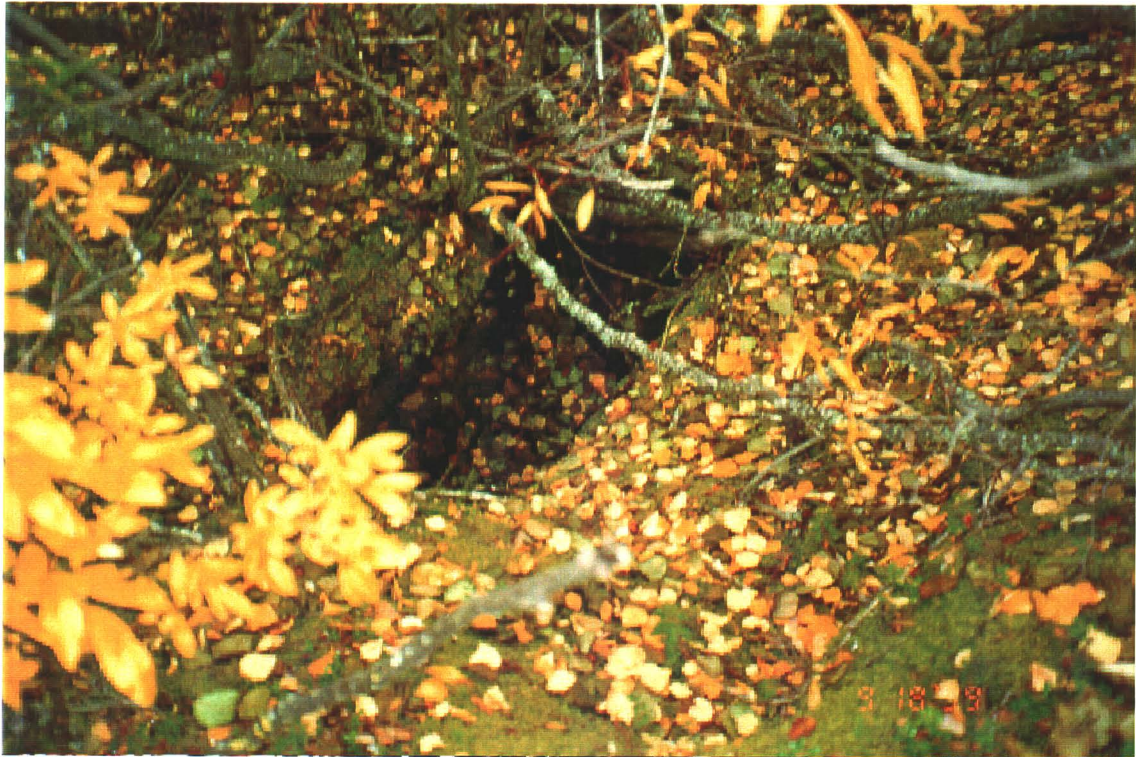
Shaft #1 (photo 15-1)

A hole in a boggy area filled almost to the rim with water. Remains of an old ladder project from the hole.

Condition: Organic material has slumped into hole. Quite stable due to water filling hole.

Accessibility: Easy access on foot. Low risk, similar to a natural pond.

Shaft #1 was flooded to near ground level. There was no surface runoff from this area at the time of the site visit. A water sample and duplicate were collected from the ponded water (WQ-StrCD-01 & WQ-StrCD-02).

Photo 15-1: Remains of shaft #1. Note water level just below grade.

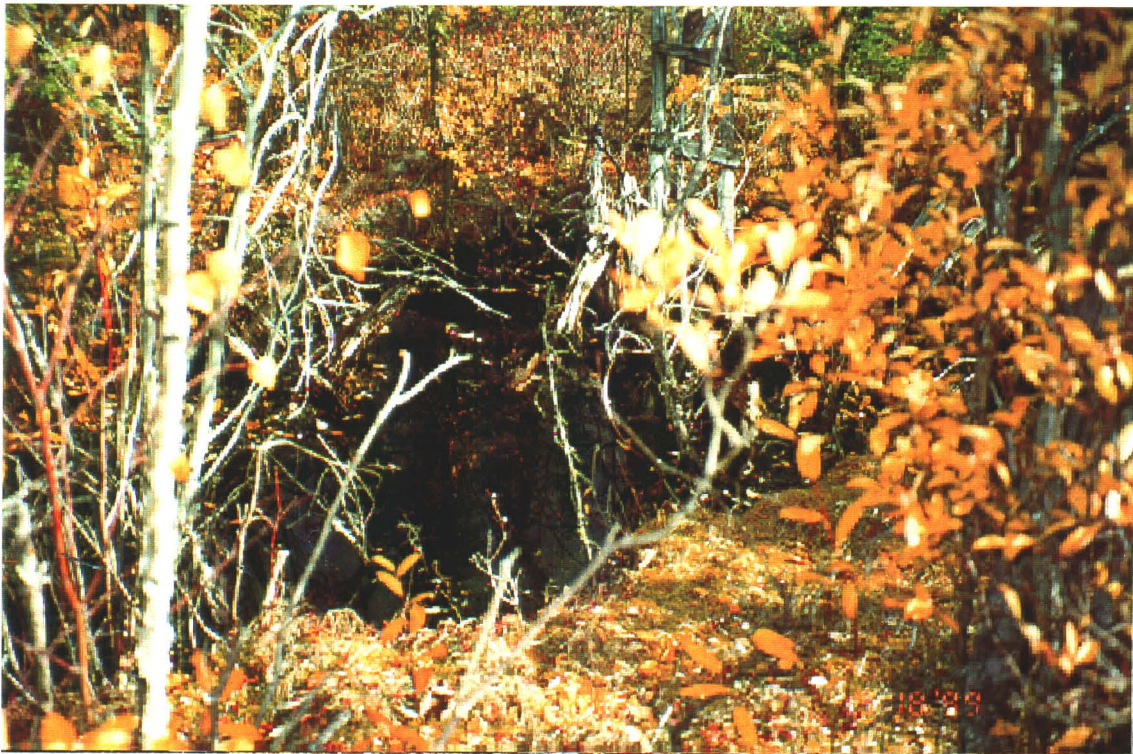
Shaft # 2(photo 15-2)

Collapsing timbered shaft, dense revegetation. Digging into waste pile located rusty greenstone with about 1% pyrite.

Condition: Partially collapsed, filled with debris.

Supports: Rotted timbers.

Accessibility: Access by foot, dense vegetation surrounding shaft limits hazard.

Photo 15-2: Timber-lined remains of shaft#2.

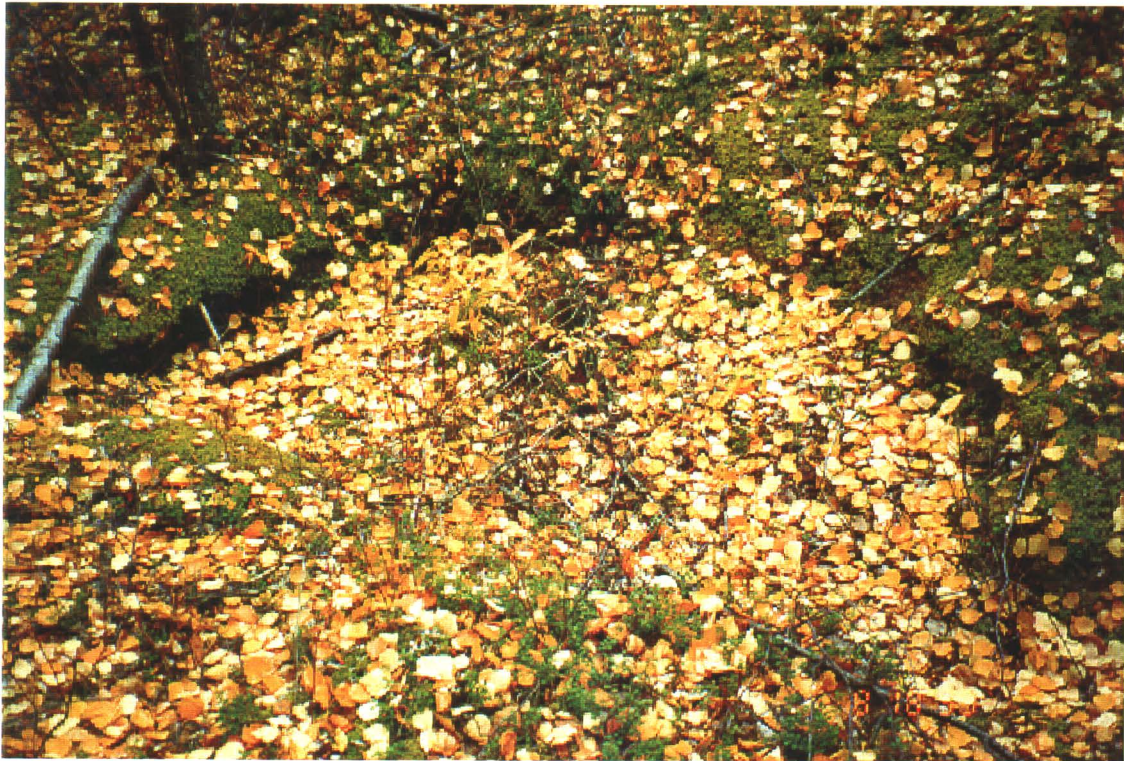
Test Pits (photo 15-3)

A series of four small test pits were noted at the site. All of these had overgrown and were difficult to locate.

Condition: The pits are extensively overgrown and there is little evidence of their former usage.

Photo 15-3: Reclaimed small test pit above shaft site.

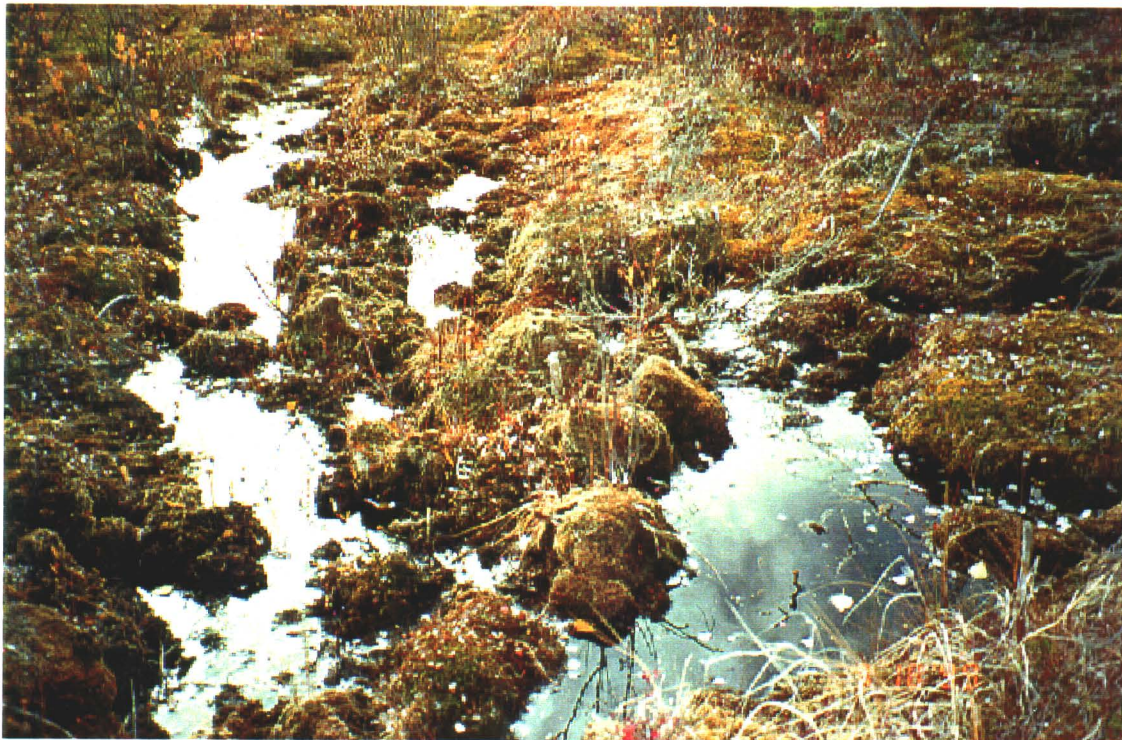
There is no surface water upstream of the site on this slope. A seasonal stream (photo 15-4), paralleling the site, surfaces downgradient from the test pits but upstream of the two shafts. A surface water sample (15-WQ-StrCD-03) and duplicate (15-WQ-StrCD-04) were collected from this stream immediately downstream of the test pit area. Stream flow was less than 1 L/s at the time of the site visit.

Photo 15-4: Small creek above shaft site.
