RICO
SITE #16
MINFILE# 105M001r

1. LOCATION AND ACCESS

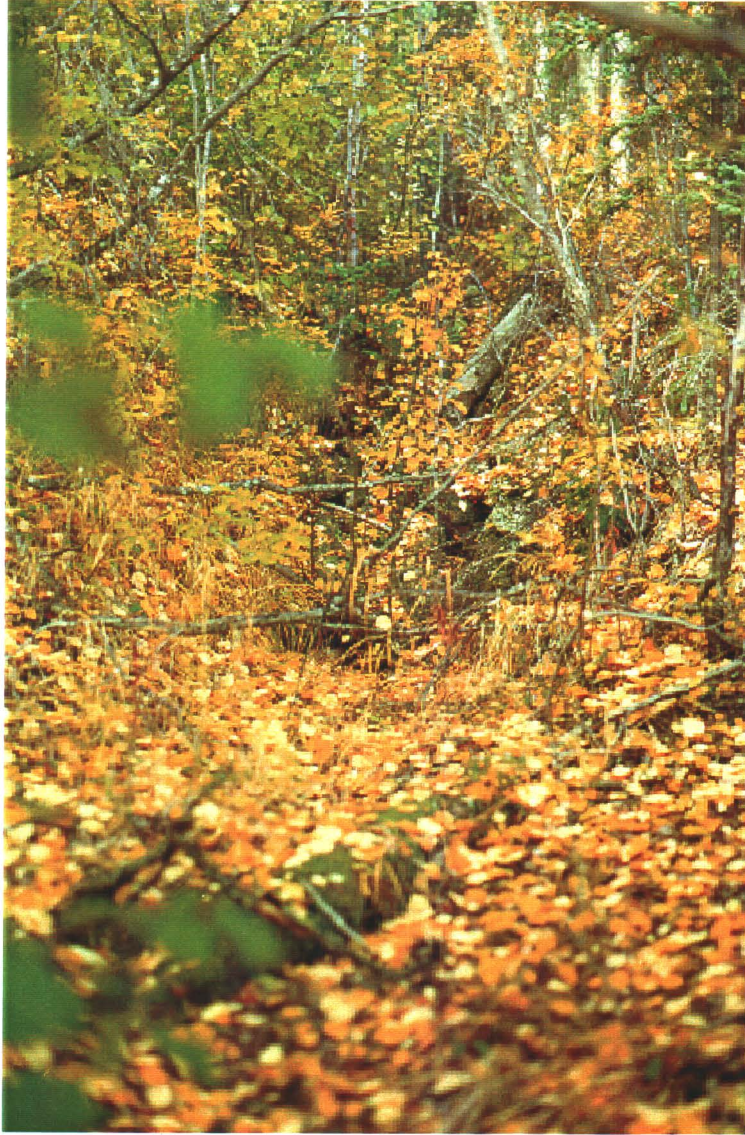
The portal and adit were difficult to locate; they have collapsed and become overgrown with trees and shrubs. Location: The portal is located 4m from the old dirt road, on the western side. A cat track leading down to the Galkeno 900 site branches from the old dirt road 75m to the south.

Condition: The first 20m of the portal have collapsed; the ground above the rest of the adit was stable at the time of the site visit.

Accessibility: The collapsed portal prevents access to the adit.

Photo 16-1: Collapsed and overgrown portal and adit are barely visible from under the leaf cover.
(Azimuth 270°)

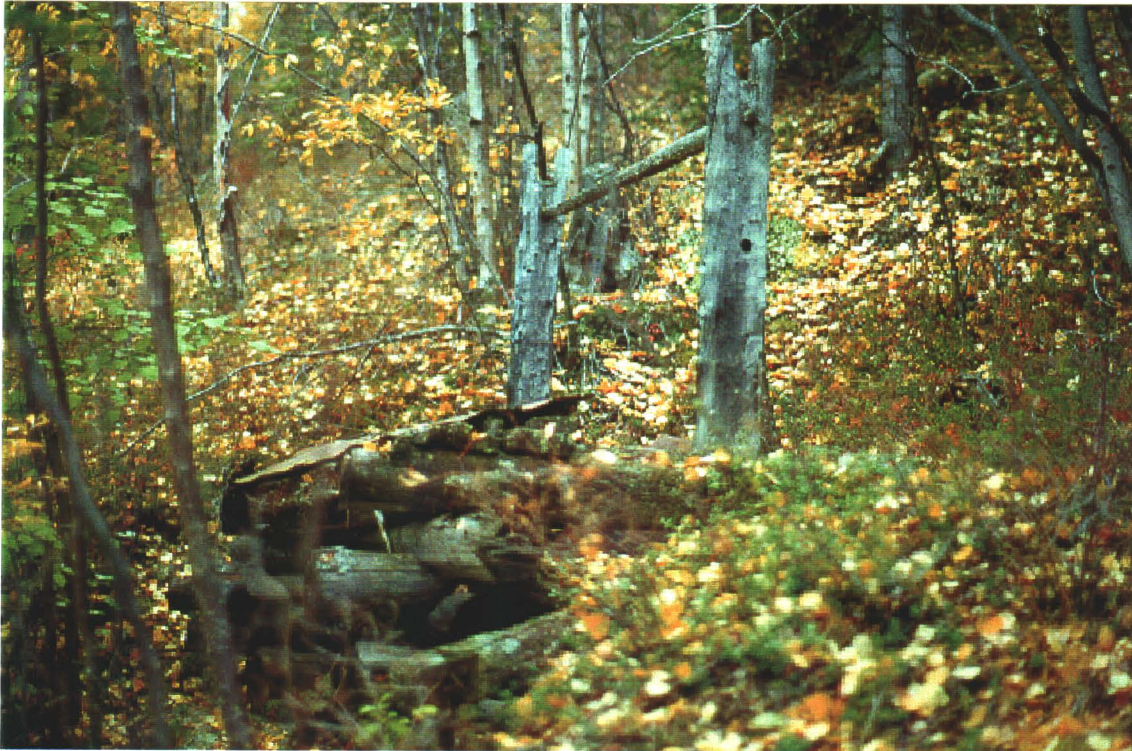
A small gully beside the adit leads uphill to a shaft. Log cribbing and a windless are built above the entrance to the shaft. A metal lid covers half of the shaft opening.

Condition: It is fair condition; the logs are beginning to rot but were stable at the time of the site visit.

Accessibility: The shaft can be accessed through the opening at the top. There is water approximately 6m below this opening.

Photo 16-2: Rico shaft with windless on top. (Azimuth 210°)

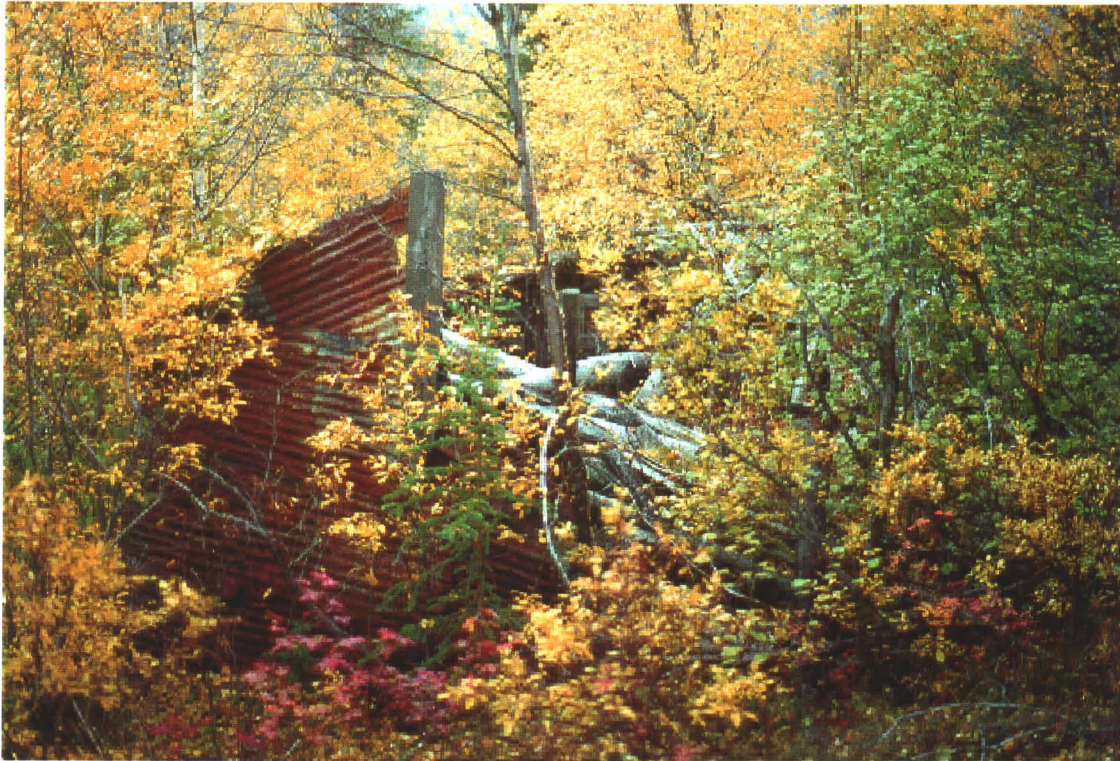
There is an old log cabin with the roof and one wall collapsed. Household debris of mainly glass jars and tin containers are scattered around the cabin.

Photo 16-3: Collapsed log cabin with metal sheeting which covers the north side of the cabin. (Azimuth 150°)
