ONEK MINESITE (#19)

MINFILE# 105M 001u

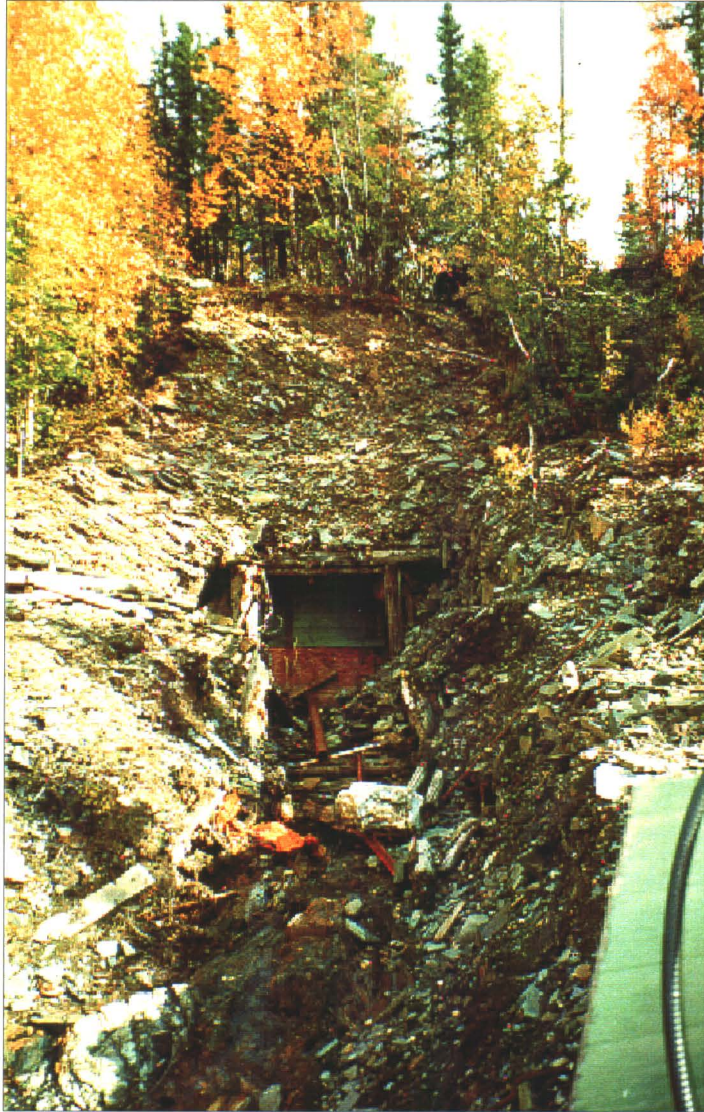
400 Level Portal (photo 19-2)

The portal was constructed circa 1950 and has been damaged by ice plug damming. Recent rehabilitation includes excavation of rotten timbers and removal of the track to improve flow of water away from residences. The adit has been sealed to restrict air-flow and a heat-traced pipe was installed to prevent future ice plug damming.

Condition: The portal timbers appear to be sound, recent rehabilitation.

Photo 19-2: 400 level portal and runoff channel. Note debris at entrance.

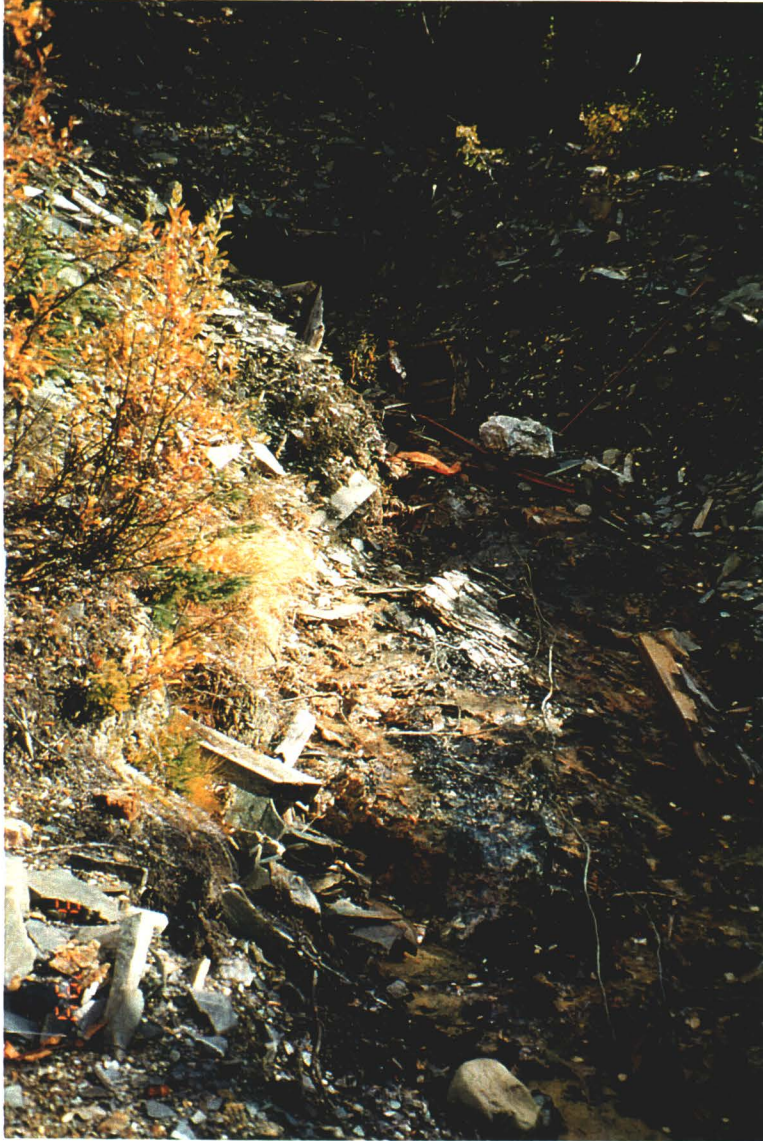
Waste rock pile – 400 Level Portal (photo 19-3)

Waste rock from underground was dumped along the rail tracks on surface, and spread around the work area. There is approximately 5000 to 10,000 tonnes of mine waste in this area. Much of this material is mineralized with iron sulphides, with traces of sphalerite and galena. Most of this area is

not revegetated despite clearing ca. 1950. There is local evidence of vegetation mortality. There is local staining related to sulphide oxidation, with yellow and orange colours developed on originally grey rock. Analytical results show high metal levels and indicate Acid Rock Drainage, however sulphide sulphur levels are moderate to low (1.69%, 0.29%).

Photo 19-3: Runoff channel below 200 level portal. Note adjacent waste rock.

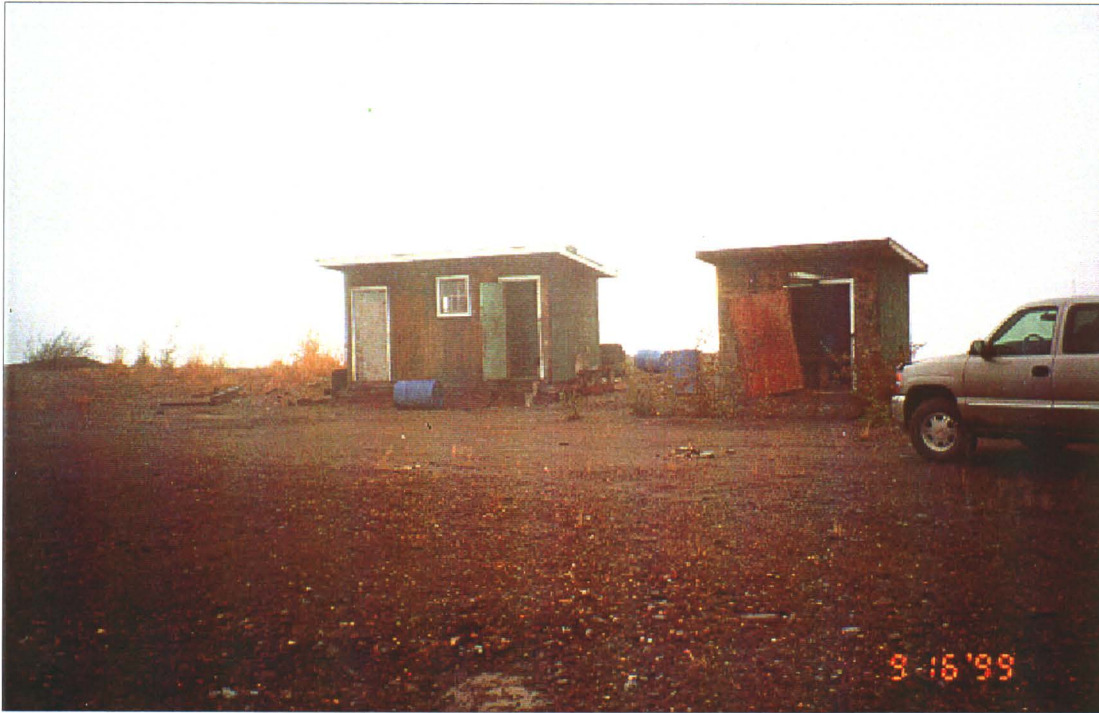
With the exception of the trailer, this is the largest building at the upper site. The building appears to have been used for miscellaneous storage including some hazardous material.

Structure is a smaller version of building #1 and appears to have been used exclusively as POL storage shed. Gravel under shed was stained and had a strong hydrocarbon odour.

Photo 19-5: Buildings 19A & 19B at upper camp.

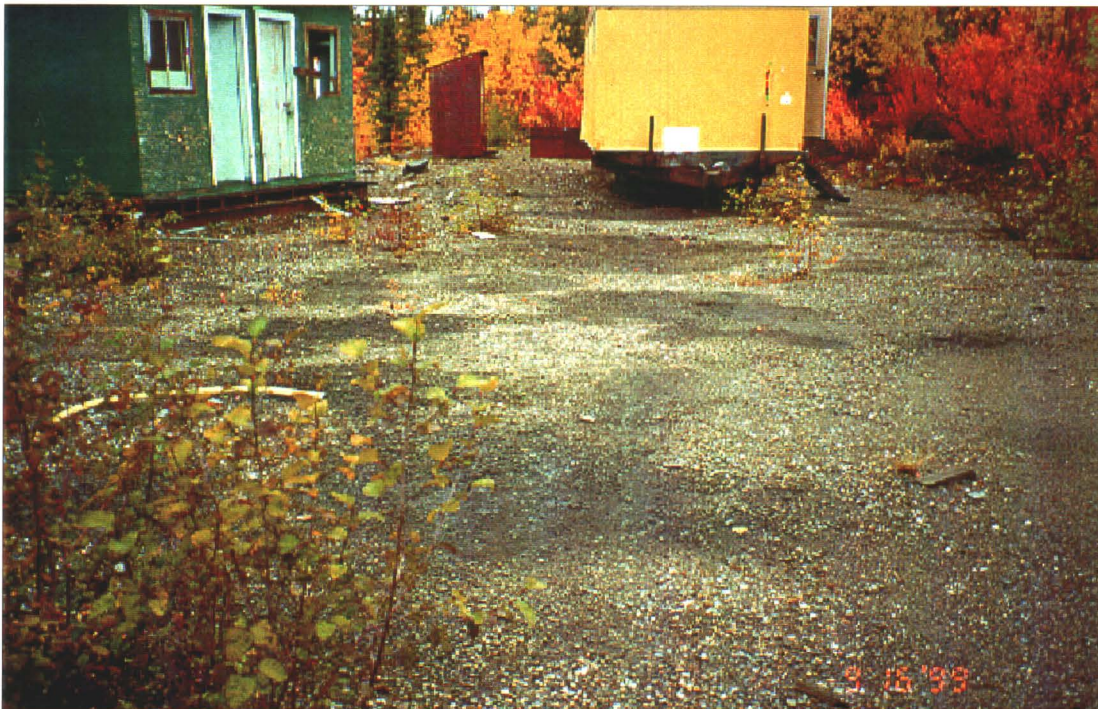
Structure is a larger shed directly adjacent to the trailer. South area of building appears to have been used by electrician or other trade. North area formerly contained furnace but has since been gutted.

Structure is a mobile trailer formerly used as both an office and living quarters at the upper camp. Interior is water damaged.

Photo 19-6: Buildings 19C & 19D at upper camp. Note oil staining in foreground.

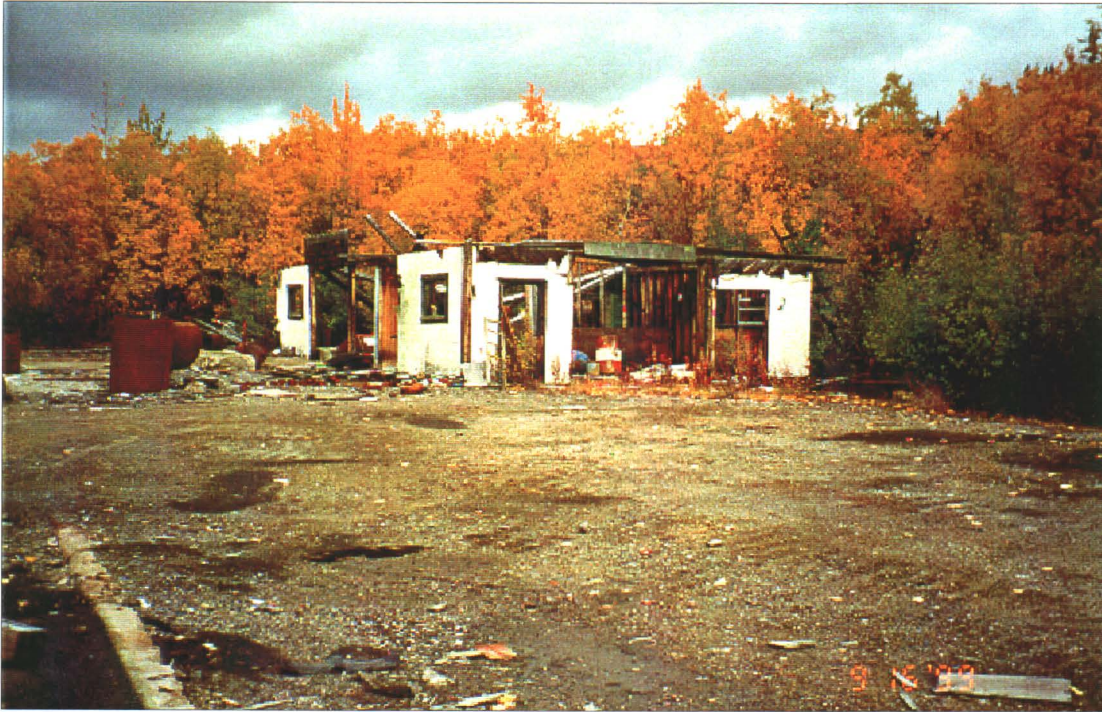
Building appears to have formerly served as a combination storage and compressor building but has partially collapsed and much of the former heavy generator equipment has since been removed.

Construction: Wood frame; formerly with wood roof and rolled asphalt roofing; roof has now collapsed; exterior walls clad in asbestos tar paper.

Asbestos: Asbestos tar paper on entire exterior of building.

Photo 19-7: Remains of building 19E at lower area. Note oil staining in foreground.

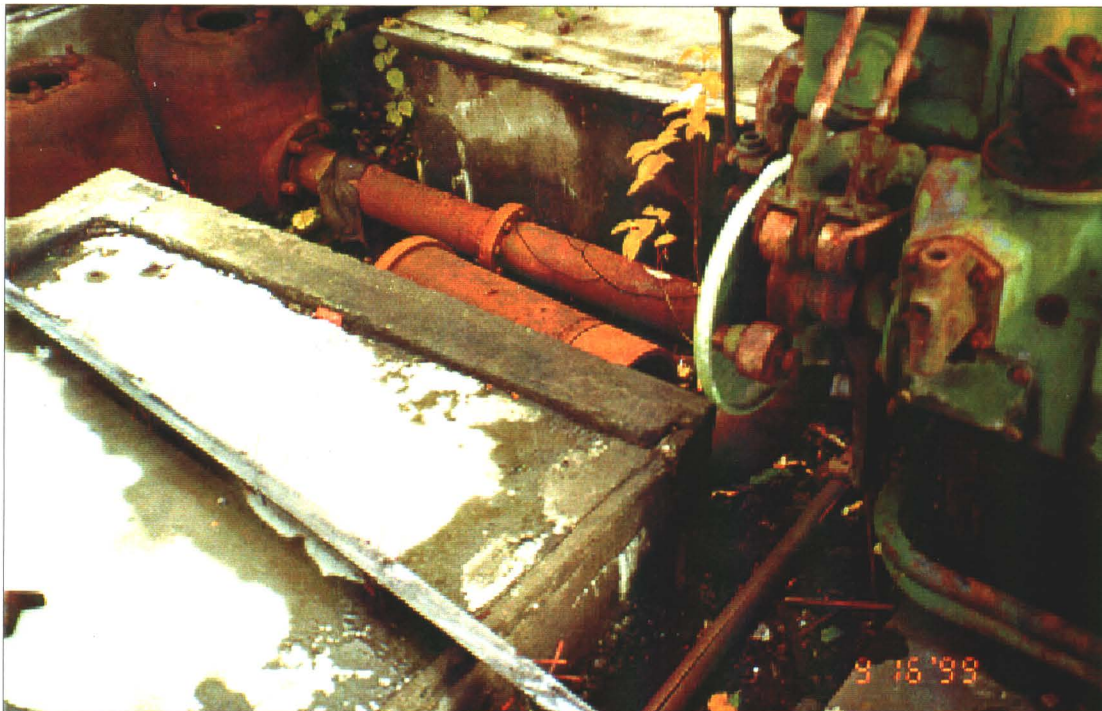
Foundation: concrete; many pipes encased in concrete; concrete sumps (with hydrocarbon staining) (photo 19-8) and stands for compressors and other heavy equipment.

Photo 19-8: Equipment and staining in sumps at compressor building (19E).

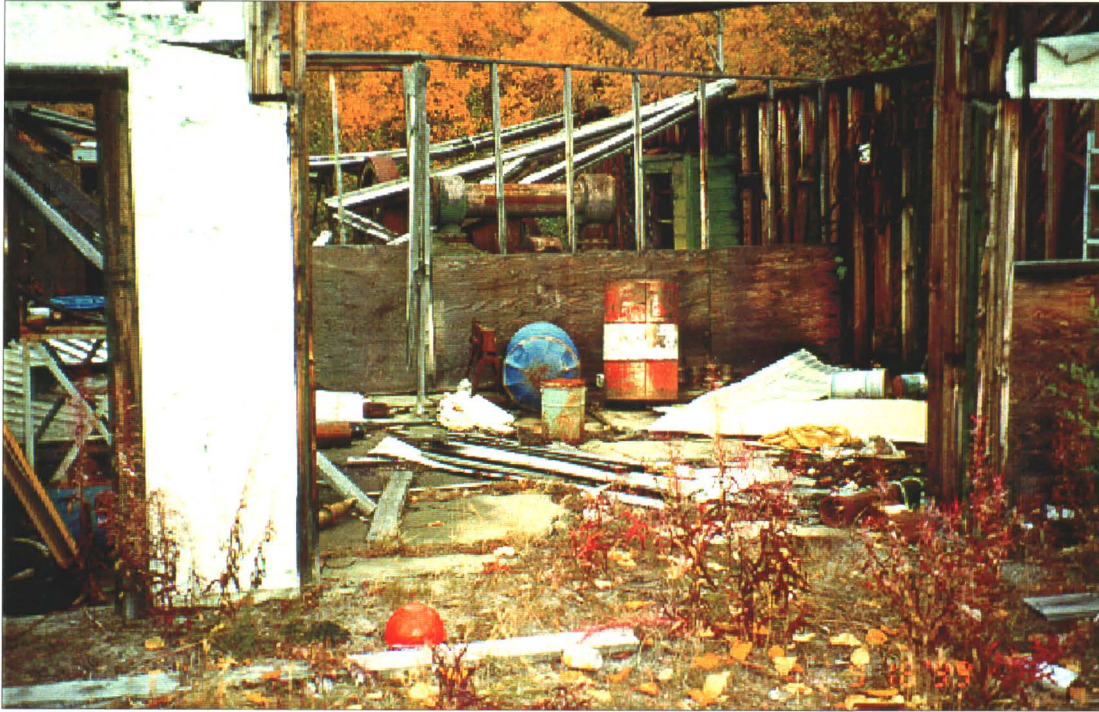
Hazardous products: Used six-volt battery. Partially full barrels and pails (photo 19-9). Note: all partially full pails and barrels at the lower site were placed in this building prior to sampling.

Photo 19-9: Former storage area in building 19E where hazardous liquids stored.

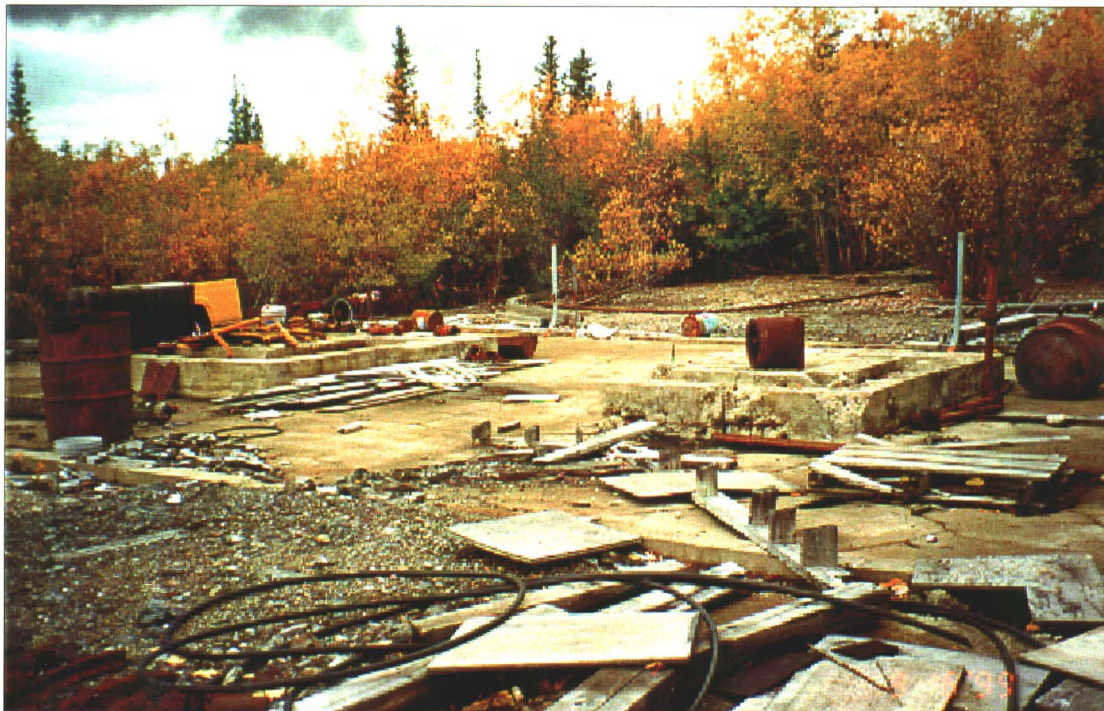
Only a concrete pad remains. The former usage of the building could not be ascertained, however, a large amount of obsolete equipment remains on the pad.

Photo 19-10: Concrete foundation (building 19F) with much metal and debris.

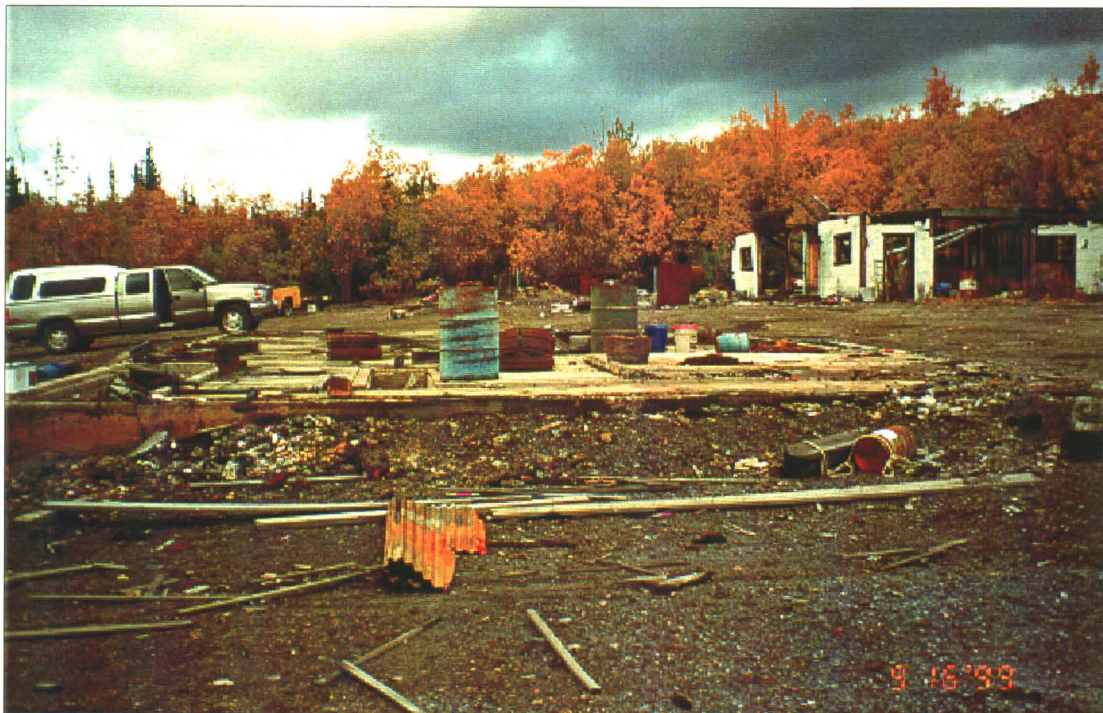
All that remains is a concrete foundation that appears to have formerly been used as a multi-bay garage.

Photo 19-11: Concrete foundation (building 19G) and much debris.

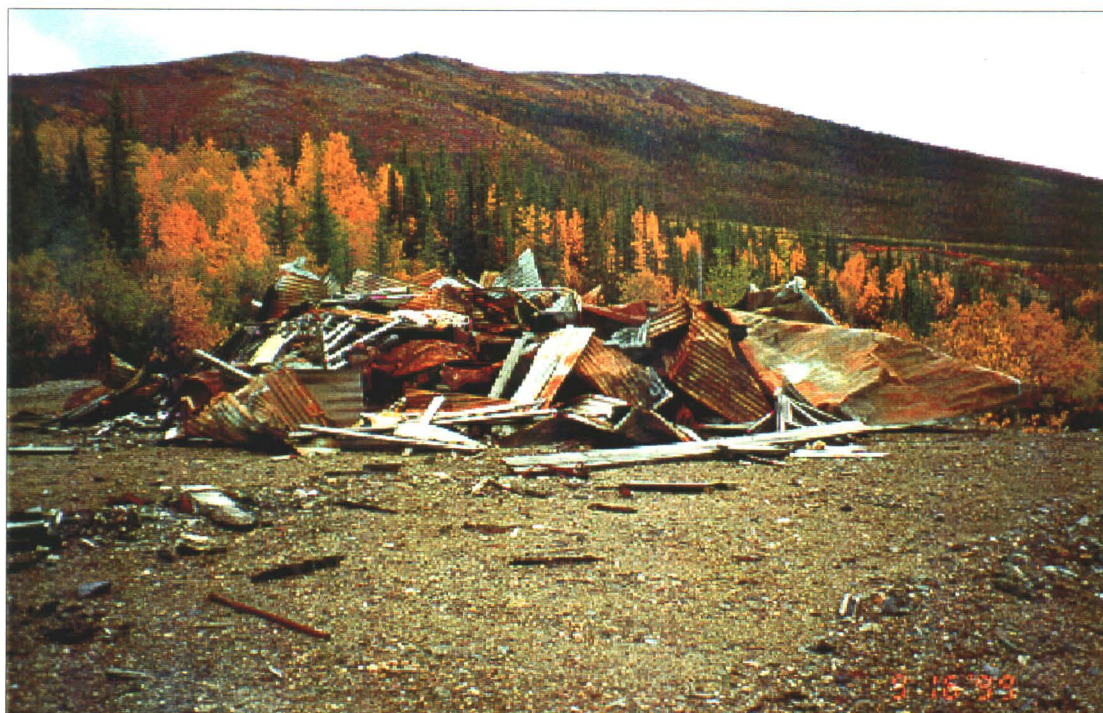
Surrounding area: Large amount of demolition debris in a single pile (metal cladding, small equipment, wood) (photo 19-12) that has been extensively burned; metal and wood debris; vehicle hulk; barrels and pails (empty and partially full).

Photo 19-12: Construction waste debris remaining from demolition of building 19G.

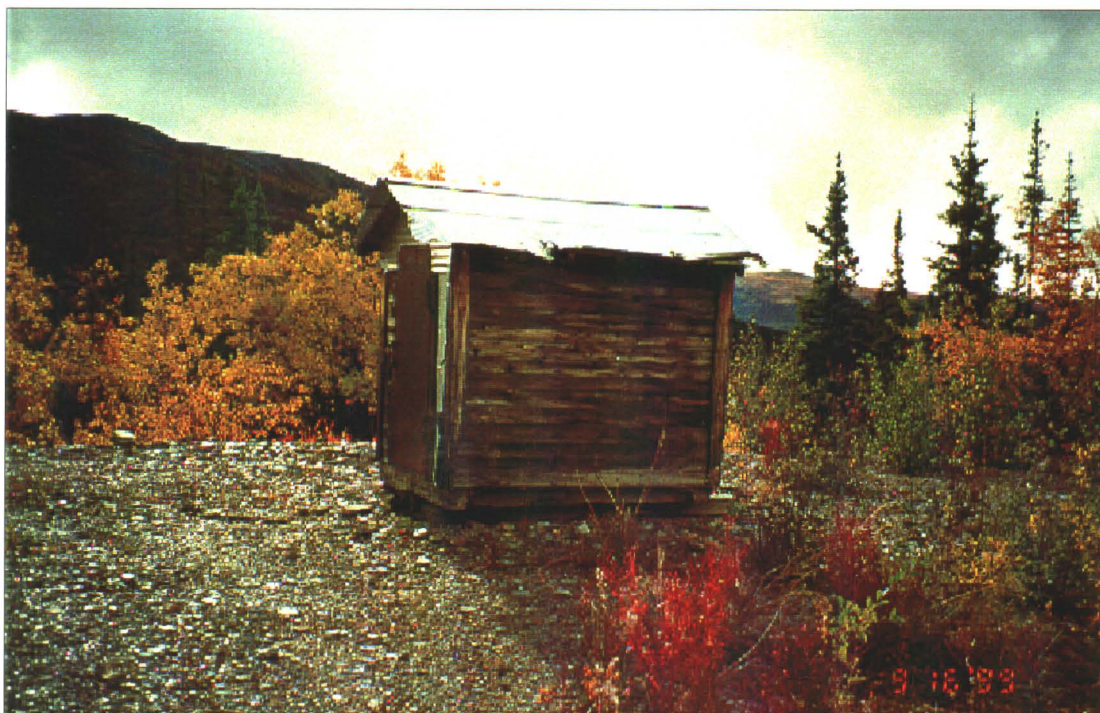
Building appears to be a small explosives storage shed a considerable distance from nearest infrastructure.

Non-Hazardous contents: Unknown (locked); possibly still contains explosives.

Photo 19-13: Explosives shed above pit site.

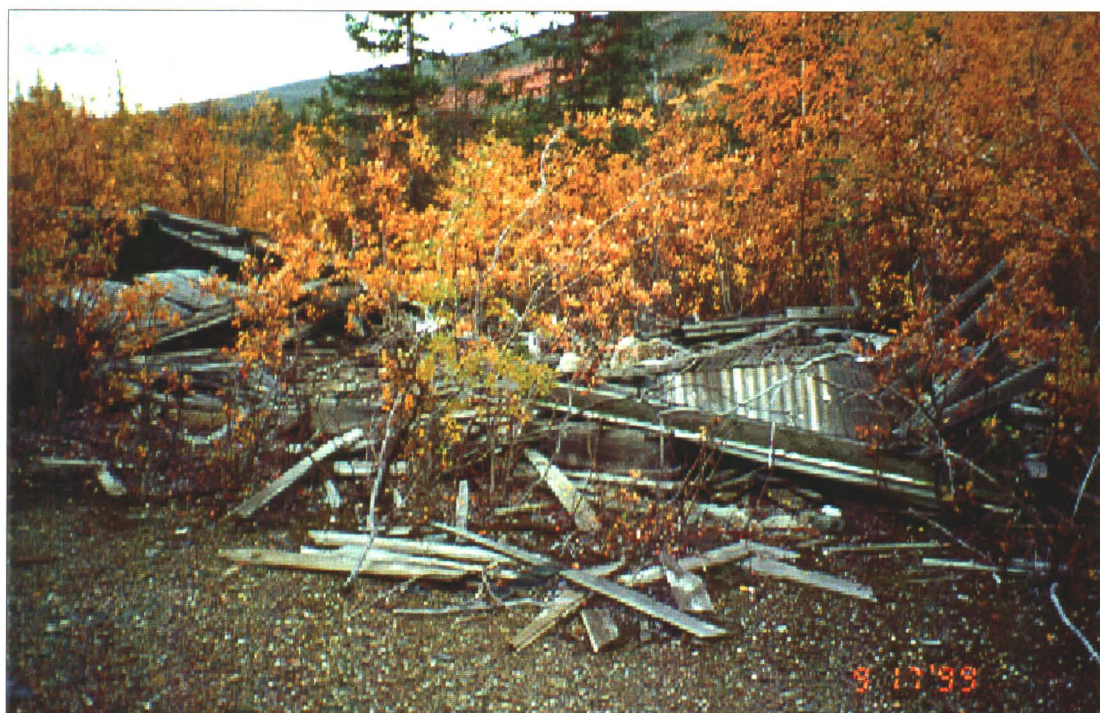
Large collapsed building at loadout area probably used as the loadout building.

Photo 19-14: Remains of building 19N at loading site below lower road.

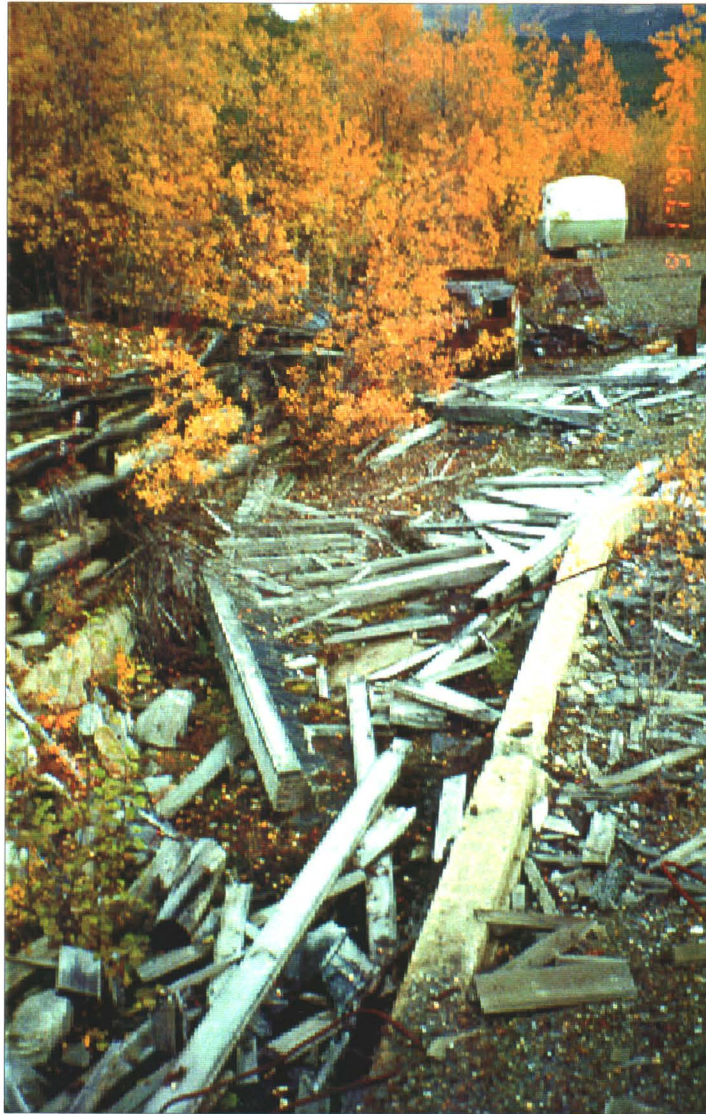
Non-Hazardous contents: Building debris strewn throughout area including construction waste from the former loadout ramp (photo 19-15).

Photo 19-15: Wood debris at loadout site.

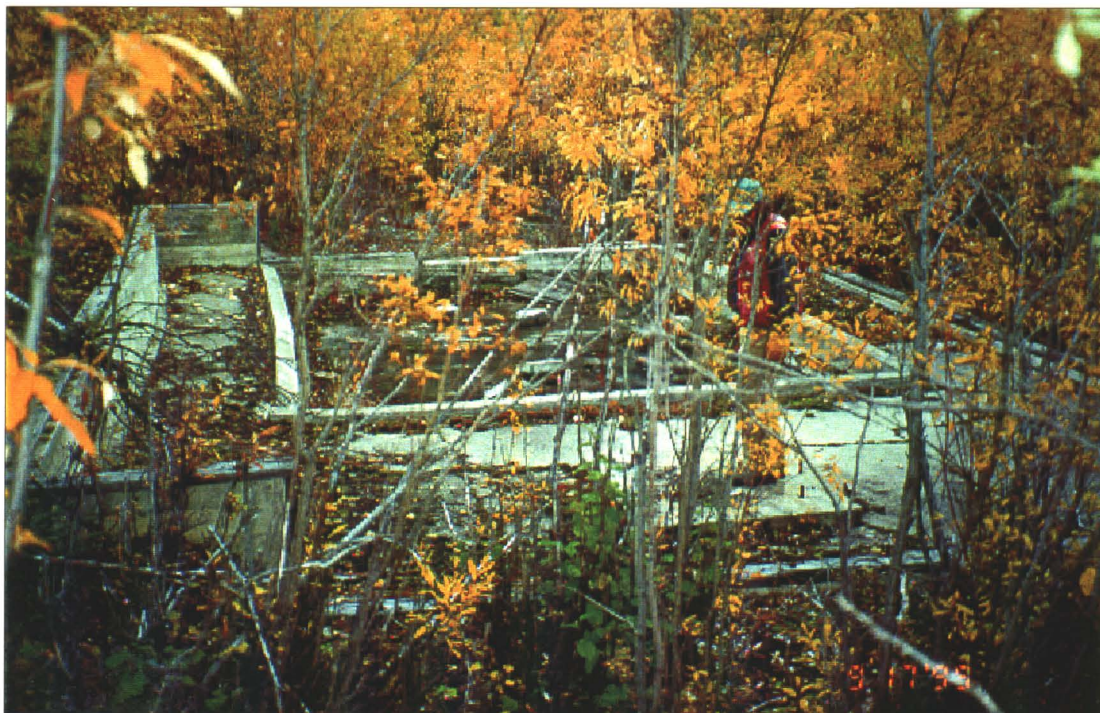
Building located at loadout facility but former usage unknown. Only concrete foundation of building remains. Large amount of debris in area may have formed portions of other former buildings.

Photo 19-16: Concrete foundation (building 190) at loadout site.

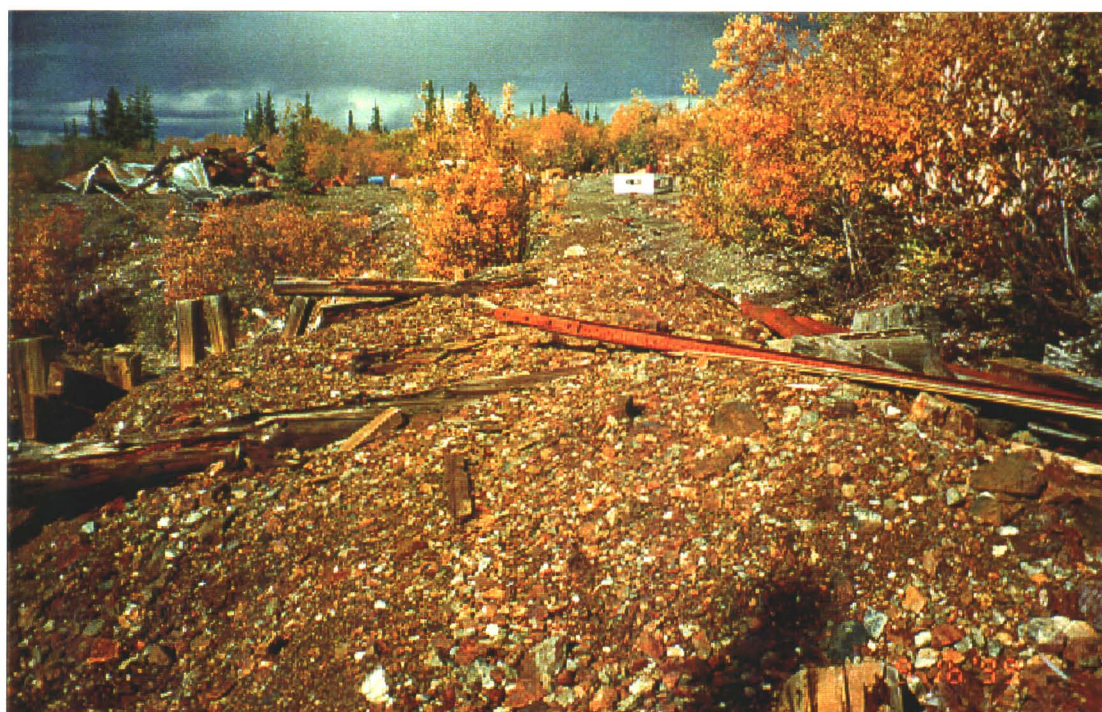
Condition: Most of this infrastructure has been demolished; rail has been piled to south east of portal and trestle has been pushed aside to the north of original location.

Photo 19-17: Former trestle area at 400 level portal.

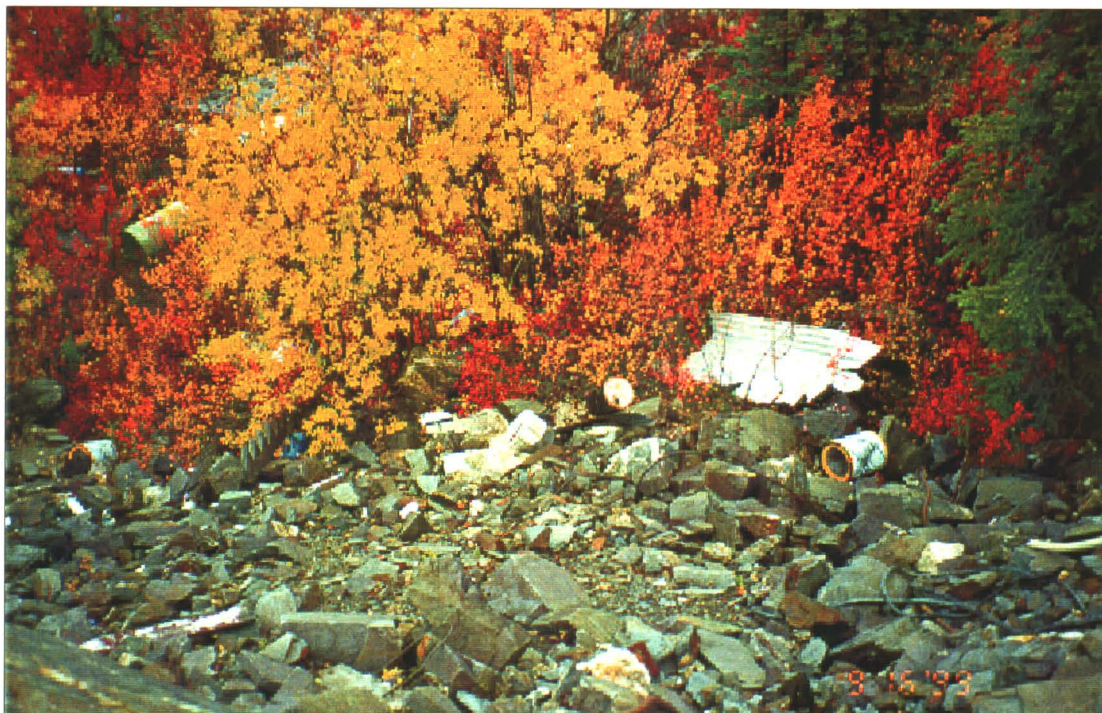
General composition: Used oil and filters; empty barrels and pails; miscellaneous wood and metal debris. No hazardous wastes noted.

Photo 19-18: Solid waste dump at bottom of waste rock dump at upper camp.

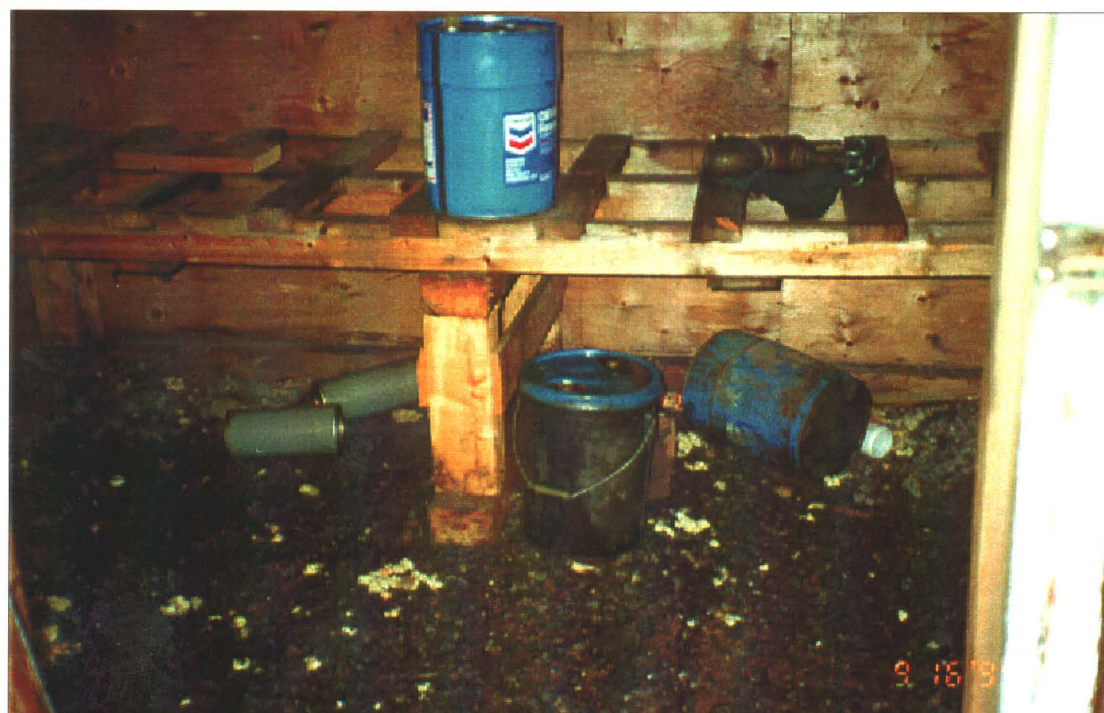
Extensive staining was also noted under the POL shed at the upper camp that appeared to be attributable to leakage and spillage from various hydrocarbon based liquids stored in the building in the past (photo 19-19). The surface area of the stain was approximately 6 m².

Photo 19-19: Hydrocarbon containers and extensive staining inside building 19C.

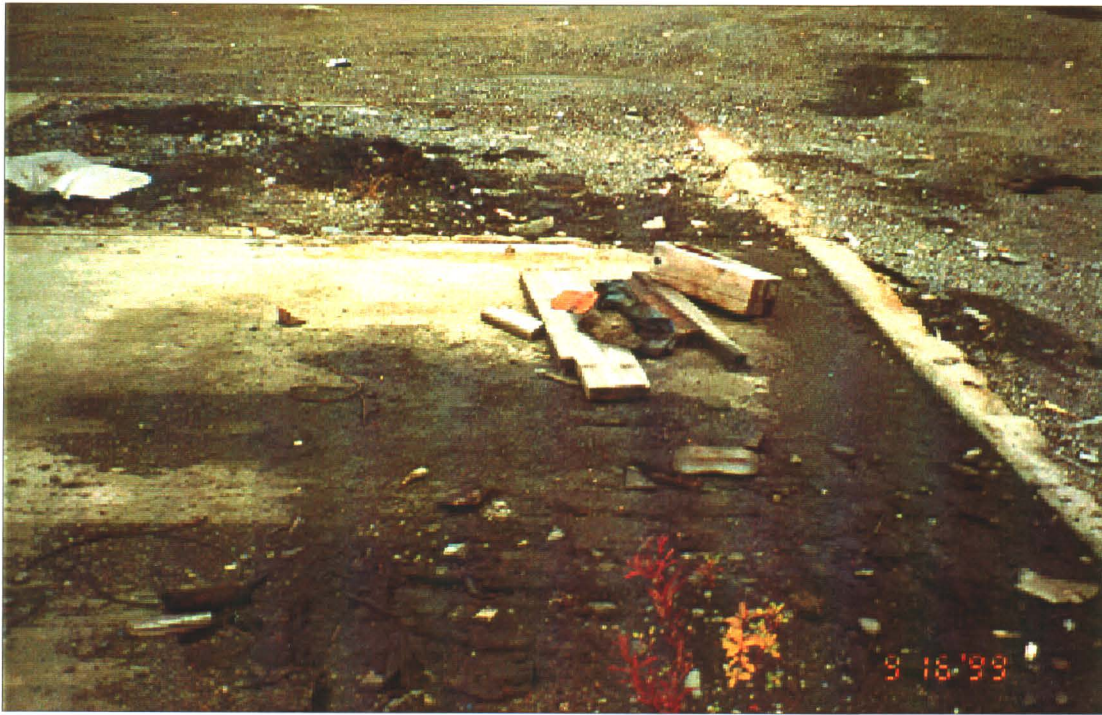
Approximately five large waste oil stains were also noted at the lower site. Four of these were present to the north of building 19G and one stain immediately to the south. The total surface area of these stains was approximately 30 m². Soils within unlined sumps in building 19G (garage) were also heavily stained and appeared to be representative of the staining at the site (photo 19-20). One sump was excavated to a depth of approximately 0.6 m. Staining was noted to depth and a composite sample was taken from the excavation. A duplicate sample was also collected. PCBs were not detected in either sample. Elevated concentrations of heavy metals were noted in both samples. Laboratory analysis are provided in Attachment B.

Photo 19-20: Extensive staining in sumps at building 19G.
