SADIE LADUE/WERNECKE CAMP

SITE #21

MINFILE 105001w,x

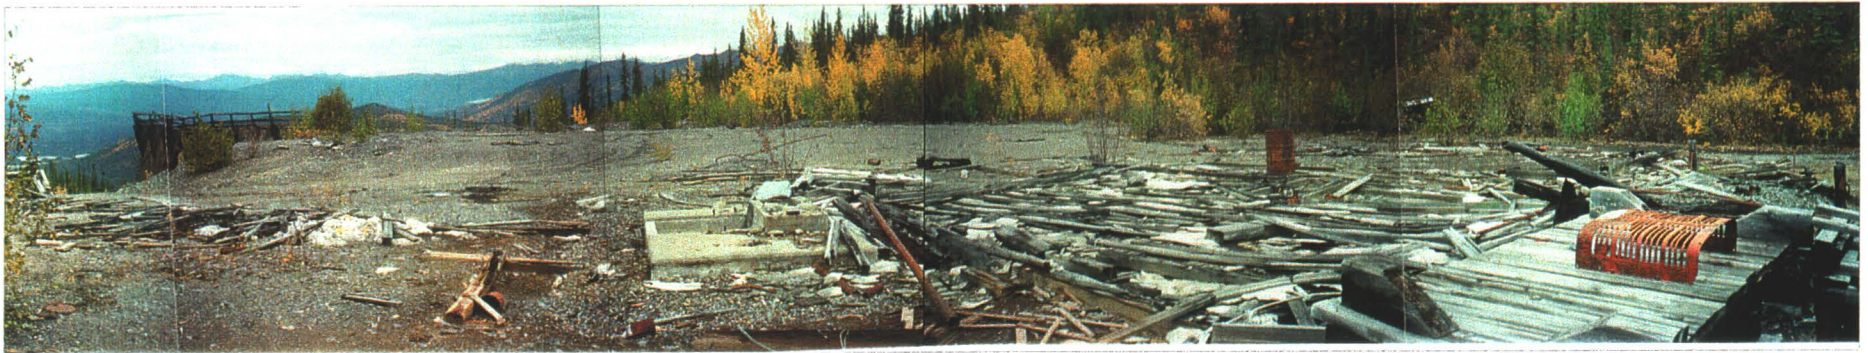
Photo 21-1: Panorama of main Werecke Camp and Sadie Ladue Mine area showing end dumped waste rock and overburden piles, Pitt#1 and decline hole to left, and partially collapsed shaft structures to far right.

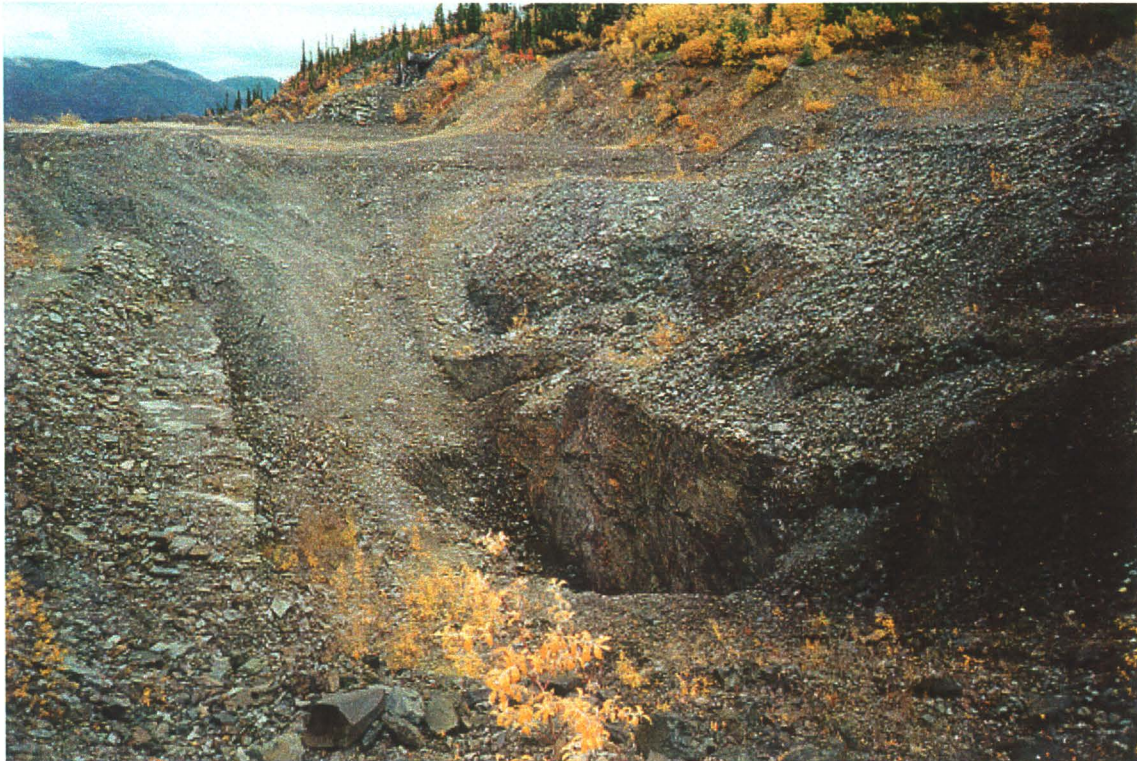
Description: The largest pit on site oriented roughly azimuth 045°; developed in the 1980s to mine ore left behind by the original mining. Benched down in two levels. The southeast wall is the highest with a vertical lift of over 6m. The bottom of the pit is dry.

Condition: The pit is stable, although loose rock is common on most level surfaces.

Photo 21-2: Overview of Pit#1 developed in the late 1980's. (Azimuth 060°)

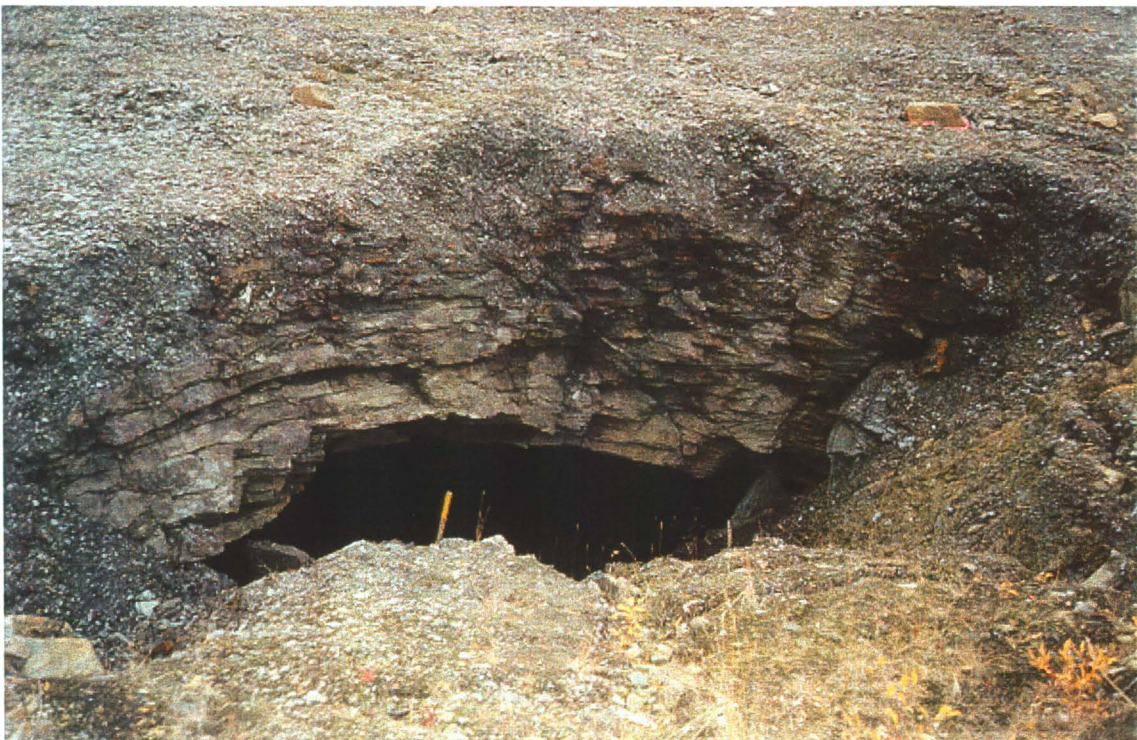
Condition: The site geology consists of near flat lying quartzites with phyllitic partings that have fallen off in slabs into the abandoned workings below, forming the cavity. Slabs of rock up to 50kg are

loose in the backs (roof) of the opening and pose a serious risk to persons entering. No signs have been posted identifying the hazard.

Photo 21-3: Open decline from recent (late 1980's) work. Note hazard from loose slabs in the roof resulting from horizontal foliation structures. (Azimuth 170°)

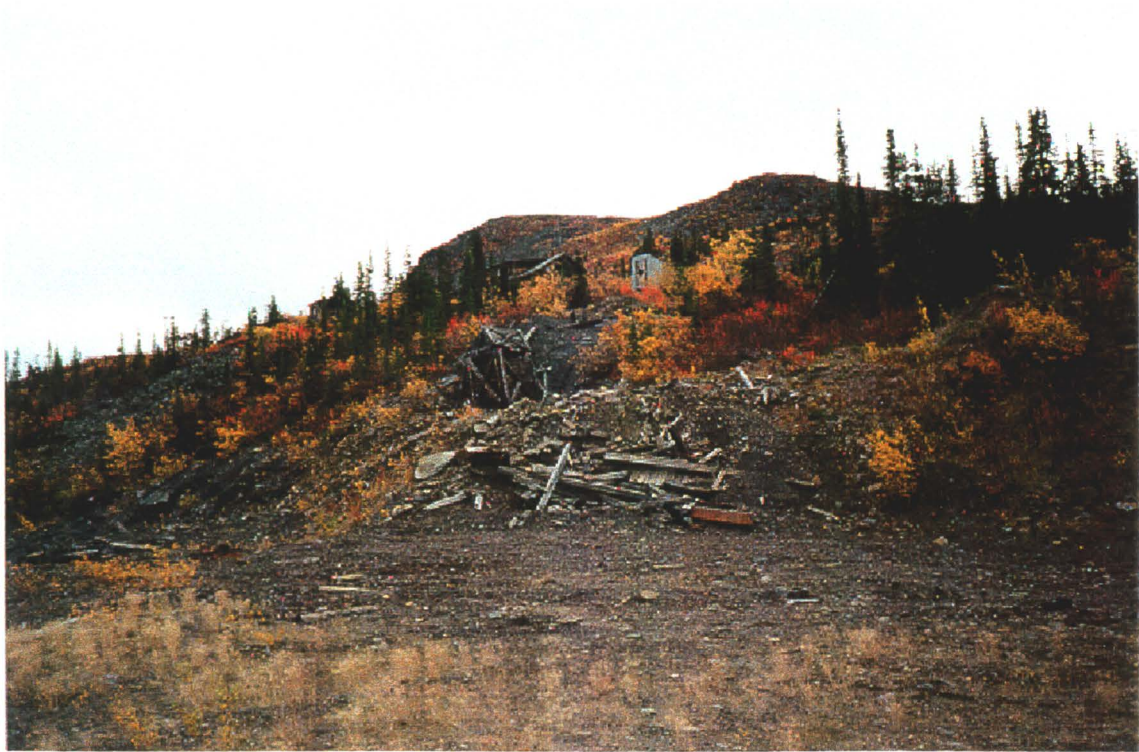
Description: A hole into bedrock is visible below the outhouse. It is largely filled with loose rock, but may have been a raise or manway.

Condition: The opening poses no obvious safety risks.

Photo 21-4: Sadie Ladue shaft area. Note dilapidated tressel, outhouse over callapsed manway and managers house in background. (Azimuth 080°)

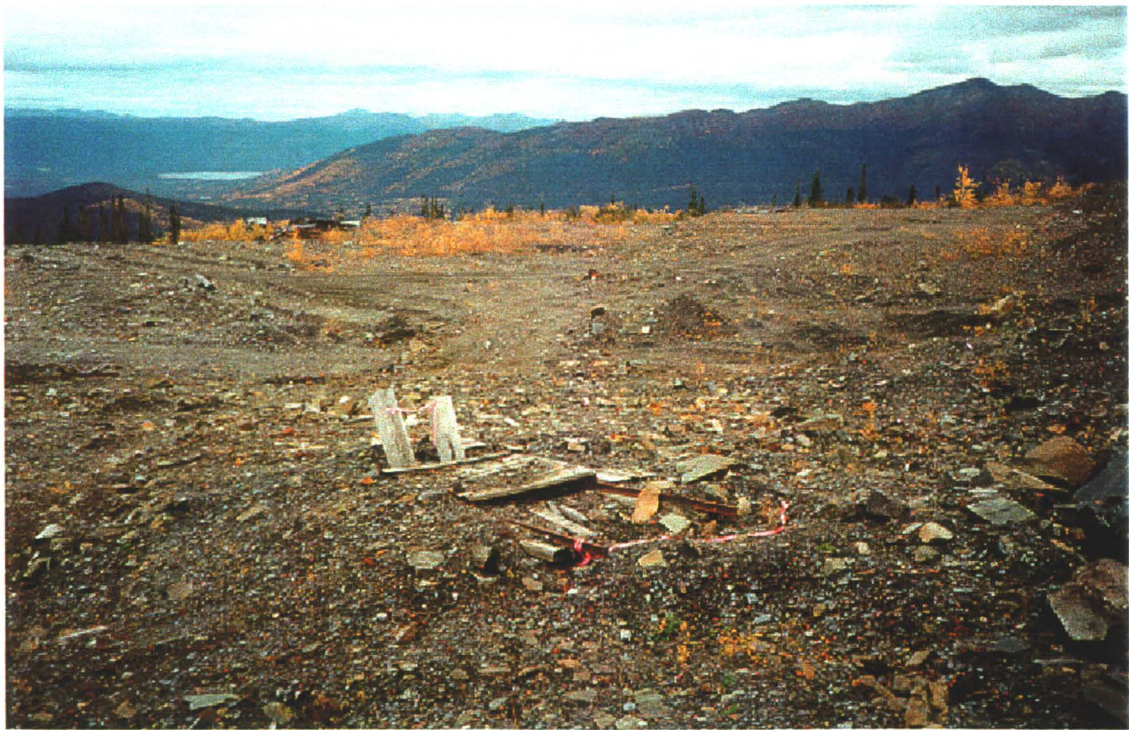
Description: The shaft headframe structure has been completely removed, the shaft partially backfill and opening sealed with wood planks. The shaft is still partially open to roughly 5m depth. Recent (1980s) stripping work may have reduced the elevation of the shaft collar by over 1m.

Condition: The shaft poses some safety risks due to loose rock. The plank cover is reasonably sound.

Photo 21-5: Sealed haulage shaft. (Azimuth 000°)

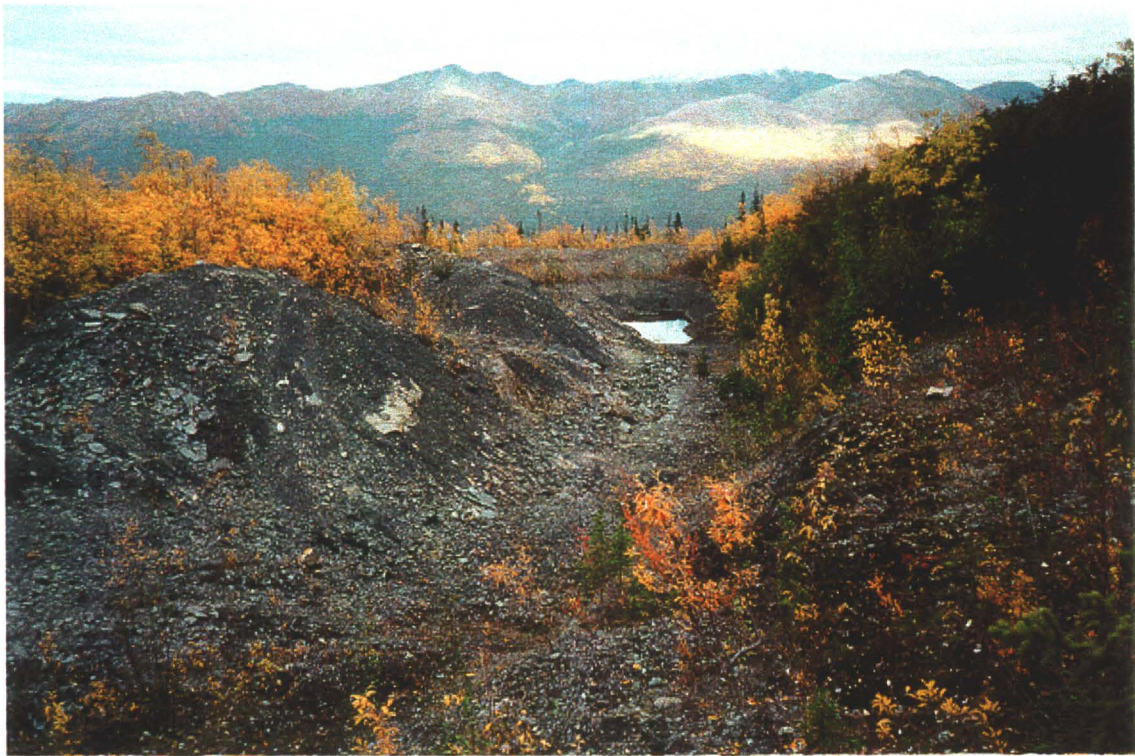
Description: Pit #4 may be a trench where no ore was removed, although it is excavated into bedrock. The east end of it is filled with water from groundwater seeps. There is no surface inflow of outflow.

Condition: Stable.

Photo 21-6: Pit #4 with ponded water from groundwater seeps. (Azimuth 030°)

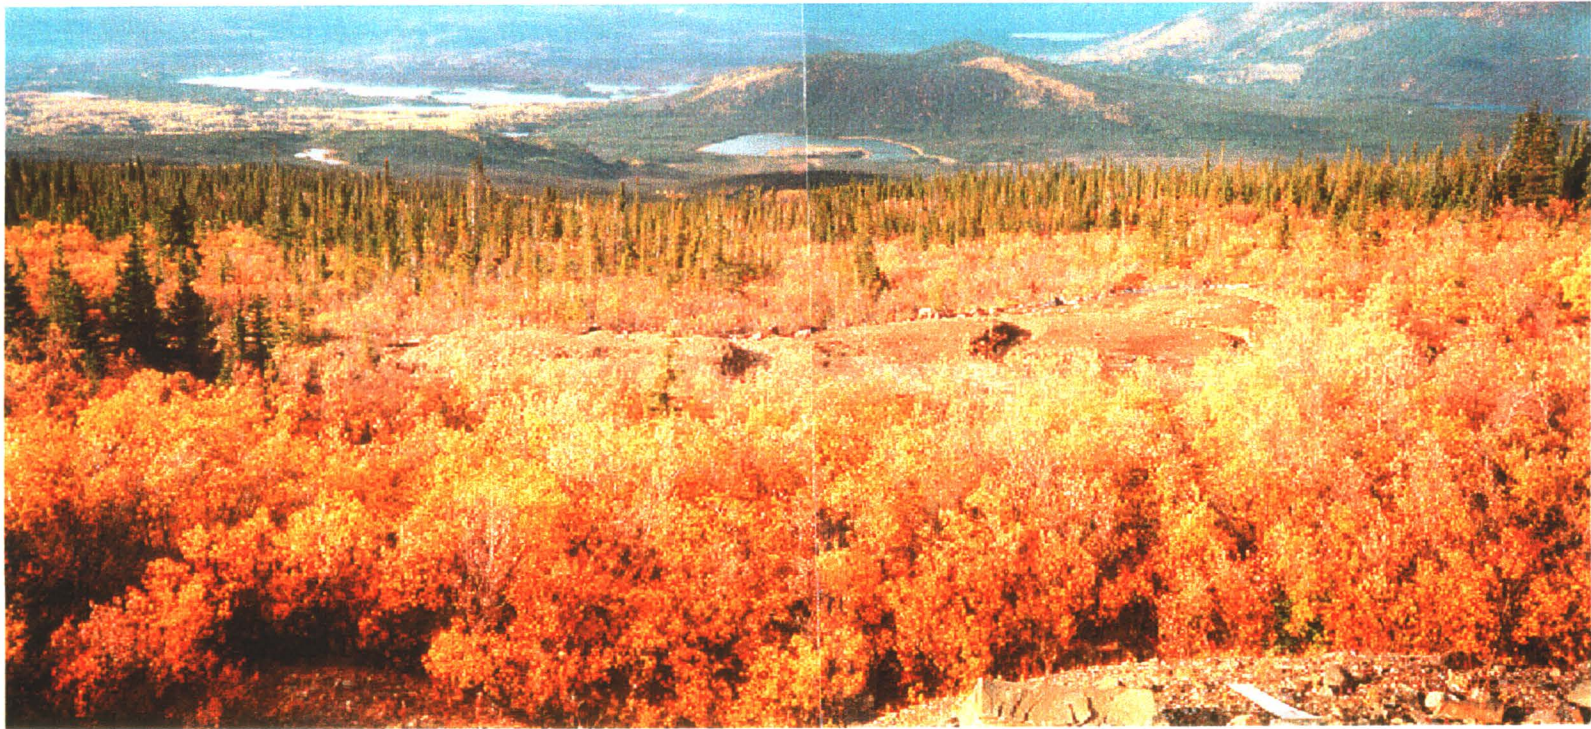
Description: Constructed out of sheet metal supported by wooden fence posts, the structure provided only limited physical confinement of the tails. The structure was not sealed against leakage or overflows. The structure is now largely collapsed. The tails material has a medium to coarse sand texture and is moderately to strongly oxidized.

Photo 21-7: Mill tailings located below waste dumps. Note collapsed sheet metal impoundment structure and tailings delta in lake below at top-centre of photo. (Azimuth 335°)

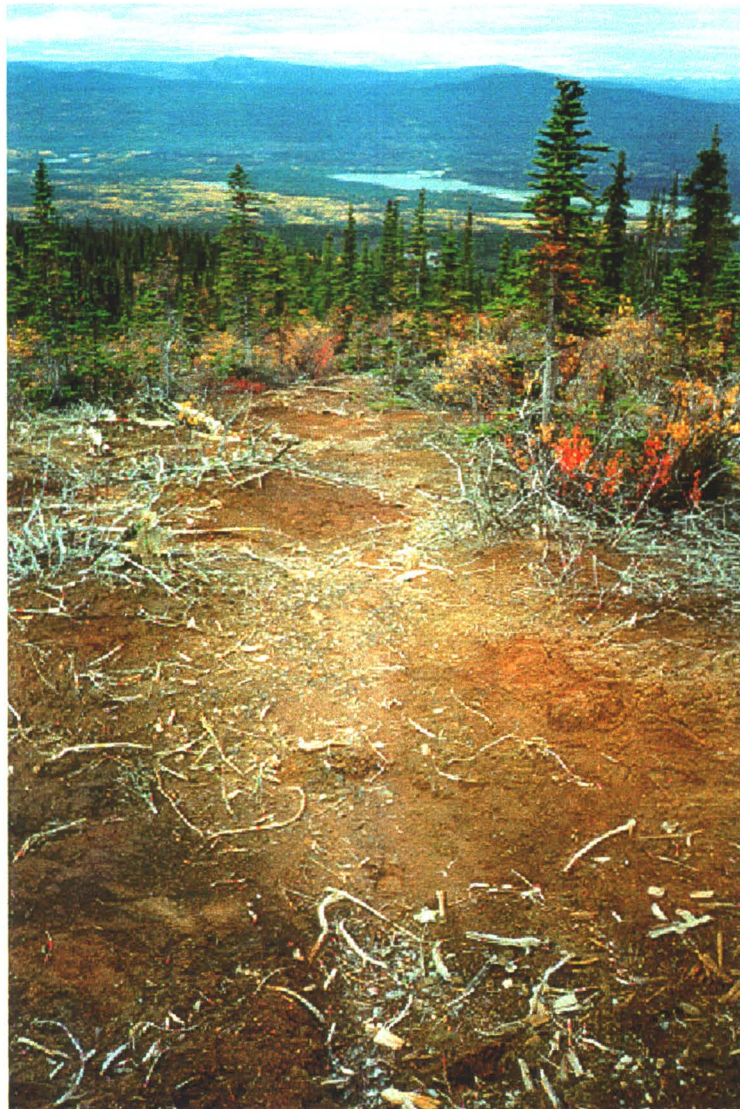
Description: The slope west of the road between the Sadie-Ladue 600 and the Wernecke camp is covered with a fan of tails material up to 0.3m deep. The tails material is similar to that found in the impoundment structure above. The tails were deposited directly on the slope or were allowed to overflow the impoundment structure and are not immersed in water.

Photo 21-8: Tailings material 250m down slope of Wernecke Camp area (el. 1220m).

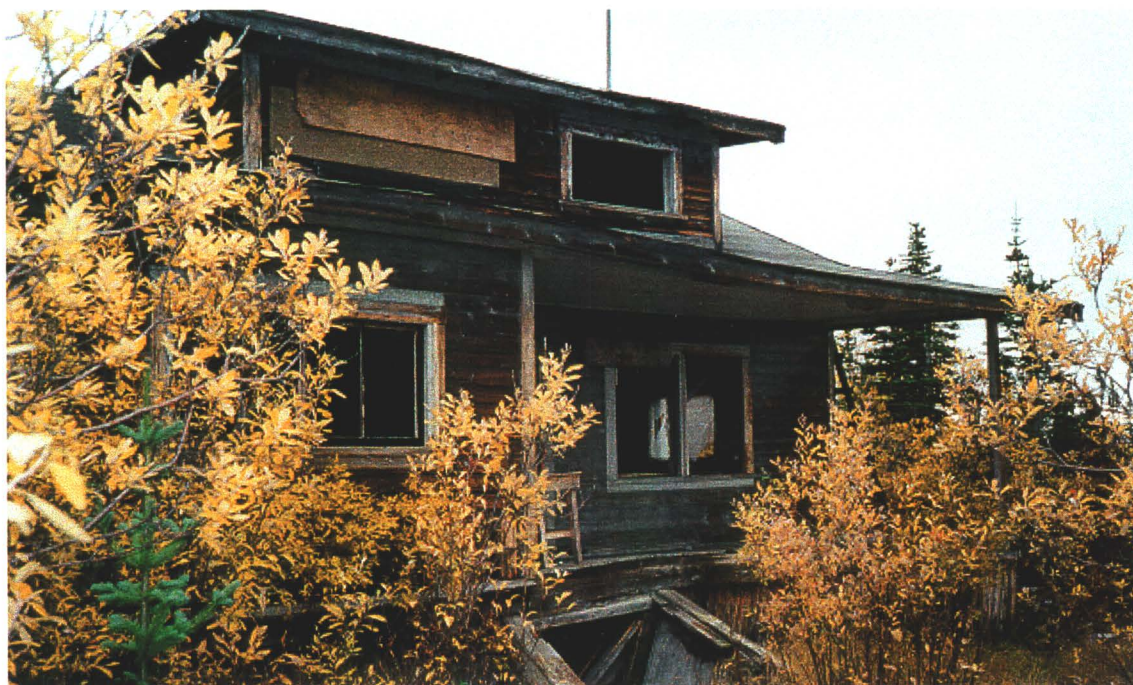
No.	Description General Location	Photo No.	Size L (azimuth) x W	Age (approx.)	Condition
21-A	Mine Managers House Located south of Ladue Shaft #2 area.	21-9	20m (@140°) x 12m	1920's	Fair; foundation failing; roof intact; floors and walls warping; metal roofing intact. Modified in 1980s.
21-B	Sauna Located near Bldg. 21-A.	21-10	4.5m (@060°) x 3.5m	1980s	Good; shake roof; still operational
21-C	Office/bunkhouse (?) Located near Bldg. 21-A.	21-11	4 m (@0130°) x 4m	1920s	Poor; roof partially collapsed; no foundation; metal roof.
21-D	Tent frame Located near Bldg. 21-A.	21-12	4 m (@090°) x 3m	1980s	Good; sound; no foundation; frame for tent; no roof.
21-E	Shed	21-13	3 m x 3m	1920's	Poor; collapsed, no foundation; metal roof.
21-F	Mine building/house (?) Located near Bldg. 21-A.	21-14	12 m (@040°) x 10m	1920s	Poor; partially collapsed and striped; no roof; wood post foundations beginning to shift; some wood and plastic debris.

Photo 21-9: Managers house (Bldg. 21-A). (Azimuth 180°)

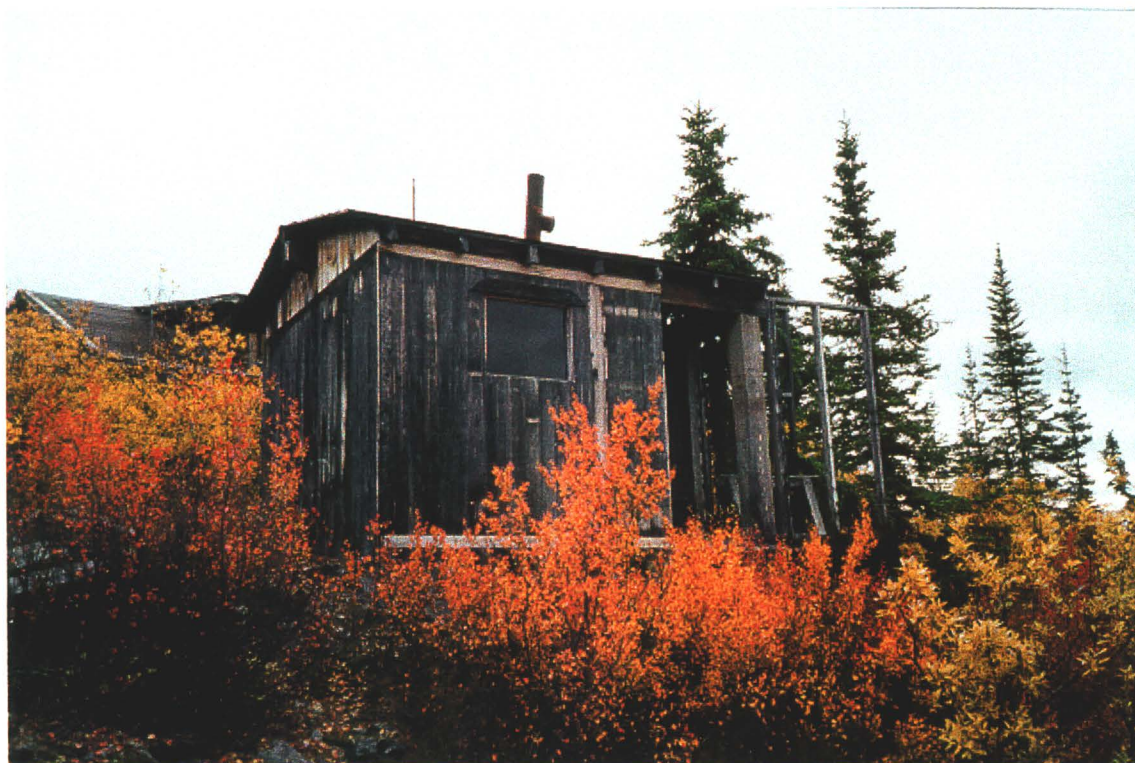
Photo 21-10: Sauna built in 1986 (Bldg. 21-B). Note sound condition. (Azimuth 180°)

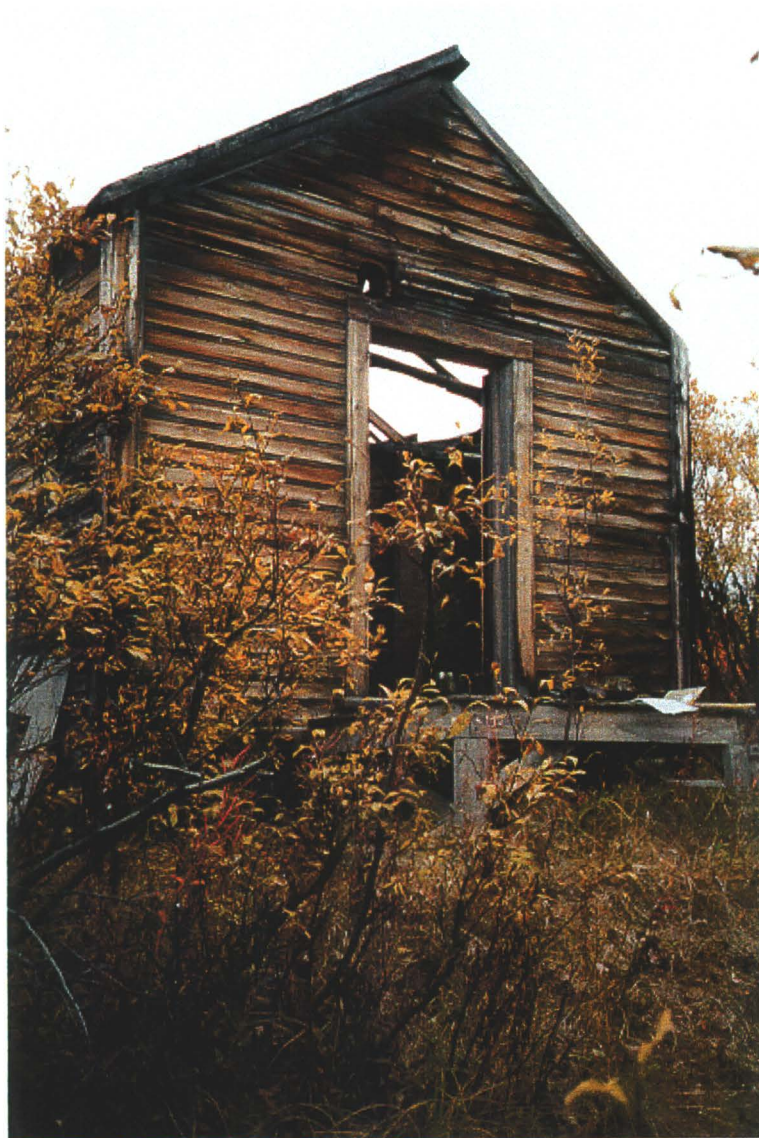
Photo 21-11: Partially collapsed building (Bldg. 21-C). (Azimuth 160°)

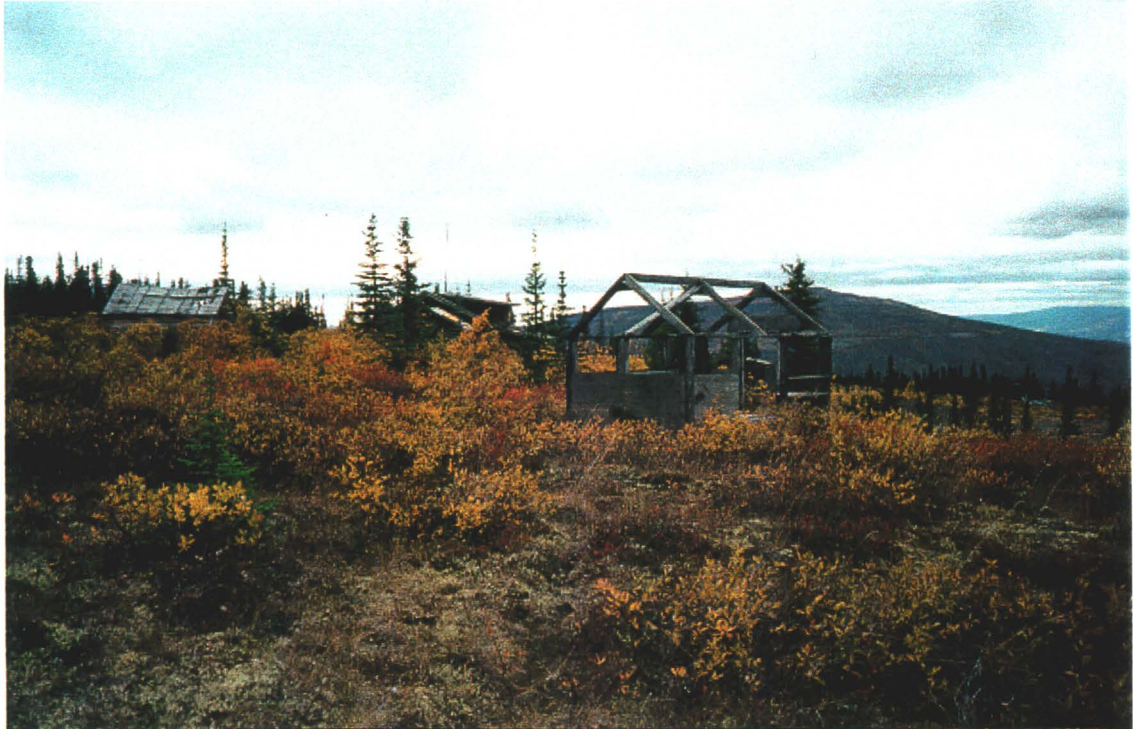
Photo 21-12: Tent frame structure (Bldg. 21-D). Note Bldgs. 21-A & C in background. (Azimuth 230°)

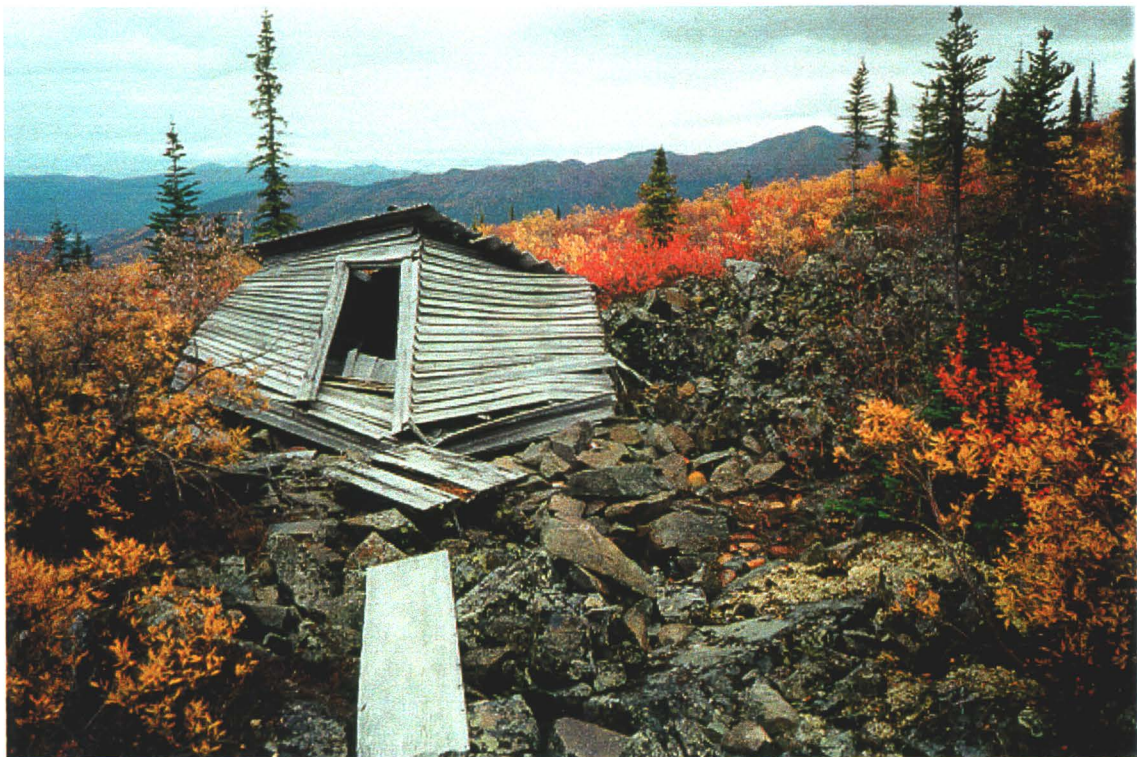
Photo 21-13: Collapsed shed (Bldg. 21-E) (Azimuth 000°)

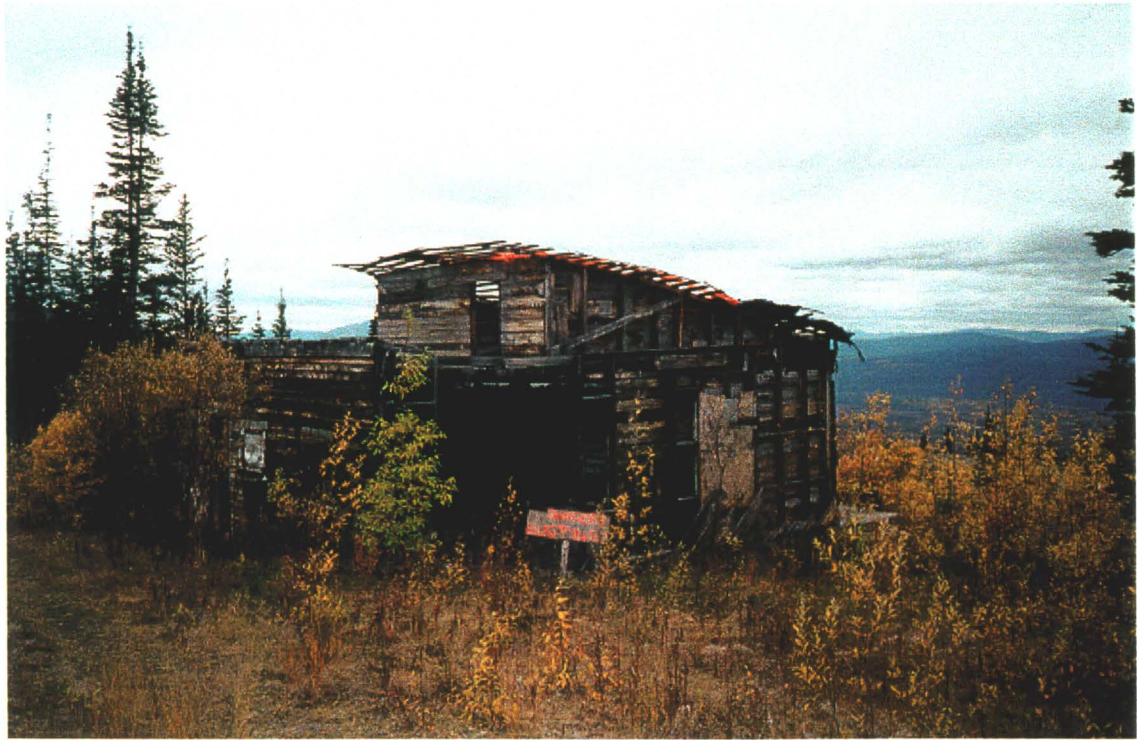
Photo 21-14: Dilapidated mine building (Bldg. 21-F). (Azimuth 260°)

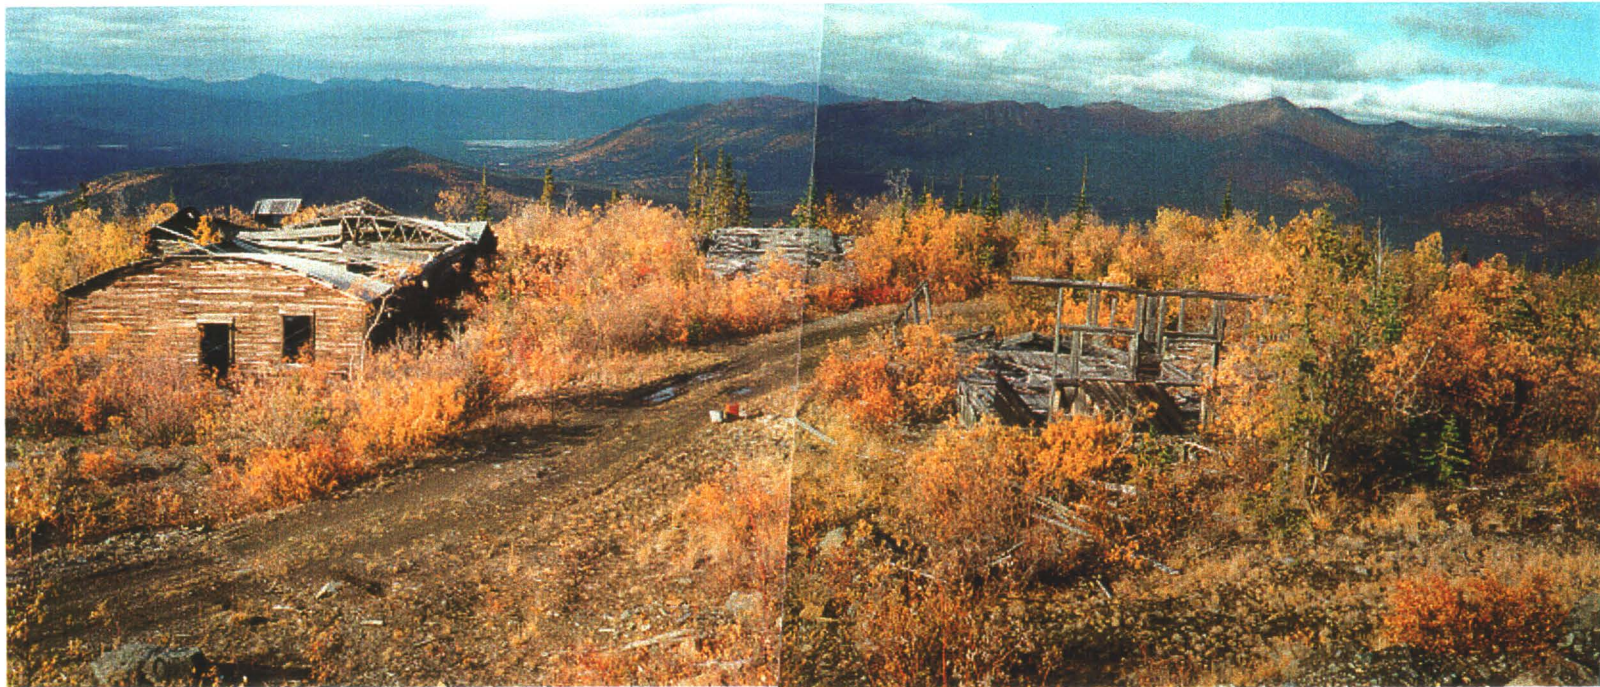
21-G	Mess and recreation hall Kitchen Located east of road down to Sadie-Ladue 600 level.	21-15	15 m (@000°) x 10m	1920s	Poor; hall partially collapsed; wood frame with wood truss roof; floor removed. Kitchen building attached; log construction; partially collapsed foundation and roof. Metal roof on both structures; partially removed.
21-H	Bunkhouse Located near Bldg. 21-G.	21-15	6m x 5m (approx.)	1920s	Poor; totally collapsed; wood frame; no roofing material.
21-I	Bunkhouse Located near Bldg. 21-G.	21-15	7m x 5m (approx.)	1920s	Poor; totally collapsed; wood frame; no roofing material.
21-G	Lookout (attached to kitchen) Located near Bldg. 21-G.	21-16	3 m (@160°) x 2.5m	1920s	Fair to poor; still standing; built on 4m stilts; flooring and foundation partially rotten; metal roof.
21-J	Unknown mine building Located west of road down to Sadie-Ladue 600.	21-17	16 m (@140°) x 10m	1920s	Poor; collapsed; wood frame; no roofing material.

Photo 21-15: Mess hall, cookhouse and bunk houses (Bldgs. 21-G, H, I).
Note lookout roof visible behind mess hall. (Azimuth 340-010°)

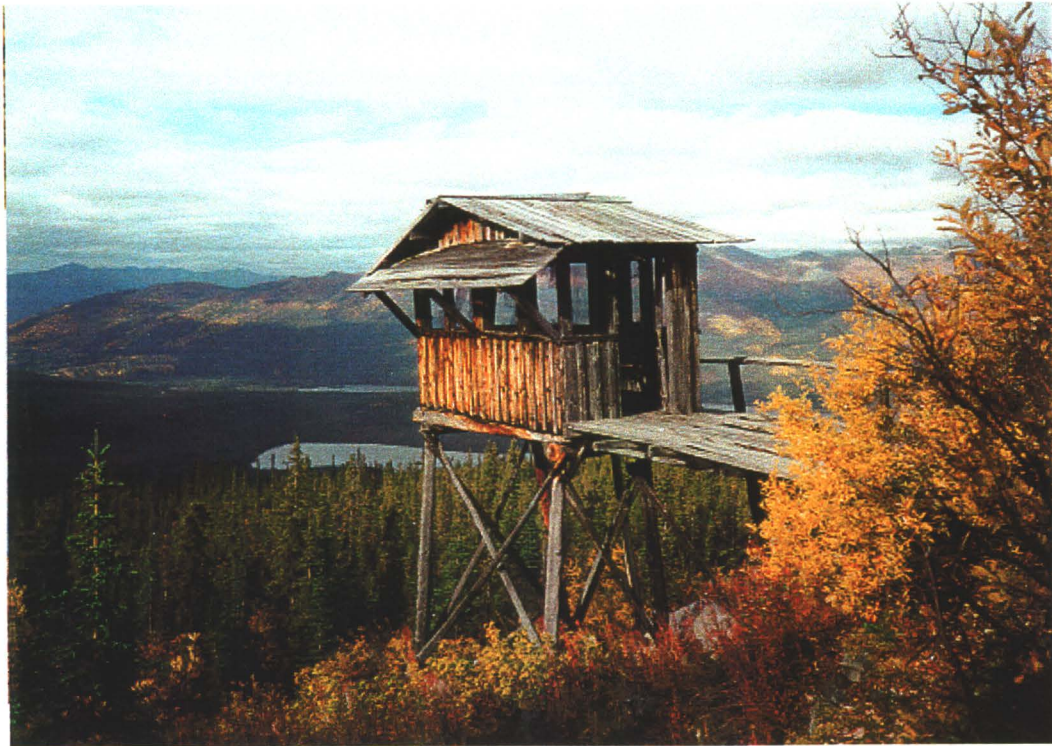
Photo 21-16: Lookout (part of Bldg. 21-G). (Azimuth 020°)

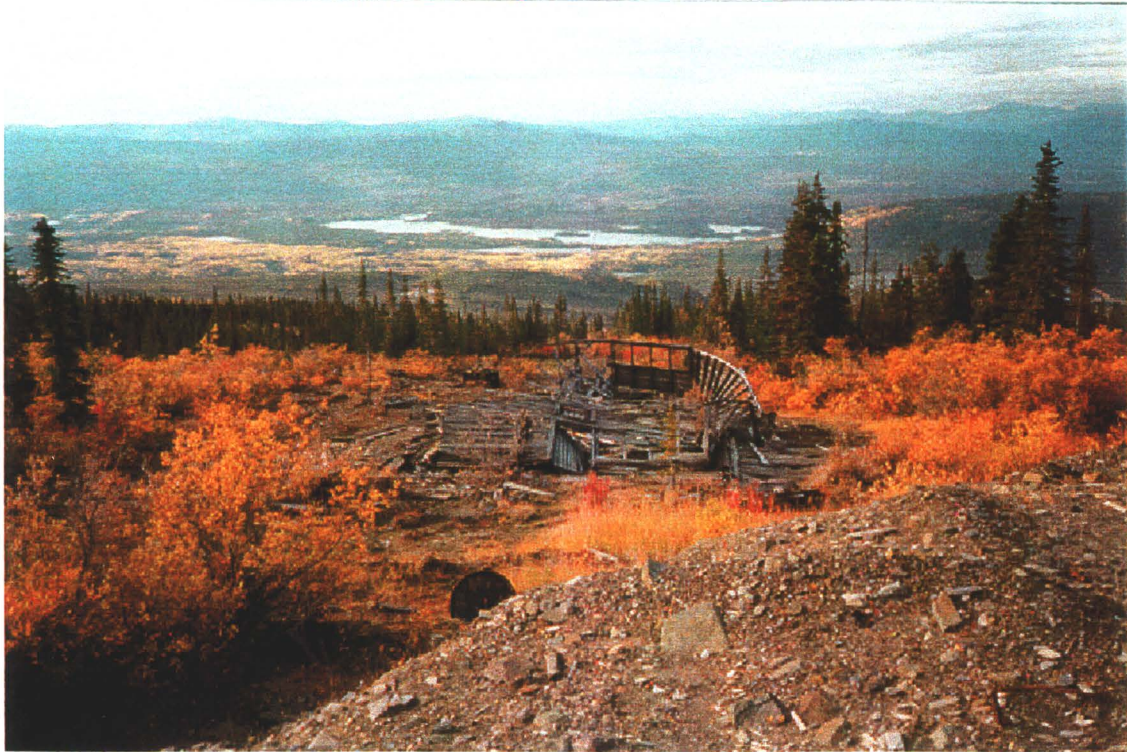
Photo 21-17: Collapsed building (Bldg. 21-J). (Azimuth 320°)

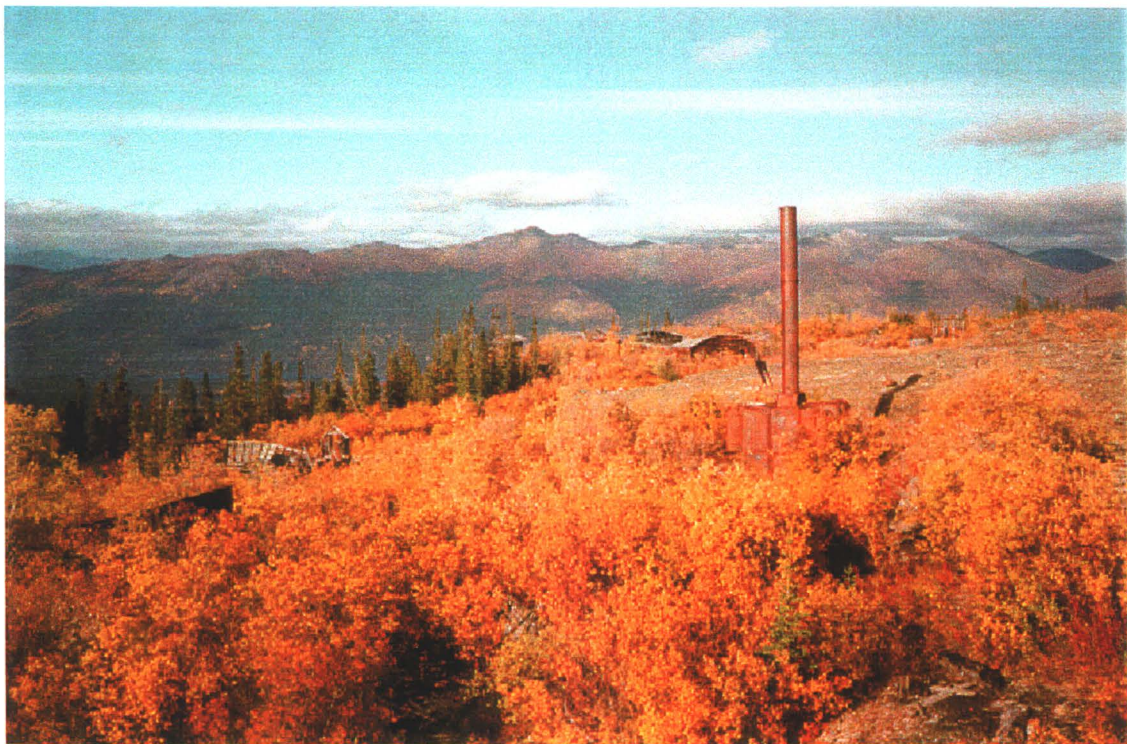
21-K	Boiler house Located near Bldg. 21-J.	21-18	n/a	1920s	Poor; collapsed wooden shed adjacent to steel boiler.
21-L	Houses or bunkhouses. Located west of Pit #1 below access road.	21-19	n/a	1920s	Site of 4 buildings; all in poor condition; all partially collapsed; all wood frame with metal clad roofs.
21-M	Log shack On Lucky Queen road	None	n/a	1920s	Poor; log construction; collapsed metal clad roof.
21-N	Outhouse Located near Bldg. 21-A.	None	n/a	1980s	Fair; metal clad wood structure.

Photo 21-18: Boiler (Bldg. 21-K). (Azimuth 000°)

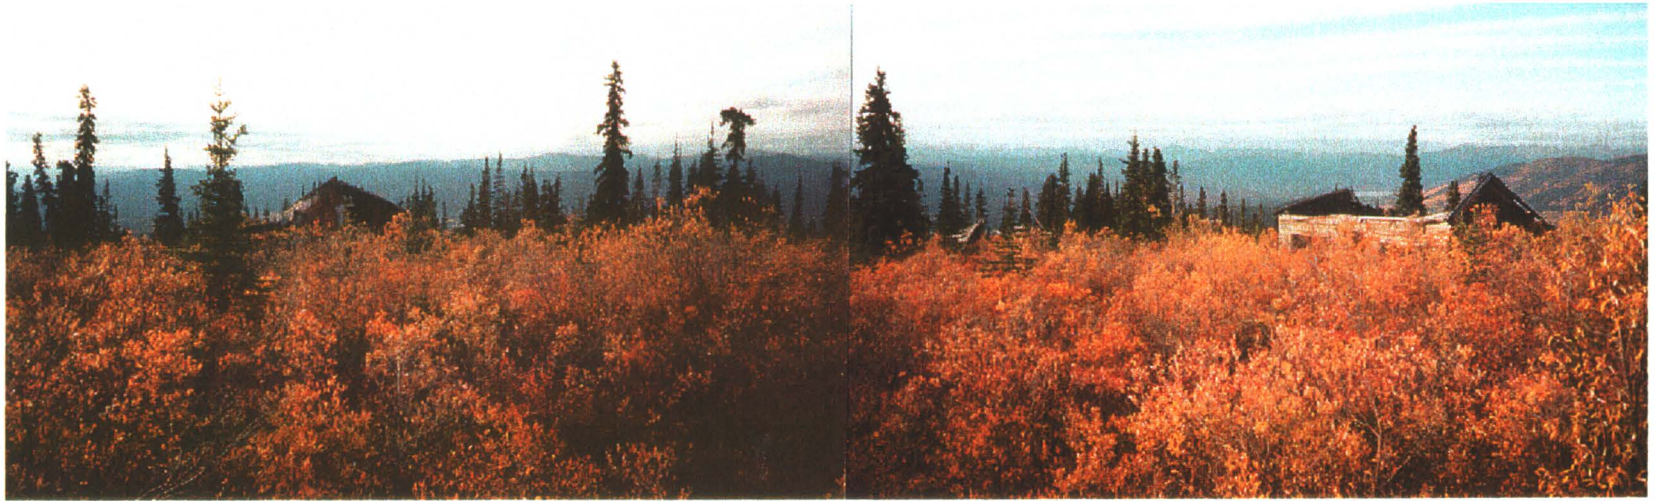
Photo 21-19: Partially collapsed buildings (Bldgs. 21-L). (Azimuth 280-340°)

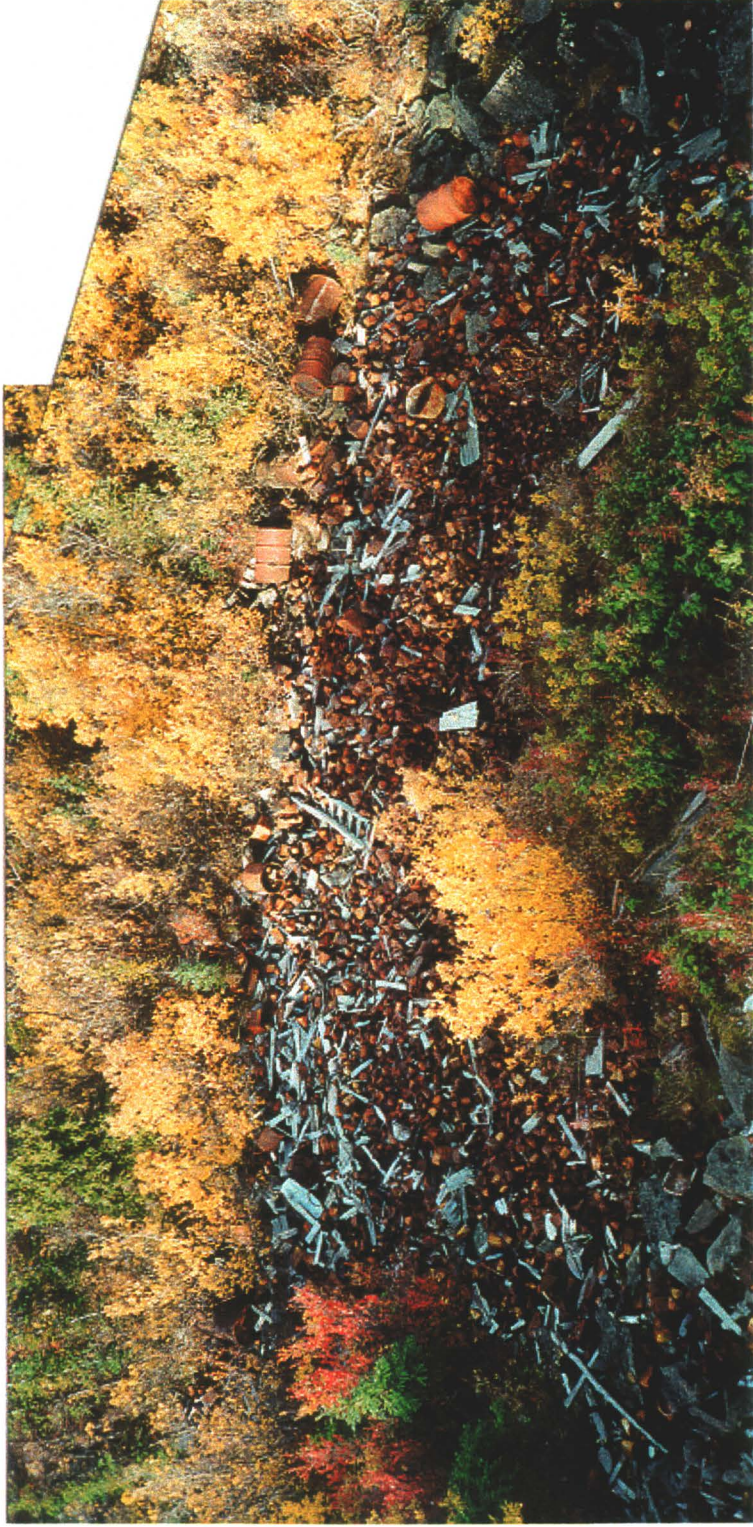
Photo 21-20: Dump site consisting primarily of cans and glass below cookhouse. (Azimuth 000°)
