BELLEKENO (#22)
(MINFILE# 105M 001y)

1. LOCATION AND ACCESS

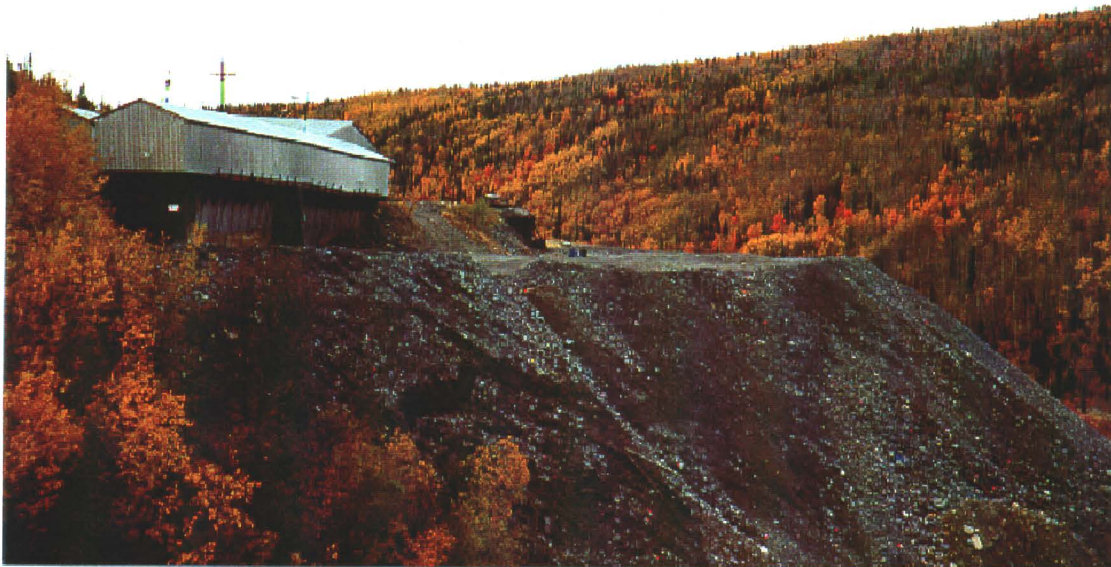
Bellekeno 625 level adit (photo 22-1)

Condition: The portal and underground workings are in good condition and continue to be maintained by United Keno Hill Mines.

Photo 22-1: View of Bellekeno 625 level adit site from opposite side of Thunder Gulch

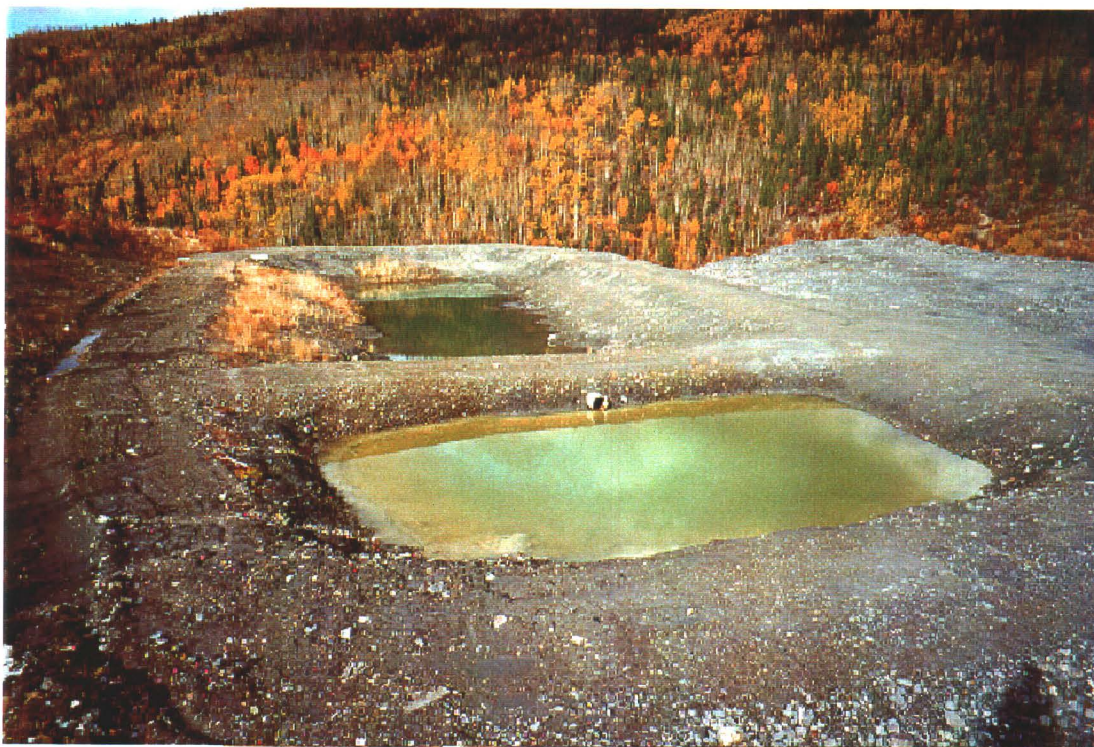
Piping: PVC tubing is used to carry the effluent from the mine to the treatment plant and from the treatment plant to the settling ponds. There were no breaks or leaks observed in the piping.

Photo 22-2: Settling ponds for treatment of water removed from Bellekeno mine at 625 level adit.

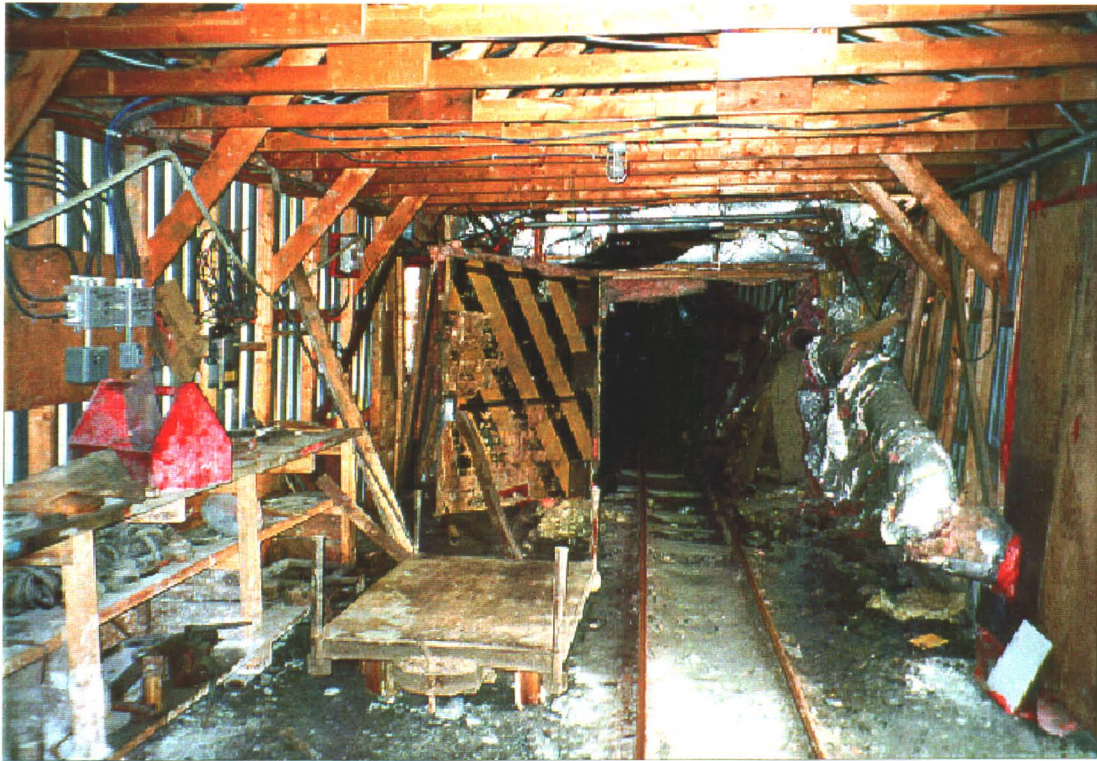
This sub-site is currently active under care and maintenance status. The 625 level adit serves as the main access to 8 levels of mine developments. It is connected to the 100 and 200 level adits. The adit portal is housed inside an adit building attached to a dump shed (photo 22-3).

Photo 22-3: View of Bellekeno 625 level adit from inside of adit building (Building 22A)

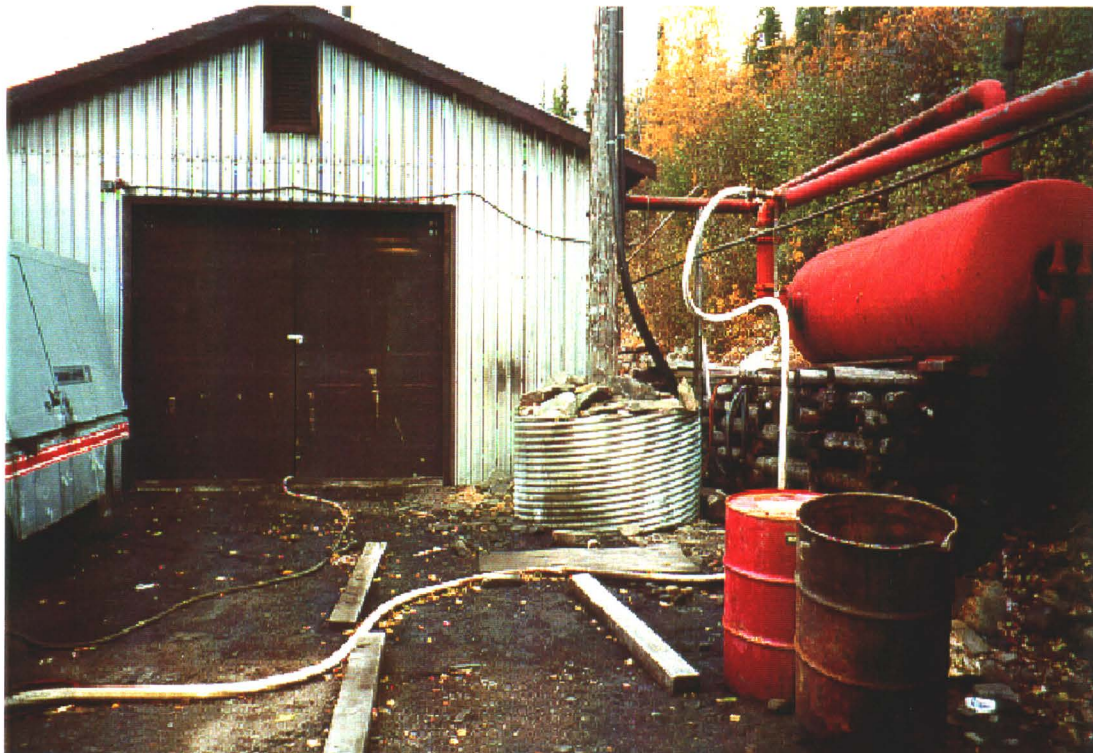
Building 22C is the Bellekeno 625 level adit compressor house. 3 compressors are housed inside the building and another mobile compressor is situated outside. A 2000 L gasoline storage tank is located in this building and appears to have been leaking at some time. The AST is currently empty. The building is also being used to store a variety of fuels, solvents and lubricants. The floor of this building is heavily stained with hydrocarbons.

A large area of stained soil was observed in and around the compressor house (Building 22A) at the Bellekeno 625 level adit site (see map). The floor of the compressor house and areas at the entrance and behind the building are black with hydrocarbon contamination. The depth of the contamination is unknown. The estimated dimensions of this area of contamination are 25 m x 5 m. Minor surface soil staining was also observed in several locations in the area between the dump shed (Building 22B), lunchroom (Building 22D) and adit building (Building 22A). No soil samples were taken at this site.

Photo 22-4: Compressor house at Bellekeno 625 level adit (Building 22C). Hydrocarbon staining is evident at entrance.

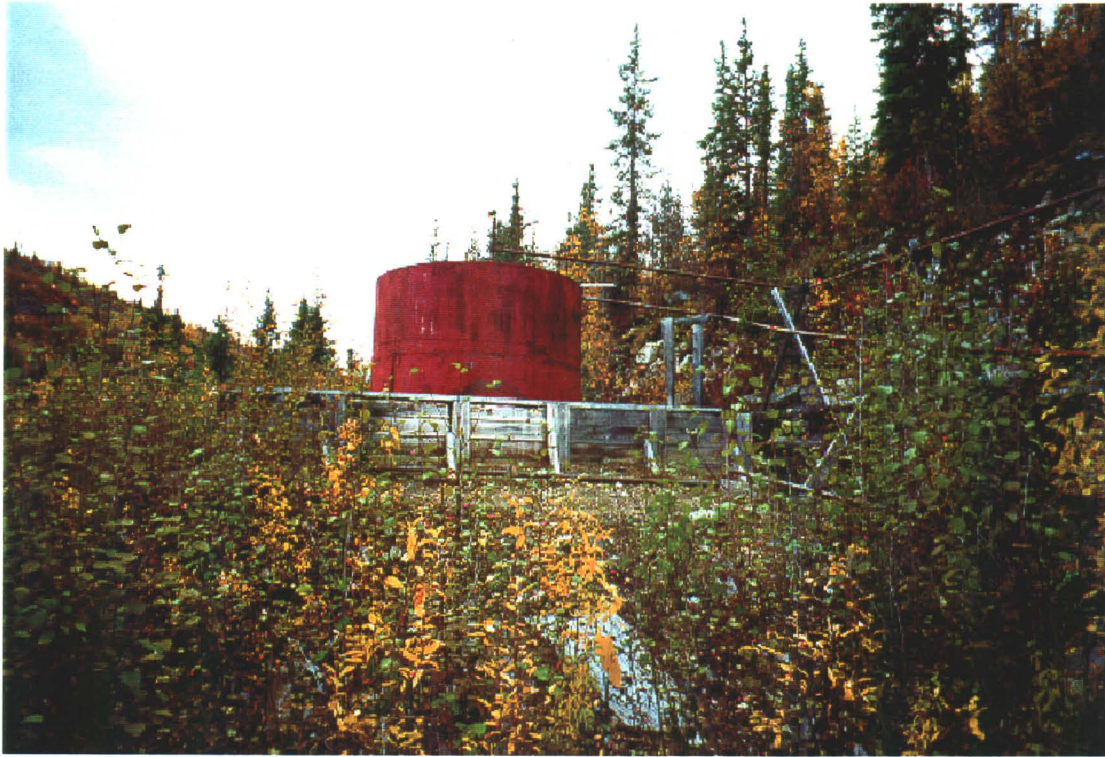
AST1 is a single-wall aboveground steel tank with an estimated capacity of 20,000 L. It is located behind the compressor house at the Bellekeno 625 level adit site. It is used to store diesel fuel for the compressors. AST1 appears to be in reasonable condition. Aboveground steel piping delivers fuel to the compressors. There is no secondary containment for the tank or its piping.

Photo 22-5: Aboveground fuel storage tank behind compressor house at Bellekeno 625 level adit.

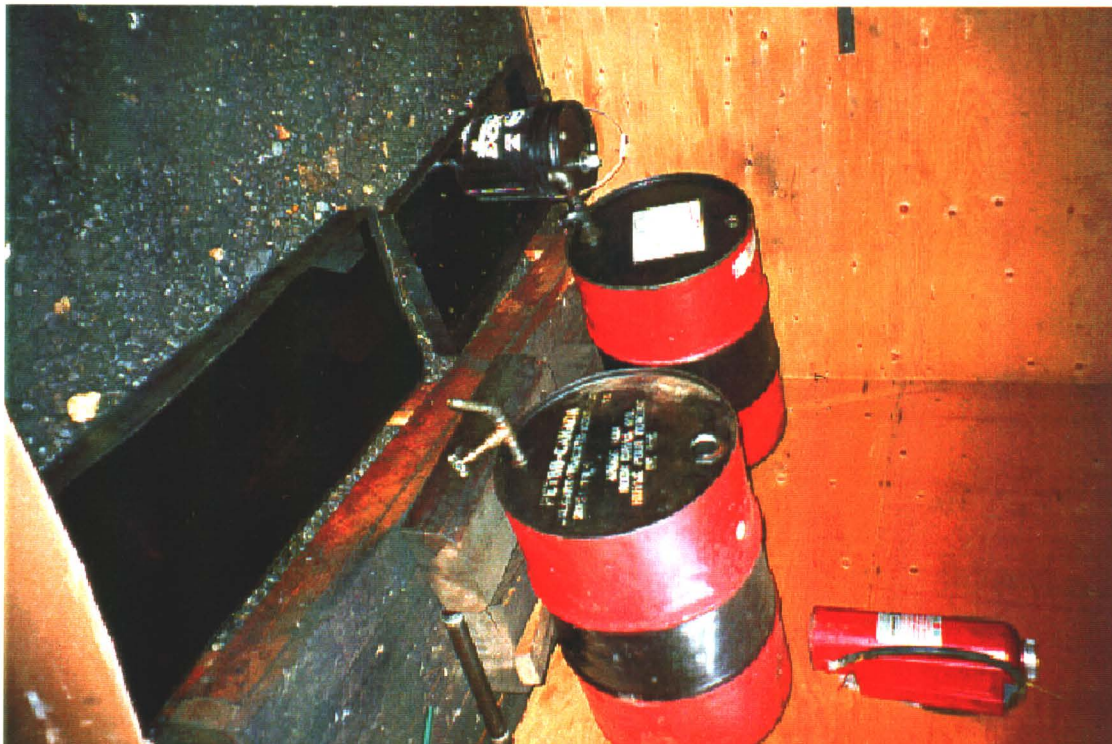
Hazardous Contents: 4 L of methyl alcohol, 20 L of tanner gas, 50-70 lb acetylene canister, 30 L motor oil, 45 gallon drum of transmission fluid, two 45 gallon drums of drill oil which have emptied into overflowing spill trays (see photo).

Several containers of liquid hazardous materials were observed in the compressor house at the Bellekeno 625 level adit site (photo 22-6).

Photo 22-6: Oil barrels fitted with dispensing valves located inside compressor house. Spill trays are filled with oil and hydrocarbon staining is evident on floor.

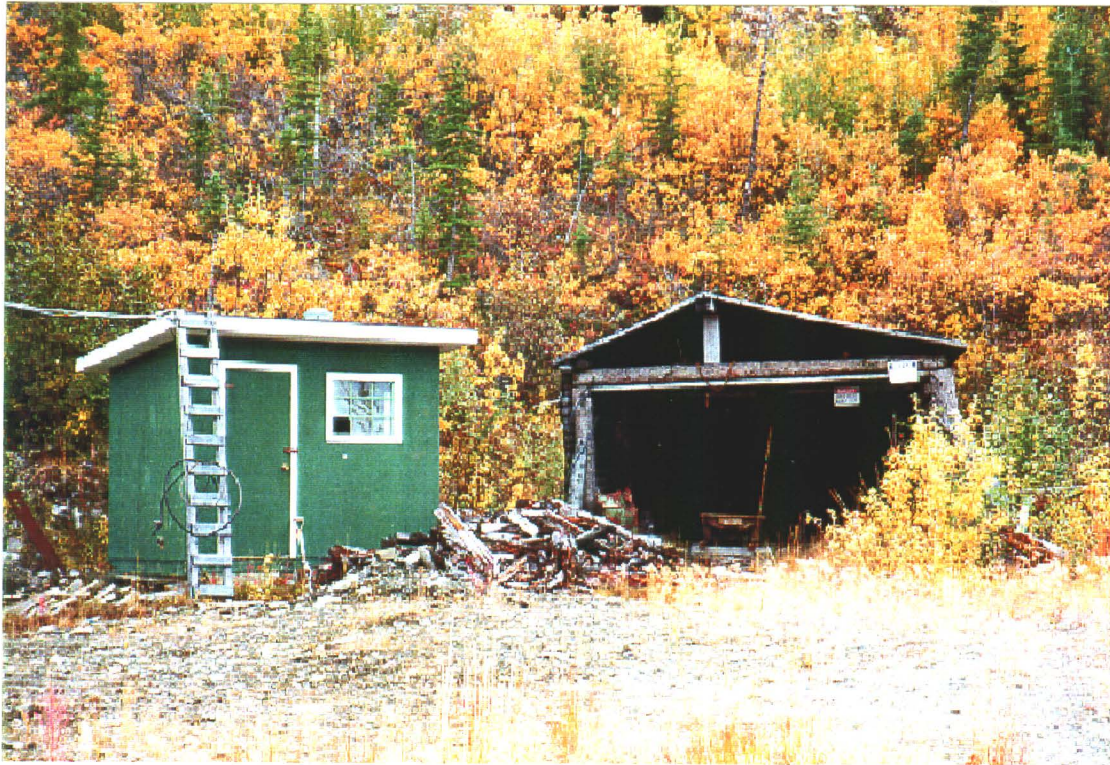
Bellekeno 200 level adit (photo 22-7)

Condition: The portal is constructed of logs and planks. It has no foundation or roofing material other than the planks. It is in fair condition and continues to be maintained by United Keno Hill Mines.

Building 22G is an electrical shed located at the Bellekeno 200 level adit site. It supplies the power going into the mine at the 200 level. The shed contains two switches, an electrical panel and a non-PCB transformer. The shed is in good condition.

Photo 22-7: View of Bellekeno 200 level adit entrance and green wooden electrical shed. (Azimuth 190°)

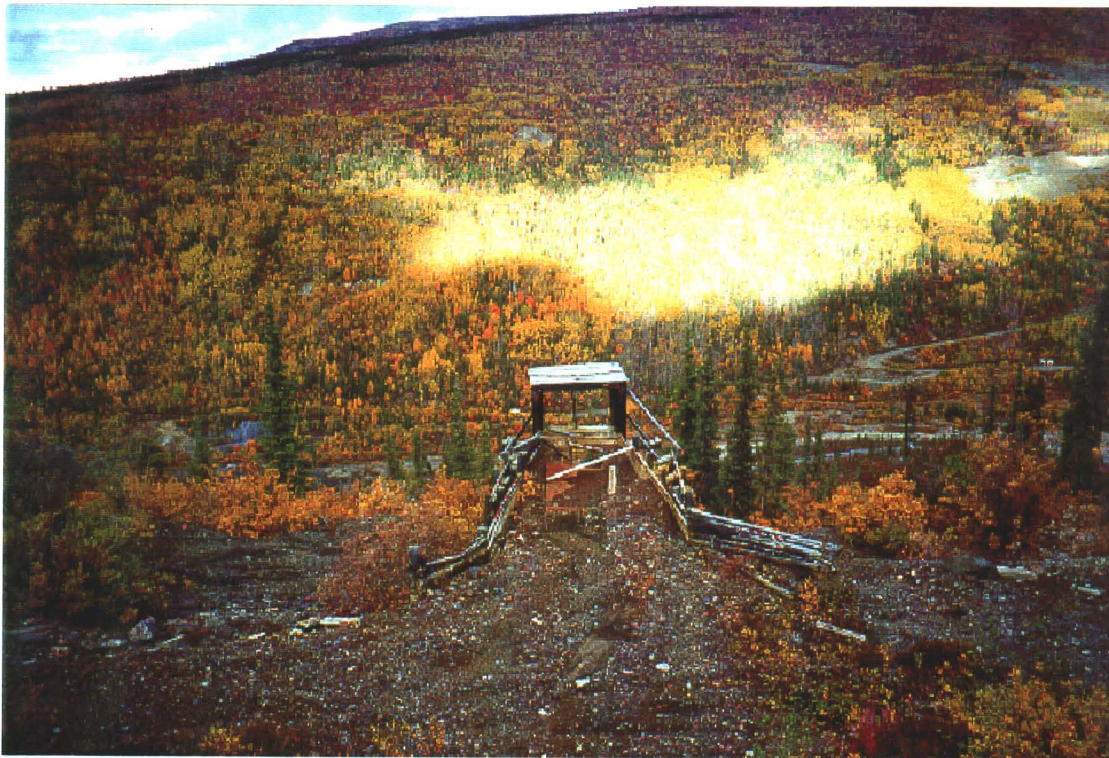
There is a dump point with a grizzly located at the Bellekeno 200 level adit site (photo 22-8). It is located at the top of the lower waste rock pile (WR200b). The structure is made of logs and planks. It is in poor condition and in danger of collapsing. There was no other milling or processing infrastructure discovered at the Bellekeno site.

Photo 22-8: View of wooden load out from the edge of waste rock dump at Bellekeno 200 level adit (Azimuth 020°)

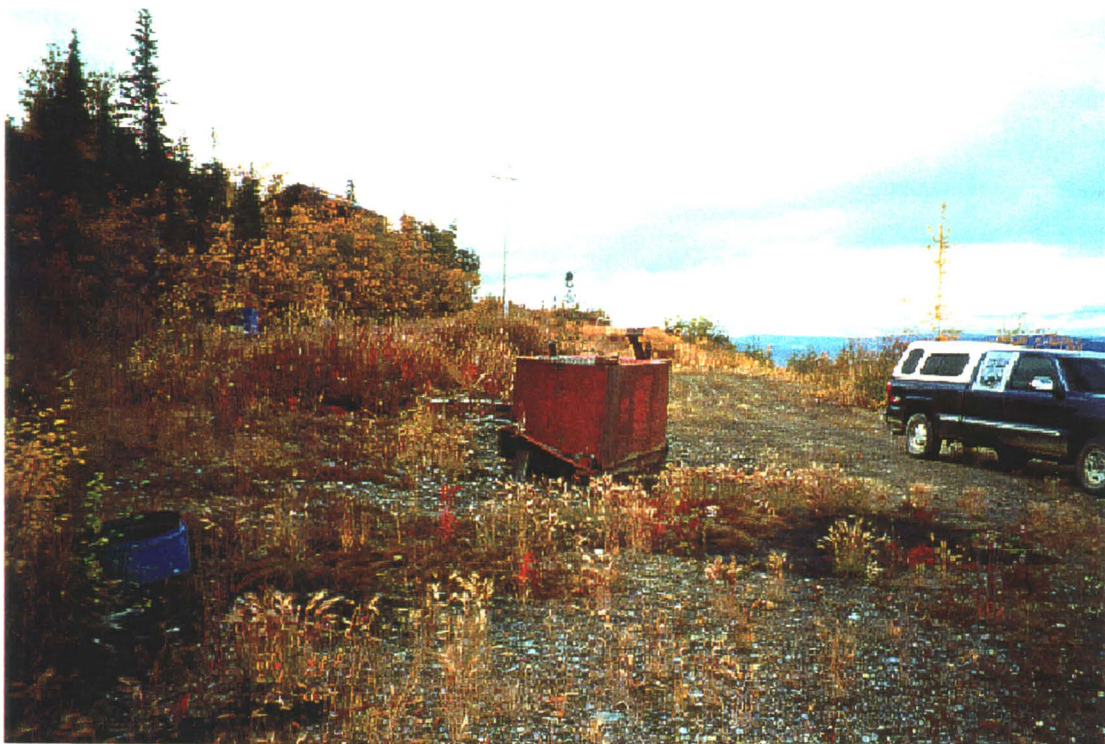
AST3 is a mobile, single-wall steel, fuel storage tank mounted on skids. This tank has two compartments with an estimated capacity of 1000 L for gasoline and 2000 L for diesel. It currently contains about 200 L of fuel. There does not appear to be any leaks in this tank. AST3 has no secondary containment. There is a zone of staining adjacent to the tank, which may have resulted from spillage during the transfer of fuel.

Surface soil staining was observed adjacent to the mobile fuel storage tank at the Bellekeno 200 level adit site (see map). The dimensions of this area of contamination are approximately 3 m x 3 m. Other minor surface staining was observed near the centre of the upper dump pad at this site. No soil samples were taken at this site.

Photo 22-9: View of mobile fuel storage tank containing diesel and gasoline located adjacent to Bellekeno 20d0 level adit (Azimuth 304°)

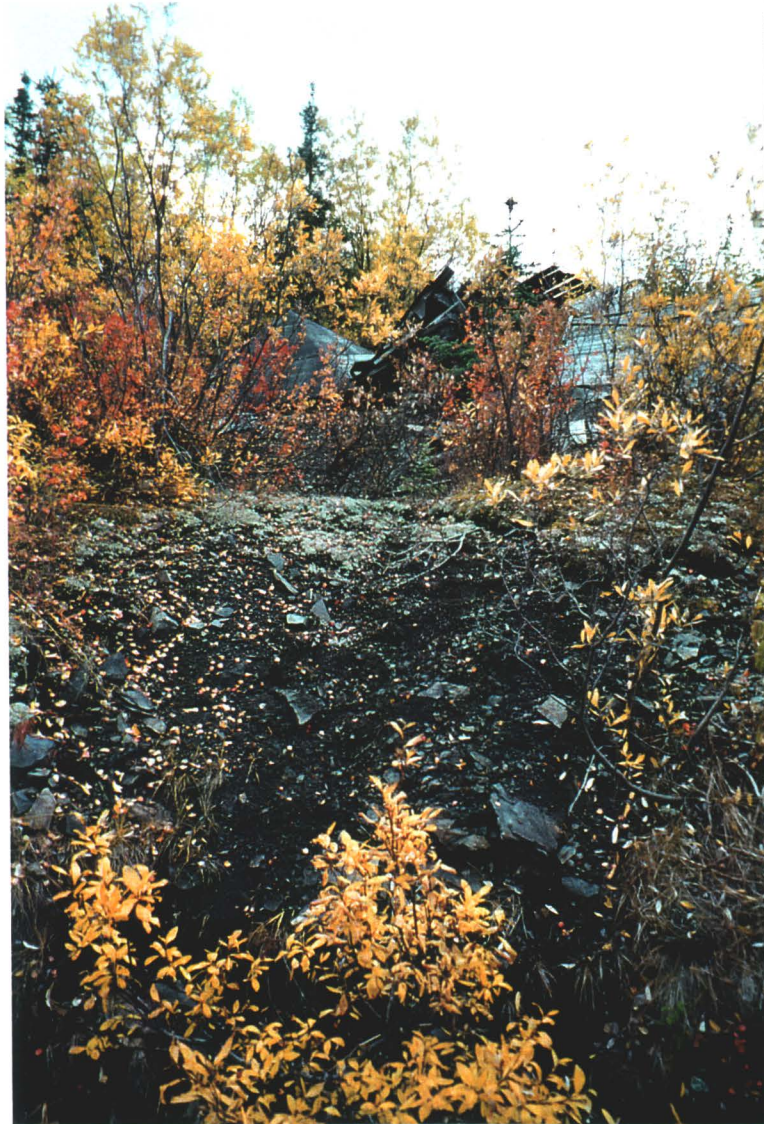
Bellekeno 100 level mine openings (photo 22-10 and photo 22-11)

Condition: Both the adit portal and the shaft house have collapsed.

A waste rock pile is located just below the Bellekeno 100 level adit. The pile is 8 m long, 3m wide and 3 m high. The waste rock in this pile consists of grey quartzite with siderite, quartz, pyrite, galena, and limonite mineralization. The waste rock is minorly rusted. The paste pH of an undocumented rock sample taken of the waste rock pile was 7.1. Parts of the waste rock pile were displaced during the construction of an adjacent power line. There is some natural reclamation of the site by moss and shrubs along the sides and top of the waste rock pile.

Photo 22-10: Collapsed entrance to Bellekeno 100 level adit with waste rock dump in foreground.

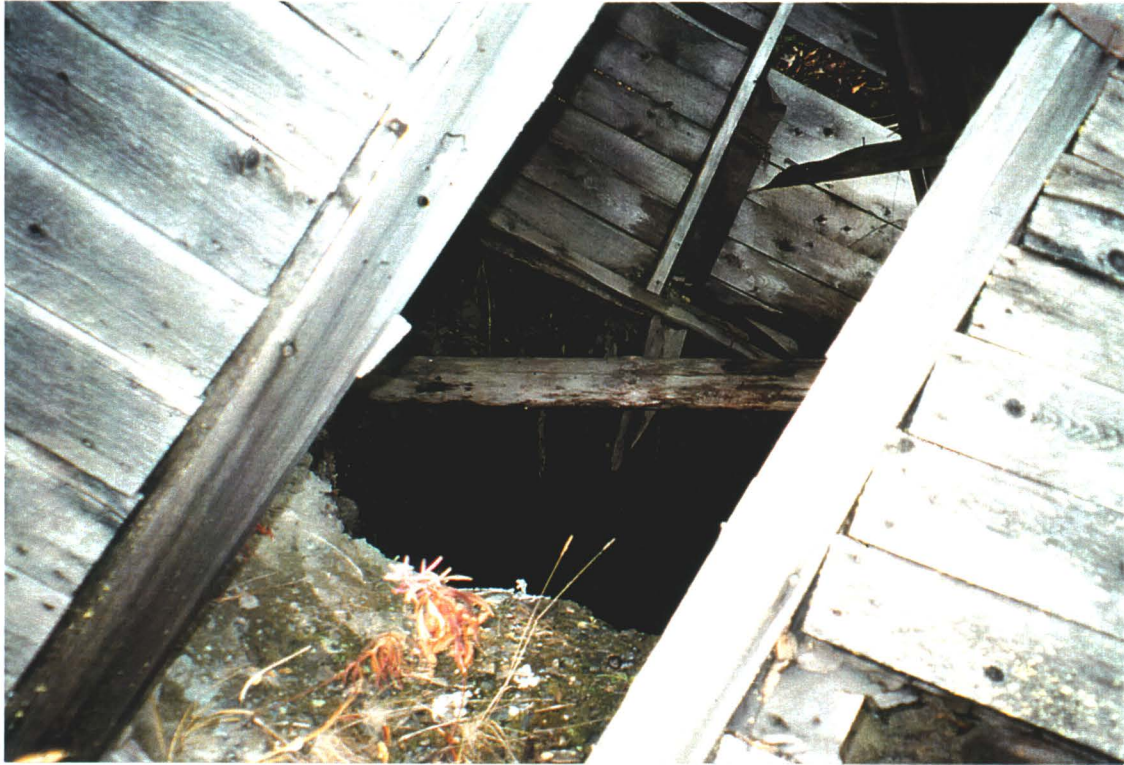
Photo 22-11: Collapsed structure enclosing shaft across Sourdough Hill Road from Bellekeno 100 level adit

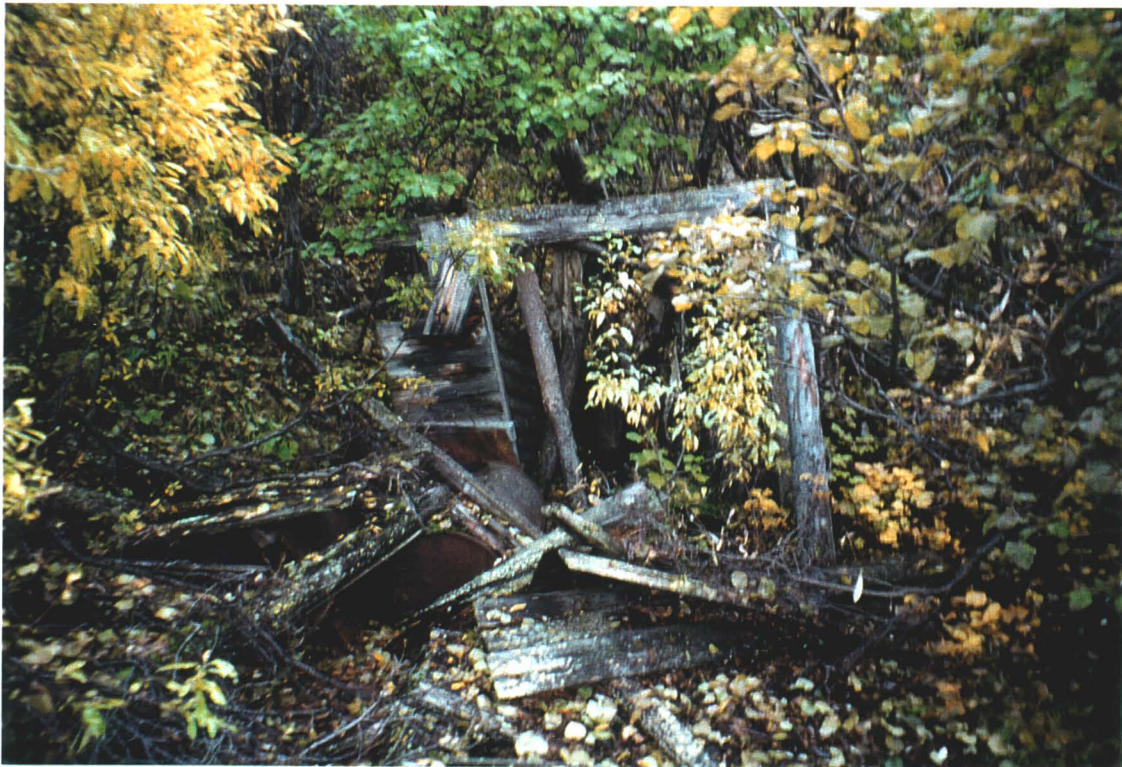
Mayo Mines adit (photo 22-12)

Condition: The adit portal has collapsed.

A waste rock pile is located at the Mayo Mines adit. The pile is 12 m long, 10 m wide, and 5 m high. The waste rock in this pile consists of grey quartzite with minor amounts of greenstone. Mineralization consists of sphalerite. The waste rock is minorly rusted. Waste rock sample 99-22-4-1 was taken from this pile. The field paste pH of this sample was 7.6. There is some natural reclamation of the site by moss and shrubs along the sides and top of the waste rock pile. Laboratory analysis data are contained in Attachment B.

Photo 22-12: View of collapsed entrance to Mayo Mines adit (Azimuth206°)

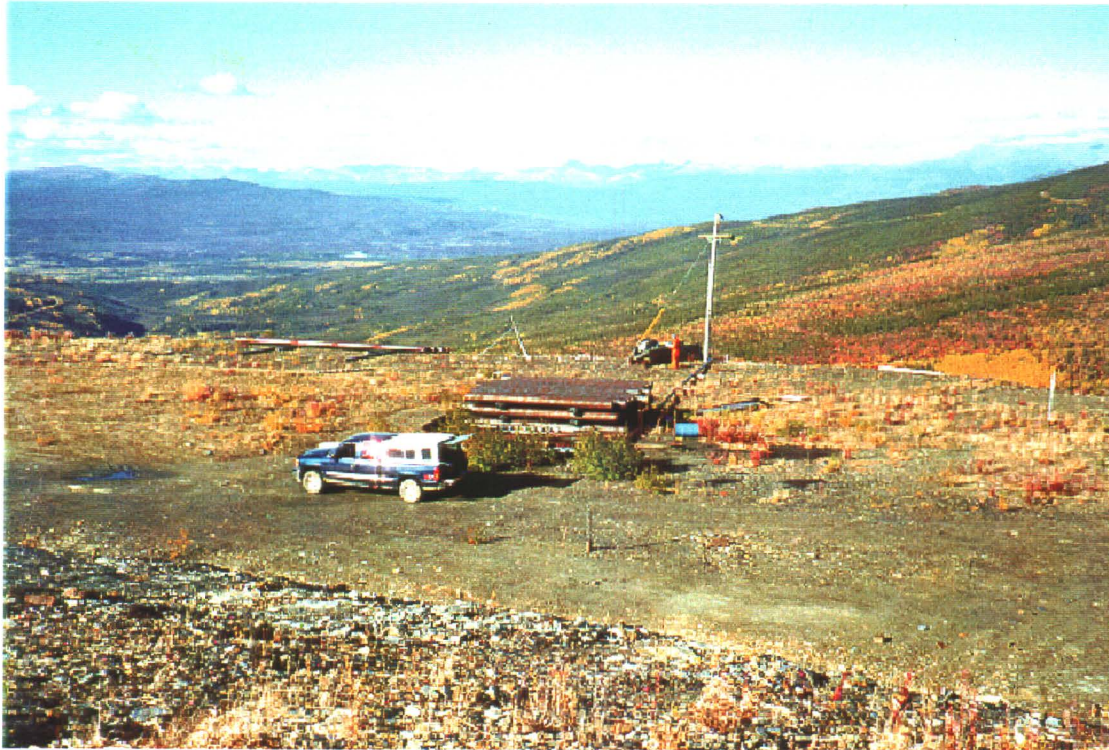
The Bellekeno backfill pad was the site of an attempt to drill a hole from the surface into the Bellekeno mine workings. The hole was to be used to backfill the underground tunnels. The operation was abandoned before the drilling was completed. An area of soil contamination was observed at this site adjacent to the drilling site (see Figure 4; photo 22-14). The source of contamination appears to have been the oily metallic sludge produced during the drilling operation. The estimated depth of the contaminated soil is 0.15 m. The estimated dimensions of the area of contamination are 12 m x 4 m. Two more small areas of surface staining were observed adjacent to the larger area. Soil sample 99-22-1-1-.01 was taken from the contaminated area at a depth of 10 cm. A background sample was taken of the soil at the Bellekeno Backfill site at a depth of 10 cm (sample 99-22-1-2-.01). Laboratory analysis data are contained in Attachment B.

Photo 22-13: Bellekeno Backfill site. Drilling site is at centre of photograph next to laydown of pipes.

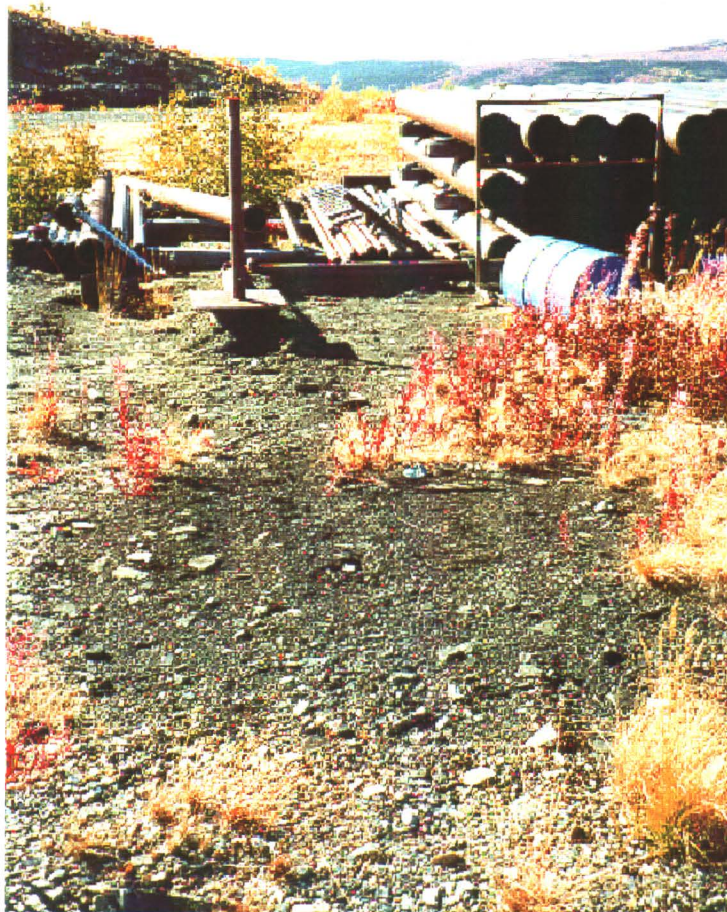
Photo 22-14: Drilling site with soil staining in foreground. Laydown of piping and empty hydraulic fluid barrel are in background.

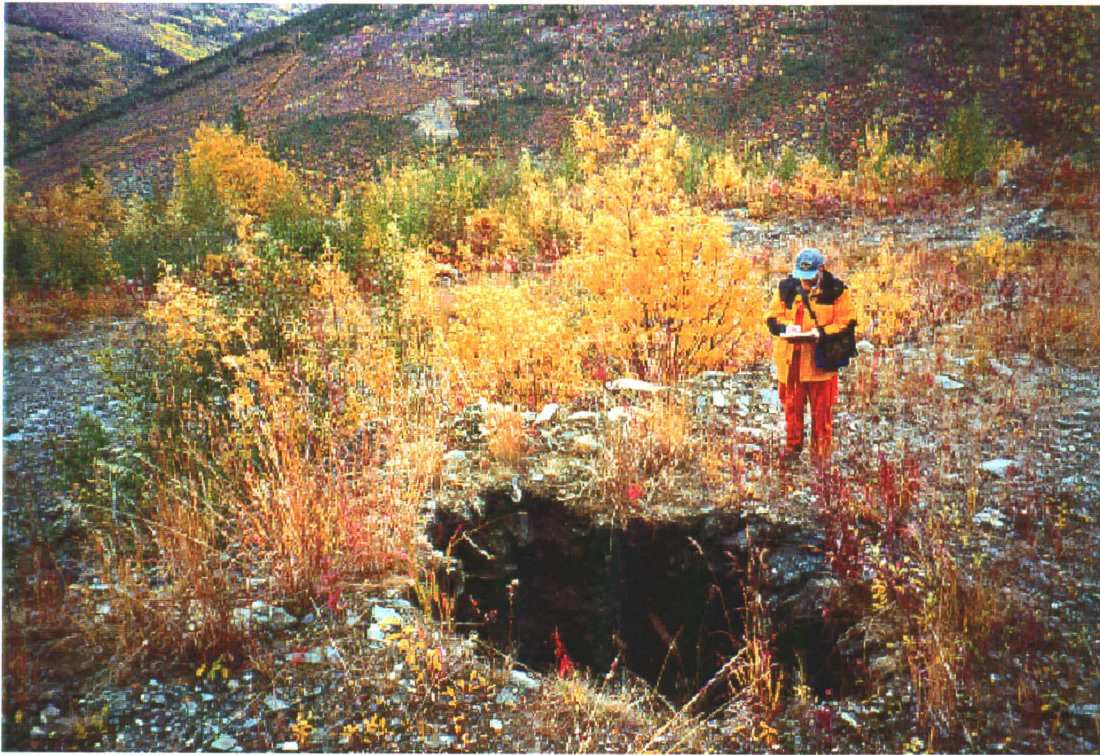
Eureka Shaft 1 (photo 22-15 and 22-16)

Condition: The shaft and stope remain unstable and could be prone to continued collapse.

Photo 22-15: Eureka Shaft 1 located in the middle of a trail off of Sourdough Hill Road.

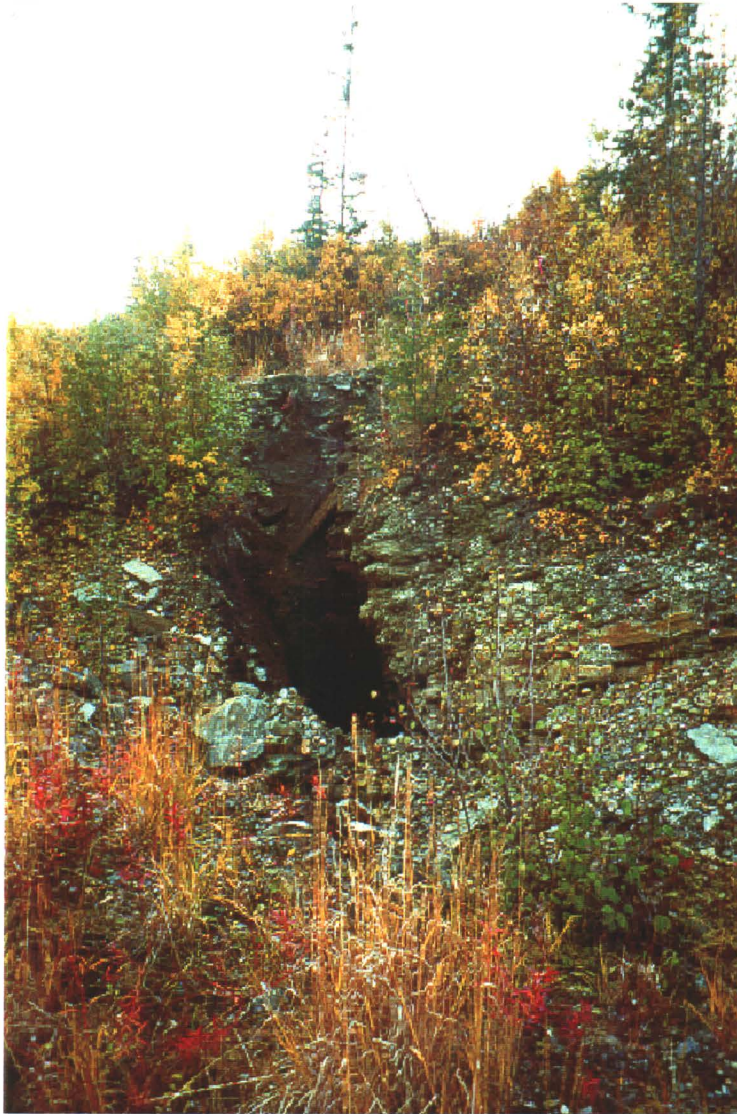
Dimensions: 2 m x 2m and about 6 m deep. The stope opening is 10 m long, 2 m wide, and filled to within 2m of the surface.

Photo 22-16: Stope broken through to surface just below Eureka Shaft 1.

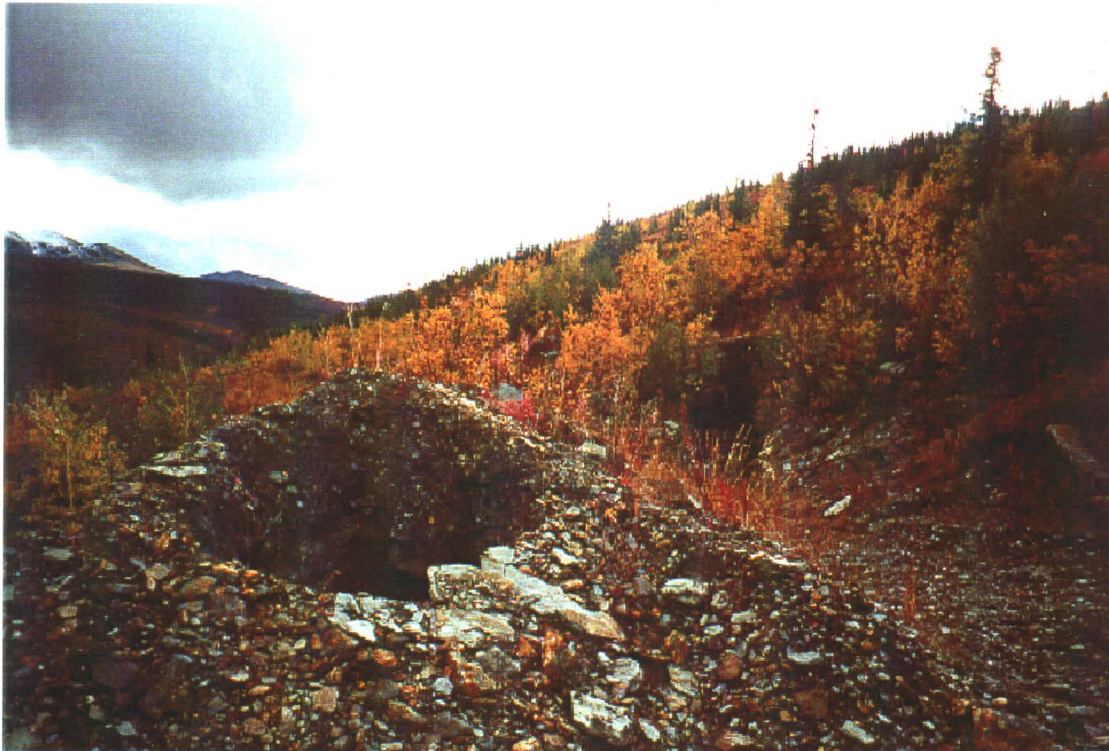
Eureka Raise 1 (photo 22-17)

Condition: The timbers of the raise are in poor condition and may be prone to collapse.

Photo 22-17: Timbered raise (Eureka Raise 1). Open stope can be seen in background.

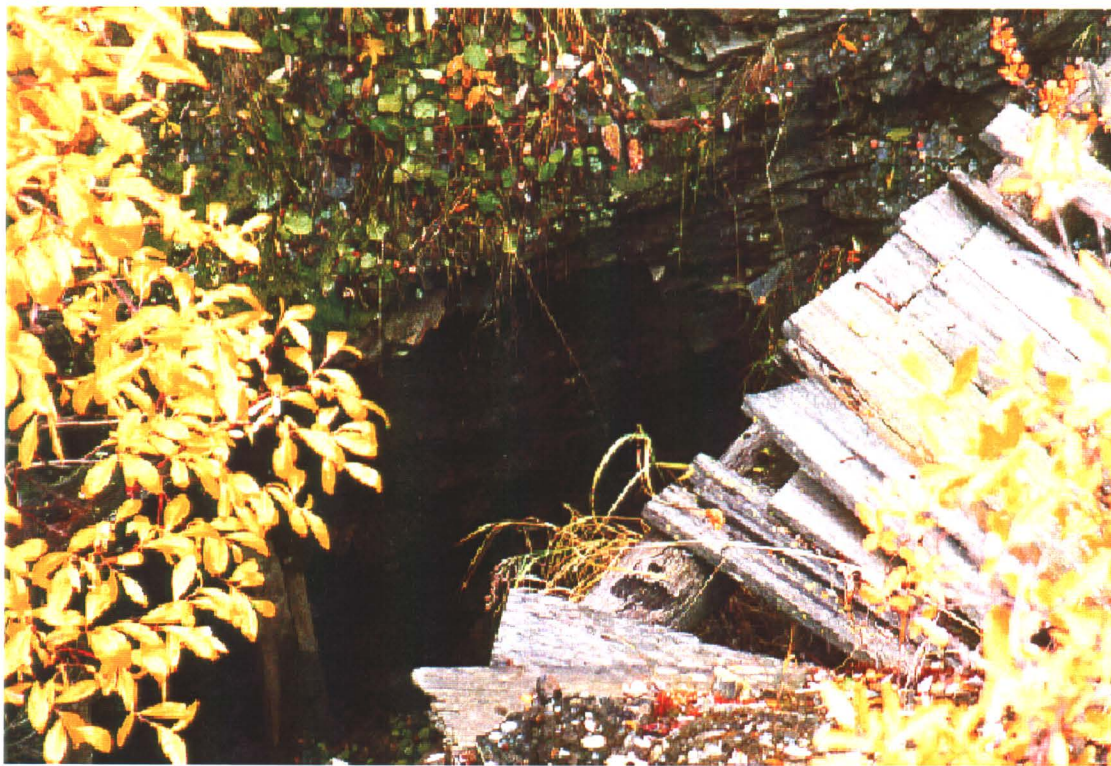
Eureka Shaft 3 (photo 22-18)

Condition: This shaft remains unstable and could be prone to continued collapse.

A waste rock pile is located at the Eureka workings near Eureka Shaft 3 (see Figure 5). The pile is 3 m long, 2 m wide, and 2 m high. The waste rock in this pile consists of steely grey and rusty oxidized ore. The rock is mainly grey quartzite with minor amounts of greenstone. Mineralization includes siderite, sphalerite, limonite, pyrite, and trace galena. Waste rock sample 99-22-06-01 was taken from this pile. The field paste pH of this sample was 6.4. Laboratory analysis data are contained in Attachment B.

Photo 22-18: Partially collapsed shaft (Eureka Shaft 3) located about 37 m south of Eureka Shaft 1.

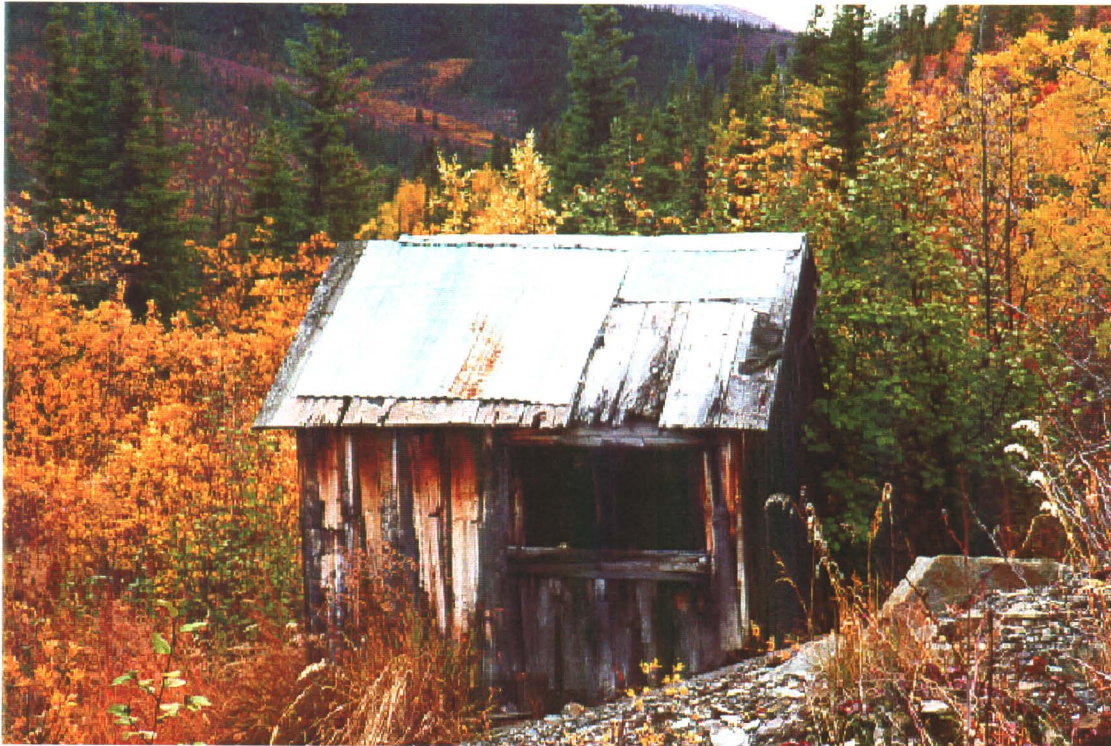
Building 22M is a powder magazine located near Eureka Shaft 3. This building is in poor condition although it does not appear to be failing.

Photo 22-19: Powder shed located adjacent to Eureka Shaft 3.

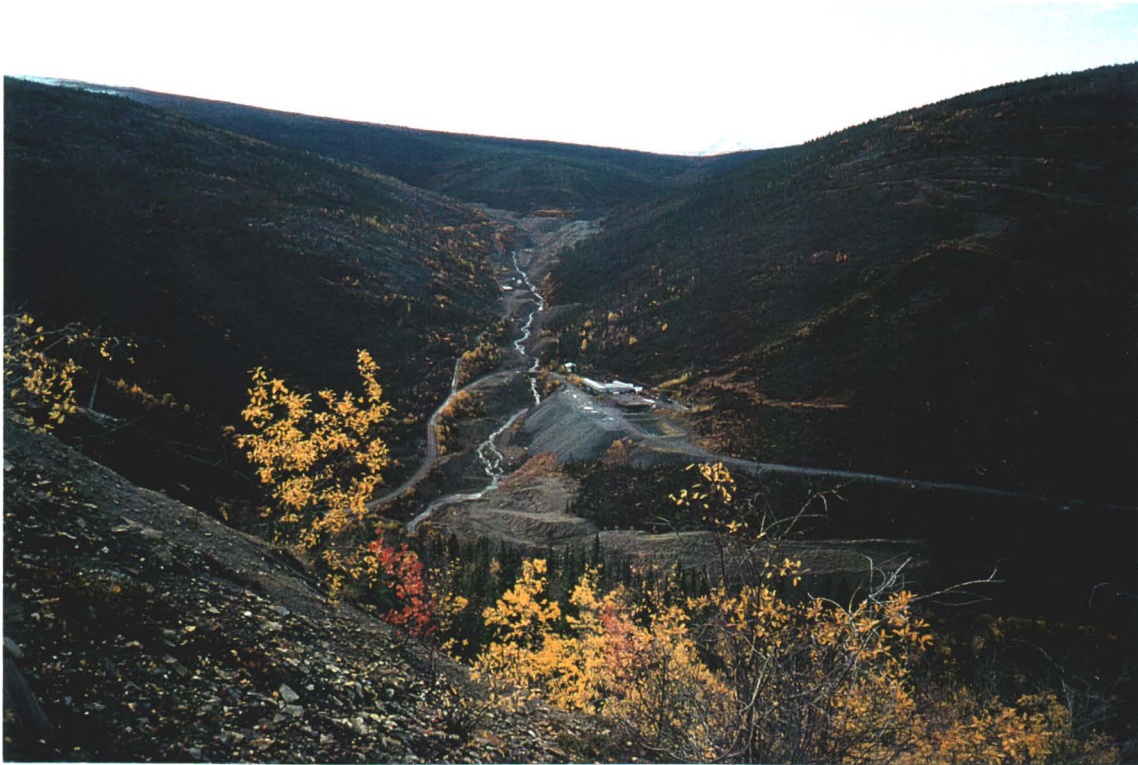
Photo 22-20 : Overview of Bellekeno site. Note use of mine waste rock for road ballast and its proximity to creek in Thunder Gulch.(Azimuth 170°)

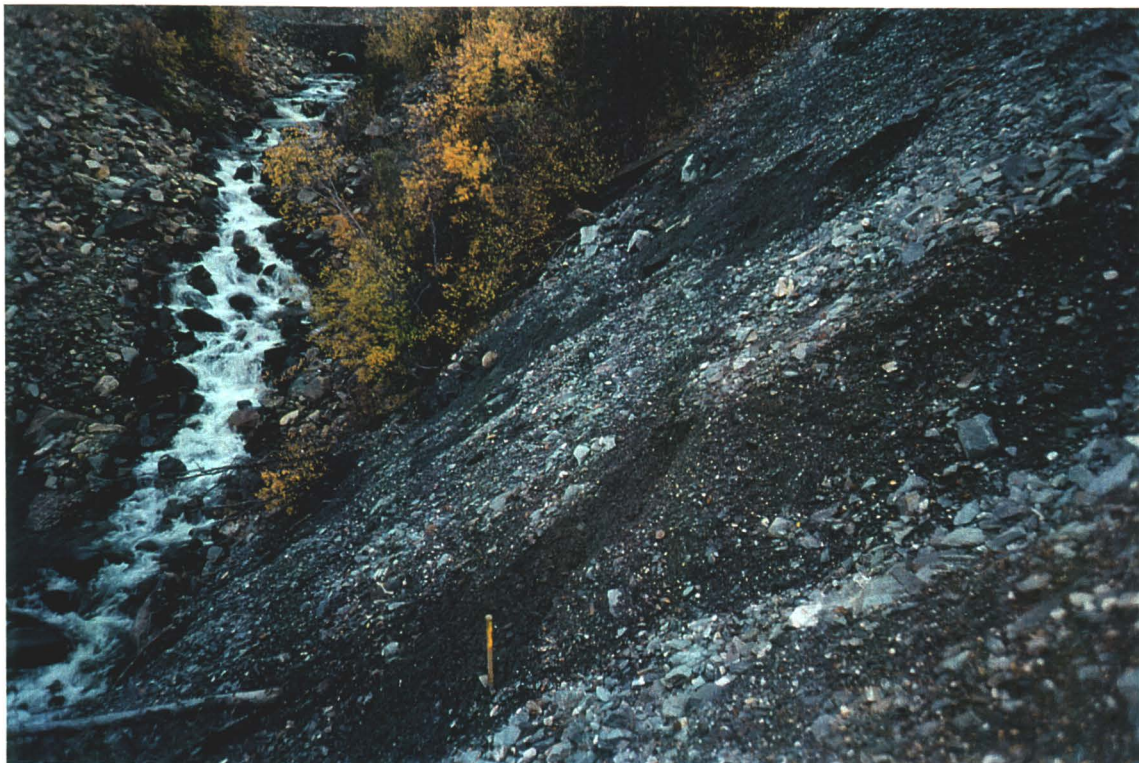
Photo 22-21 : Slumping evident in Bellekeno mine waste rock above Thunder Gulch creek. (Azimuth 160°)
