KIJO
SITE #23
MINFILE# 105M001aa

| Drawing title: Kiljo Site #23 Site Assessment Yukon Territory | Titre du dessin: revisions: project no. no. du projet: 125-12.01 dwg. no. dessin no.: 1 of 1 |

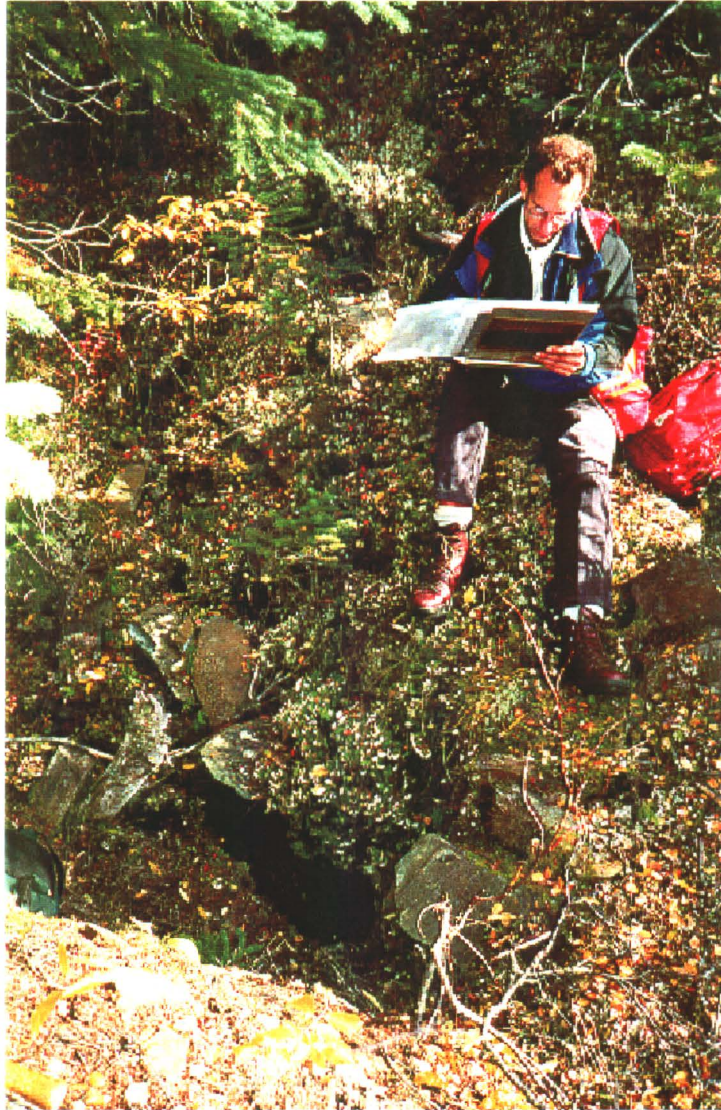
Lower Adit/Trench (photo 23-1)

The trench is oriented at 030°. The trench and portal is overgrown with trees and shrubs. The lower portal area is caved; there is a small opening into the adit.

Condition: The adit is collapsed, and the trench appears to be safe. The trench has been reclaimed by shrubs and other bush.

Accessibility: The trench is overgrown but can still be accessed by foot. The adit has partially collapsed and the opening is too small to access the adit.

Photo 23-1: Caved lower portal area; note small opening below mapper's feet and natural revegetation of the site. Photo Direction (Azimuth 040°)

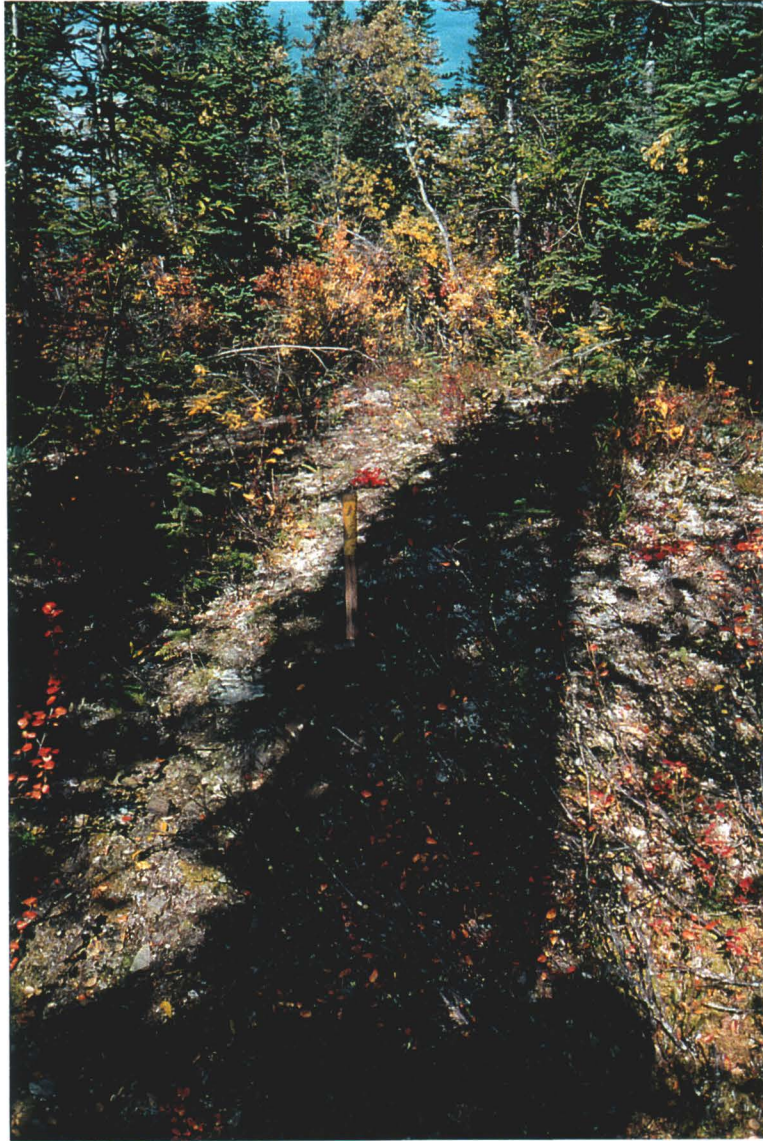
Waste rock pile #2 (photo 23-2)

Waste rock in this pile is from the lower adit/trench. The waste material is composed of overburden, soil, and trenched bedrock. Revegetation of trees and bushes are growing on the waste rock pile. No surface water runoff was noted. No sign of oxidation was noted on the rock pile.

Photo 23-2: Rock dump from lower trench and adit. Note heavy natural revegetation. Photo Direction(Azimuth 340°)

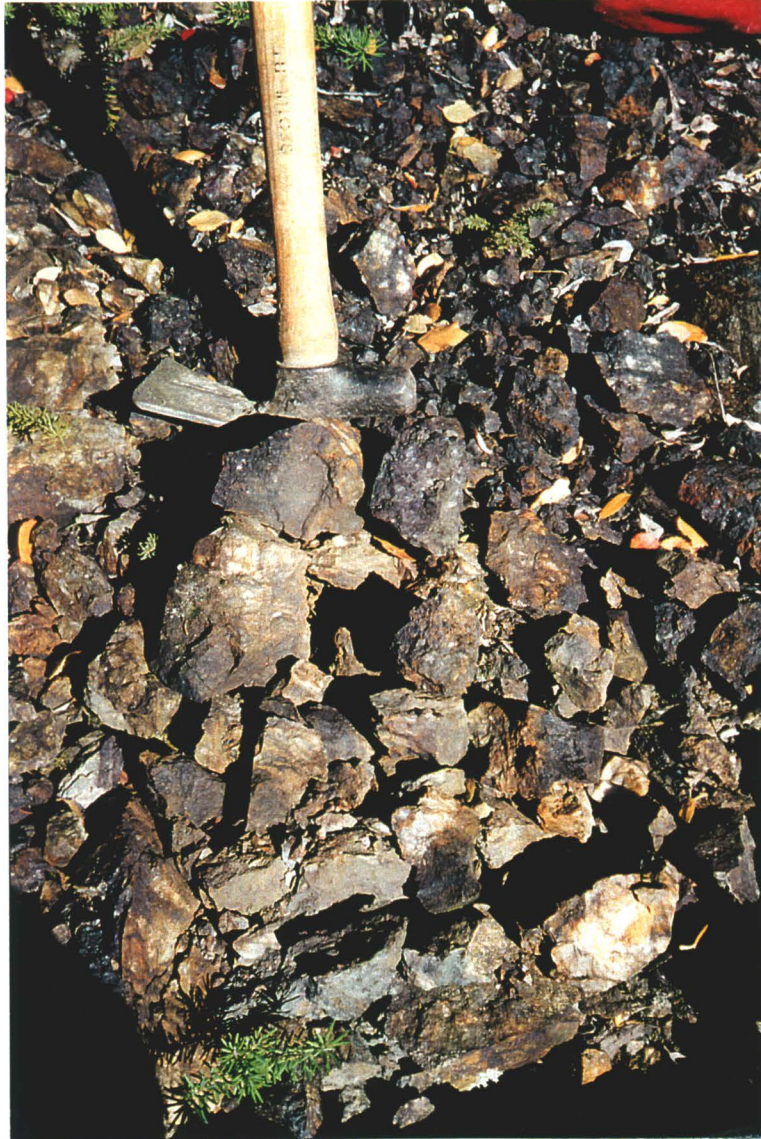
Ore Stockpile #1 (photo 23-3)

The small ore stockpile is composed of strongly weathered semi-massive galena, tetrahedrite, siderite quartz vein. The ore was extracted from the middle adit/trench. No surface water runoff was noted. Oxidation on the ore rock was observed.

Photo 23-3: Close-up of strongly weathered, semi-massive galena-tetrahedrite siderite-quartz vein ore stockpile material (5m x 3m x 0.5m).

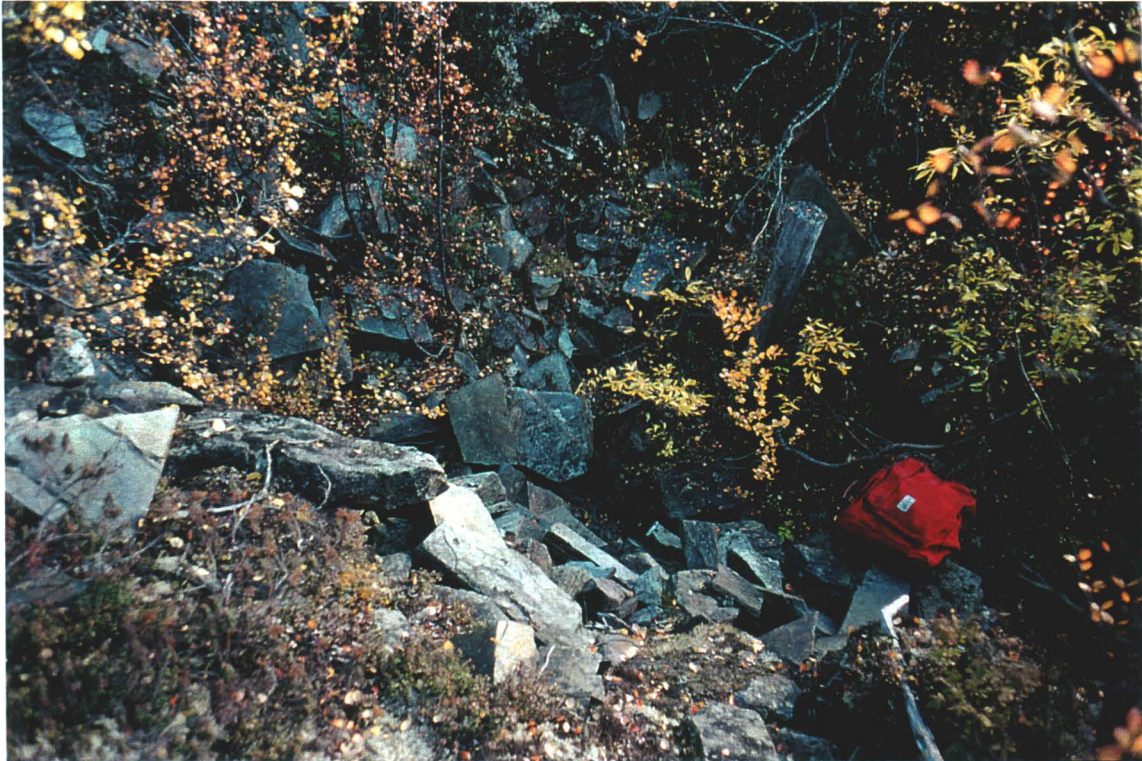
Middle Adit/Trench (photo 23-4)

The trench is oriented at 070°. The trench is overgrown with trees and shrubs. Timber used to construct the portal protrudes from angular colluvial greenstone boulders in the trench.

Supports: Likely wood or rock; however, the adit has collapsed and is re-vegetated. A portal timber was noted (see photo).

Condition: The adit is collapsed and not visible, and the trench appears to be safe. The trench has been reclaimed by shrubs and other bush.

Photo 23-4: Collapsed middle trench and adit area. Note portal timber above pack protruding from angular colluvial greenstone boulders.

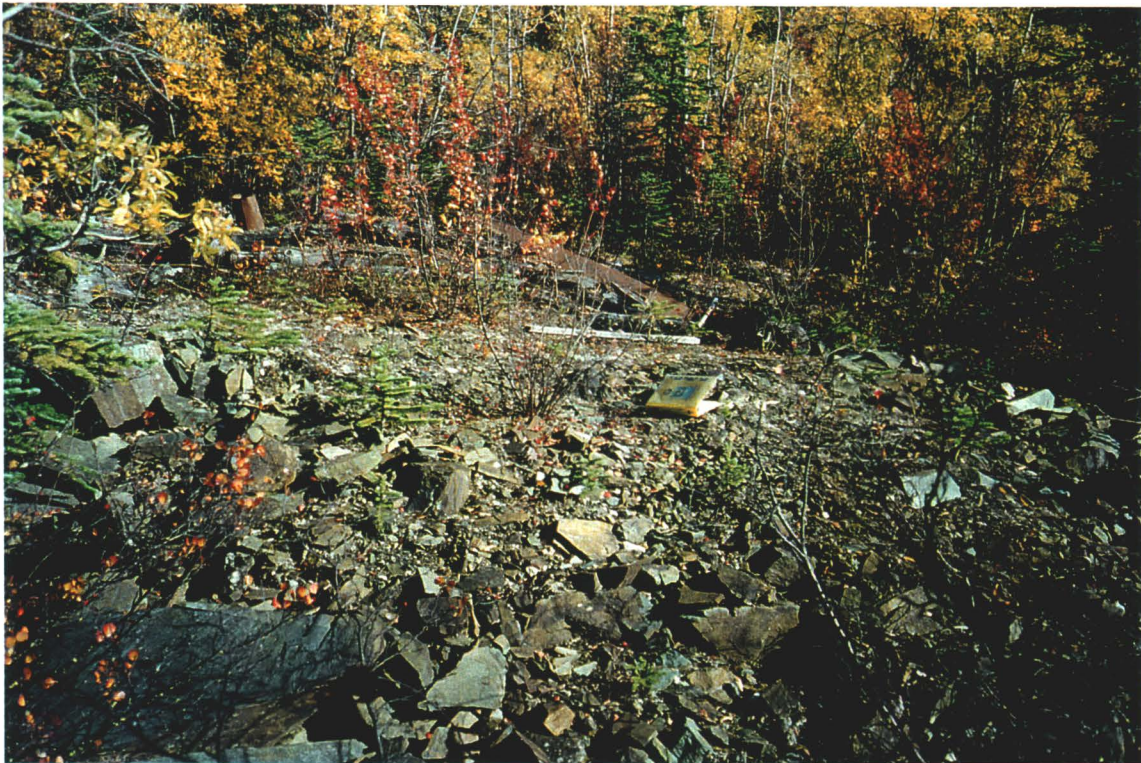
Waste rock pile #1 (photo 23-6)

Waste rock in this pile is from the upper adit/trench. The waste material is composed of roughly 80% overburden, soil, and coarse angular boulders. Revegetation of trees and bushes are growing on the waste rock pile. No surface water runoff was noted. No sign of oxidation was noted on the rock pile.

Photo 23-6: Rock dump from upper trench and adit (18m x 4m x 2m). Material comprised of approximately 80% colluvial soil and angular greenstone boulders.

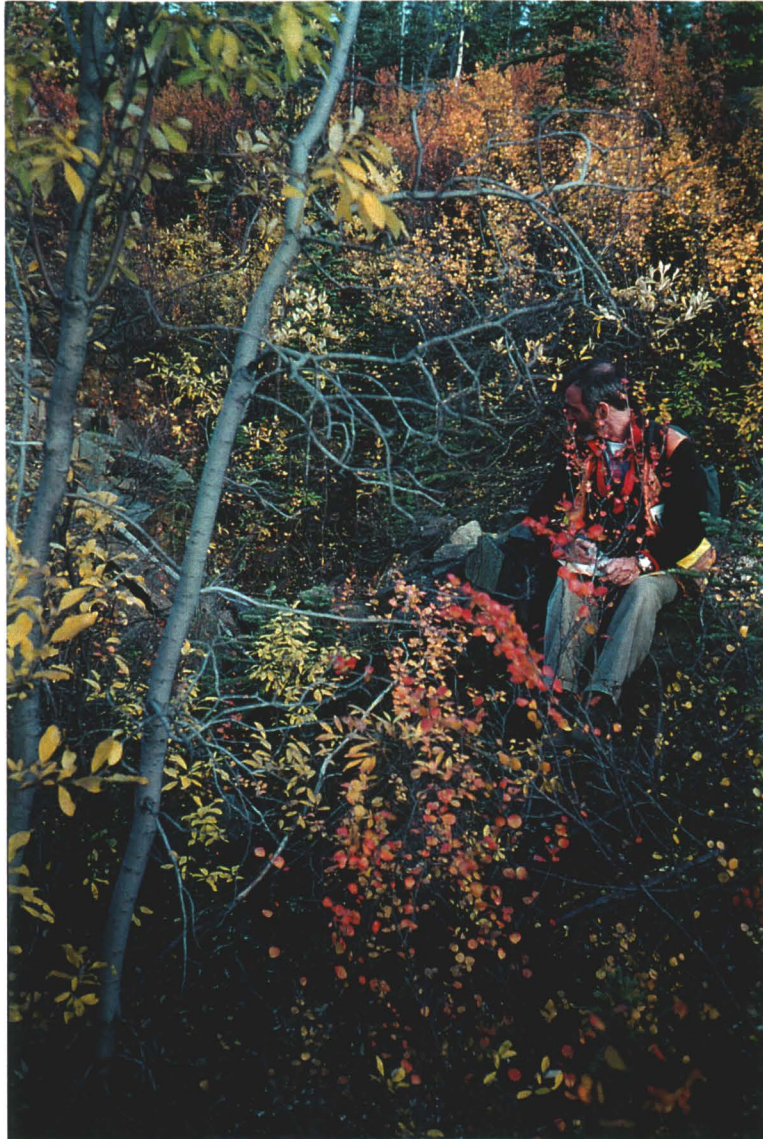
Upper Adit/Trench (photo 23-5)

The trench is oriented at 070°. The trench is overgrown with trees and shrubs. A colluvial rock pile composed of small boulders is deposited at the south end of the trench. The adit is collapsed and is not a safety risk. Vegetation has re-claimed the area.

Condition: The adit is collapsed and not visible, and the trench appears to be safe. The trench has been reclaimed by shrubs and other bush.

Photo 23-5: Collapsed upper trench and adit area.
Photo Direction (Azimuth 120°)
