LAKE
SITE# 27
MINFILE# 105M001ac

Public Works And Government Services Canada	Travaux publics et Services gouvernementaux Canada	designed by:	date:
	Architectural & Engineering Services Western Region		drawn by: C.S.	Nov. /99
Drawing title:		Titre du dessin:		revisions:
Lake Site #27 Site Assessment Yukon Territory		project no. no. du projet:	diag. no. dessin no.	
		125-12.01	1 of 1

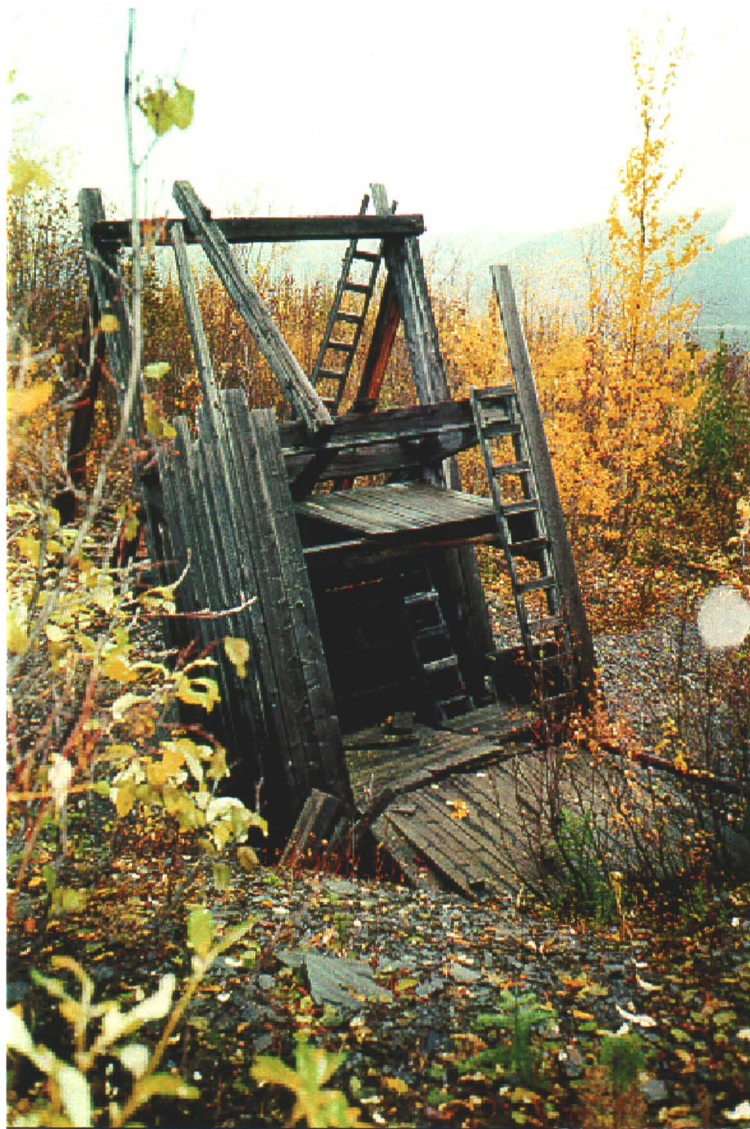
A series of ladders connects the top of the main shaft headframe to a deck located 3m below ground. The shaft is blocked by ice 4m below ground level. The shaft was excavated at an incline of 80°. Less than 20m of metal air and water lines extend from the shaft to surface.

Condition: The headframe and the retaining walls are weathered but are still in fair condition.

Accessibility: The shaft is filled with ice and is no longer accessible below 4m. The manway opening was nailed shut with available planking.

Photo 27-1: Shaft headframe (Bldg. 27-1). (Azimuth 340°)

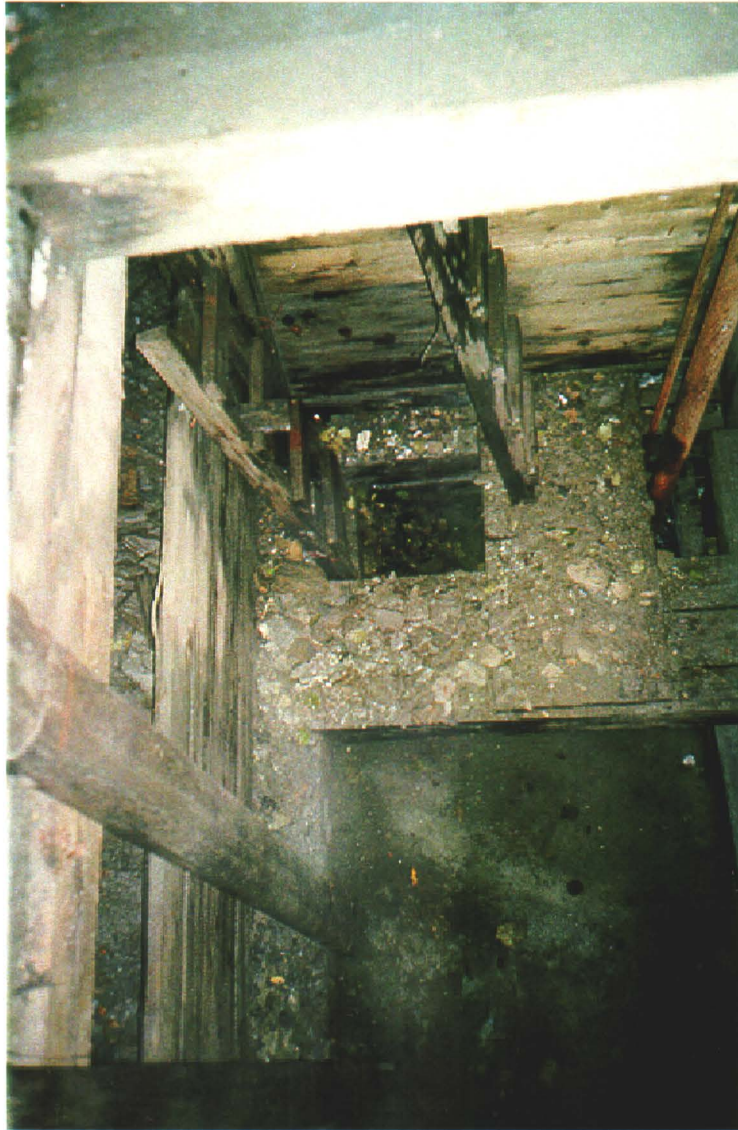
Photo 27-2: Interior of shaft A01 headframe (Bldg. 27-1).

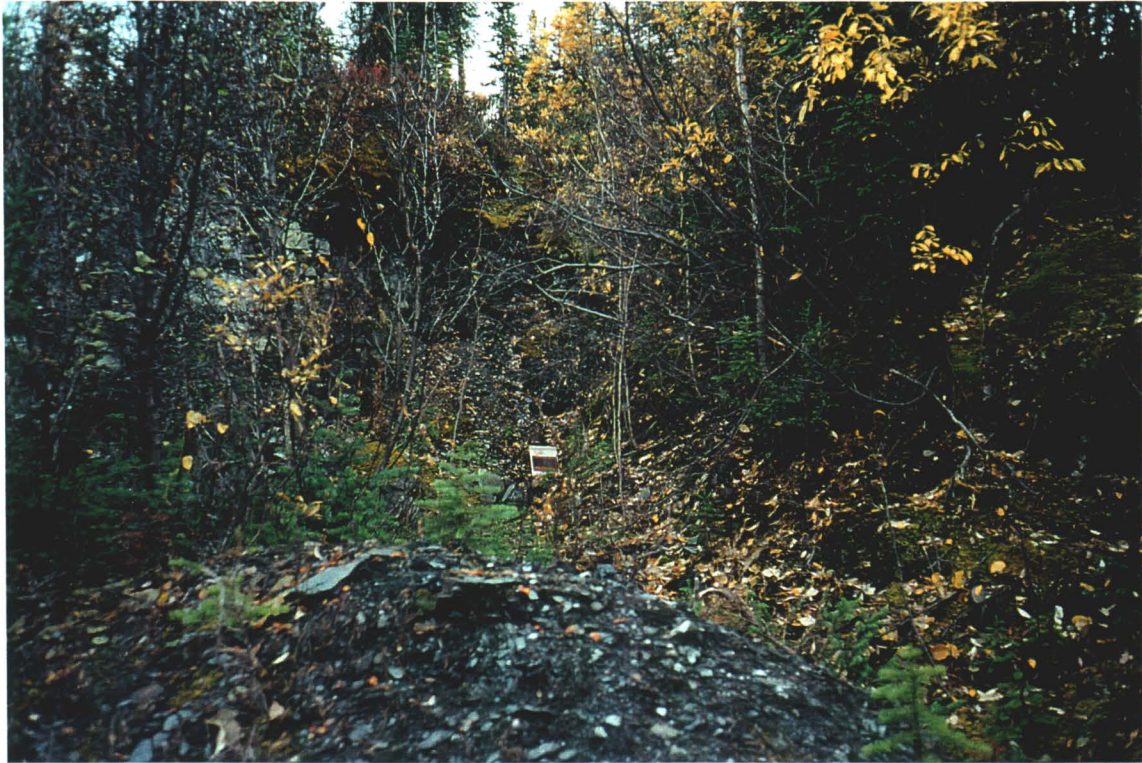
The portal to the lower adit is completely collapsed and covered by rock.

Condition: Collapsed

Accessibility: Inaccessible

Photo 27-3: Collapsed adit portal (A02). (Azimuth 220°)

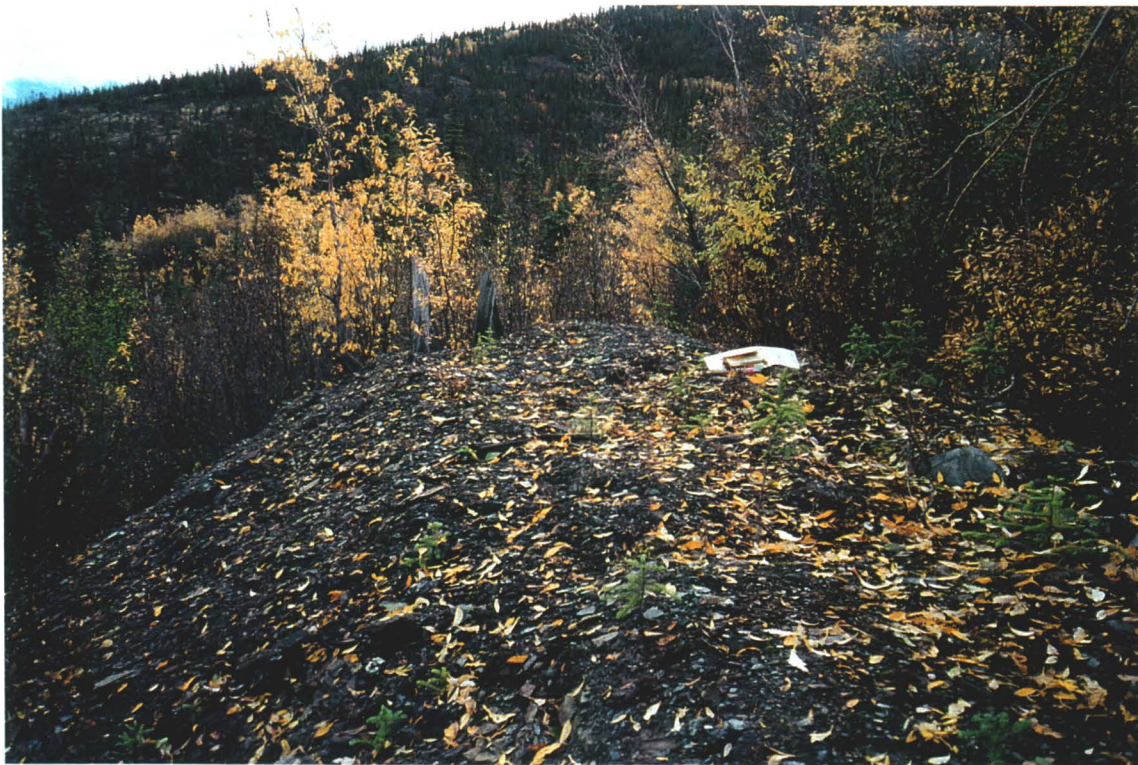
This long dump area has been broken down based on shape into three waste rock piles. These piles were formed by end dumping from rail mounted ore cars that transported rock from the underground workings. Observed content of the waste rock piles was predominantly thinly banded quartzite with graphitic phyllite interbeds. There are 0.2-2% disseminated pyrite and trace galena stringers up to 2mm wide within the quartzite and phyllite. These stringers occur parallel and perpendicular to quartz and quartz-siderite-pyrite veins up to 2cm wide. Only 2-5% of the waste rock material is the quartz-siderite-pyrite veining. The waste rock is bi-modal, ranging in size from sand to gravel. No apparent oxidation was observed.

Photo 27-4: Waste rock dump below shaft A01. (Azimuth 110°)

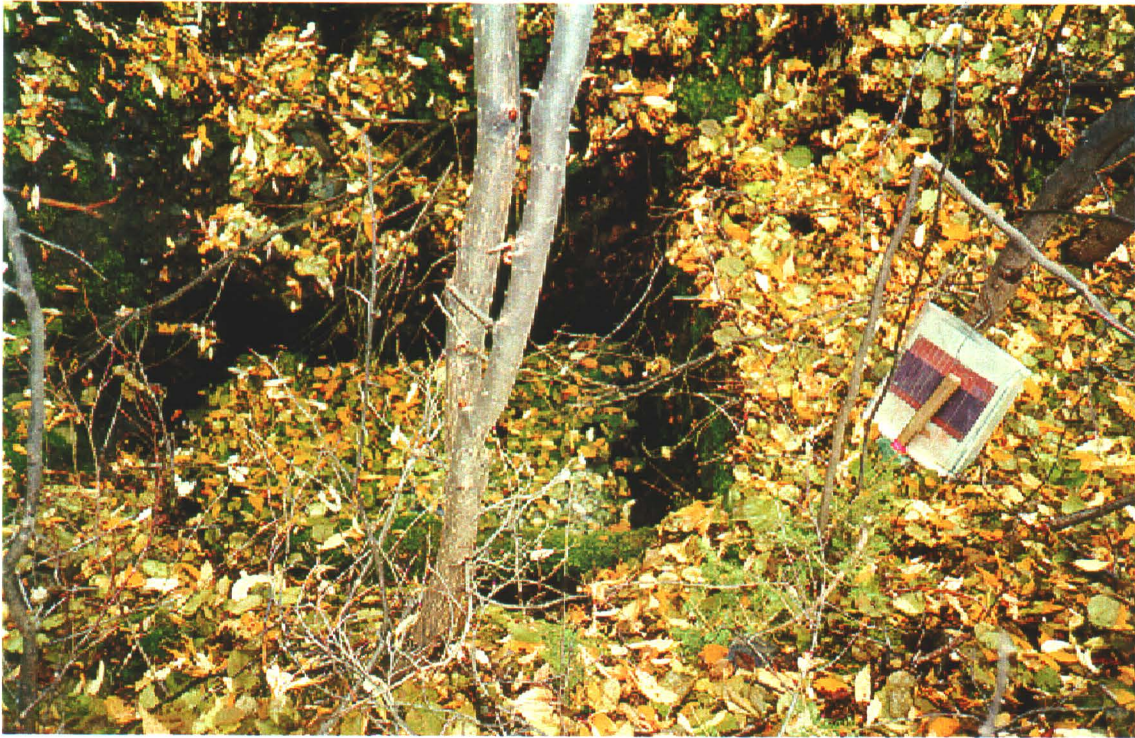
Developed probably for exploration, the upper shaft was hand-dug 3m into the overburden. The vertical shaft is filled with 2m of water.

Condition: Fair; no visible signs of collapse.

Accessibility: The shaft is filled with water and is no longer accessible. The shaft is situated in thick willows and alder with no perimeter barrier protection. Florescent, plastic flagging tape was hung around the opening to mark its location.

Photo 27-5: Upper shaft hole to left of clipboard (A03). Note leaves covering the surface of standing water.(Azimuth 070°)

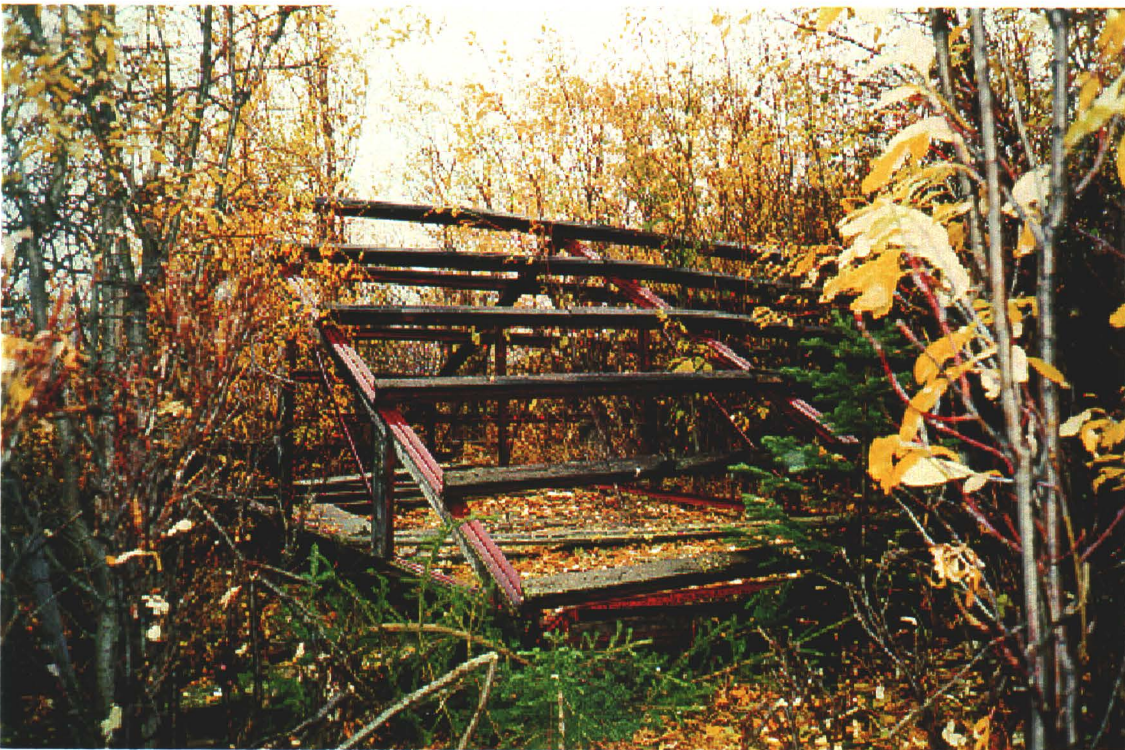
A collapsed steel building frame is located on the site. The steel and wood roof frame structure is intact, however the steel wall supports have collapsed.

Photo 27-6: Collapsed steel building frame (Bldg. 27-2). (Azimuth 120°)

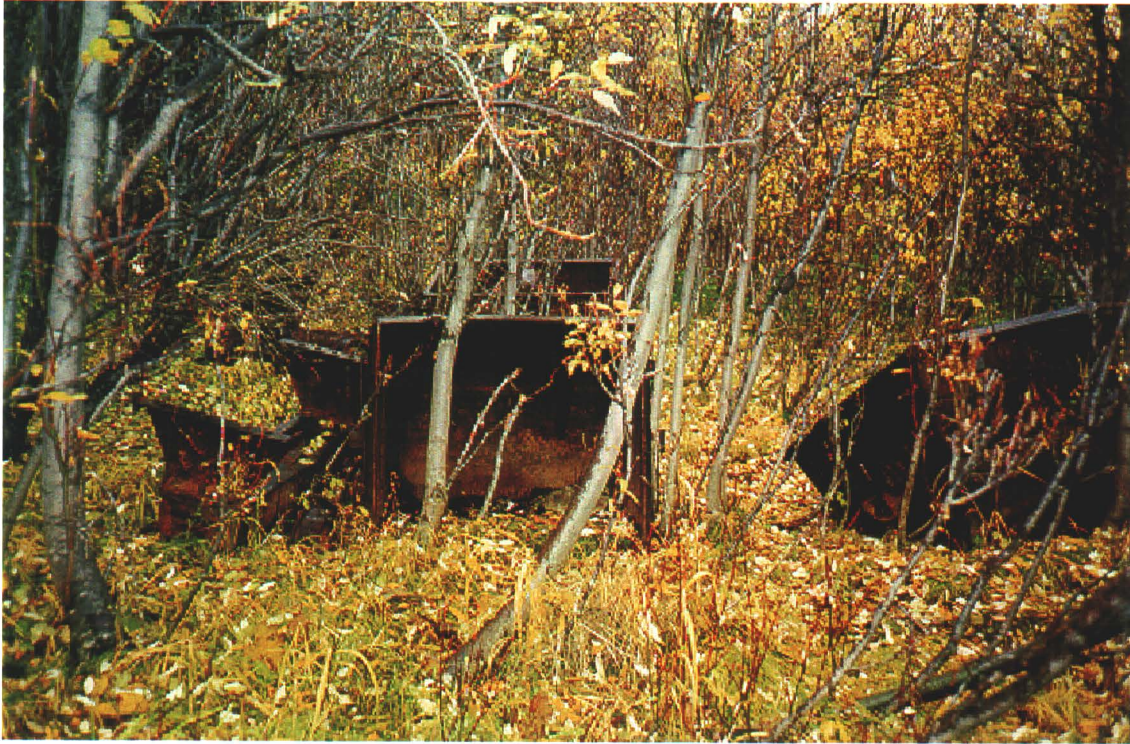
Waste material found on the site is comprised of old abandoned metal mine equipment.

General composition: 3 ore cars, some old fuel drums and some scrap metal.

Photo 27-7: Abandoned ore cars. (Azimuth 240°)
