SHAMROCK (Original Shamrock) (#28)
(MINFILE# 105M 001ah)

Public Works And Government Services Canada	Travaux publics et Services gouvernementaux Canada	designed by:	date:
		conçu par:	
Architecture & Engineering Services Western Region		drawn by:	C.S.
Drawing title: Shamrock Site #28 Site Assessment Yukon Territory		designe par:	NOV 1999
		approved by:	
		approuve par:	
		revisions:	
		project no. no. du projet:	dwg. no. dessin no.
		125-12.01	1 of 1

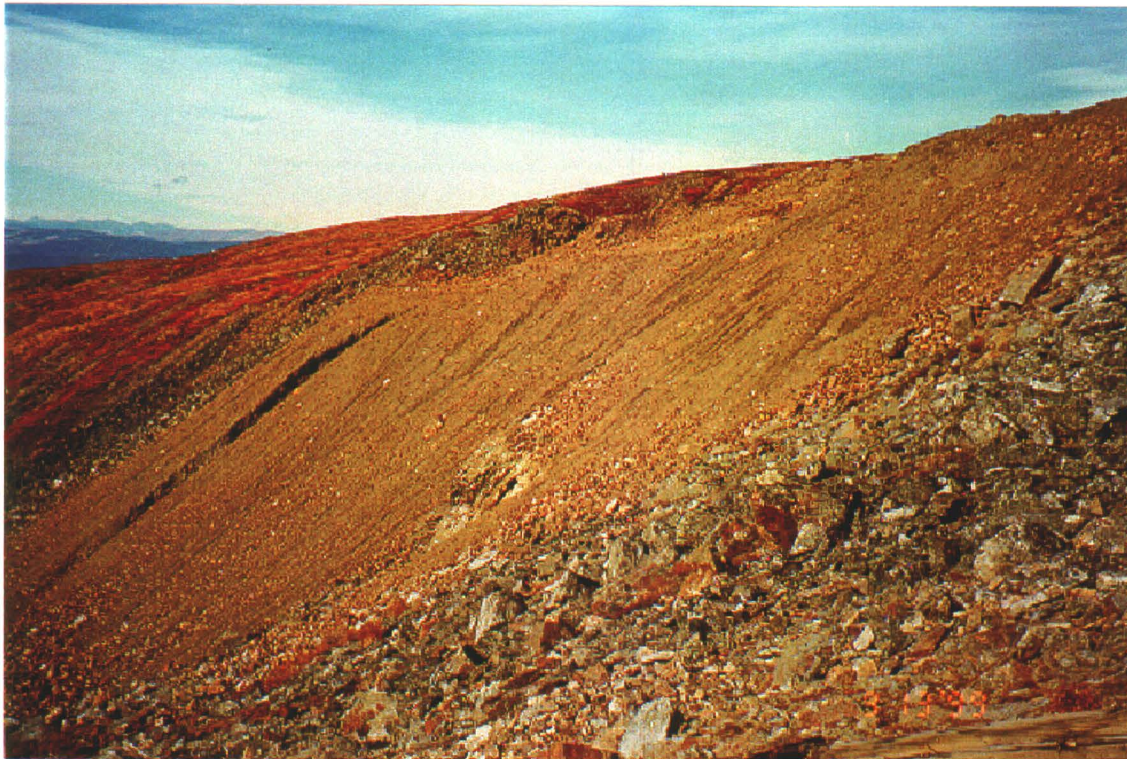
Open Pit – Original Shamrock (photo 28-1)

An open cut with waste dumped at the lower, southwest end. The pit recovered an ore pillar around the shaft.

Condition: Very steep pit walls appear to be stable.

Waste rock pile - ORIGINAL SHAMROCK (photo 28-1)

Overburden and waste rock were pushed downslope from the open cut. The pit drains through the dump, and deep troughs are present on the dump slope. No significant vegetation was noted. The dump toe rests on an underground waste dump at the 200 level.

Location: See site location map. Pit dump has a slope of 38 degrees.

Photo 28-1: Waste rock below open cut at upper end of site. Note deep erosion path.

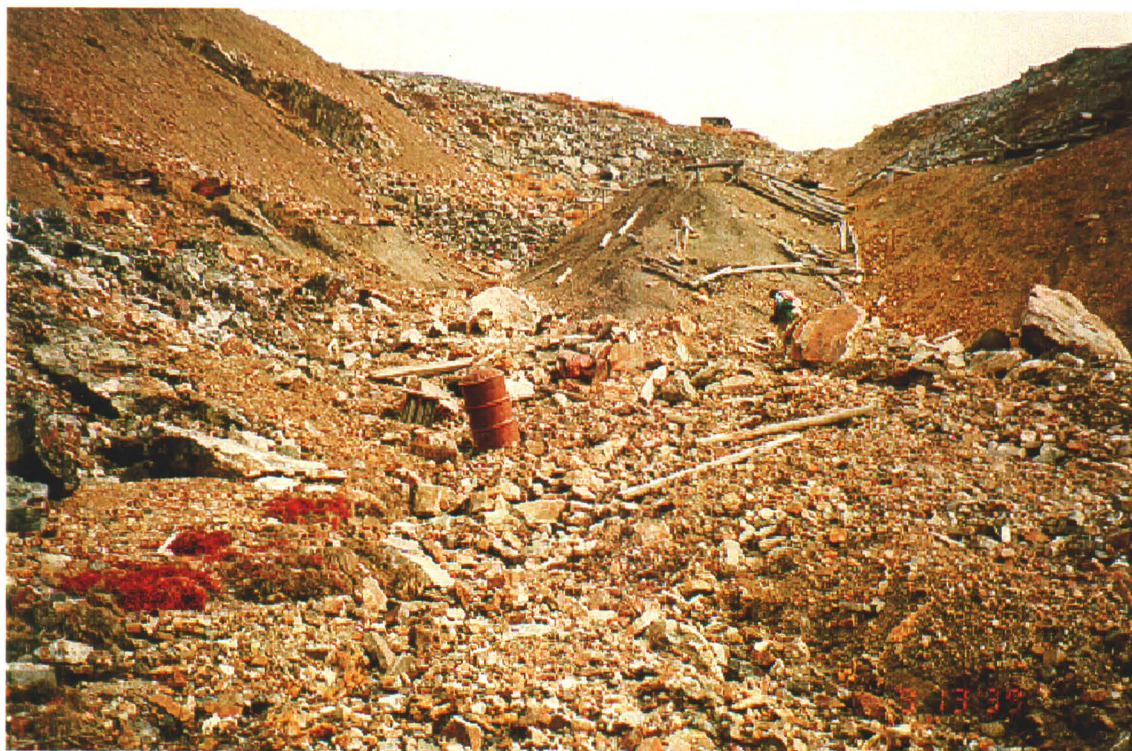
Waste rock pile - #200 level portal (photo 28-2)

Fine-grained underground muck extends along both sides of the gully at the portal elevation. The western dump is mostly covered by open pit waste, and appears to be mostly unmineralized waste rock. The eastern end of the eastern dump is well mineralized material. The waste that would have originally been in front of the portal has been removed by bulldozer and/or flash flood. The site is in a gully that was dry when visited, but bear evidence of considerable flow in the past. Mining debris is widespread below the site. Although some material is well-mineralized, only traces of sulphide were noted. An acidic pH was noted, however the sulphur levels are very low for all samples.

Photo 28-2: Ravine below adit and associated waste rock piles.

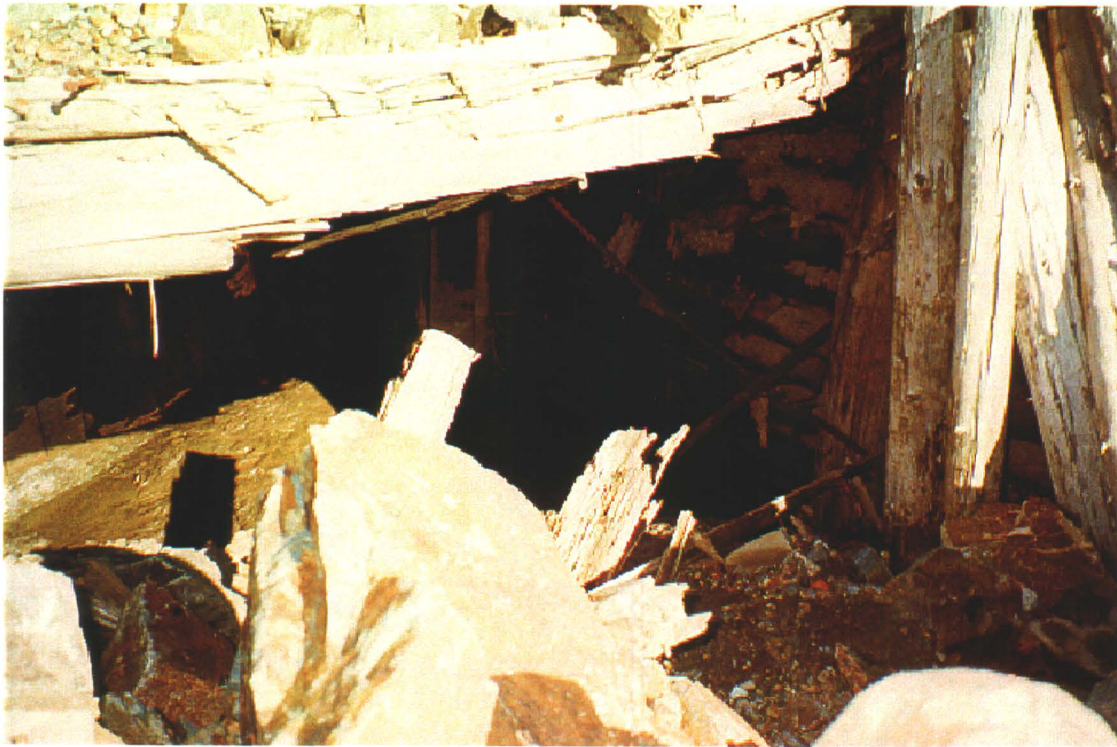
200 Level Portal (photo 28-3)

Partially collapsed timbered portal. Underground waste dumps with rails are present on both sides of the adit. The adit is located in a gully, and waste from the open pit above has partially covered the adit site. Constructed in 1953.

Condition: Partially collapsed, mostly blocked by open pit waste and debris

Accessibility: Access is possible but difficult, risk of collapse is evident.

Photo 28-3: Partially open adit entrance.

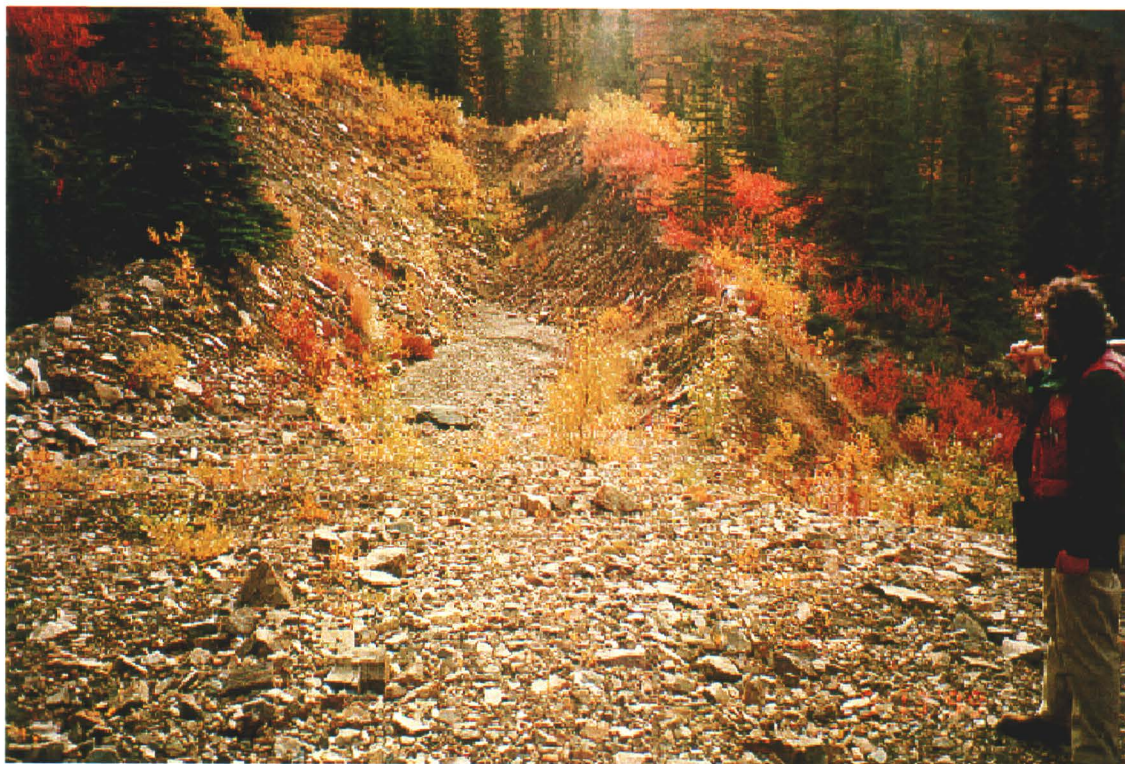
Six Trenches Southwest of Mine (photo 28-4)

Trenches cut across the mineralized structure that hosts the Original Shamrock mine to the northeast. Very little true outcrop is exposed, however subcrop indicates very strongly oxidized, rusty quartzite with minor schist. Veining and mineralization are weak. Manganese oxides are common. The trenches appear to be from the 1980's.

Condition: The trench sides are steep, with little revegetation. The adjacent, undisturbed gully area is similarly steep, with little vegetation.

Photo 28-4: Small test pit at lower end of site.

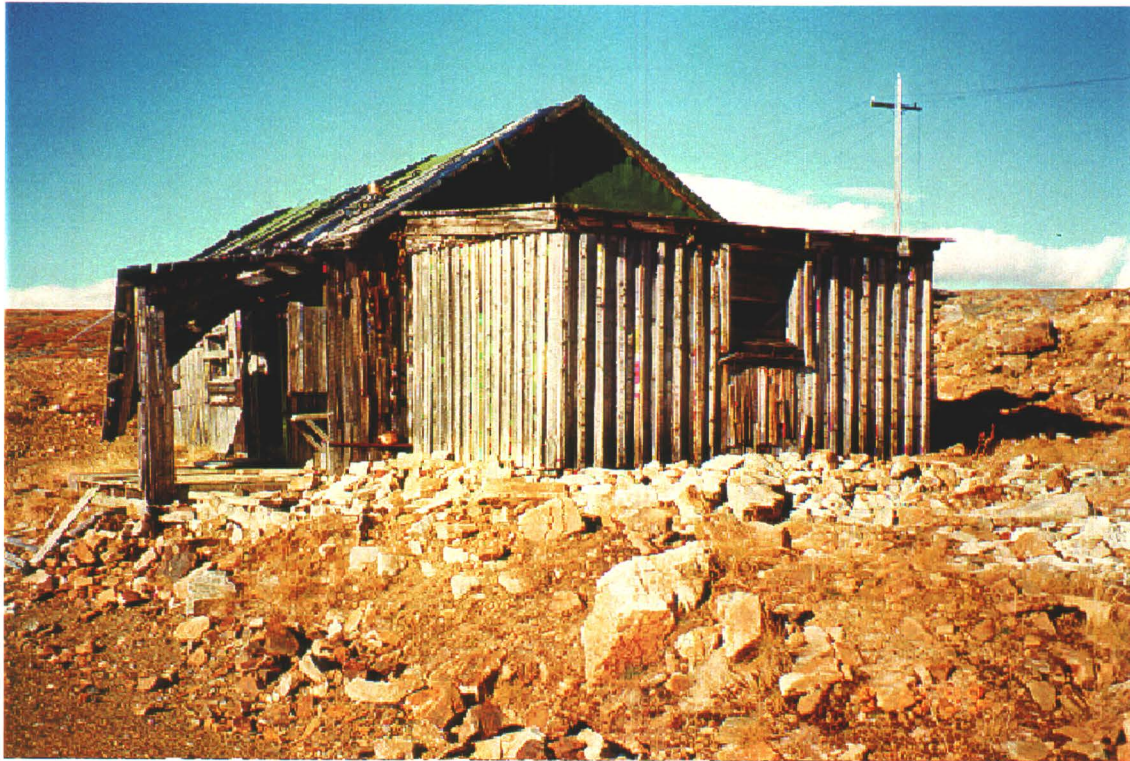
Building 28A – Main Site Building (photo 28-5)

Building appeared to have formerly served as both living quarters and office space for site workers. An addition to the rear of the facility was probably used for storage space.

Two small petroleum hydrocarbon-based stains were noted to the east of the building, both with dimensions of 1 m² or less. A two-inch diameter pipe was noted extending from the building, however its former usage could not be determined. No staining was noted at the pipe end.

Photo 28-5: Main site living quarters (building 28A).

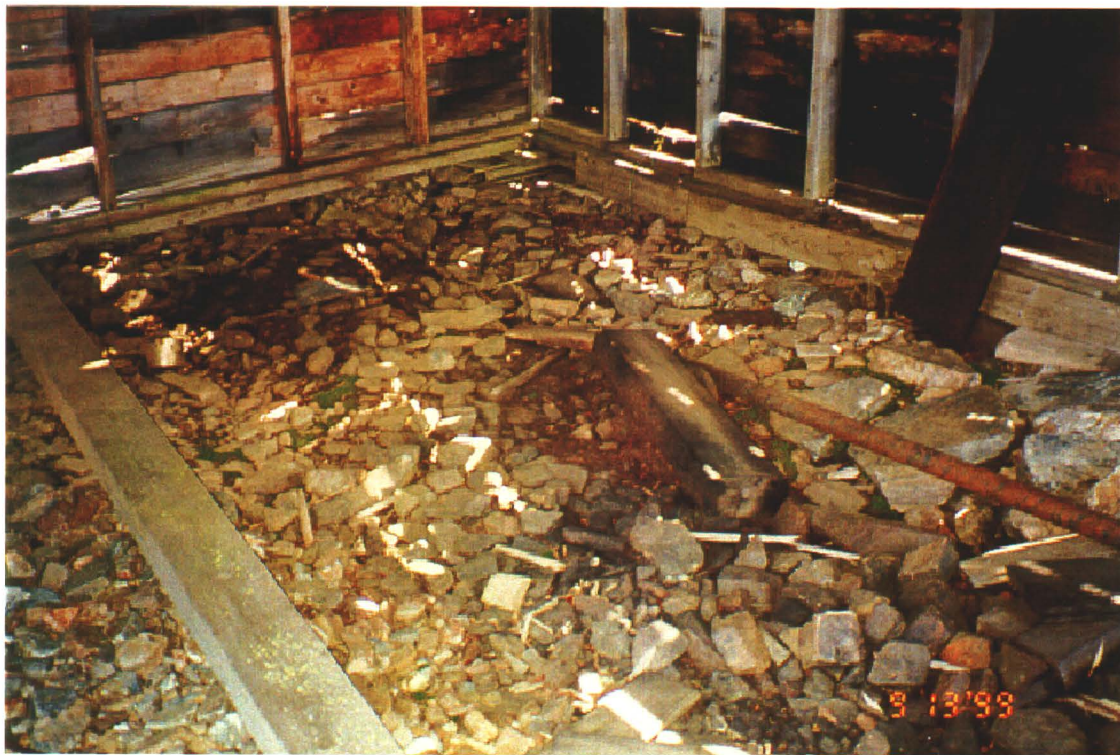
Building 28B – Generator Shed (photo 28-6)

Shed consisted only of a wood frame structure directly on grade. A strong petroleum hydrocarbon odour was present in the building.

Soils within the former generator building were stained and strong odours were present in the building. Stained areas, approximately 4 m² in total, did not extend out of the building. Soils under the building are very thin or nonexistent with much of the building situated directly on cobble/rock or bedrock. Due to the substrate, excavation was not possible.

Photo 28-6: Interior of generator shed (building 28B). Note staining on rock.

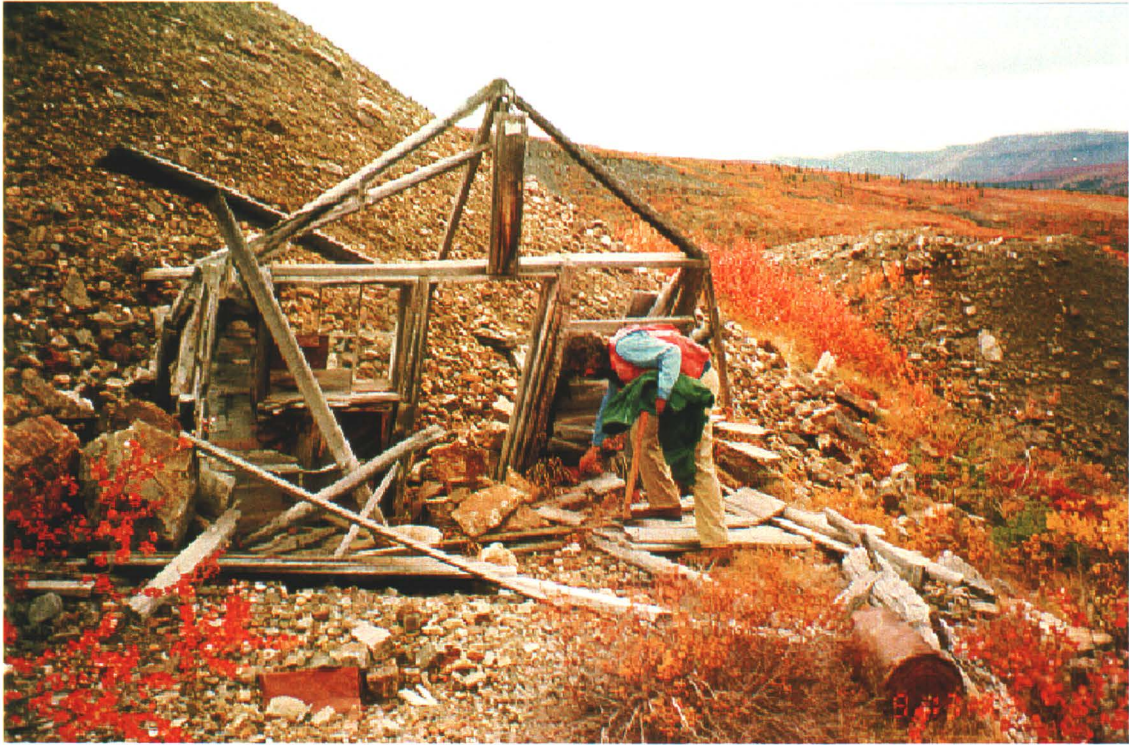
Building 28D – Collapsed Shack (photo 28-7)

The shack was formerly used as temporary living quarters (probably summer only). The building has completely collapsed.

Photo 28-7: Remains of collapsed shed (building 28D) at old shaft.

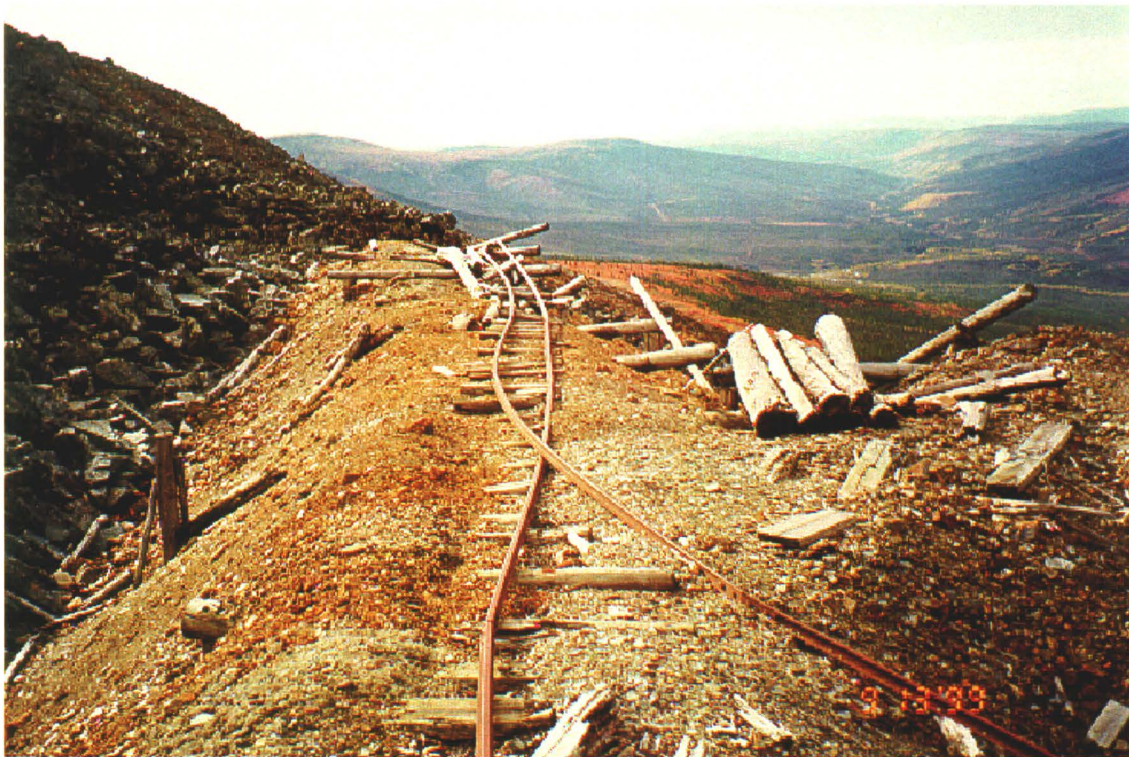
6.3 Rail and Trestle (photo 28-8)

Fabrication: Steel rails, about 20 m long. Some wooden trestle remnants. Large volume of timber and steel trash in area.

Condition: No significant hazard.

Photo 28-8: Rail and trestle at main adit.

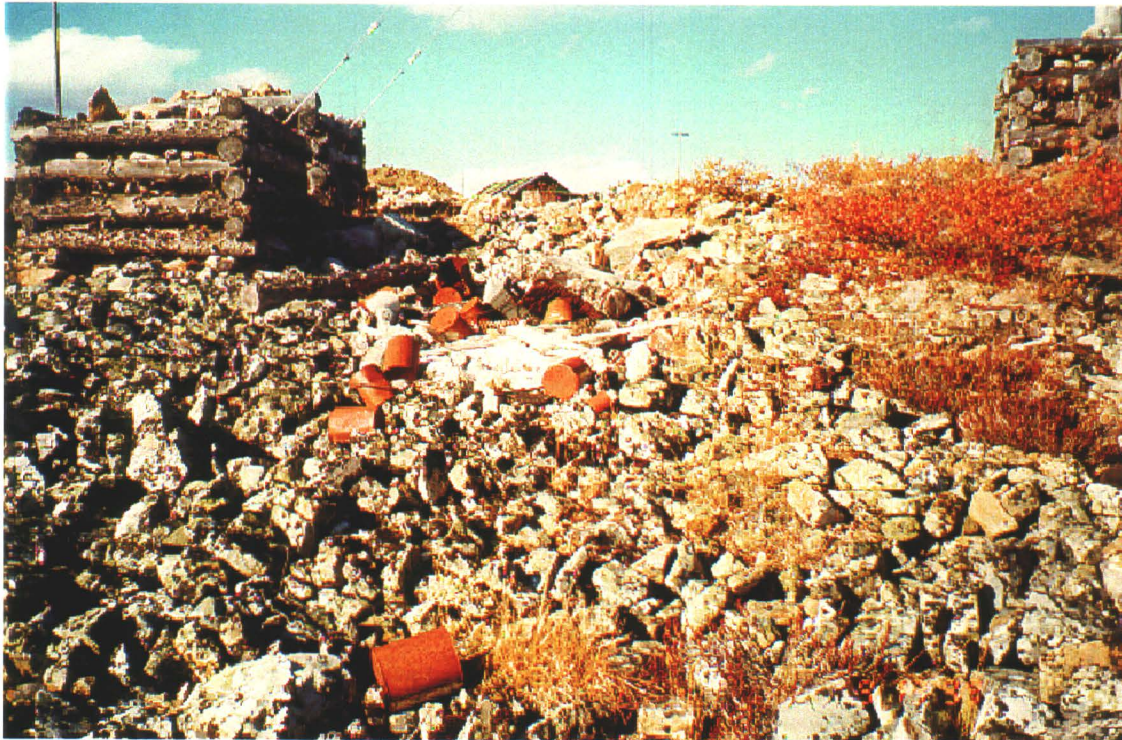
Location & access: approximately 50 m east of main building, near collapsed building and generator building and adjacent to power pole (photo 28-9).

General composition: Approximately 11 newer paint cans, 6 used oil filters, wire, 1 lead-acid battery; evidence of burning.

Photo 28-9: Small solid waste dump adjacent to generator shed.
