HIGHLANDER (#29)
(MINFILE # 105M 001ai)

Public Works And Government Services Canada Travaux publics et Services gouvernementaux Canada Architectural & Engineering Services Western Region	designed by: conçu par: drawn by: dessiné par:	C.S. Nov. / 99	date:
	approved by: approuvé par: revisions:	project no. no. du projet:	desig. no. dessin no.:
Drawing title:		Titre du dessin:	
Highlander Site #29 Site Assessment Yukon Territory			
		125-12.01	1 of 1

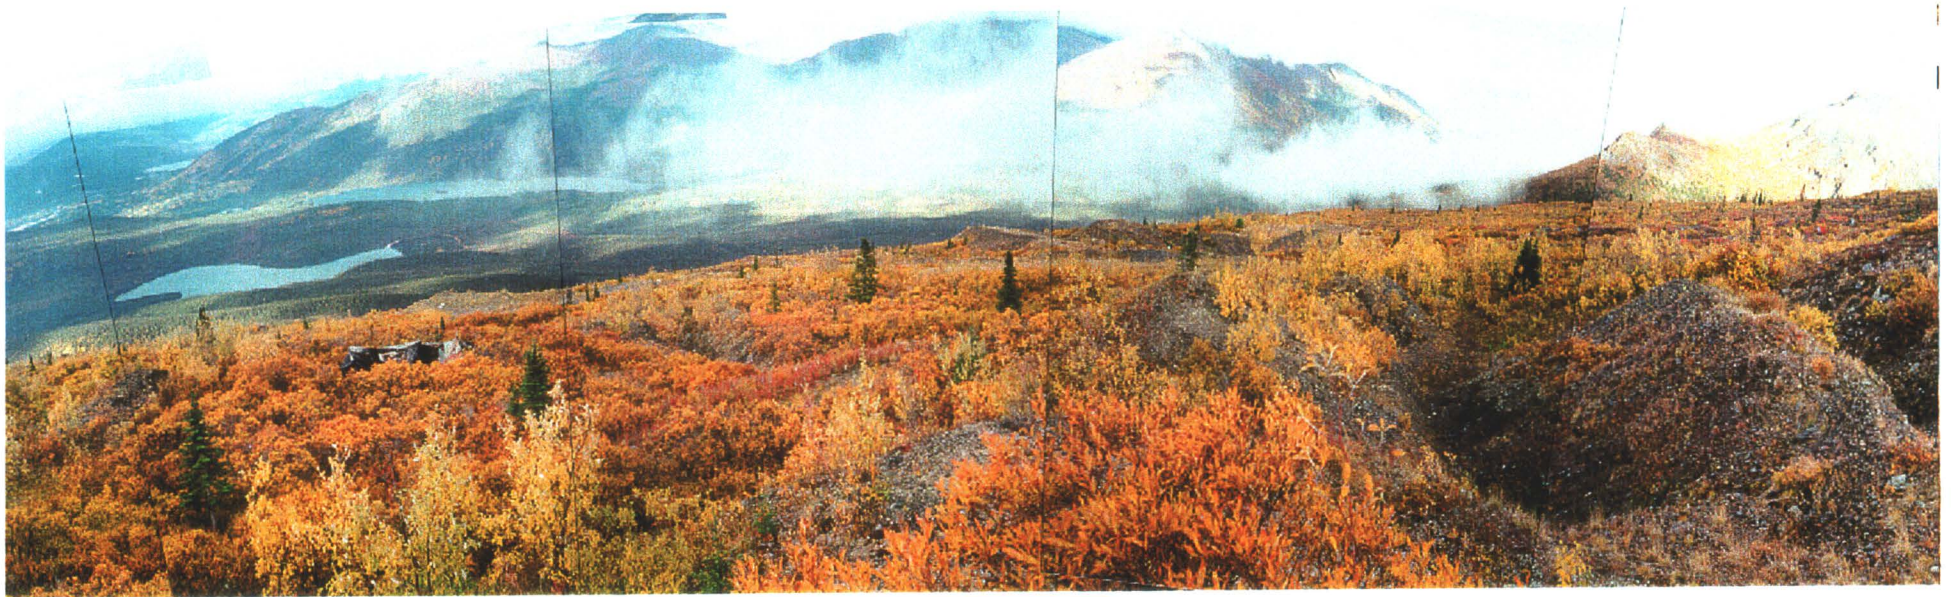
Photo 29-1: Panorama of upper Highlander area showing both older hand/excavator trenches and more recent cat trenches.

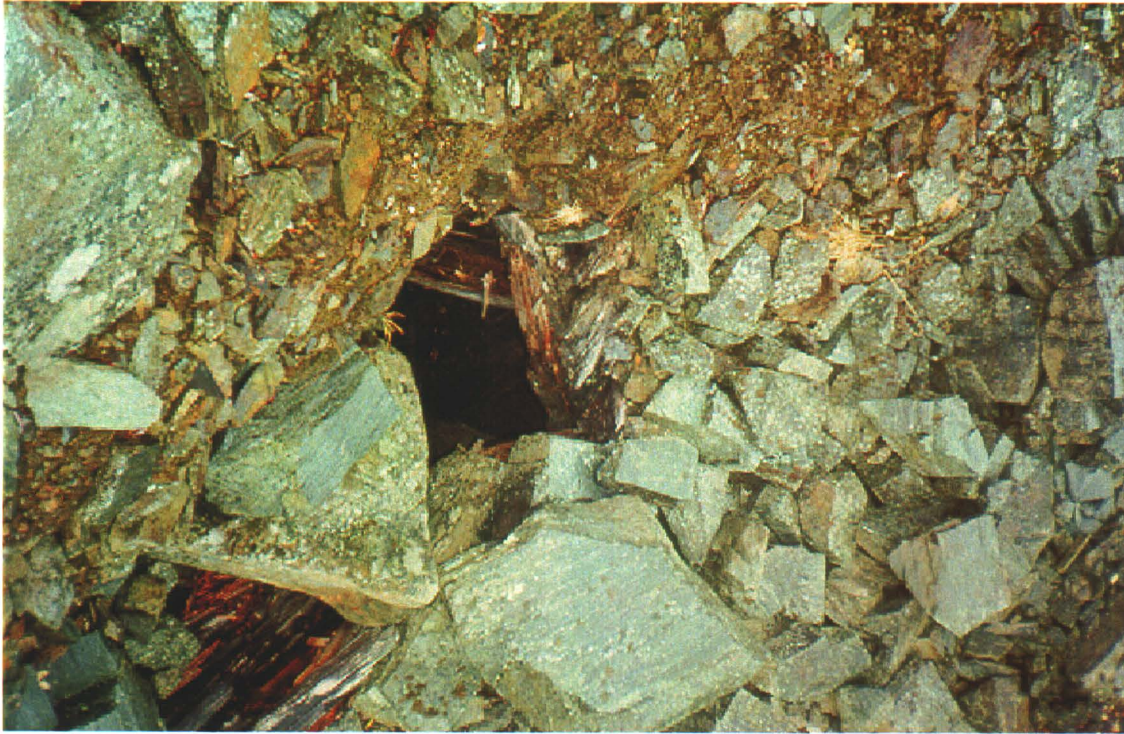
Upper Adits (photos 29-2,3)

Condition: Adits are collapsed.

Accessibility: Northernmost adit is partially blocked but still accessible. Other adits are blocked with waste rock

Photo 29-2: Northern partly collapsed adit, upper workings.

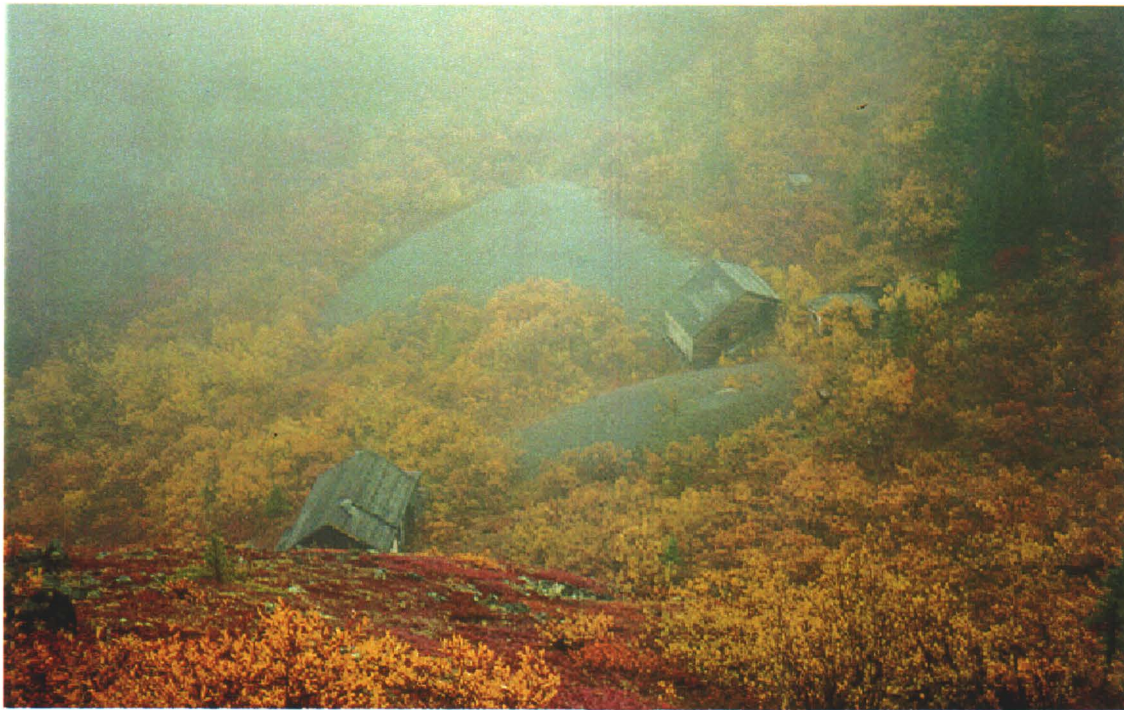
Photo 29-3: Lower workings waste rock piles, bunkhouse and ore processing building viewed to northeast of upper workings.

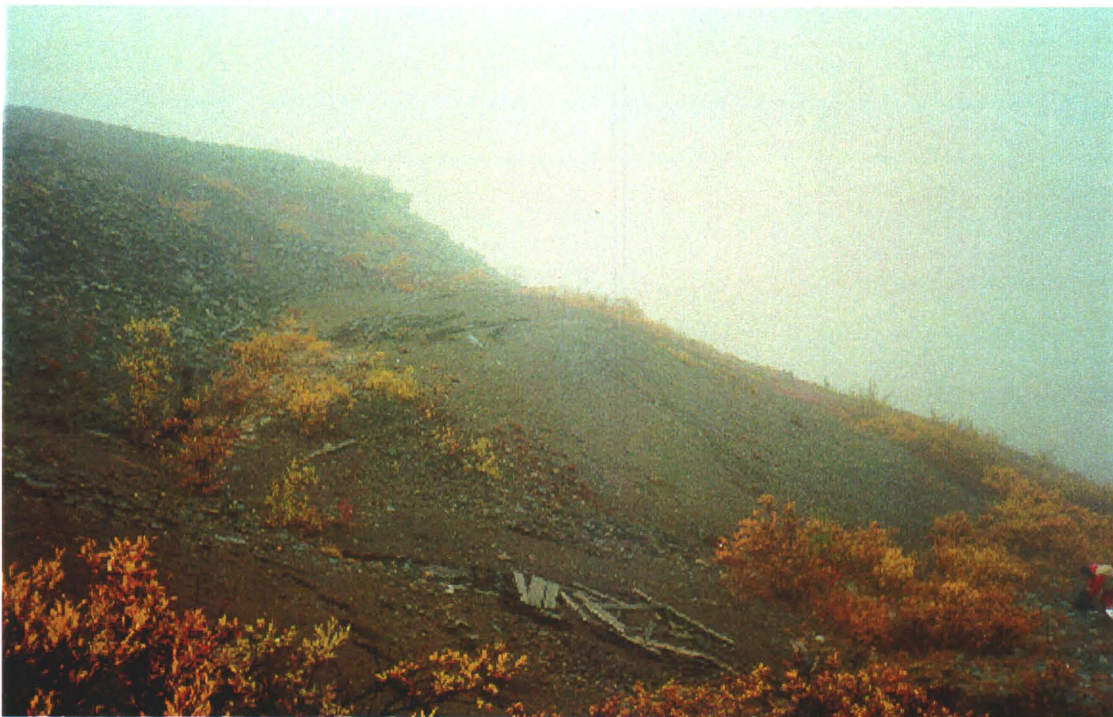
There is less than 5,000 tonnes in the upper waste rock pile. The rock is unsorted and the slopes appear to be stable.

Stability: There is no evidence of the waste rock pile slumping. The waste rock pile appears stable.

Photo 29-4: Upper workings waste rock piles.

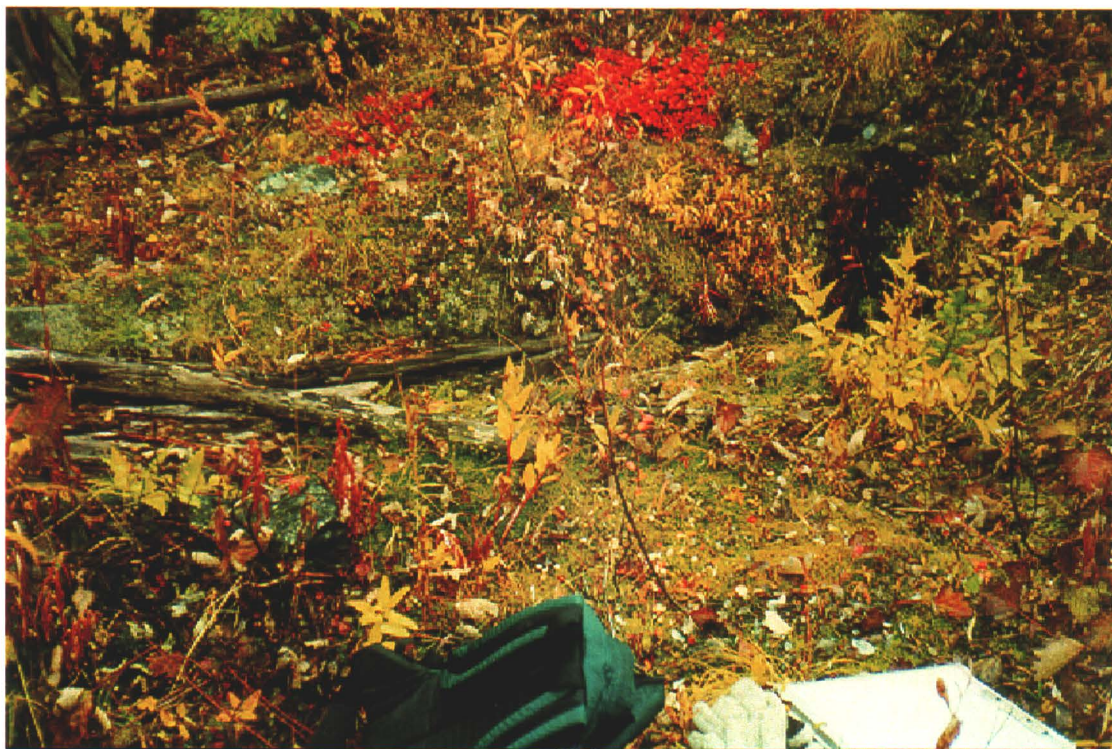
Condition: Adit is collapsed.

Accessibility: Adit is securely sealed.

Mine water flows from the lower workings adit for a distance of 10m to Gambler Gulch. No discoloration or precipitated oxides were observed in the mine water or discharge stream channel.

Photo 29-5: Collapsed adit, lower workings."

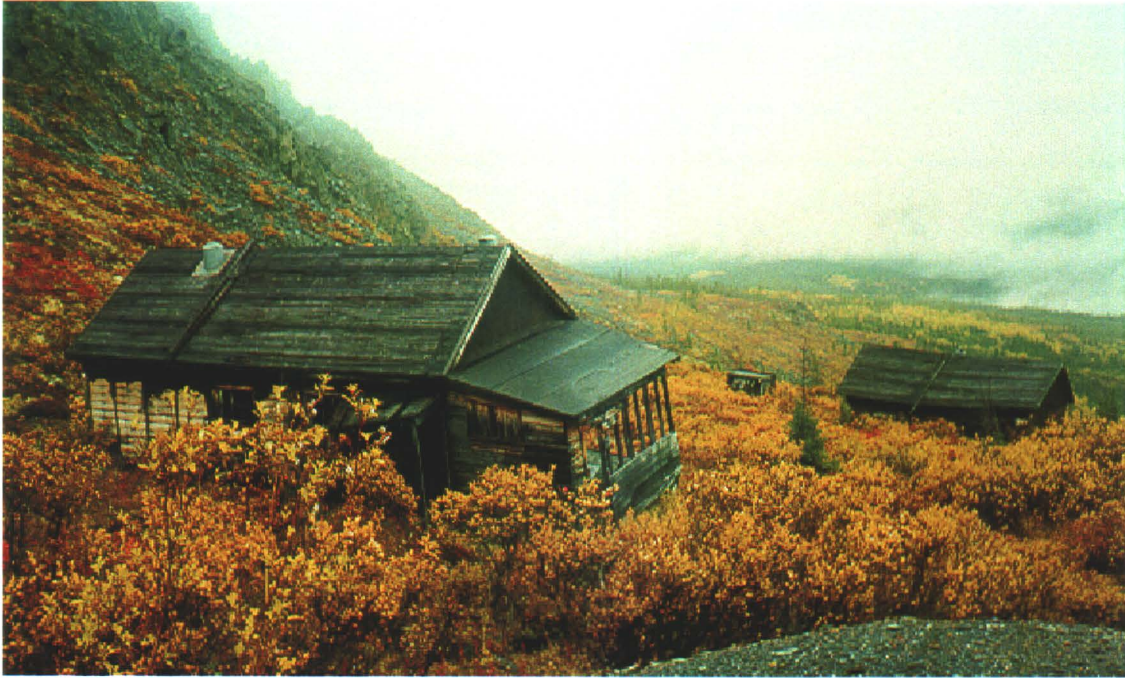
Construction: wood frame and clapboard, 2"x 6" floor, roof, and ceiling joists. partially collapsed porches

Construction: wood frame and clapboard, 2"x 6" floor, roof, and ceiling joists; partially collapsed porches

Photo 29-6: Bunkhouse and cabin, looking northwest.

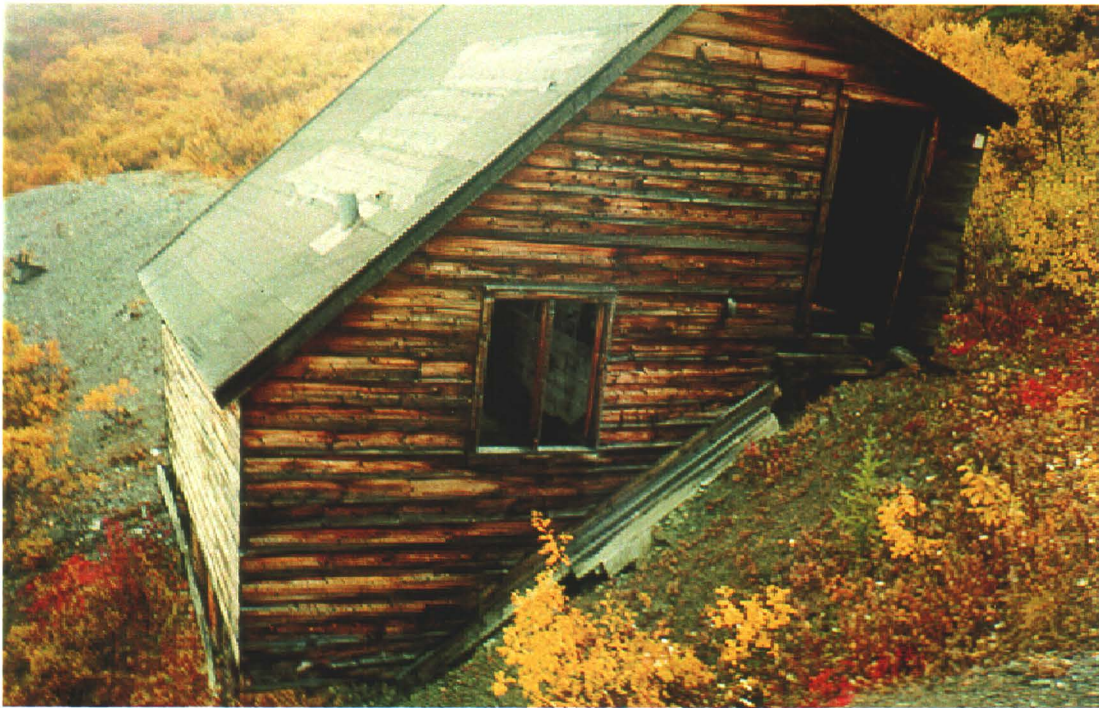
Construction: three level wood frame, wood siding, and wood roof

Photo 29-7: Ore processing building.

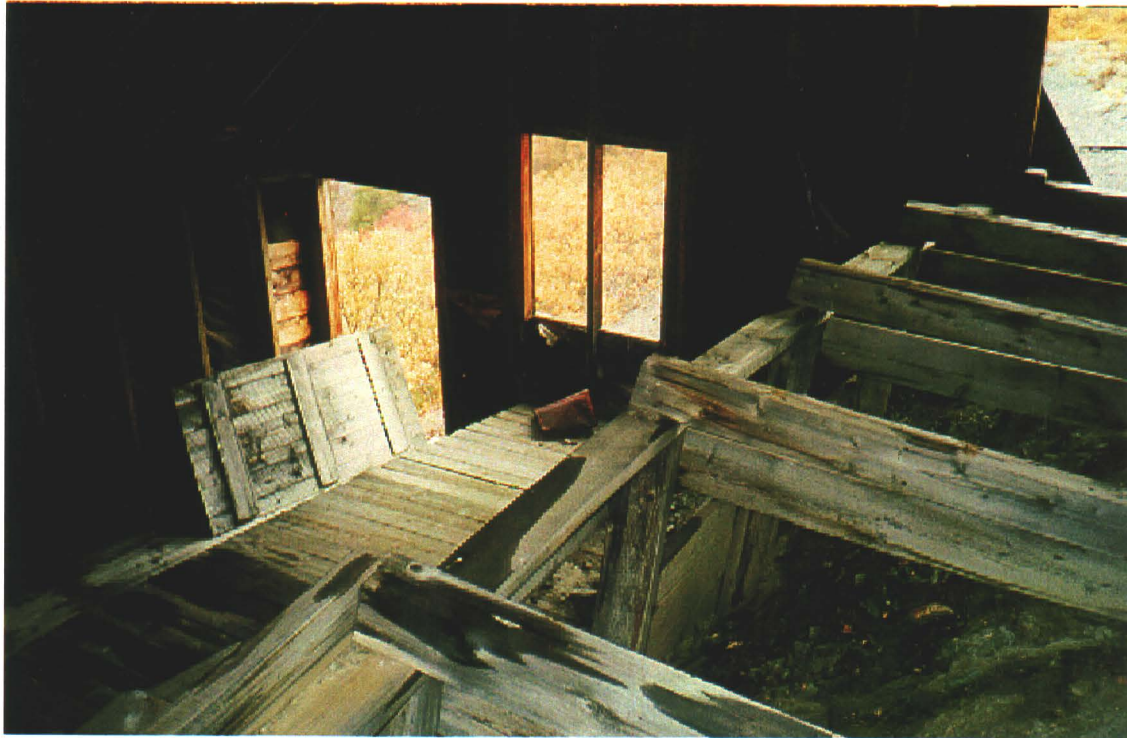
Photo 29-9: Interior of ore processing building.
