STONE
SITE# 31
MINFILE# 105M001ak

Public Works and Government Services Canada	Travaux publics et Services gouvernementaux Canada	designed by: _____	date: _____
	Architecture & Engineering Services Western Region		drawn by: C.S.	Nov. / 99
Drawing title: Stone Site Site #31 Site Assessment Yukon Territory			approved by: _____	revisions: _____
project no. / no. du projet: 125-12.01		dep. no. / dessin no.: 1 of 1

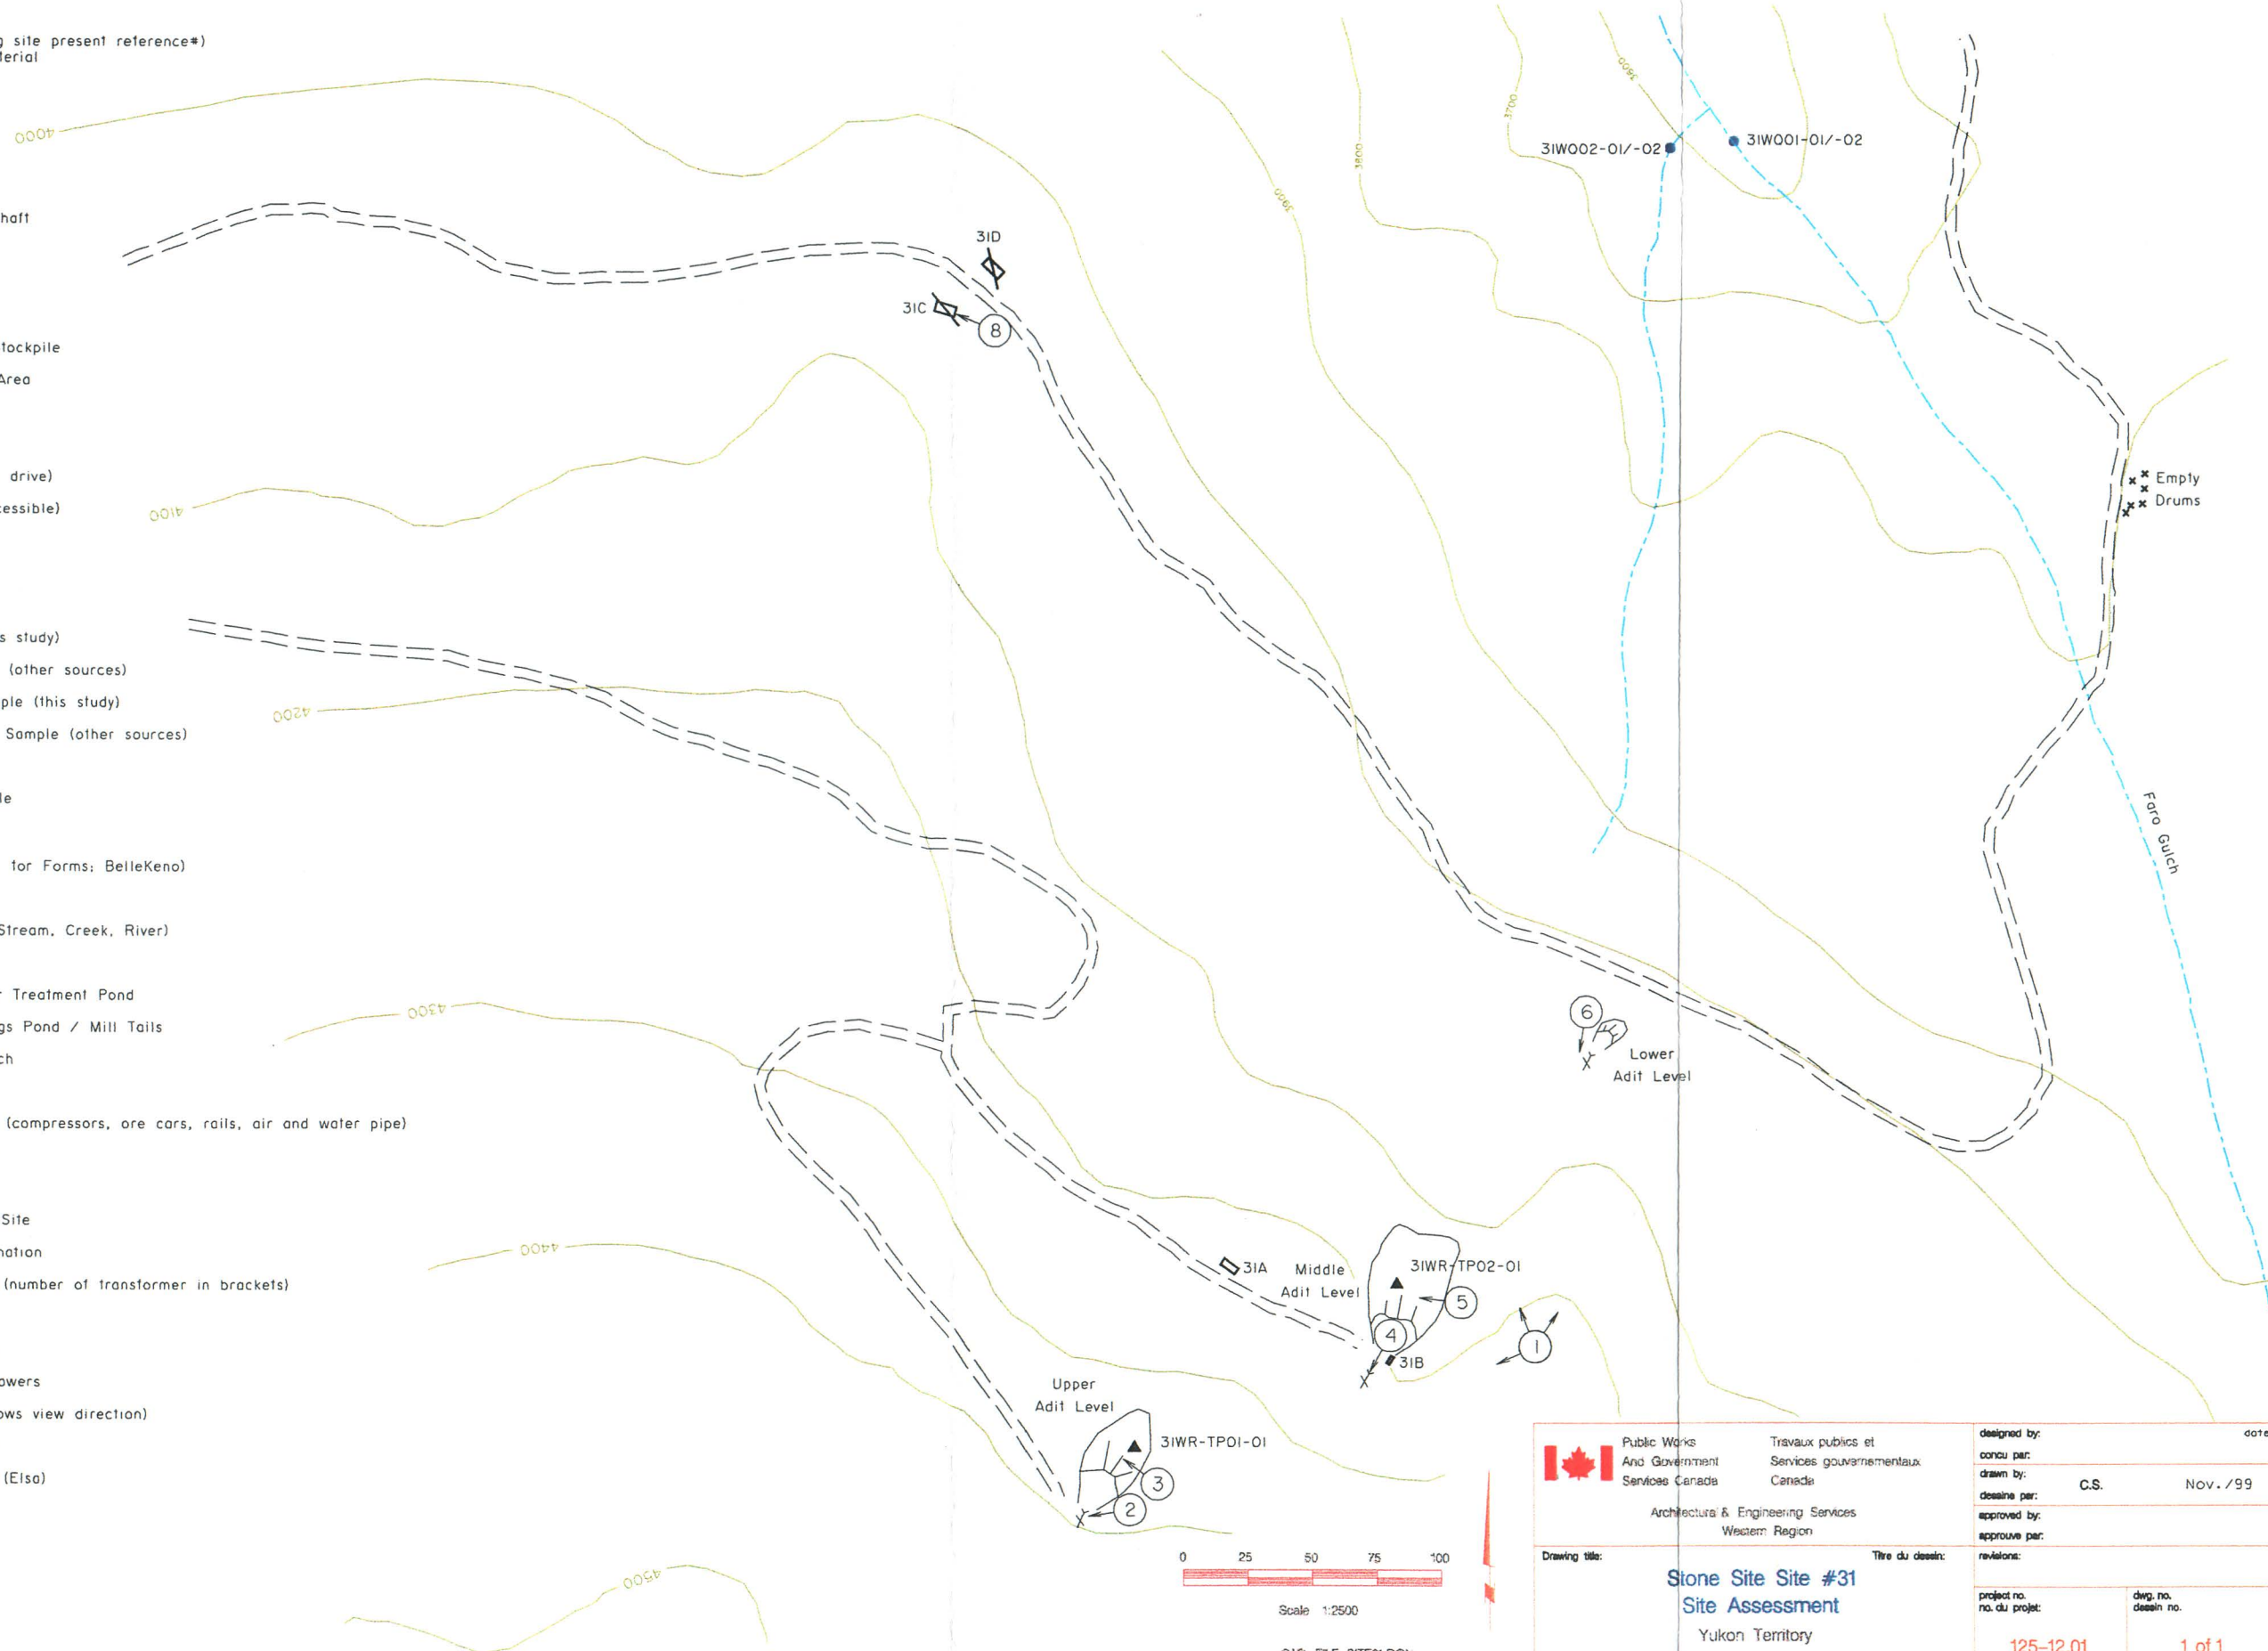
There are three adits on the property and all three were inspected during the site visit. The airphoto indicates possible activity below the road, but this was not investigated. Waste rock piles are located outside the three adits. Site details can be found in Figure 1; site photos are in Attachment 1.

There are four buildings associated with the property. A small volume of rail was encountered near the middle adit. Site details are located on Figure 1: site photos can be found in Attachment 1.

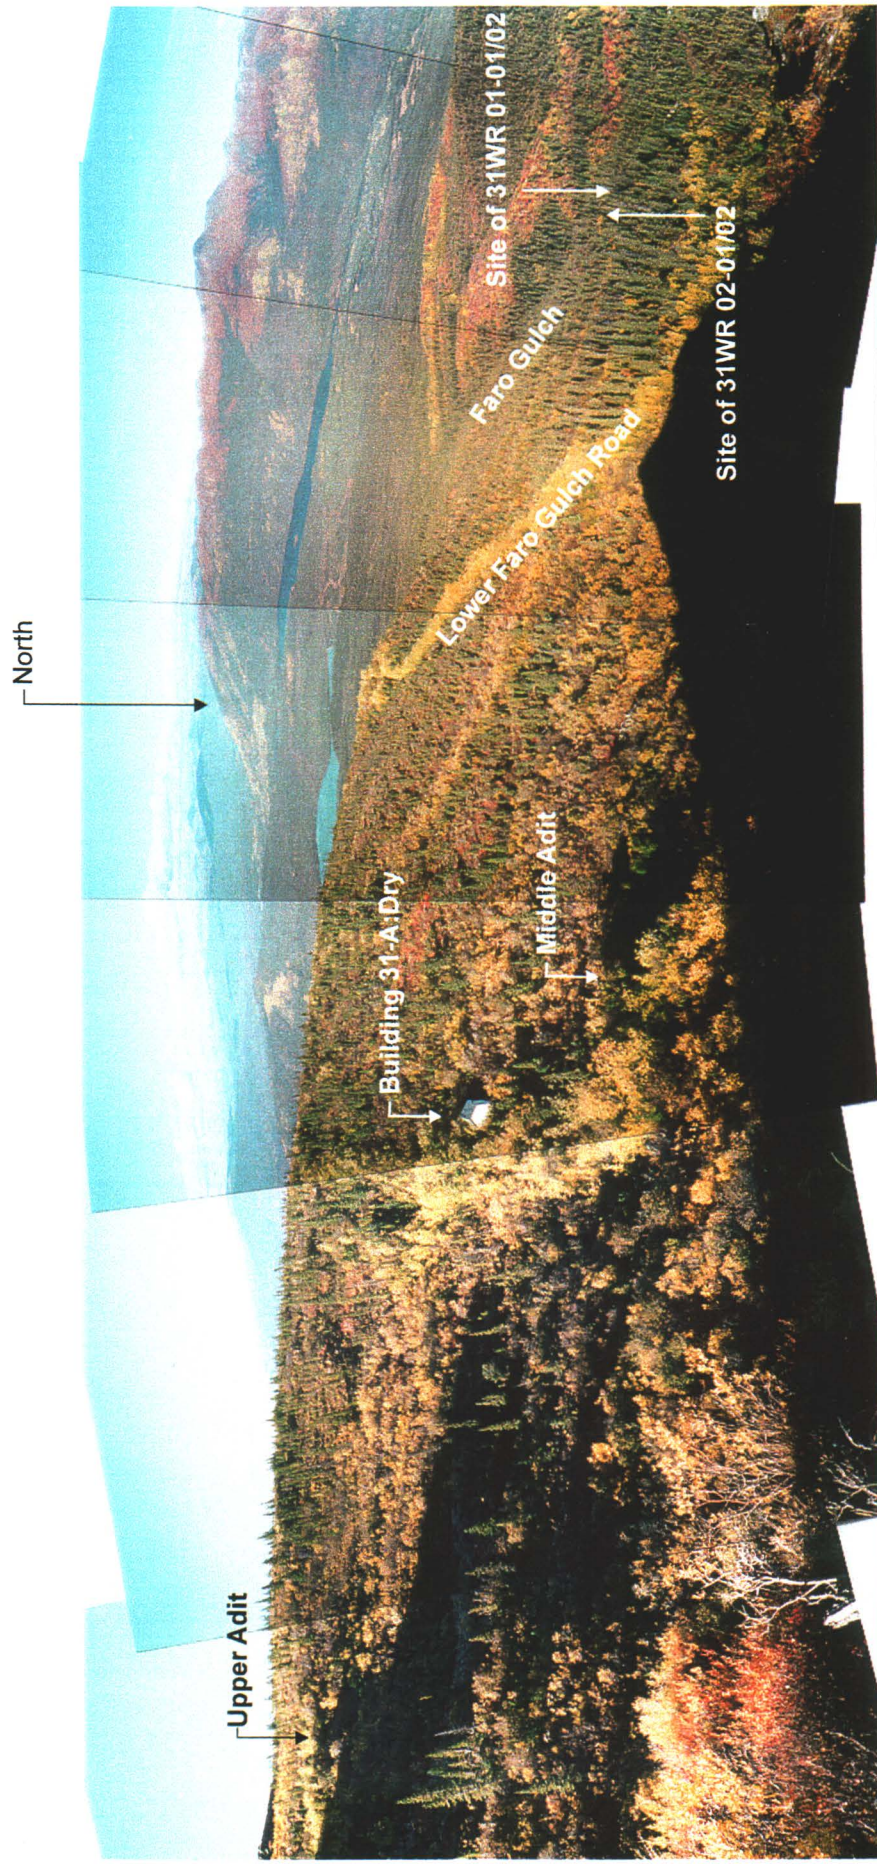
The Stone site is located on a moderately steep north-facing slope on Keno Hill, and is likely underlain by permafrost. The site and surrounding area is thickly vegetated with willows, alders, and spruce trees as well as shrubs. The ground is covered with a blanket of moss and decaying leaves. Surface runoff from the mine site flows northward via a small tributary of Faro Gulch, eventually joining the Keno Ladue River 3.1km to the north. The tributary of Faro Gulch starts 65m downslope of the lower adit and flows northward 300m before joining Faro Gulch. Site photos are located in Attachment 1.

Photo 31-1: Panorama of Stone site.

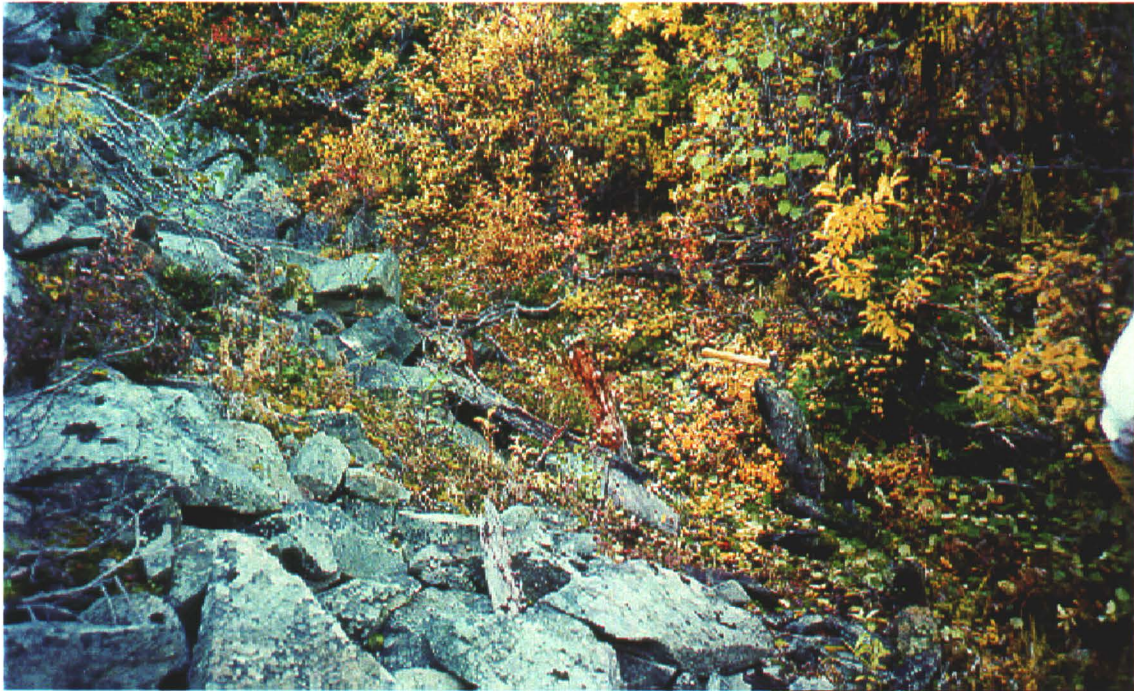
All that remains of the upper adit portal is some collapsed rocks and broken timbers at the bottom of a talus slope.

Condition: The portal has collapsed.

Accessibility: The adit cannot be accessed.

Photo 31-2: Collapsed upper adit portal. Note hammer in old portal timbers.
Photo Direction (Azimuth 230^o)

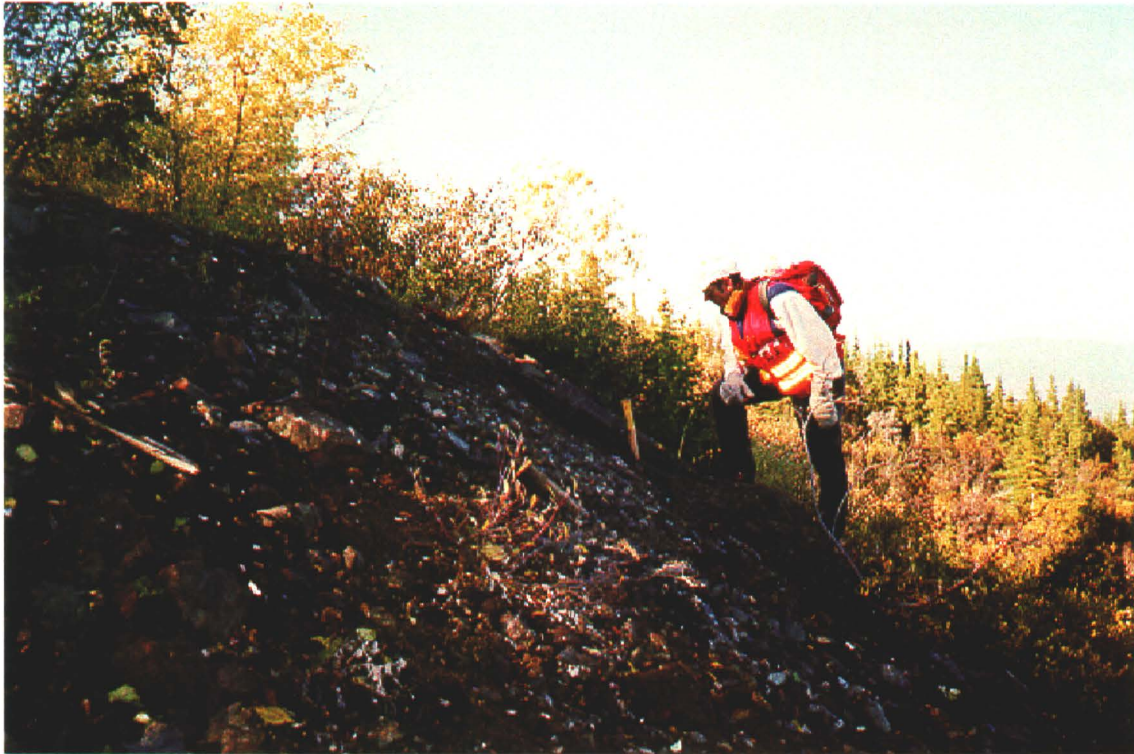
The waste rock pile appears to have formed by end dumping from the upper adit opening. A 50cm test pit was excavated from the east side of the waste rock pile. The waste rock is bi-modal with 50% fines, 35% 2mm to 2cm and 15% 2cm to 30cm. Four distinct layers based on colour and oxidation were identified. The surface layer (0-3cm) is moderately oxidized green-brown phyllite and greenstone with 3-8% siderite-sphalerite vein.

The next layer (3-5cm) is a yellow-green oxidized layer. From 5-15cm, there is a green-brown oxidized layer. Below this (15-50cm), is a green-yellow unoxidized material with 27-30cm of dark gray graphitic shear material. There was no surface water or seeps flowing through the rock pile.

Sampling: Sample 31WR01-01 was collected from the test pit and analyzed. The field paste pH was 8.5 and the conductivity was 40uS/cm.

Photo 31-3: Upper adit level waste rock dump.
Photo Direction (Azimuth 300^o)

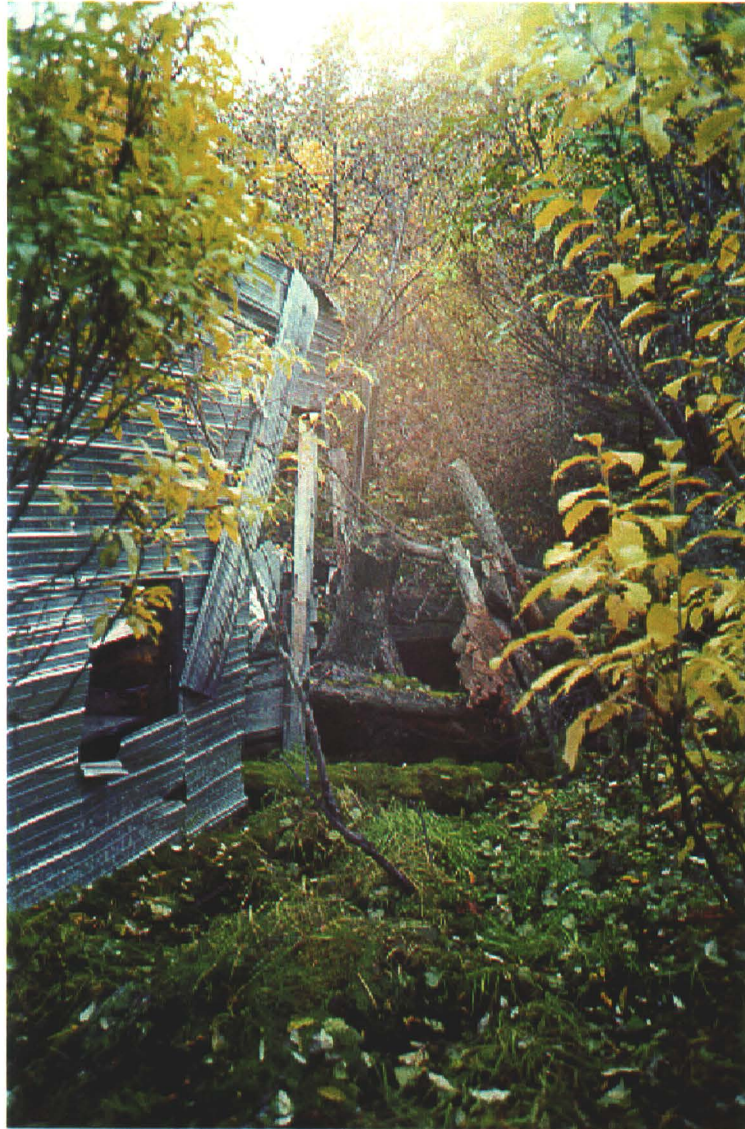
The rock and timbers supporting the portal have collapsed, leaving a small 1m by 1m opening that is blocked by ice. There is a building immediately to the west of the adit (discussed in Section 6 below).

Condition: The portal has collapsed.

Accessibility: The adit cannot be accessed.

Construction: The building was constructed with a wood frame and aluminum siding. The building has almost completely collapsed.

Photo 31-4: Collapsed middle adit portal and storage shed (Bldg. 31-B). Note damp ground from mine seepage. (Azimuth 160°)

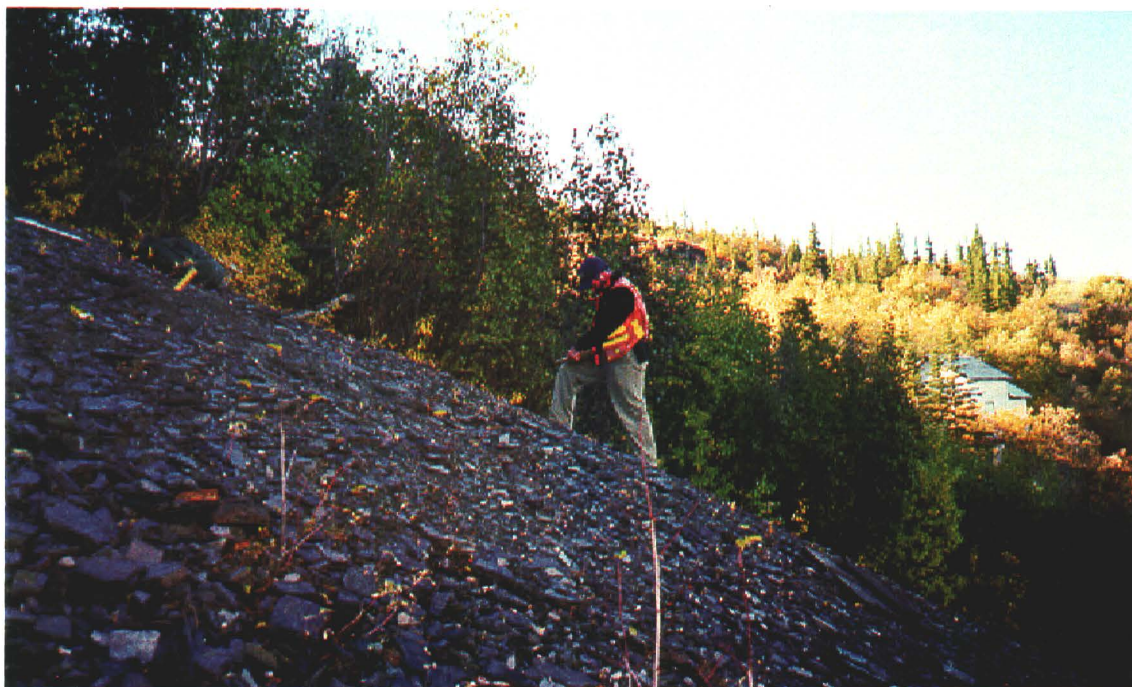
The waste rock pile appears to have formed by end dumping from the middle adit opening. A 30cm test pit was excavated from the middle of the pile. The waste rock in the pit appeared uniform and is composed of dark gray graphitic phyllite with 2-5% quartz-siderite veinlets and vugs. The waste rock is bi-modal with 50% fines (<2mm); 40% 2mm-5cm, and 10% greater than 5cm. There was no surface water or seeps flowing through the rock pile.

Sampling: Sample 31WR01-01 was collected from the test pit and sent for Acid-Base Accounting (ABA) and metals analysis. The field paste pH was 8.5 and the conductivity was 40µS/cm.

Photo 31-5: Middle adit level waste rock dump with mine dry in background.
Photo Direction (Azimuth 270°)

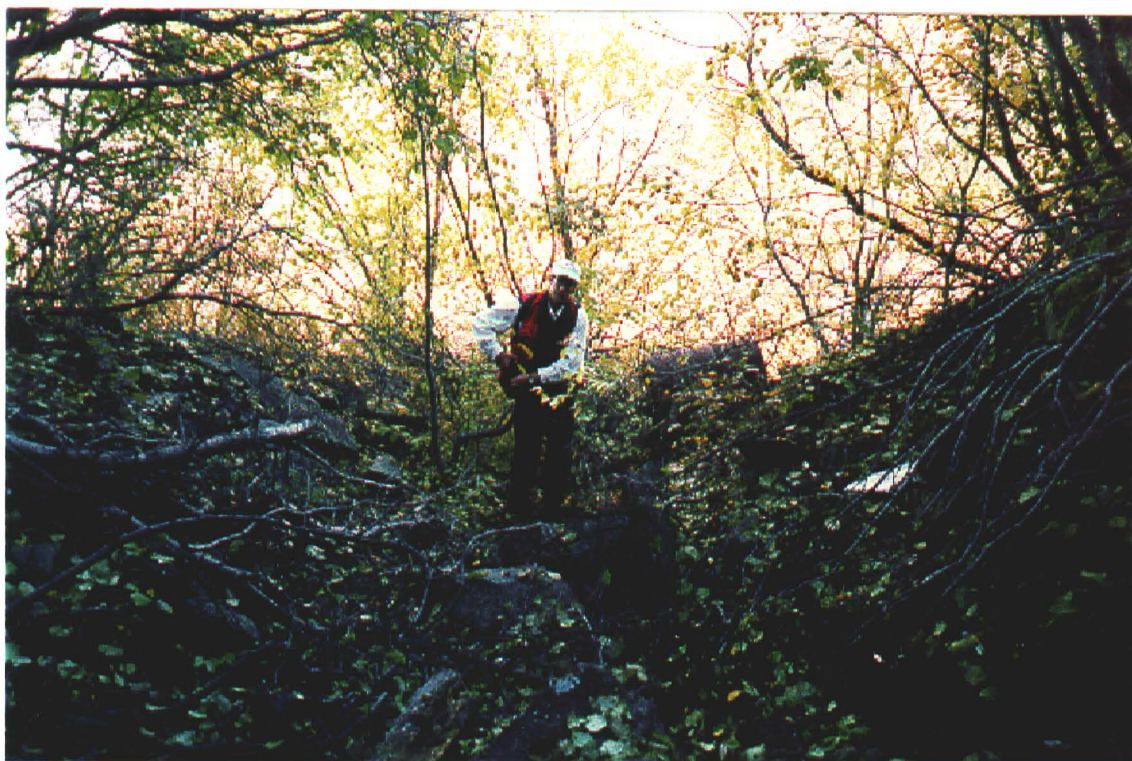
A shallow depression full of coarse, angular talus material and willows is all that remains of the lower adit. The portal and supporting structures are no longer visible.

Condition: The portal has collapsed, the area is stable.

Photo 31-6: Collapsed lower adit portal.
Photo Direction (Azimuth 032°)

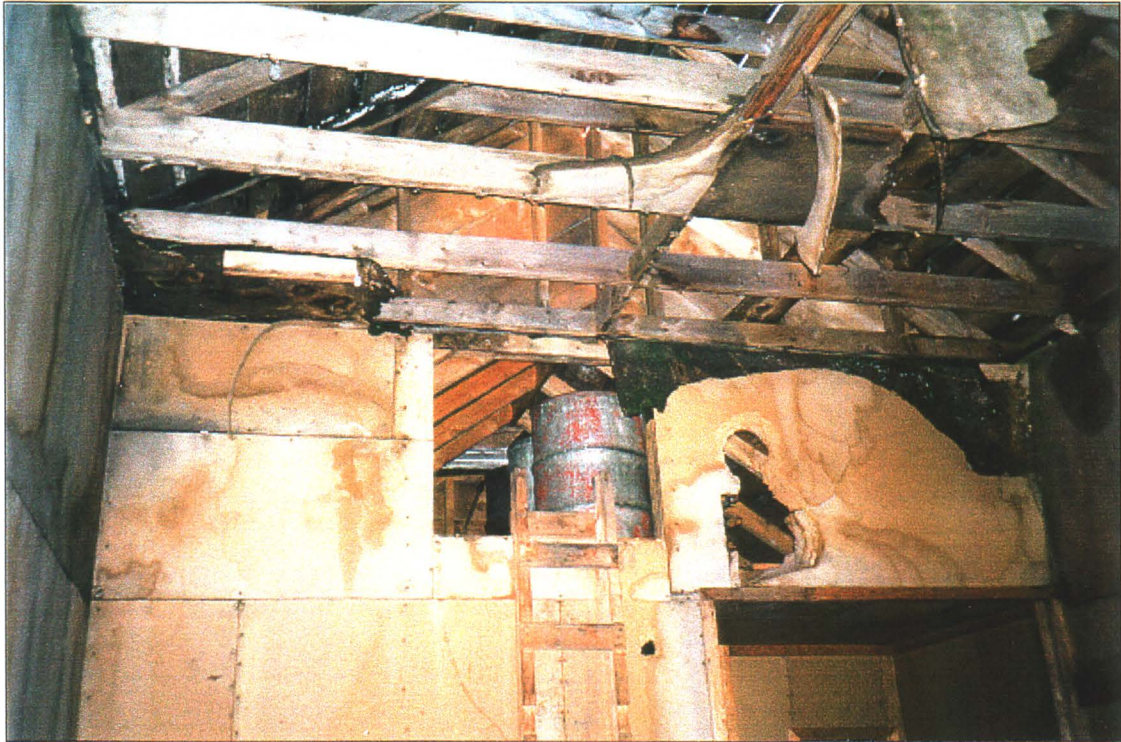
Construction: The entire building, frame, roof, floor and sides are constructed with wood. The floors are rotting but the rest of the building is moderately sound. The exterior of the building is painted white.

Photo 31-7: Interior of dry (Bldg 31-A) showing rafters, wallboard and water tanks for shower and sauna.

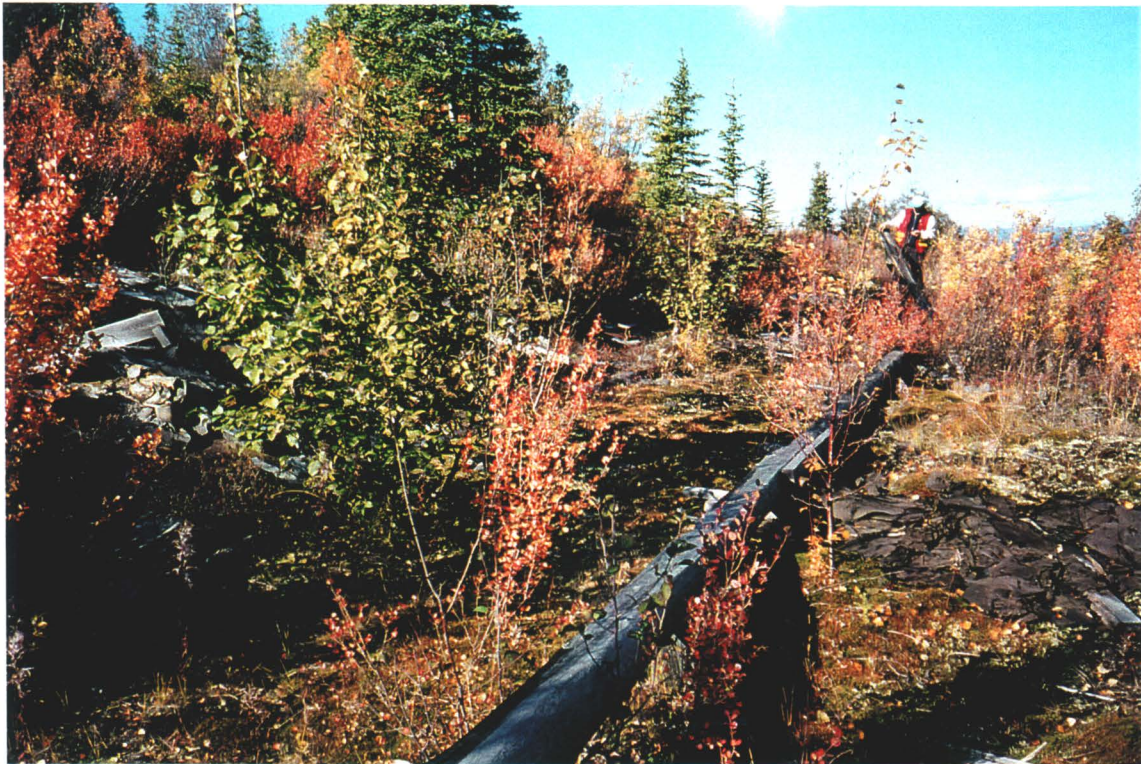
The frames of both Building 31-C and 31-D appear to have been removed; the roofing and siding material for the buildings is all that is left.

Construction: The roof and wall panel are likely constructed with an asbestos-containing material.

Asbestos: Suspect that the roof and wall board contain asbestos.

Photo 31-8: Demolished buildings (Bldgs. 31-C, D) along road west of Stone. Note discarded asbestos containing siding at right and in background held by field personnel. at depth in pit and abundant siderite vein cobbles.
Photo Direction (Azimuth 290°)
