KENO 700, PORCUPINE, AND COMSTOCK

SITE #32

This report describes the field investigation of parts of the Keno No. 9 System, including the Keno 200 and 700 levels, the Porcupine Open Pit, and the Comstock 150 and 200 levels. Investigations of the Shamrock J18 Vein Raise, No. 3 Vein Open Pit and Adit, No. 9 Vein Open Pit, Faro Gulch Portal, the Keno No 4 trenches and Upper Adit and the No. 5 Vein trenches are reported in a separate report (site #36). The sites of the Keno No. 1 Vein Adits, Keno No. 4 and 5 Shafts, Keno No. 6 Vein and No. 2 Vein Shafts, Keno No. 5 Vein Adit, and Keno No. 12 Vein Adit were not investigated.

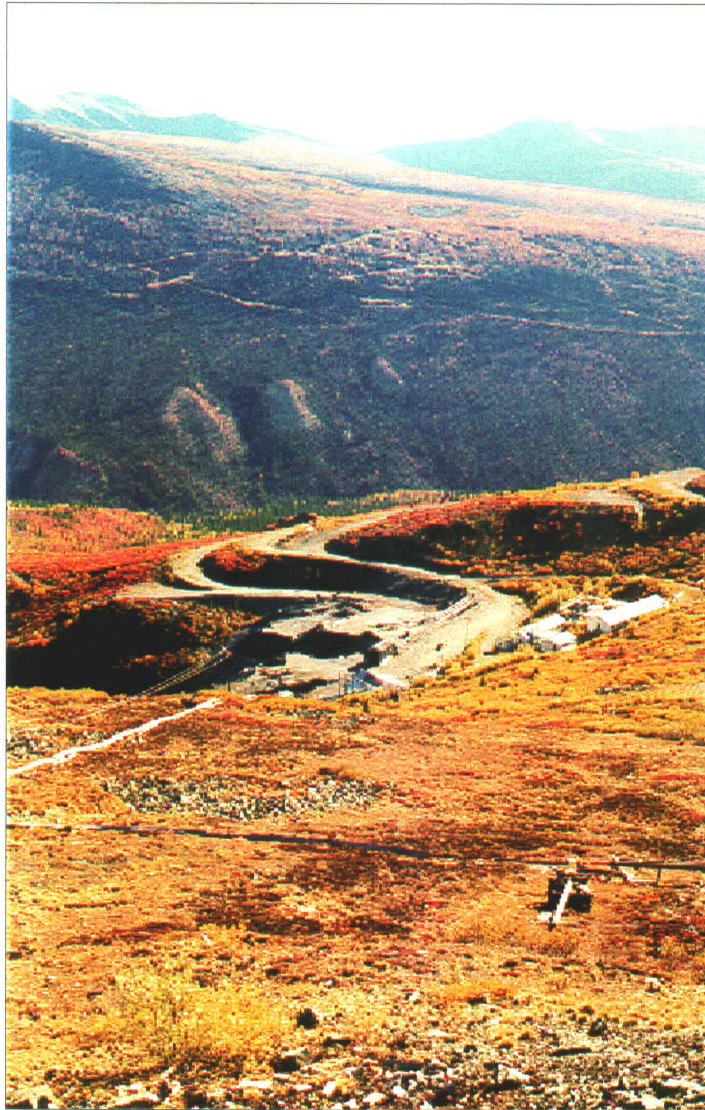
The Keno No. 9 System (including Keno 200 and 700, Porcupine, and Comstock 150 and 200) of mine sites is situated along a broad and gentle southeast-facing slope which converges and drains down into Hope Gulch approximately 800 m further to the southeast (Map 32-1). From here, Hope Gulch drains into Lightning Creek further to the south. The sites occur well above the treeline, located in sub-alpine to alpine tundra terrain, with characteristic shrub vegetation and soils. Raised frost-heave areas, polygons and the high altitude suggest the presence of continuous permafrost in the area (Photo 32-

1). The mine system was recorded as being in permafrost at the 400 level from the summit.

Photo 32-1 : Keno 700. Looking down on site from mountain to the S. (at Comstock-Keno 200).

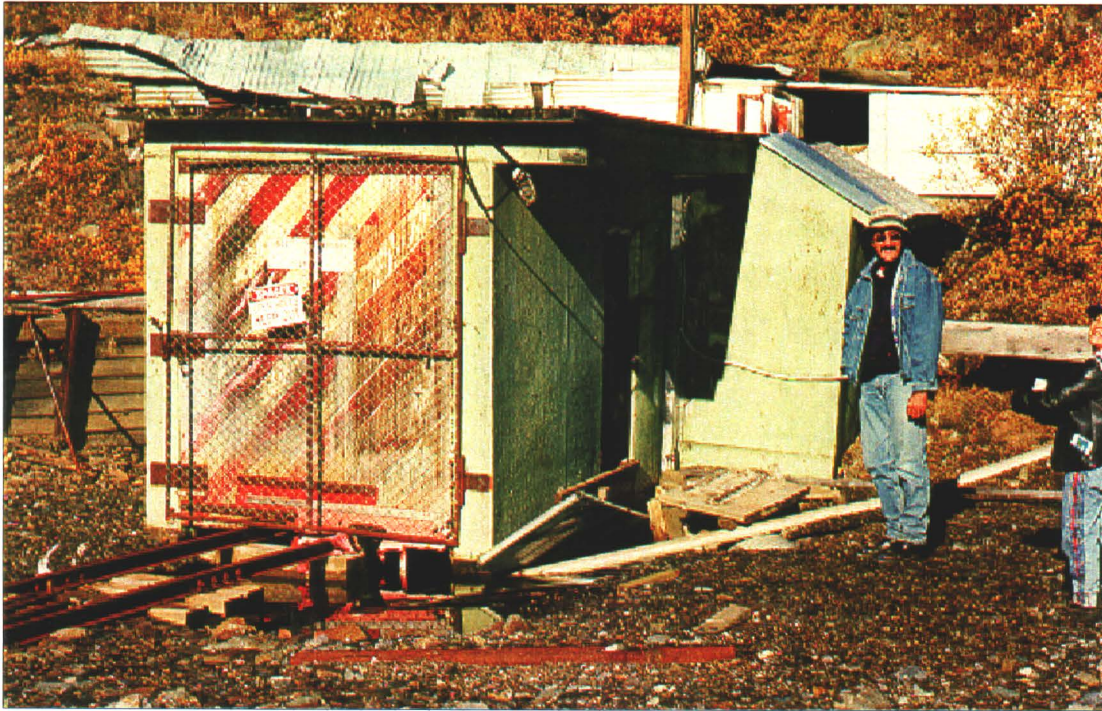
Keno 700 Adit (Photo 32-2)

Description: Portal is enclosed in plywood housing with reinforced metal aluminum roofing; deep melt water occurs on the eroding portal floor. There is a rail car on the track inside the shack.

Supports: railway tie wood supports along inner portal walls in relatively good condition, but beginning to rot.

Condition: structure appears to be stable

Accessibility: Inaccessible. A locked fence blocks the main adit entrance, but entry can be gained from a open side door. A large ice plug blocks a majority of the portal opening.

The Keno 700 adit drains an extremely large expanse of underground workings of which many are up to 70 years old (UKHM, 1996). Water samples were taken in seepage at the entrance to the Keno 700 adit (99-32-WQ-01, see Photo 32-2), below the end of the drainage culvert through the waste rock pile exposed and damaged by erosion (WQ-02, Photo 32-28) and in the receiving stream at the bottom of the outwash area a few hundred metres below the site (WQ-03, Photo 32-29). The results of the geochemical analyses for these samples are presented in Attachment 2.

Photo 32-2 : Keno 700. Mine adit shed (building 7) looking N.W.

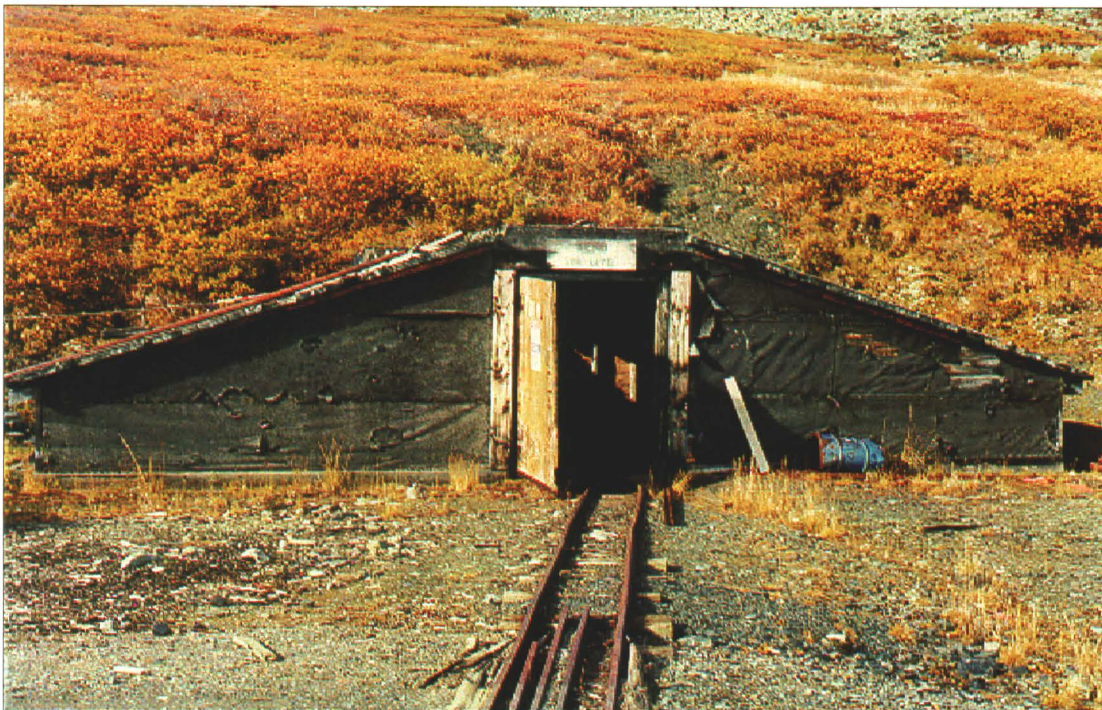
Keno 200 Adit (Photo 32-3)

Description: Portal is enclosed in plywood housing with tar paper siding and roofing, a portion of which has blown off the top. A rail car was found on the track within the shack in front of the portal opening (Photo 32-4). Some equipment, mostly ties and metal parts, was also stored along the inside of the shack.

Photo 32.3 : Keno 200. Adit shack looking W.

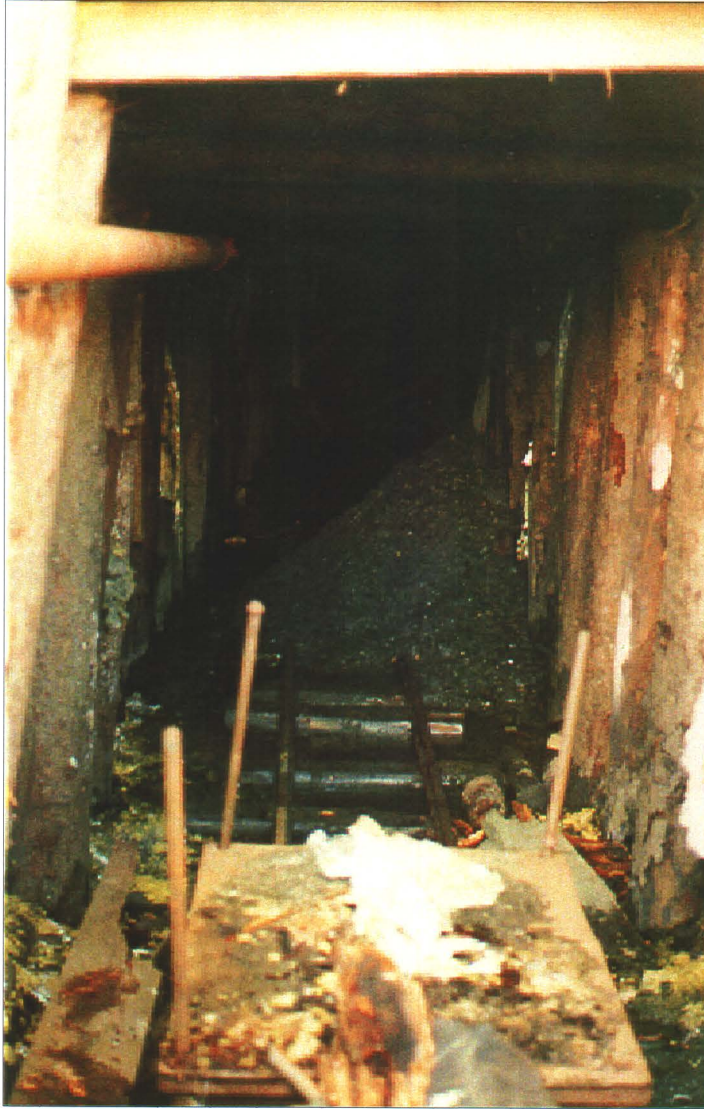
Supports: log reinforced walls at portal entrance (see Photo 32-4)

Condition: stable near portal entrance; however, some wall collapse observed 3 m into adit (see Photo 32-4)

Photo 32-4 : Keno 200. Mine adit water sample.

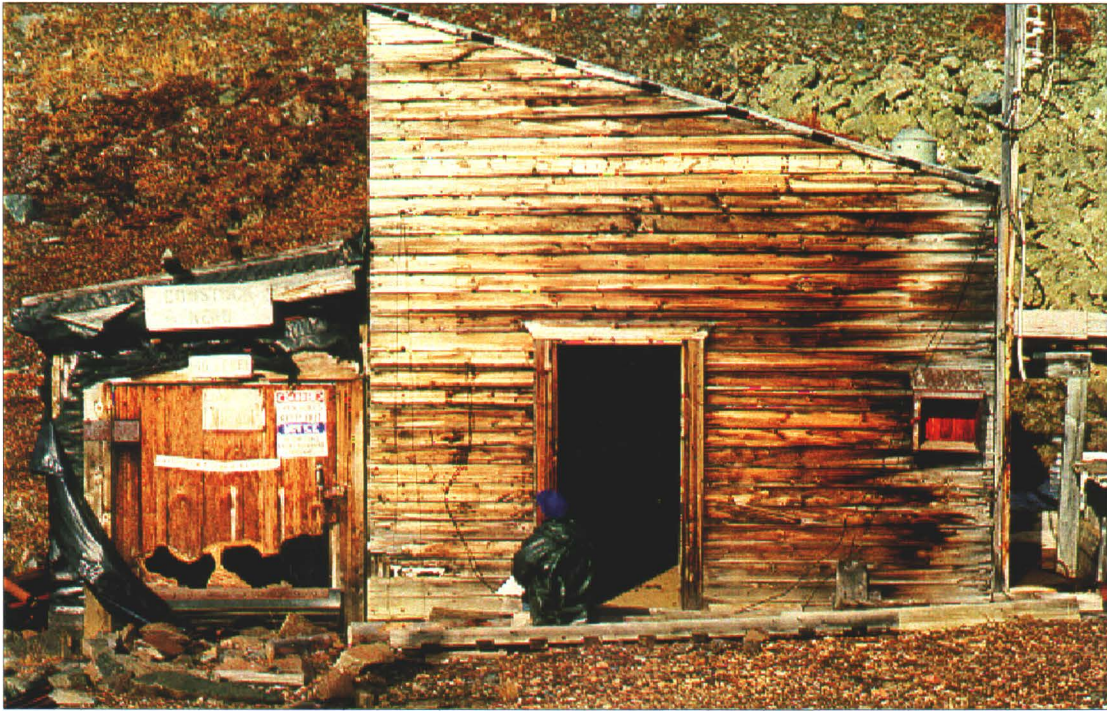
Description: Portal is enclosed in on the north-west side of two-roomed wood plank housing with reinforced aluminum metal roof; a portion of the reinforcing has been blown off. Access door to other room has been removed. This second room consists of a small office with a wood floor, electrical supply, switch box and an old desk. A small vent shaft enclosed in a stable wood housing, with an aluminum metal reinforced roof and hand ladder occurs at the 100 level just above this adit (Photo 32-6).

Condition: appears to be stable near portal entrance, shack is shifting but solid

Accessibility: Access door to the adit has been sealed but partially damaged (see Photo 32-5).

Photo 32-5 : Comstock-Keno 150. Adit Shack (looking N.).

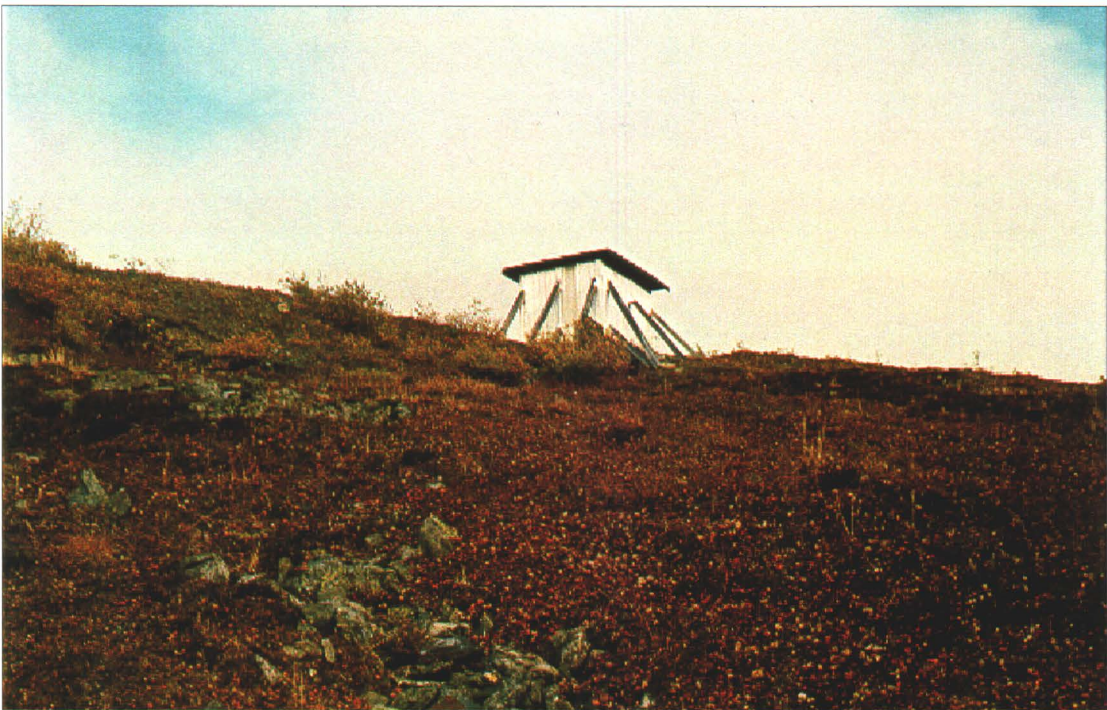
Photo 32-6 : Comstock-Keno. Vent shaft shack above site (looking N.E.).

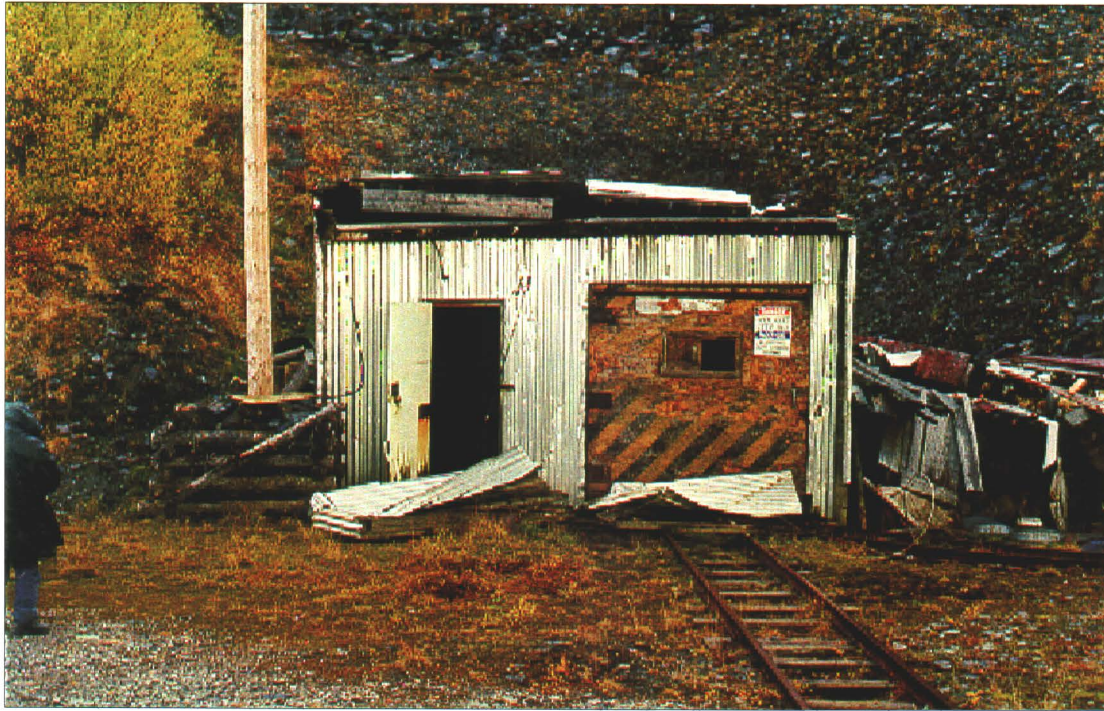
Comstock 200 Adit – (Photo 32-7)

Description: Portal is enclosed in plywood housing with aluminum-reinforced siding and roof; a portion of the roof has been blown off. The floor of the adit shack consists of soft mud.

Supports: plywood and log reinforced walls at portal entrance, still in good condition

Condition: appears to be stable near portal entrance, shack is shifting but solid

Photo 32-7 : Comstock-Keno 200. Adit entrance (looking N.E.)

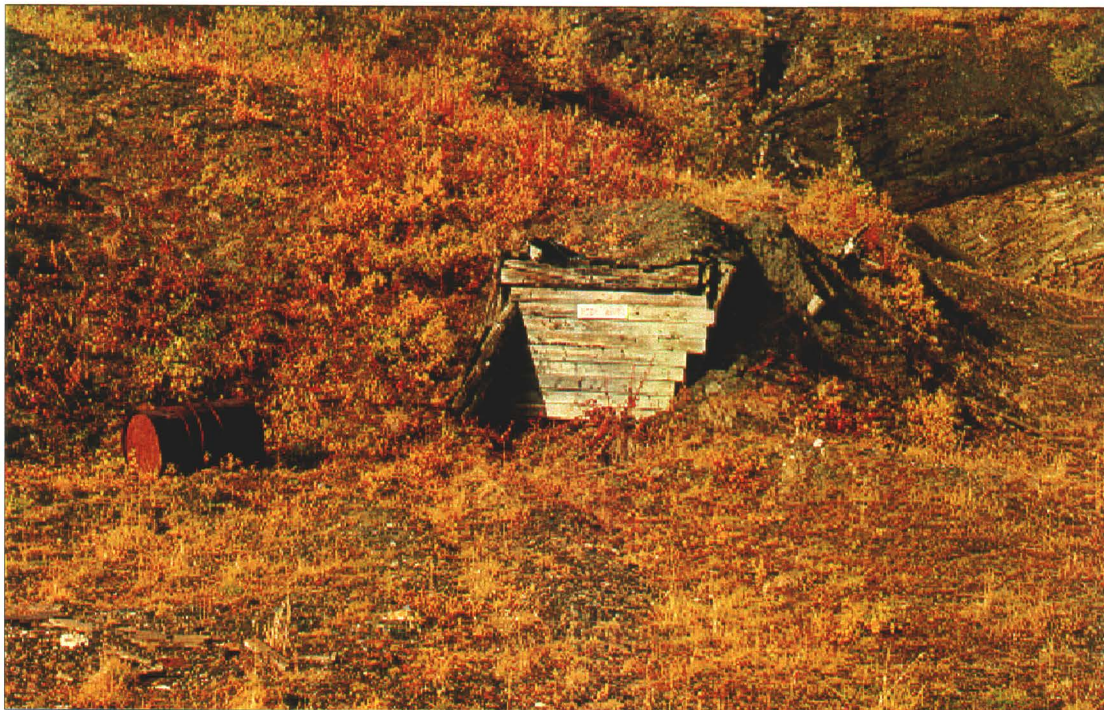
Porcupine Pit Portal (Photo 32-8)

Description: The location has been overgrown by natural vegetation. An old empty drum is situated near its entrance, in addition to a smaller barrel with a spigot at the north end of the adit.

Supports: although most of the portal has collapsed, the walls were apparently reinforced using logs.

Condition: unstable near portal entrance; majority of remainder of adit has caved in

Accessibility: Portal is blocked by wood planks and has collapsed along a majority of its length. A vertical shaft occurs further along the adit approximately 30 m into the pit; the opening, which is exposed, has been caved in with large boulders.

Photo 32-8 : Porcupine Adit looking N.W.

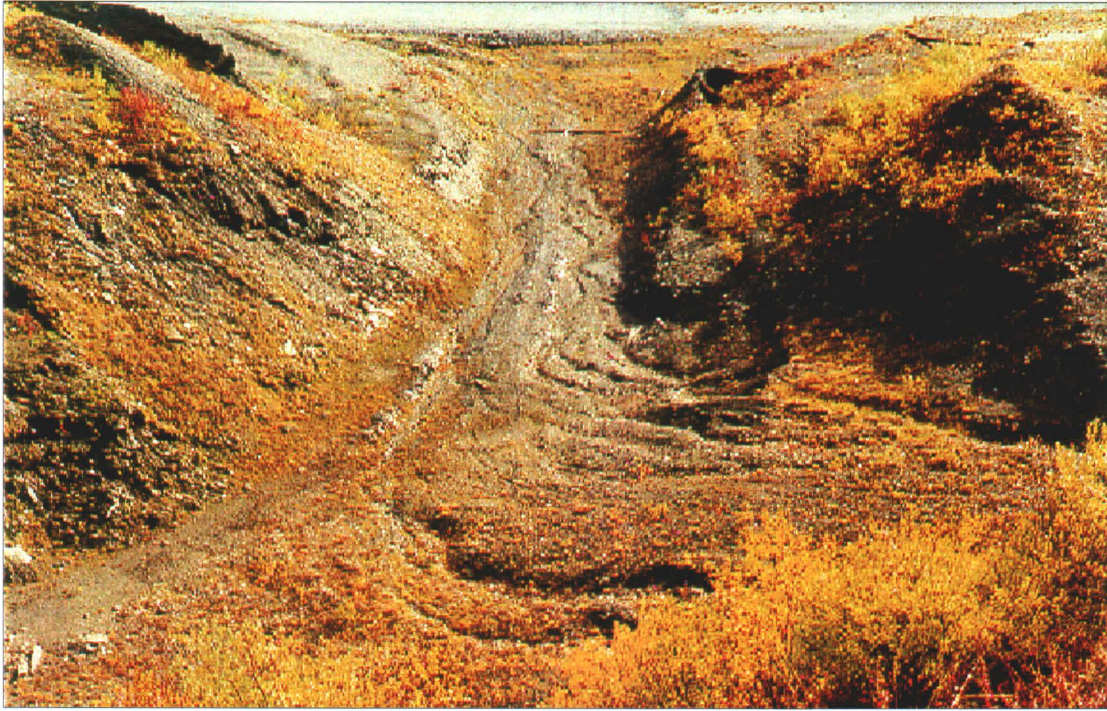
Porcupine Pit (Photo 32-9)

Description: large circular pit dug into the slope to the north of Keno 700 Road; sides are moderately steep to gently-sloping. Vegetation has begun to establish along the sides of the pit which have eroded over the years

Condition: sides of pit appear to be eroding, but partially stabilized through natural re-colonization by vegetation

Photo 32-9 : Porcupine Adit Pit looking E.

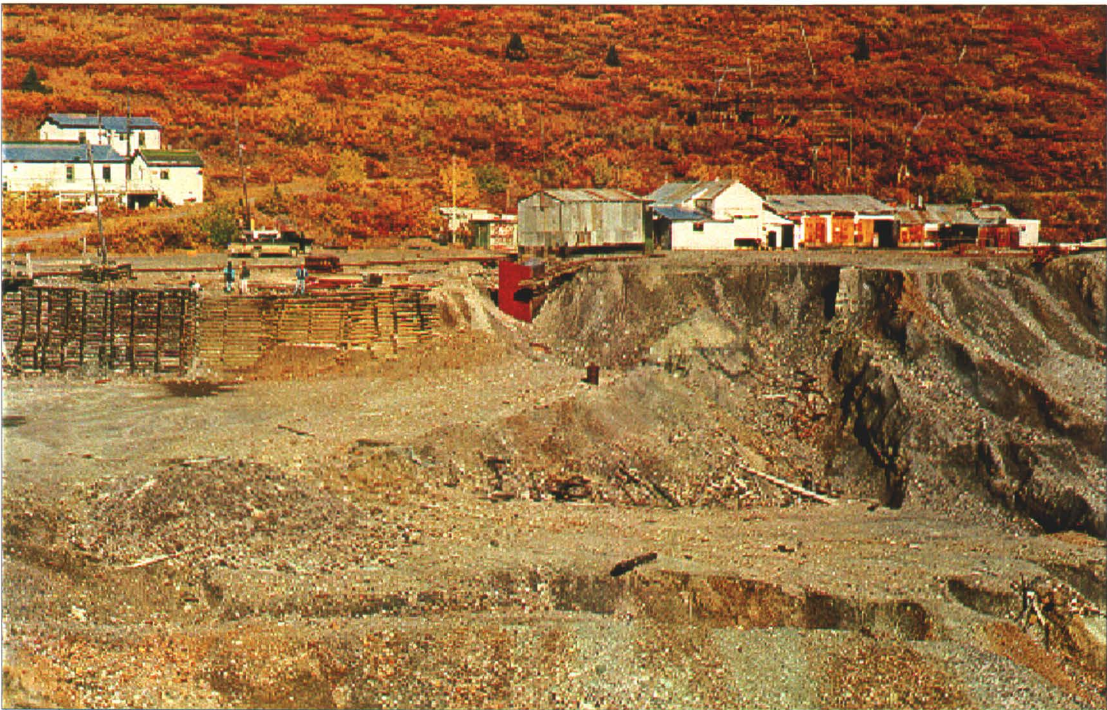
Keno 700 Waste Rock (Photo 32-10)

General Description: Large mound upon which the current campsite is located. Area has been eroded downslope as the result of erosion and catastrophic release of seep water from the Keno 700 Adit ice plug. Most of the regular adit seepage flows through a culvert in the waste pile which daylight near the upper edge flowing down towards Ray Gulch. This drainage and the steep incline make the slopes of the pile highly unstable and has resulted in erosion downslope forming a large outwash area towards Ray Gulch. Waste rock pile is direct result of mining activities from the portal, some of which is overburden. Landfilling activities have also occurred in the waste rock at the northeast end of the pile, where exposed debris resulting from erosion was observed. An inspection of the waste rock piles suggests that very little ore grade material is contained in the pile,

minor quantities of galena and sphalerite was documented throughout the pile. However, the majority of the waste rock pile appears to be associated with host rock material with very little evidence to suggest sulphide rich rock content. No evidence of staining or physical evidence of Acid Rock Drainage was documented at the site. The waste rock pile is located on a steep, well drained slope and is comprised of coarse rock material. Although water drainage from the adit flows through the waste rock pile, the pile does not appear to retain large volumes of water.

Photo 32-10 : Keno 700. Site looking N.

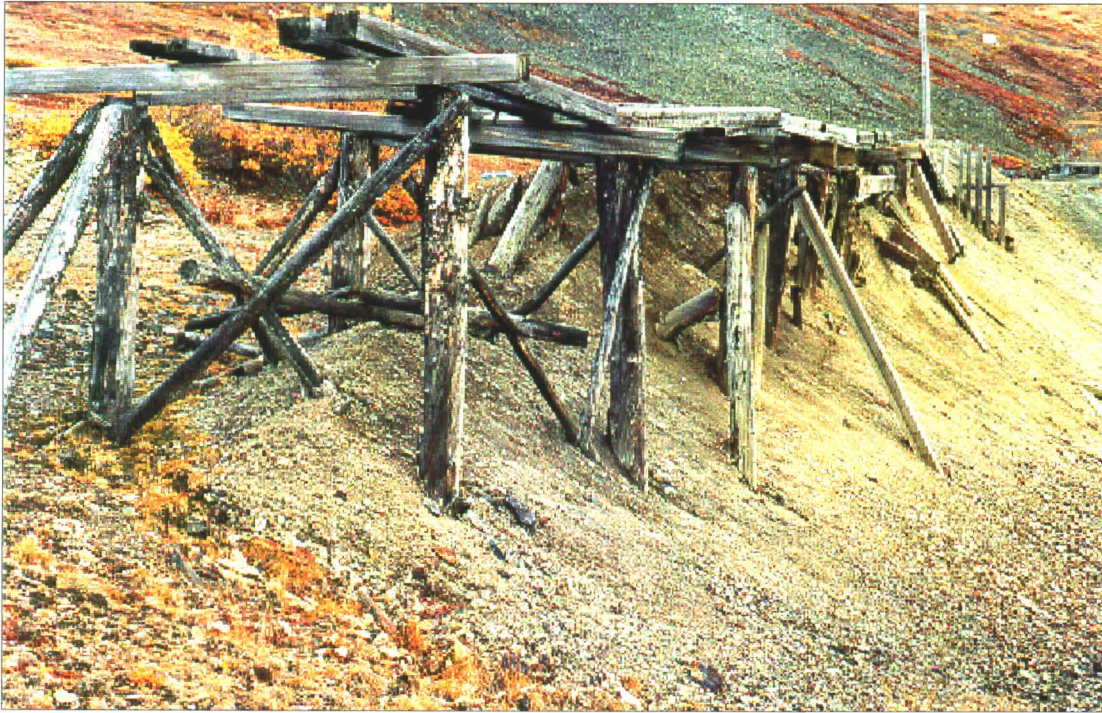
Keno 200 Waste Rock (Photo 32-11)

General Description: Large mound, mixed with overburden upon which the Keno 200 adit and loading infrastructure is located. The area is relatively high and dry; no evidence of surface adit seepage drainage was observed. Some evidence of erosion has occurred along the south edge of the pile by the loading trestle, where an erosion scree was observed. An inspection of the waste rock pile indicated no staining or indications of acid rock drainage. The waste rock appeared to be well drained with no evidence of seepage that would suggest saturated conditions within the pile. No evidence of sulphide rich

rock was documented in the waste pile. However, the upper 0.15 metres of the pile had a distinctive green colour to it when compared to the waste rock comprising the lower portions of the pile. The rock type appeared to consist primarily of host rock, not ore containing material.

Photo 32-11 : Keno 200. Old trestle to S.W. of site looking N.E.

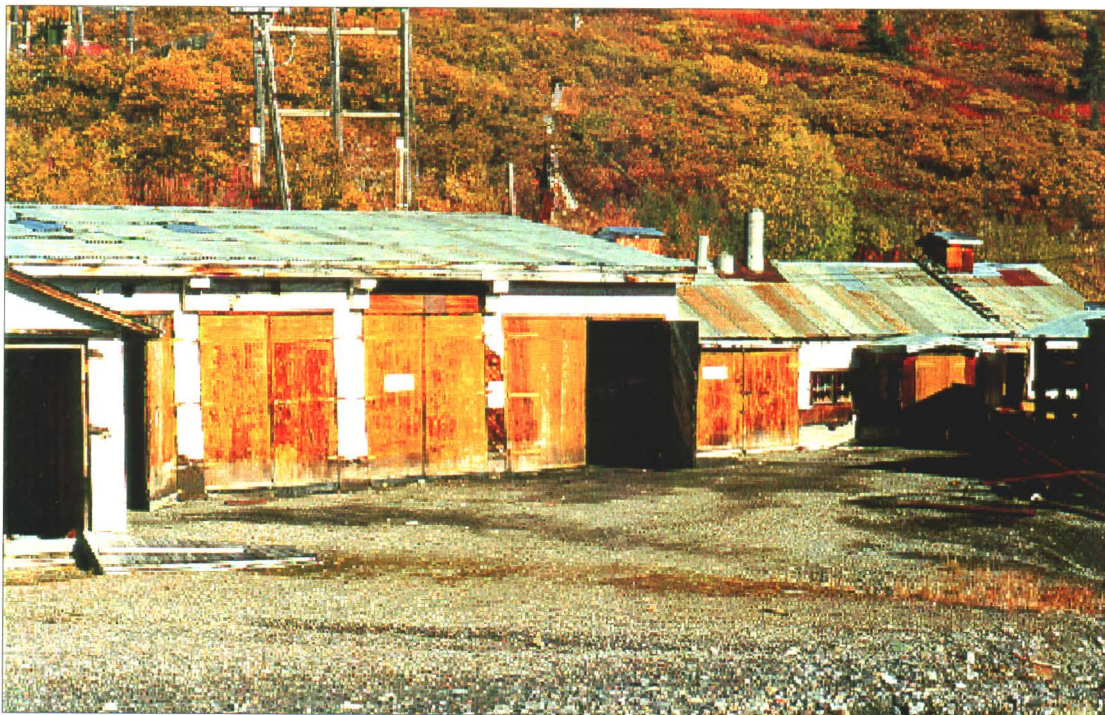
The generator shack and oil storage building (9) for the site were located just northwest of the ambulance garage (32-F) and consisted of wood construction (28 m L x 7 m W) with aluminum metal reinforced roofing, and concrete flooring. The building was relatively stable; however, faults and cracks were noted in the concrete flooring. Two

diesel generators were found inside in addition to a workshop with equipment pieces, a fuel tank in the southwest corner, drums of hydraulic oil and kerosene (2 x 45 gal.), and hydrocarbon staining on the floor leading outside to the southeast. Soil samples were collected in the large hydrocarbon stain outside the shack at surface (99-32-SS-01), 0.7 m depth (SS-01D) and in drainage from the area (SS-02). The results of the hydrocarbon analysis for these samples are provided in Attachment 2. Three samples were collected from the drums of hydrocarbon products, including 99-32-DS-1 (205 L Chevron barrel containing a green fluid), DS-2 (barrel containing a 4:1 gasoline water mixture) and DS-3 (20 L pail containing hydraulic oil). There were archived, but not analyzed. Aside from hydrocarbon, no hazardous materials were apparent within the building.

Photo 32-18 : Keno 700. Generator shack (building 9) looking north - oil staining in front.

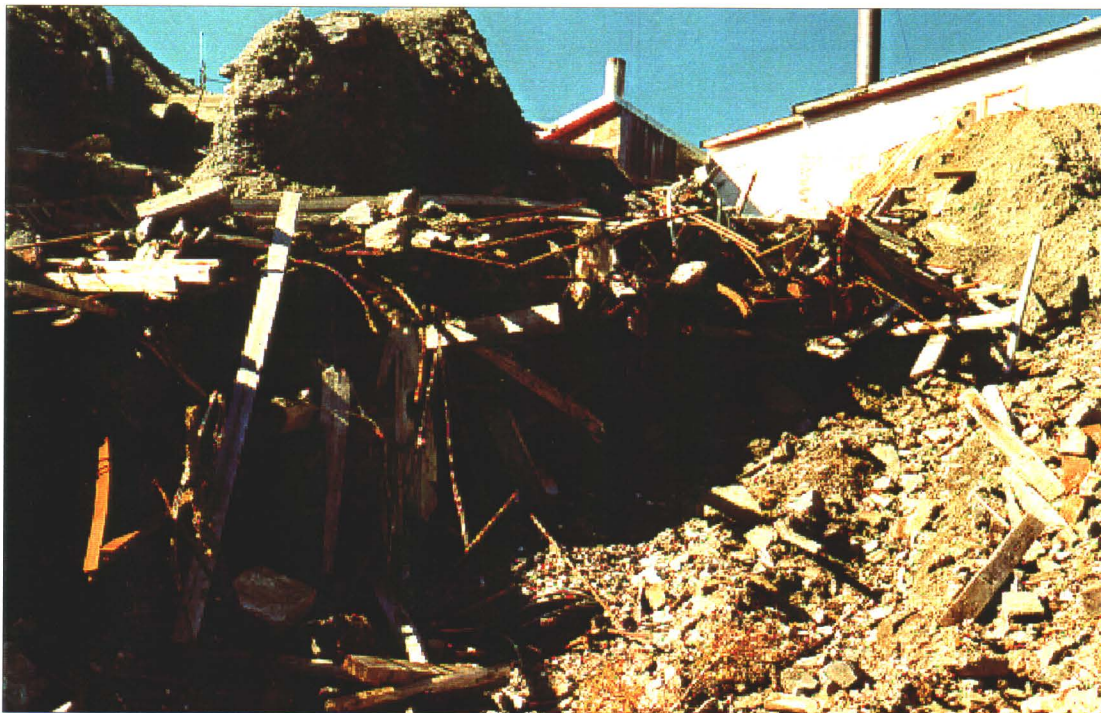
A large volume of landfill material has been incorporated into the waste rock pile at the northeast end of the site. The slope of the pile has become eroded at this point exposing a large amount of debris up to 3 m in thickness including drums, wood, plastics, cables, rail ties, rubber hose, culverts, old boiler, drill rods and other materials. Although none of the observed material appeared to be hazardous, the exposed surface was extremely unstable and in an eminent state of collapse. One soil sample (99-32-SS-08) was collected in the drainage just below this area and analyzed for contaminants; the results of the analyses are provided in Attachment 2. In addition to this and materials noted around the

buildings, wood and metal debris was also observed along the slope and outwash area below the waste rock pile to the southeast of the site.

Photo 32-24 : Keno 700. Landfill exposed debris looking upslope & S.W.
(N.E. side of waste-rock pile).

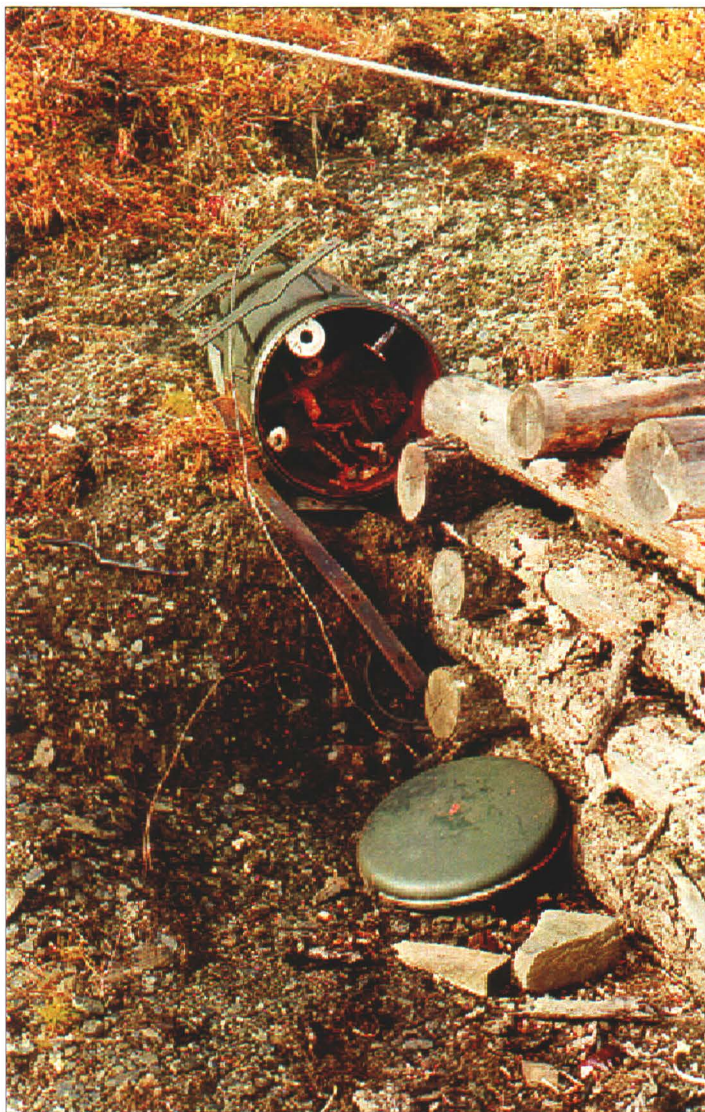
Aside from the field duplicate sample (99-32-SS-14/15) collected below the fallen transformer at Keno 200; no evidence of any significant staining, spills, or odours was observed at the other sites (i.e., Comstock 150 or 200, or Porcupine).

Photo 32-26 : Keno 200. Fallen capacitor / transformer by tower.

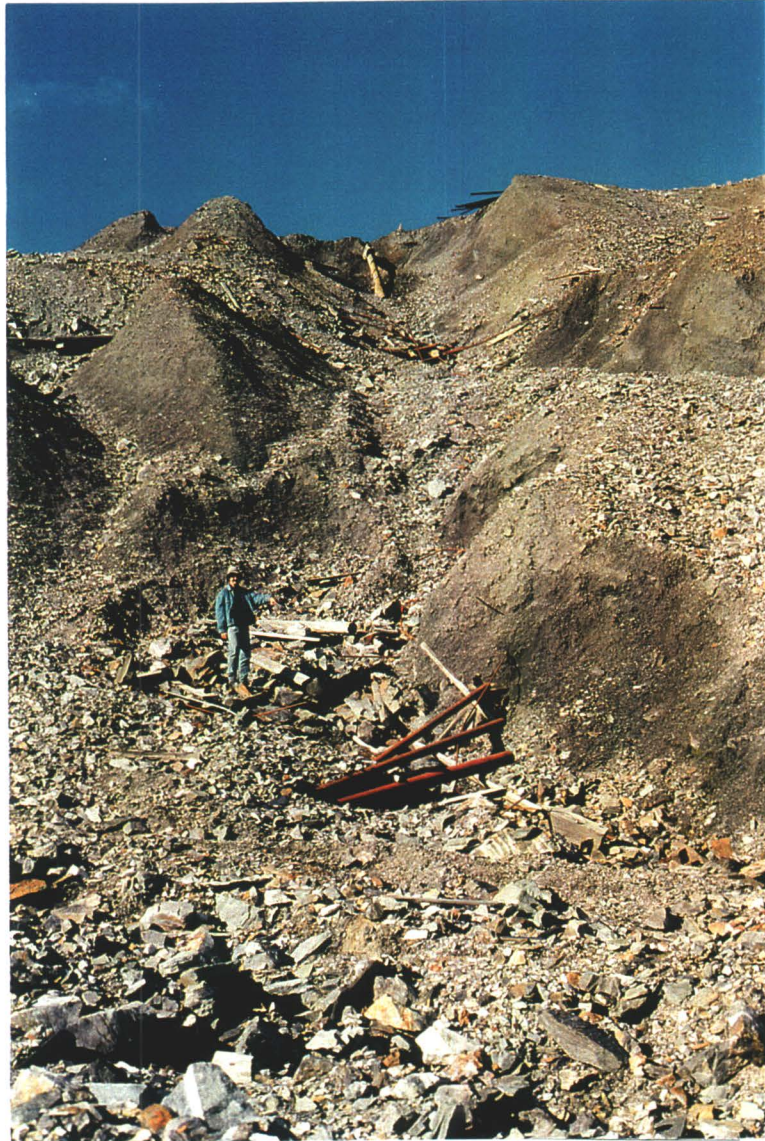
resulting in erosion of the waste dump from periodic release of the plug. The adit is also draining through a culvert under the waste dump. Future mining is planned by UKHM for the No. 18 vein.

Photo 32-28 : Keno 700. Waste-rock pile outwash area looking W. Adit culvert at top.
