## MAIN FAULT & NABOB

Site # 33

MINFILE # 105M 001aq

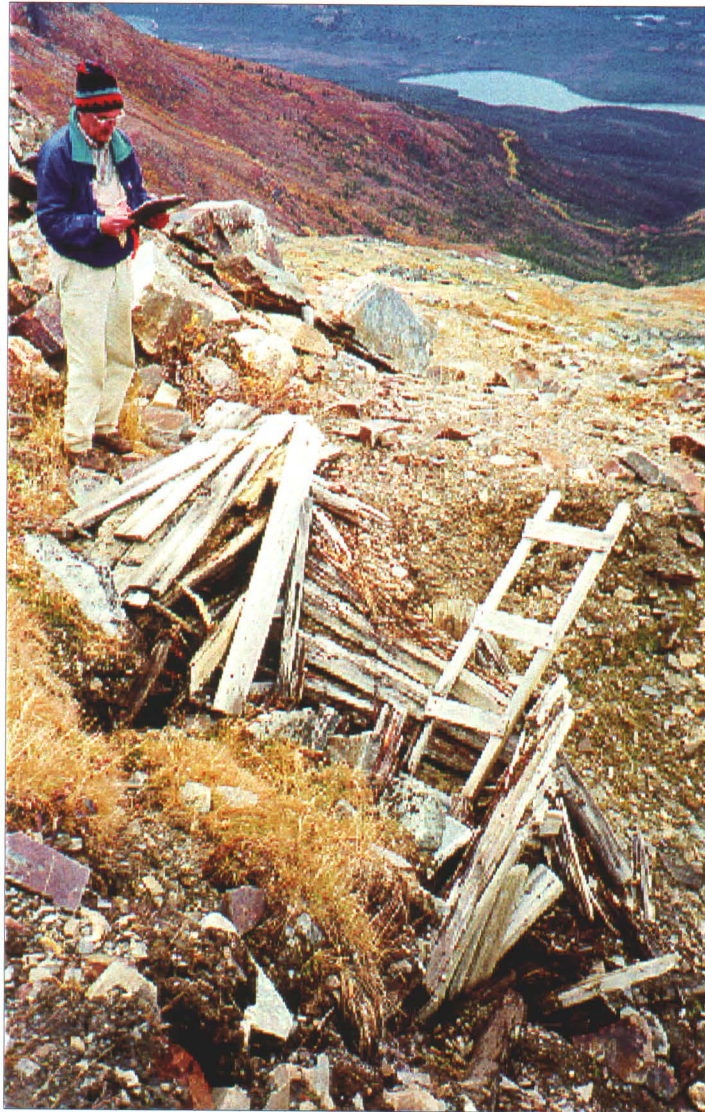
### **Main Fault Shaft (photo 33-1)**

At the west end of Trench #2 is an old collapsed prospect shaft located on the Main Fault.

Supports: The collar is supported by log cribbing.

Condition: The shaft has collapsed at surface.

Accessibility: A ladder going down the shaft is still in place, however since the shaft has collapsed the shaft can no longer be accessed.

Photo 33-1 : Main Fault and Nabob. View of the Main Fault shaft, Gambler Lake is in the background. (Azimuth330°)

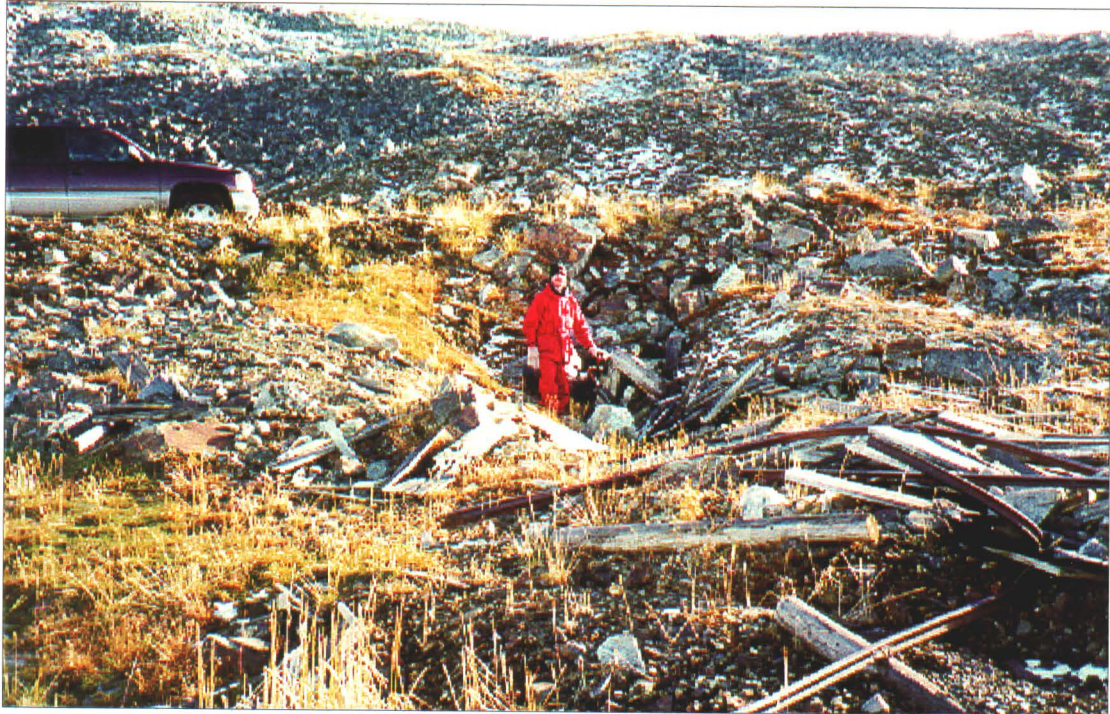
### **Main Fault and Nabob Adit (photo 33-2)**

The adit is located on the west side of Silver Basin Gulch Trail, 150m north of the shaft. The portal has collapsed.

Supports: The portal was supported with log cribbing.

Condition: The portal and the first 5m (up to the road) of the adit have collapsed. The portal is filled with broken log cribbing and large boulders. No evidence of further stability problems was observed, the road above the adit did not appear to be slumping.

Accessibility: The adit can no longer be accessed.

Photo 33-2 : Main Fault and Nabob. Collapsed Main Fault -Nabob Adit, truck is on Silver Basin Gulch Trail. (Azimuth150°)

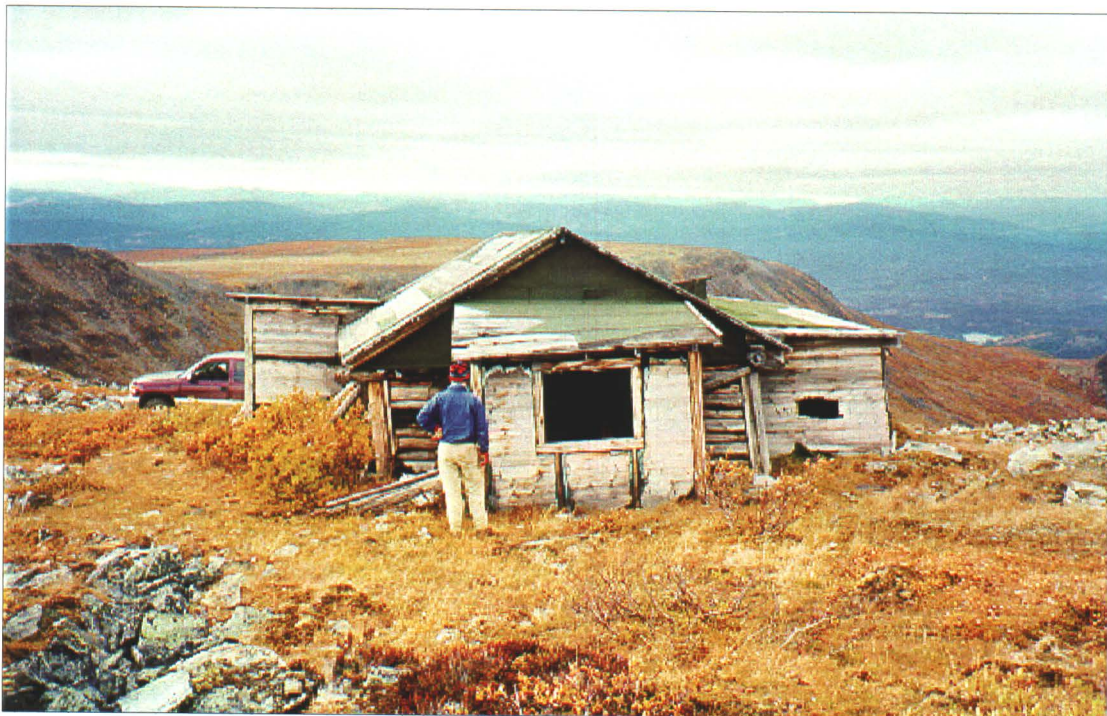
### **Building 33A (photo 33-3)**

There is an old house located on the Silver Basin Gulch Trail at the edge of the cirque, 200m southwest of the trenches. Three additions were built on to the original 5m by 5m log cabin. Most of the asbestos tar paper cladding that covered the exterior walls has fallen off and is scattered around the building. The roof is mostly covered in sheets of asphalt shingling, with one small section, now collapsed, roofed with corrugated tin. No hazardous products were encountered inside of the building.

Photo 33-3 : Main Fault and Nabob Old log house on the south side of the Silver Basin Gulch Trail. (Azimuth335°)
