**LAKE VIEW**  
**SITE #34**  
**MINFILE# 105M001ar**

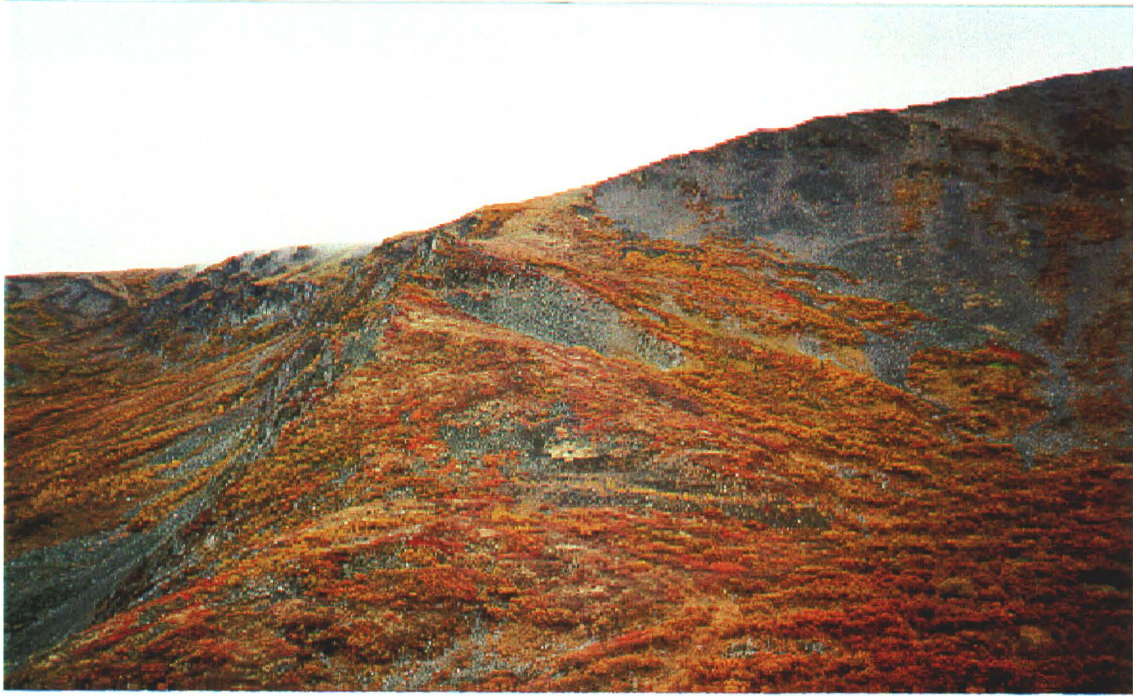
**2. SITE PHYSIOGRAPHY (Photo 34-1)**

The Lake View site is located along the rib of a rocky east-west ridge. Coarse talus is common throughout the site and soils are poorly developed. Permafrost is considered very likely. The mine site is vegetated with subalpine herbaceous plants, grasses and shrubs(willow). A variety of moss and lichens grow on the talus. Surface water from the site drains northward into the Faro Gulch, a tributary of the Keno Ladue River. No surface water was observed on the site.

Photo 34-1: Overview of Lakeview site showing both recent and historic trenching activity. (Azimuth 100°)

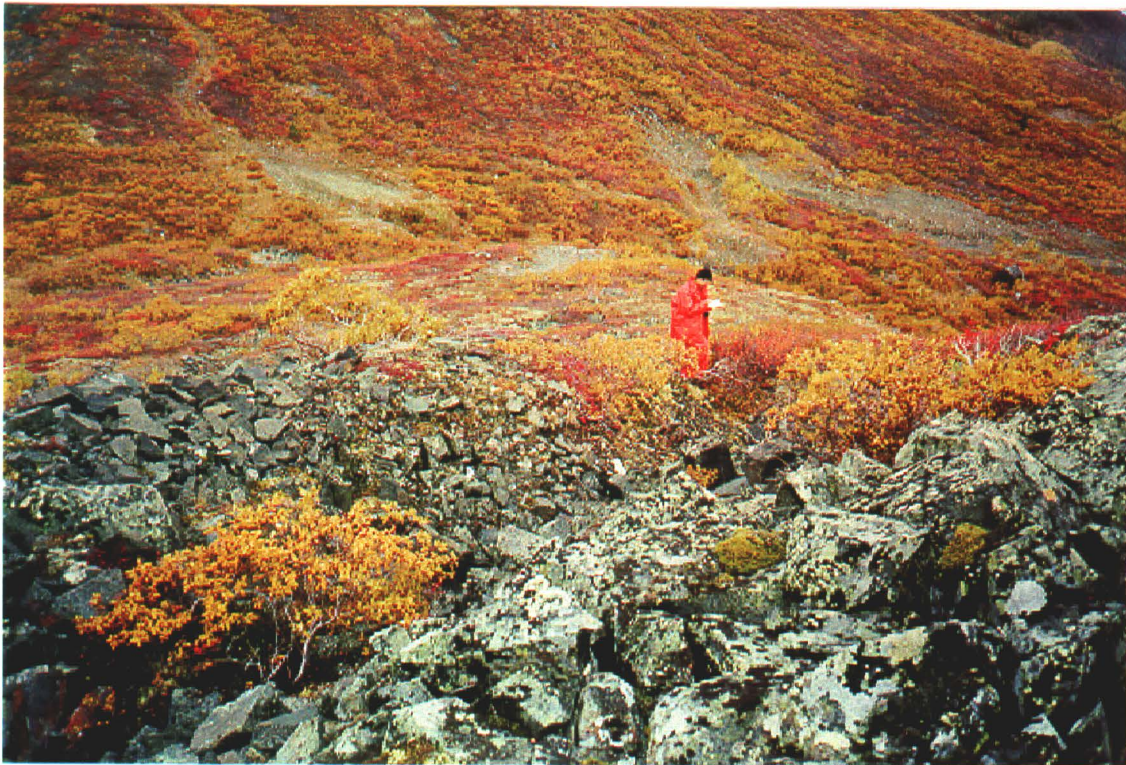
### **Trench #2 (Photo 34-2)**

Trench #2 is was hand dug in overburden consisting of colluvial soils composed of up to 70% coarse talus material.

Location: 30m up the ridge, roughly 20m south of the edge of the ridge.

Dimensions: 10m long x 2m wide x 1.5m deep

Condition: Good; partially slumped in.

Photo 34-2: Lakeview trench site. (Azimuth 310°)

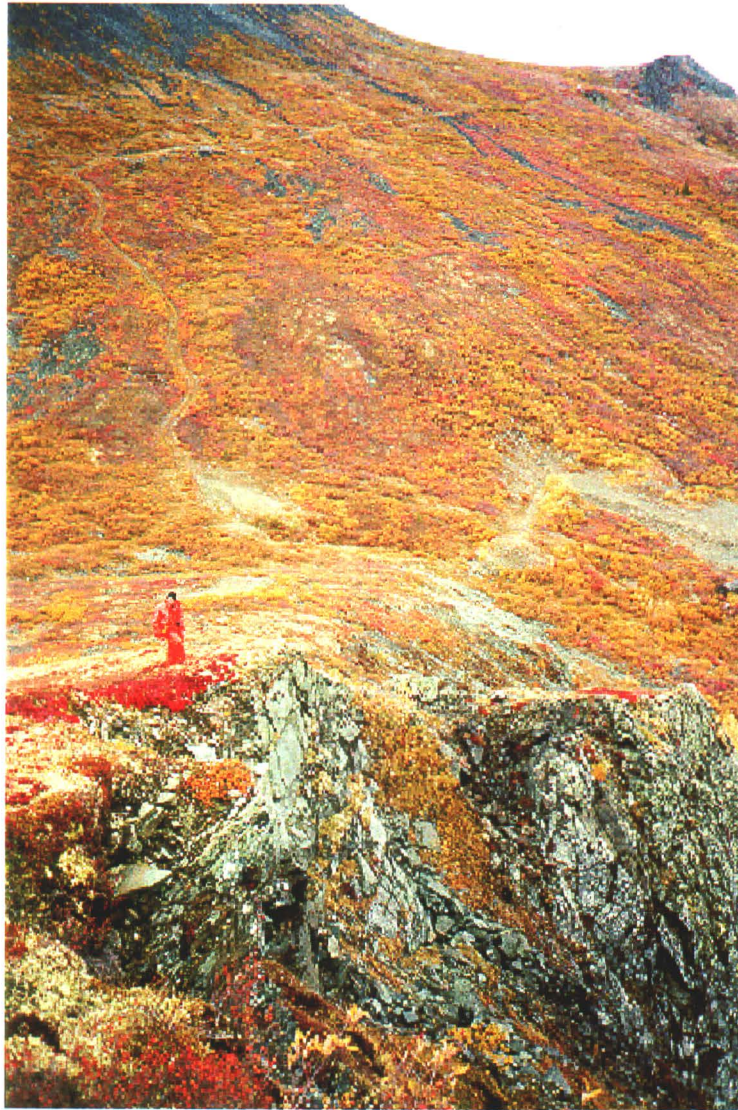
### **Trench #3/Open Cut (Photo 34-3)**

This location is more of a small open cut excavated into the exposed bedrock lip of the ridge.

Location: On cliff edge of ridge, roughly 80m east along ridge from Trench #1.

Dimensions: 5m long x 2m wide x 1m deep

Condition: Good; difficult to access.

Photo 34-3: Lakeview trench cut located 10m right of sampler.  
(Azimuth 280°)

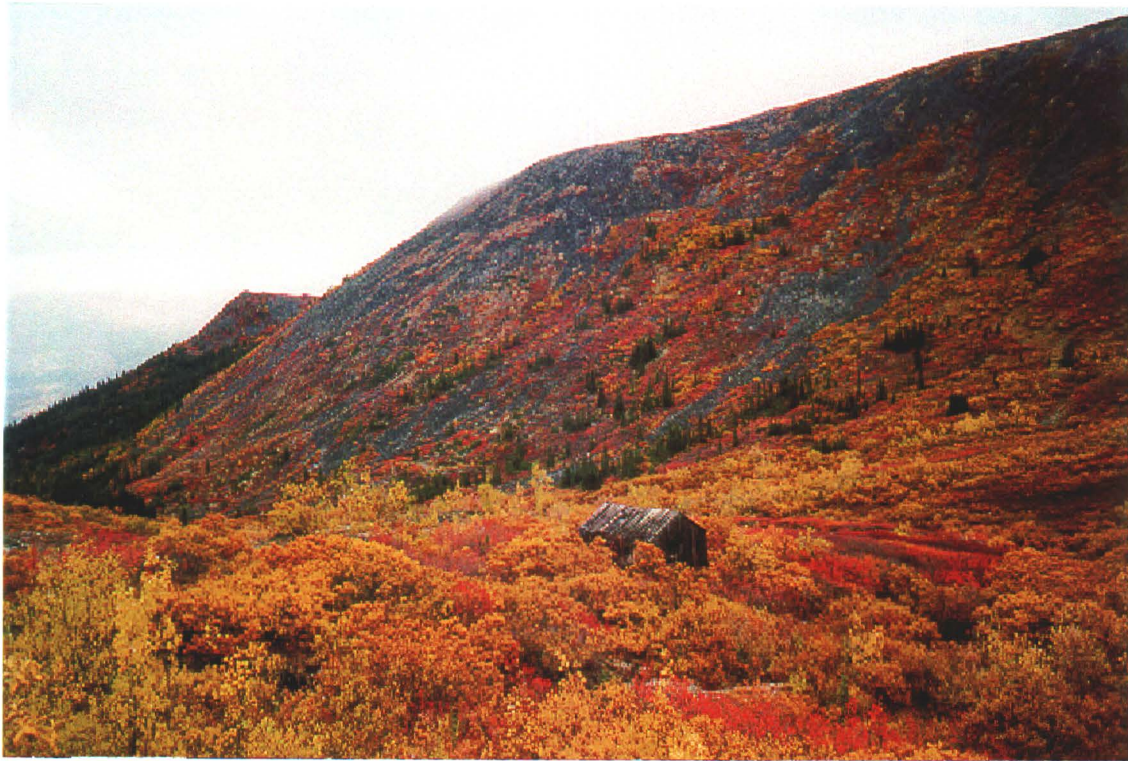
### **Building 34-A: Cabin (Photo 34-4)**

Dimensions: Building material is spread out over a 20m by 15m area.

Location: End of the Upper Faro Gulch Trail, 70m north of the Trench #1.

Construction: Wood frame construction with metal roof.

Asbestos: None observed.

Photo 34-4: Lakeview building (Bldg. 34-A). (Azimuth 280°)
