KENO No. 9, MAIN FAULT & SHAMROCK J18

SITE #36

MINFILE #105M 001ao, aq & ap(?)

This report describes the field investigation of parts of the Keno No.9 Vein system including the:

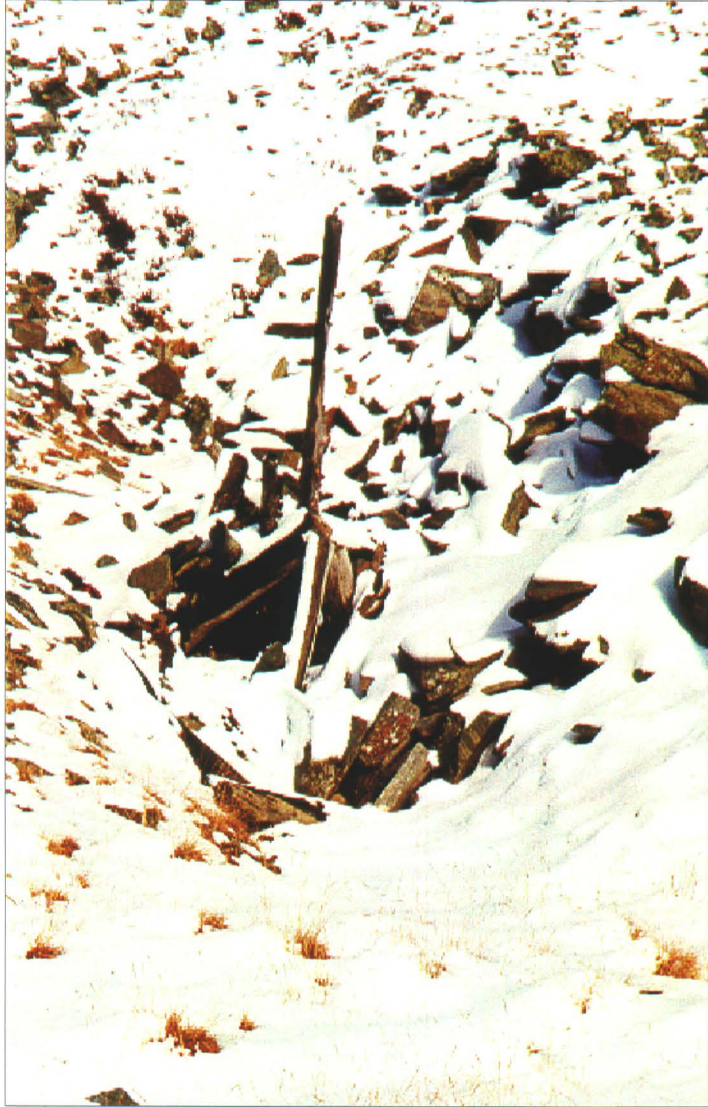
No. 5-2 Vein Adit, Upper and Lower No. 4 Vein Adits (Photo 36-1)

Supports: The portal to the adit was supported by log cribbing.

Condition: The log cribbing has collapsed and there is roughly 2m³ of wood debris scattered around the adit.

Accessibility: The adit cannot be accessed.

Photo 36-1 : Keno No.9 Collapsed log timbers mark the location of the No.5-2 Vein Adit. (Azimuth 025°)

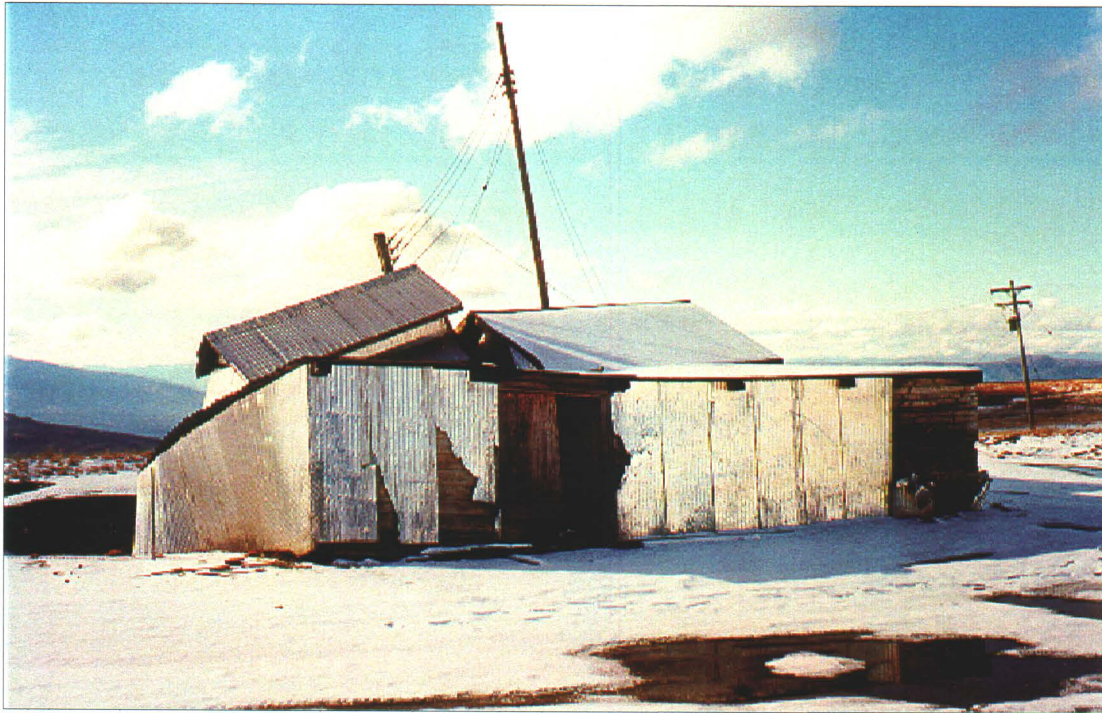
Shamrock J18 Covered Raise (Photo 36-2)

Condition: The ground around the raise and building covering it are unstable and collapsing. An area of approximately 7m by 10 m has collapsed.

Accessibility: The building can be accessed. The raise and the collapsed area around it have been fenced off.

6.1 Building 32A (Photos 36-2)

A wood frame building clad in corrugated steel covers Shamrock J18 Raise. Part of the building and the underground workings below it have collapsed and are fenced off.

Asbestos: The interior of the building is clad in a gyprock with asbestos coating.

Condition: Half the building is unstable and has partially collapsed into the underground workings below.

The transformer on a power pole near the Shamrock J18 Raise Building is suspected of containing PCB's based on its age. Other potential contaminants of concern include any metals washing off the pit or trench walls and from the waste rock piles.

Photo 36-2 : Keno No.9 Shamrock J18 Vein Raise Building (36-A). Note collapse of building into failing underground workings and fencing around opening. Also, transformer on power pole in background. (Azimuth 290o).

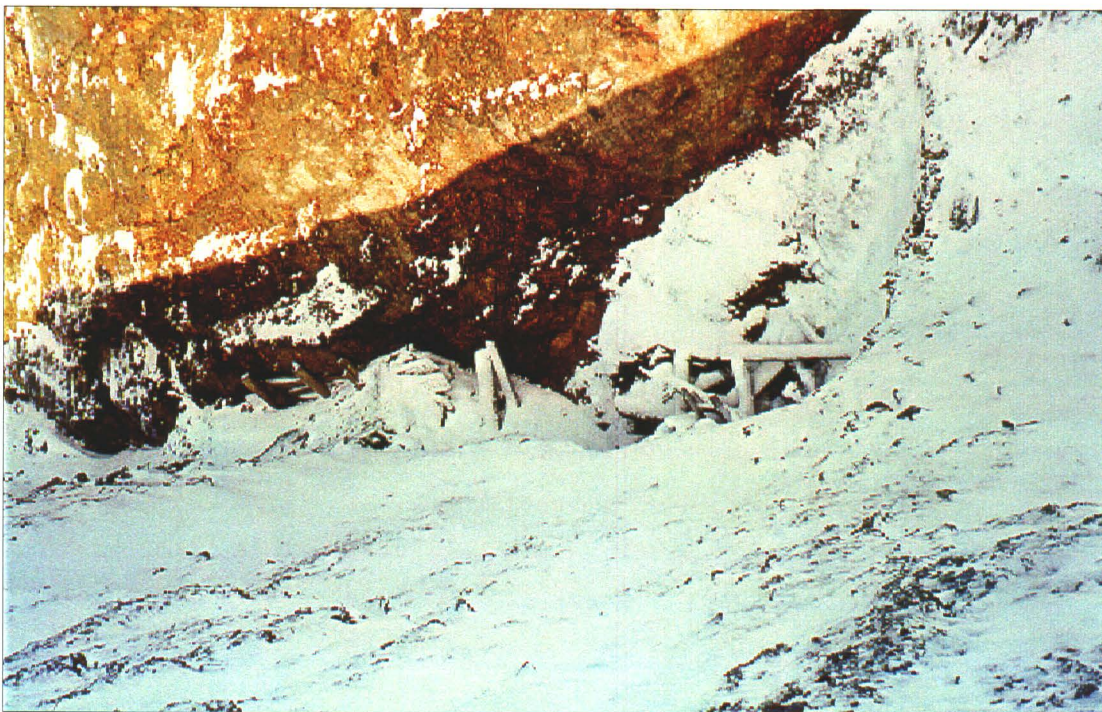
No. 3 Vein Adit (Photo 36-3)

The excavation of the No. 3 Vein Open Pit exposed an adit from earlier development. An adit was reportedly uncovered in the base of the No.9 Vein Open Pit, but has been recovered by loose rock.

Condition: The support structure for the adit has been broken up by the later pitting.

Accessibility: The adit cannot be accessed.

Photo 36-3 : Keno No.9 The log square sets and ladders of the No.3 Vein Adit exposed in the bottom of the No.3 Vein Pit. (Azimuth ~350°)

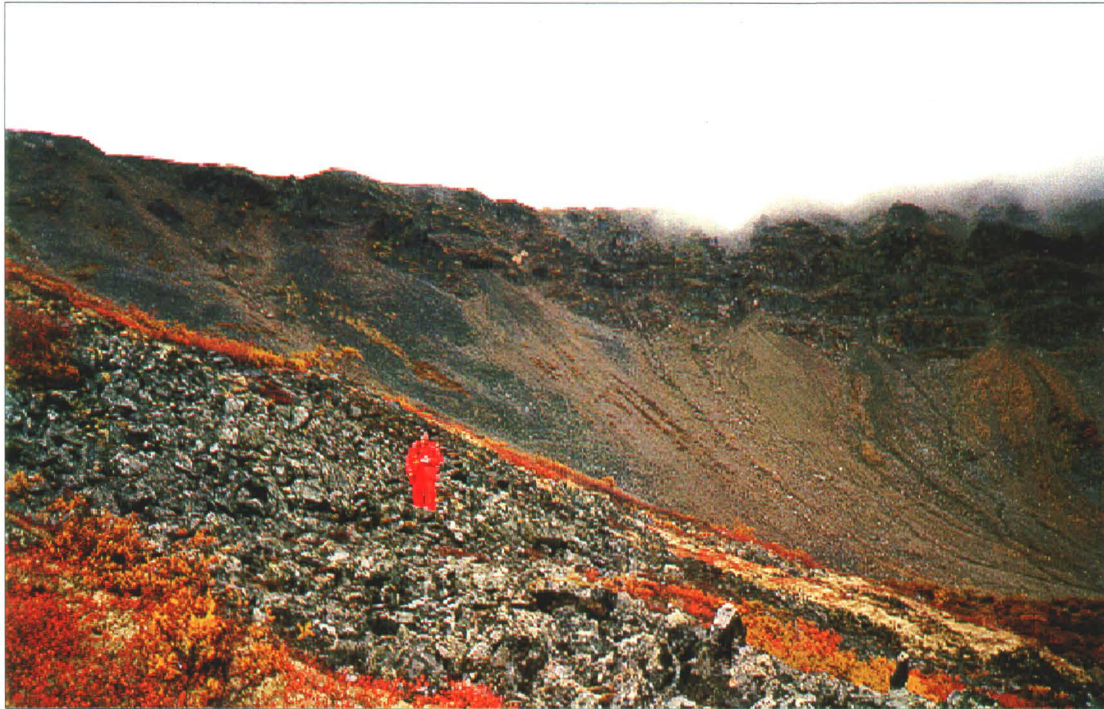
Faro Gulch Portal (Photo 36-4)

Supports: The portal is constructed with square set timbers.

Condition: Condition of the portal structure is not known.

Accessibility: The portal is not easily accessed, although hikers could climb up the scree slopes from below.

5.2 Waste Rock Disposal Areas (Photo 36-4)

Description: Roughly 4,500m³ composed of chlorite-sericite and carbonaceous schist, thick-banded quartzite and minor greenstone. Located on large scree slopes of similar composition

Photo 36-4 : Keno No.9 Faro Gulch cirque headwall with Faro Gulch Portal / Dump shed visible above person. Cuts along skyline left of person are (from left to right), No. 9 Vein and No.3 Vein Pits. Note waste rock dumps associated with each of the Pits and the Portal. Also note meltwater channels in waste rock from the No.3 and No.9 Vein Pits.

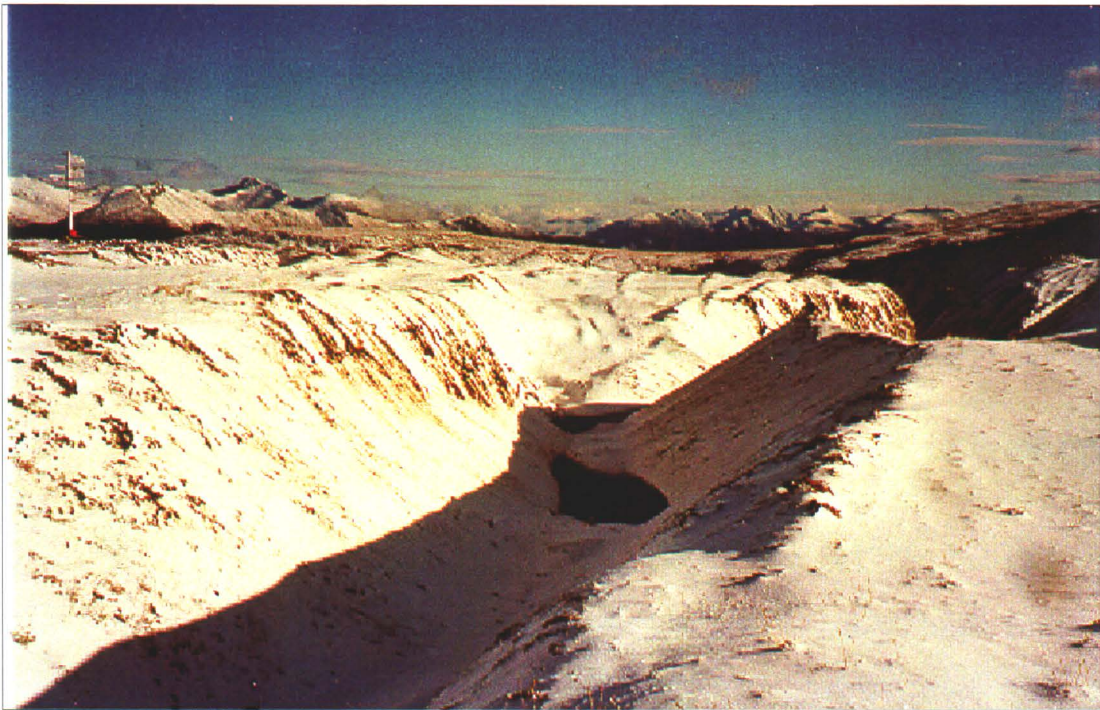
No. 3 Vein Open Pit (Photos 36-3, 36-5)

To the east of the Signpost is a 'Y-shaped' open pit excavated on the No. 3 Vein. The north end of the pit opens up into the Faro Gulch cirque. There are three ponds at the base of the pit.

Condition: The pit walls were stable at the time of the site visit.

Photo 36-5 : Keno No.9 No.3 Open Pit. Note signpost on the left hand side and two of three ponds present.

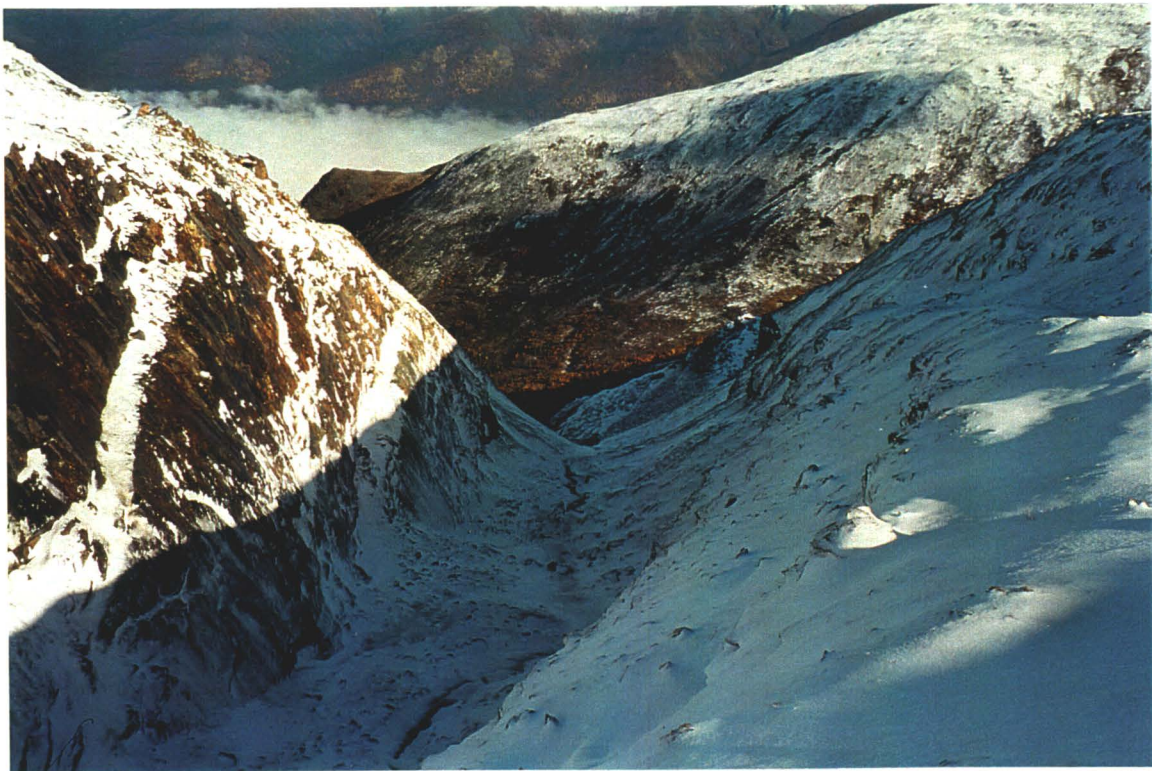
Photo 36-6 : Keno No.9 No.9 Vein Open Pit.

No. 9 Vein Open Pit (Photo 36-6)

Condition: The boulders at the bottom of the trench likely are from the steep western pit wall. The pit wall is fairly stable but given the boulders at the base, occasional rocks do break off. The eastern wall is a gentler slope and appeared stable at the time of the site visit.

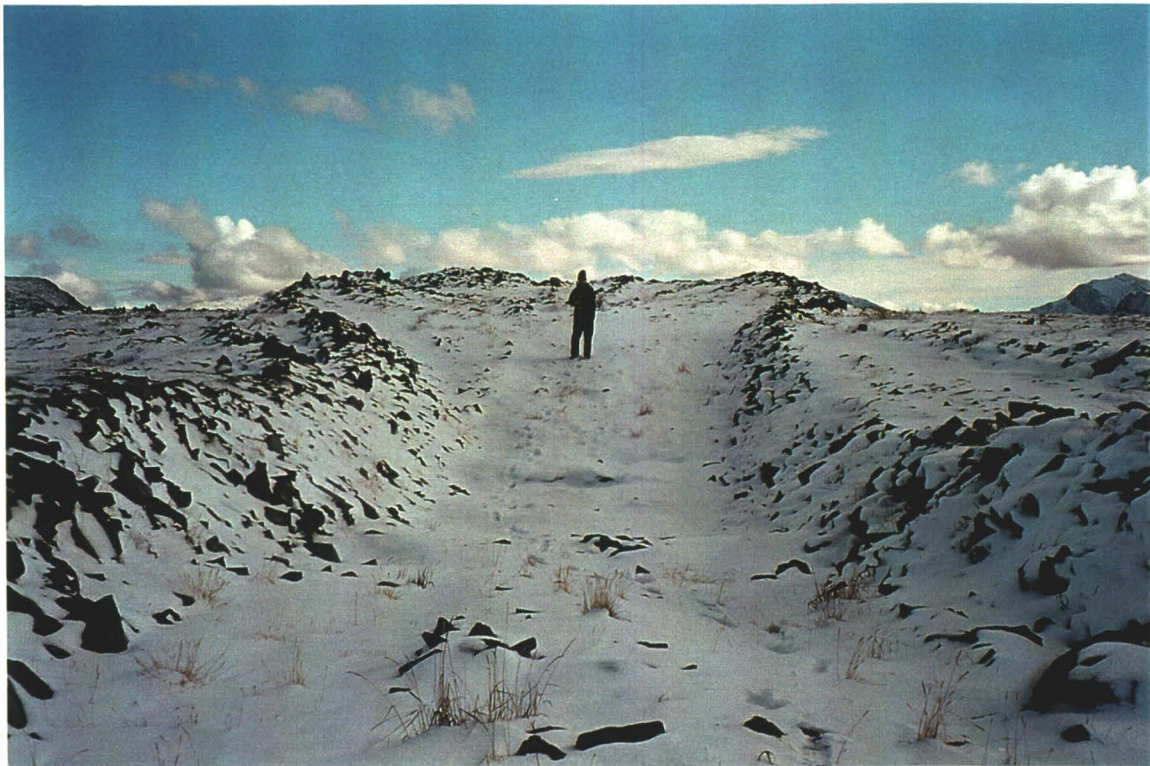
Trenches (Photo 36-7)

Eight trenches were examined extending southwest along the trend of the No. 4 and No. 5 Veins over the Keno Hill Summit from the Signpost. The trenches varied in length from 26m to 70m, in width from 1m to 5m (5m average) and in depth from 1m to 3m. The trench walls appeared stable at the time of the site visit and the trenches could be easily accessed. All the trenches, except Trench L3, were cut by a bulldozer.

Photo 36-7 : Keno No.9 View of Trench L5 located on the No.4 vein. (Azimuth130°)

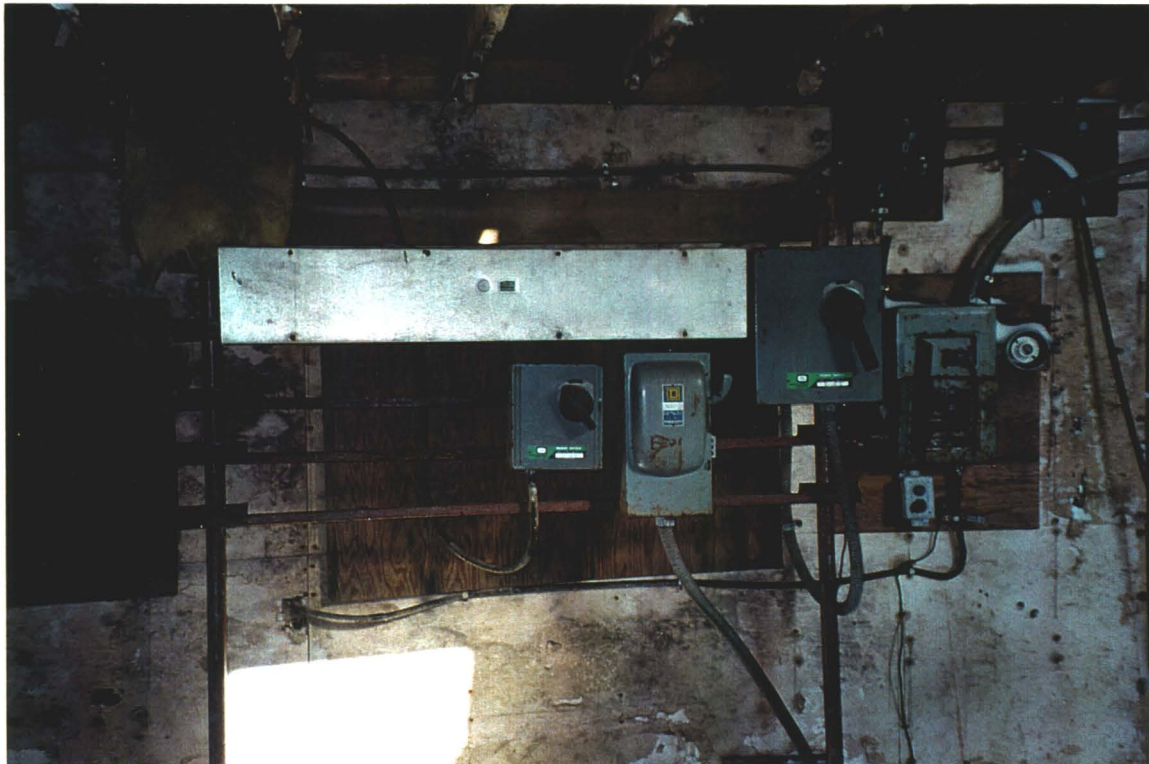
6.2 Electrical Equipment (Photo 36-2, 36-8)

There is a power line that roughly follows the Signpost Road and goes from Keno City to the Shamrock J18 Raise Building. One of the poles beside the building has a transformer on it. An electrical panel is present in the Raise Building (Building 36A).

Photo 36-8: Keno No. 9 Electrical panel inside Building 36A.
