CARIBOU and ALICE

SITE #39

MINFILE# 105M 001ax, aw (105M 062)

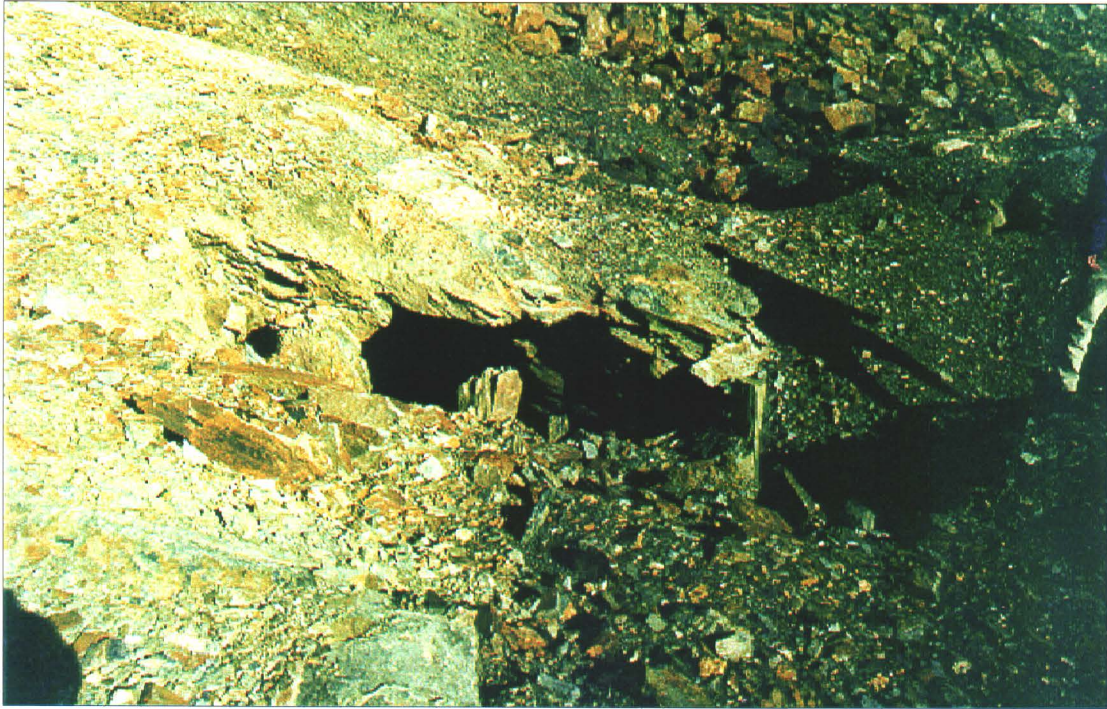
Caribou Adit (photo 39-1)

Surface stripping has exposed part of the adit, at least 10m from the portal. The support structure at the portal of the adit has likely been buried by the bulldozer trenching. The dimensions of the adit could not be determined. There is no evidence of the adit collapsing, however it is difficult to determine since the area around the adit has been extensively worked. The adit cannot be accessed.

Photo 39-1 : Caribou. Caribou adit; portal exposed by bedrock striping. (Azimuth 080 °)

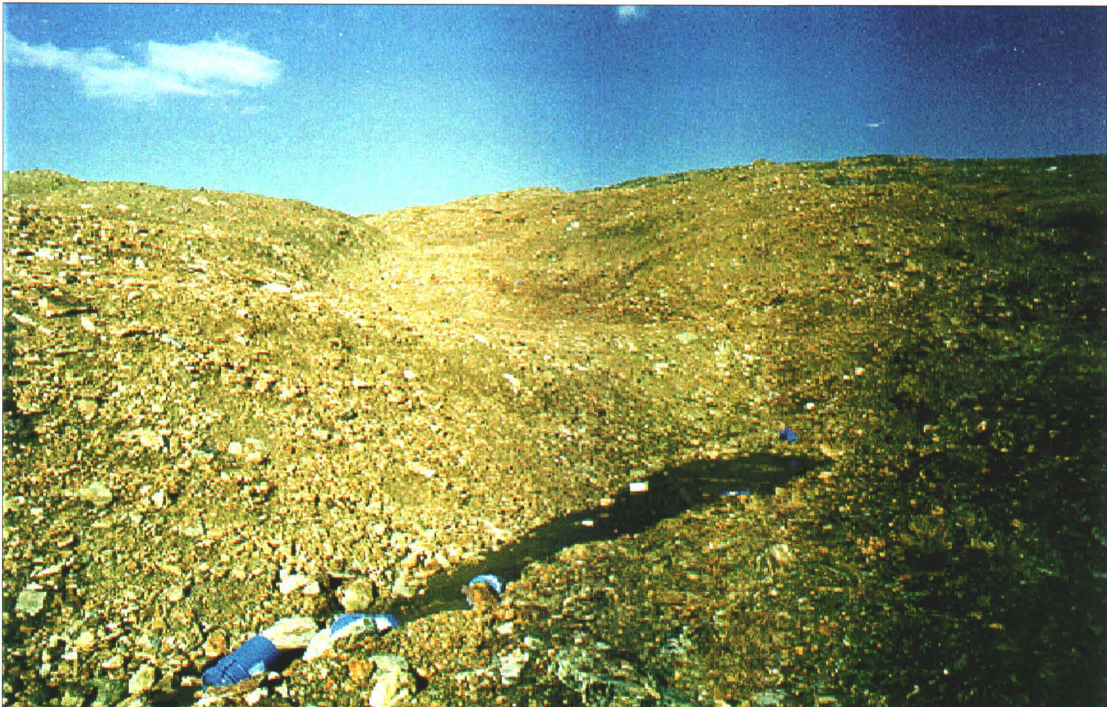
Trenches (photo 39-2)

There were four trenches examined. Trench #1 is a single about 65m in length, bulldozer trench located at the rim of the cirque, 50 m east of Caribou Hill summit. Trench #2 is a 30m by 40m area at the rim of the cirque, approximately 100m west of Caribou Hill summit, where the bulldozer has stripped to expose bedrock. There are two trenches near the Caribou Adit. Trench #3 is 67m in length, 4-13m in width and up to 8m high. At the south end of the Trench #3 is Trench #4, measuring 33m in length and 3m wide, which was filled with ponded water at the time of the site visit.

Photo 39-2 : Caribou. View of bedrock trench at Caribou. Note empty plastic pails and water sample site in foreground. (Azimuth ~000 °)
