**DIVIDE**  
**SITE #40**  
**MINFILE# 105m 001ay**

Public Works And Government Services Canada	Travaux publics et Services gouvernementaux Canada	designed by:	
		conçu par:	
Architecture & Engineering Services Western Region		drawn by:	C.S.
		dessiné par:	Nov. / 99
Drawing title: <b>Divide Site #40 Site Assessment</b> Yukon Territory	Titre du dessin: 	approved by:	
		approuvé par:	
		revisions:	
		project no. no. du projet:	125-12.01
		dwg. no. dessin no.:	1 of 1

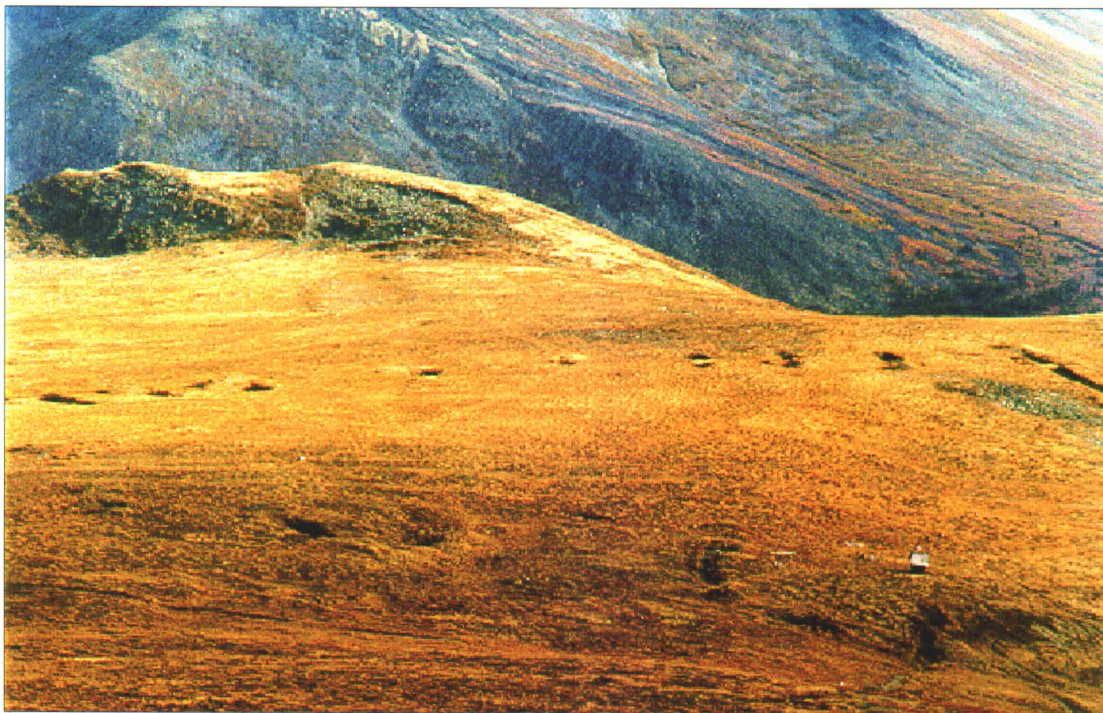
Bulldozer trenches were examined in three areas, which for this report are referred to as Zones 'A', 'B' and 'C'. Zone 'B' is sub-parallel and approximately 300m south of Zone 'A'. Zone 'C', consisting of a single trench, is located approximately 600m east of Zone 'B'. A total of 17 trenches were observed.

Photo 40-1 : Divide. View to southeast of trench areas. B (background) and C (foreground) at Divide. Note Building 40A in bottom right. (Azimuth 120°)

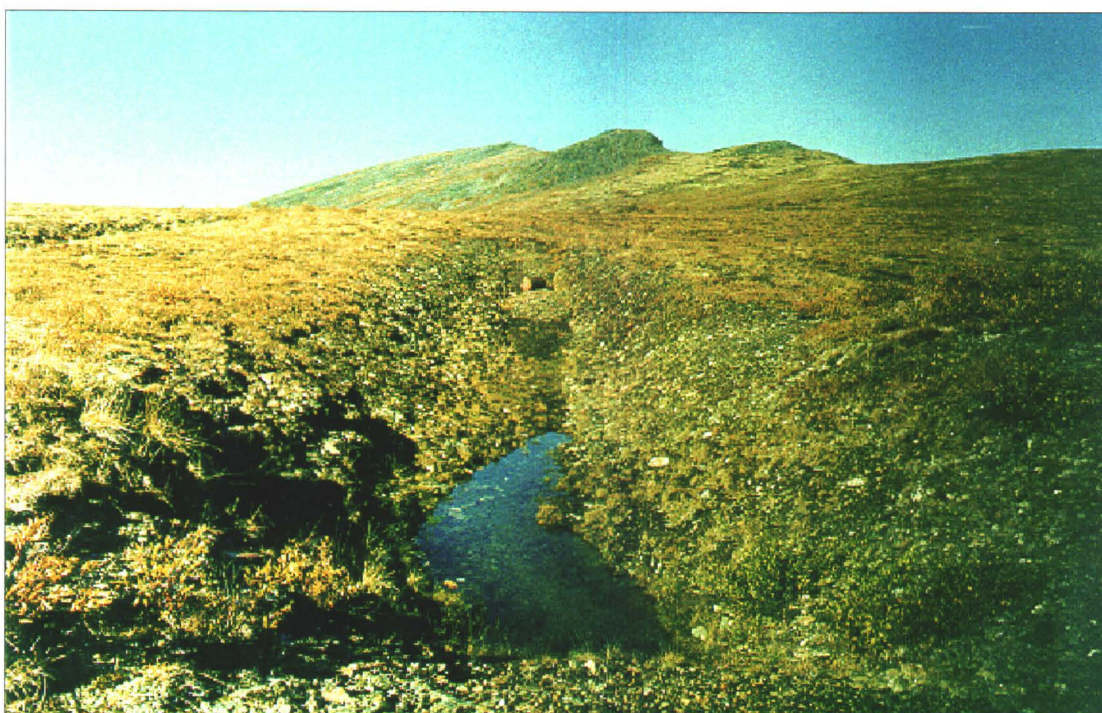
There are 13 trenches in zone 'B'. The trenches vary in width from 1 to 4m, in height from 1 to 2.5m and in length from 8 to 100m. All of the trenches were excavated in phyllite containing minor amounts of siderite and quartz veining. Trenches B7 to B10 had ponded water at the bottom.

There were 6 empty fuel drums encountered around Building 40A. One capped 45-gallon drum approximately one quarter full of diesel was encountered in trench B10.

Photo 40-2 : Divide. Trench B10: note ponded water and partially full barrel. (Azimuth 290°)

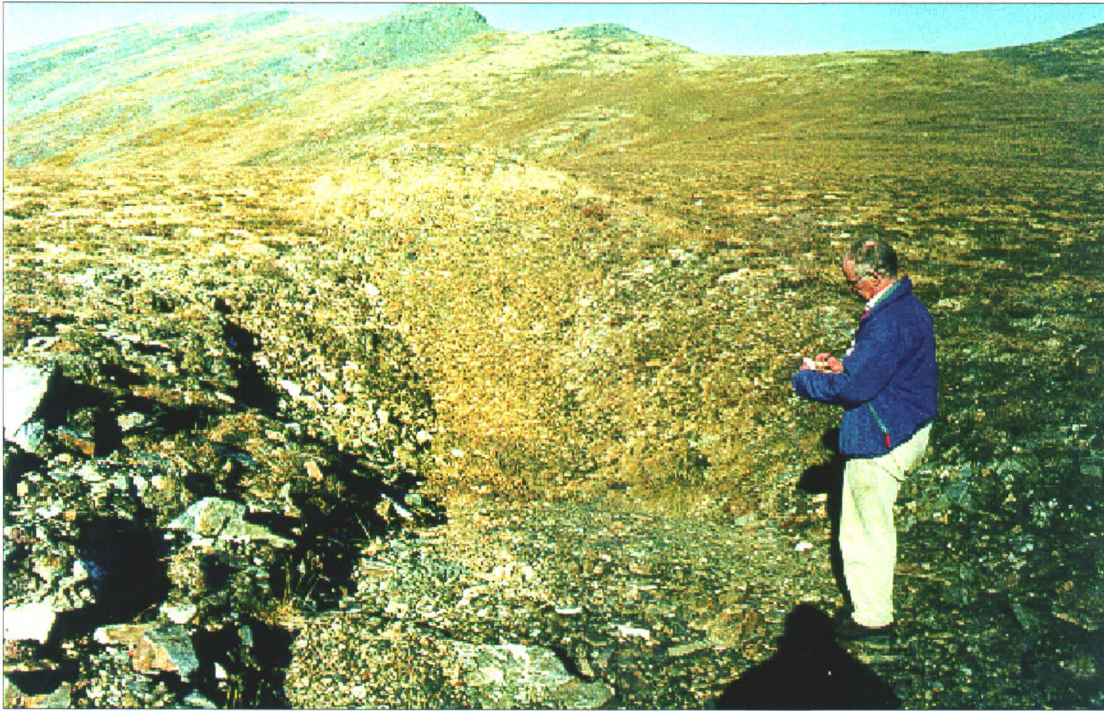
There are small piles of waste rock comprised of overburden and some bedrock that are deposited to the sides and ends of the trenches. Most of the piles are overgrown with grasses. A sample (Divide-Waste Rock-Sept.14/99) of the wallrock in trench B6 was collected for analysis.

Photo 40-3 : Divide. Trench b6; site of rock sample Divide-Waste Rock - Sept.14/94.  
Note building 40A in center background. (Azimuth ~130 °)

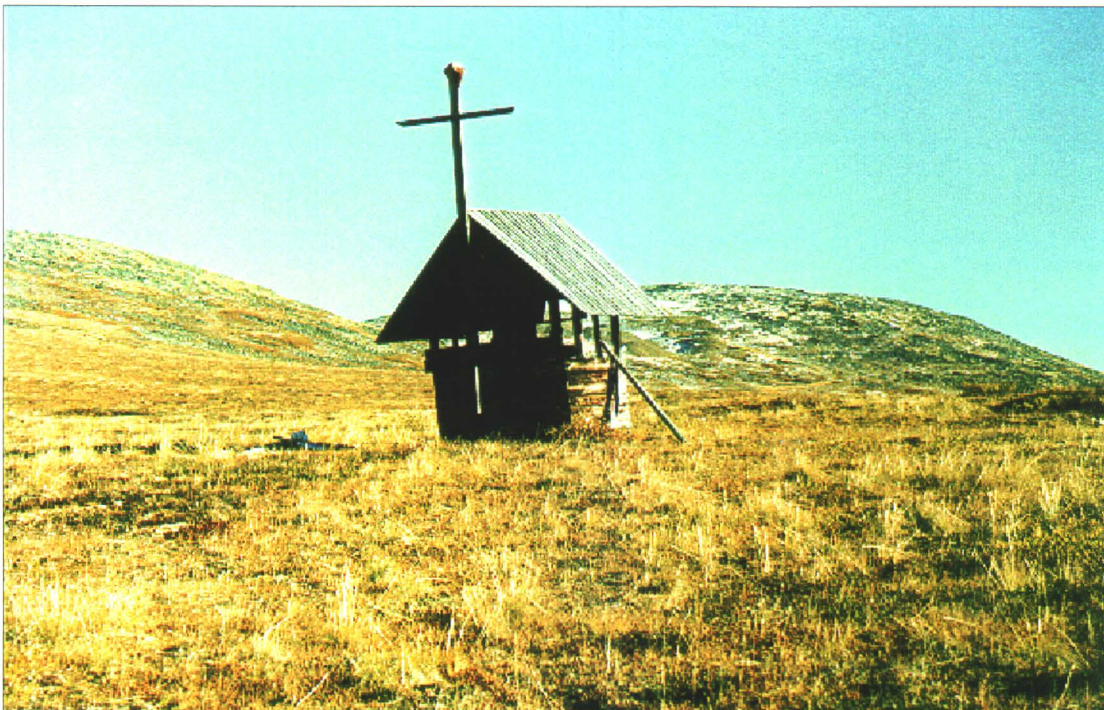
There is a small wood frame building with a corrugated tin roof located near zone 'A' and roughly 250m east of the headwaters to Hope Gulch. The building has a large wooden cross attached to the top of the roof.

Photo 40-4 : Divide. View of Building 40A. (Azimuth ~050 °)
