DEVON
SITE #41
MINFILE# 105M 001az

Public Works And Government Services Canada	Traux publics et Services gouvernementaux Canada	designed by:	date:
	Architectural & Engineering Services Western Region		conçu par:	
Drawing title:		Titré du dessin:		drawn by:
Devon Site #41 Site Assessment Yukon Territory				C.S. NOV. /99
project no. no. du projet:		125-12.01		approved by:
				approve par:
				revisions:
				dwg. no. dessin no.
				1 of 1

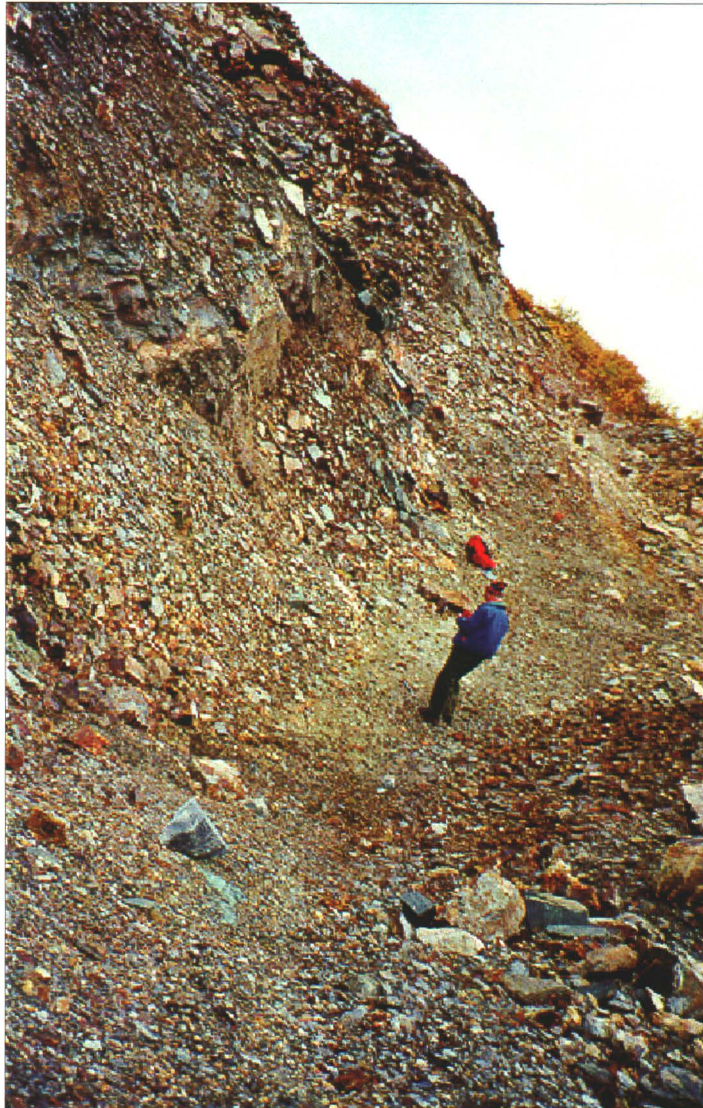
Trenches (photo 41-1)

There are three trenches to the east of the adit. The walls of the trenches are comprised of stripped overburden and bedrock and appeared stable at the time of the site visit. All three trenches are roughly 5m wide by a maximum of 4m high. The first two trenches (T1 and T2) measure about 30m in length and the third trench (T3) about 65m in length. All three trenches were accessible by foot.

Photo 41-1 : Devon. View of Trench #3. (Azimuth 052°)

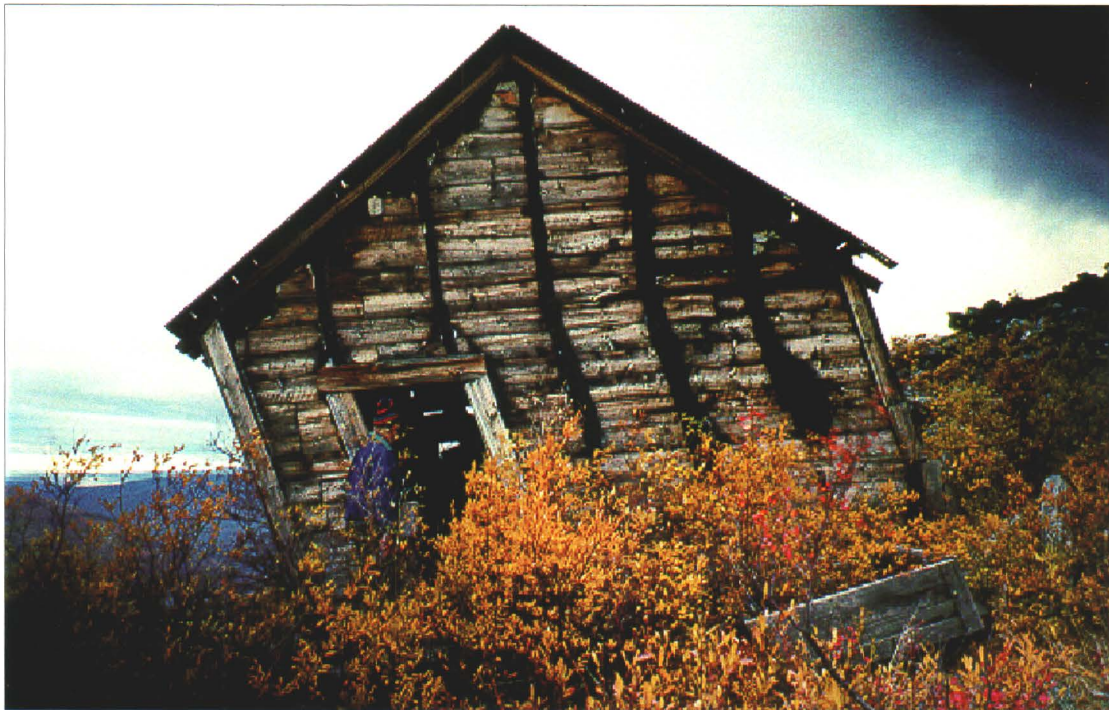
6.1 Building 41A (photo 41-2)

There is an old frame (heavy timber structure) cabin located about 10m to the south of the adit.

Asbestos: There was some asbestos tar paper cladding on the building and on the ground.

Photo 41-2 : Devon. Building 41A, located 10m south of the Adit.. (Azimuth 280°)
