MT. HINTON (#68)
MINFILE# 105M 052

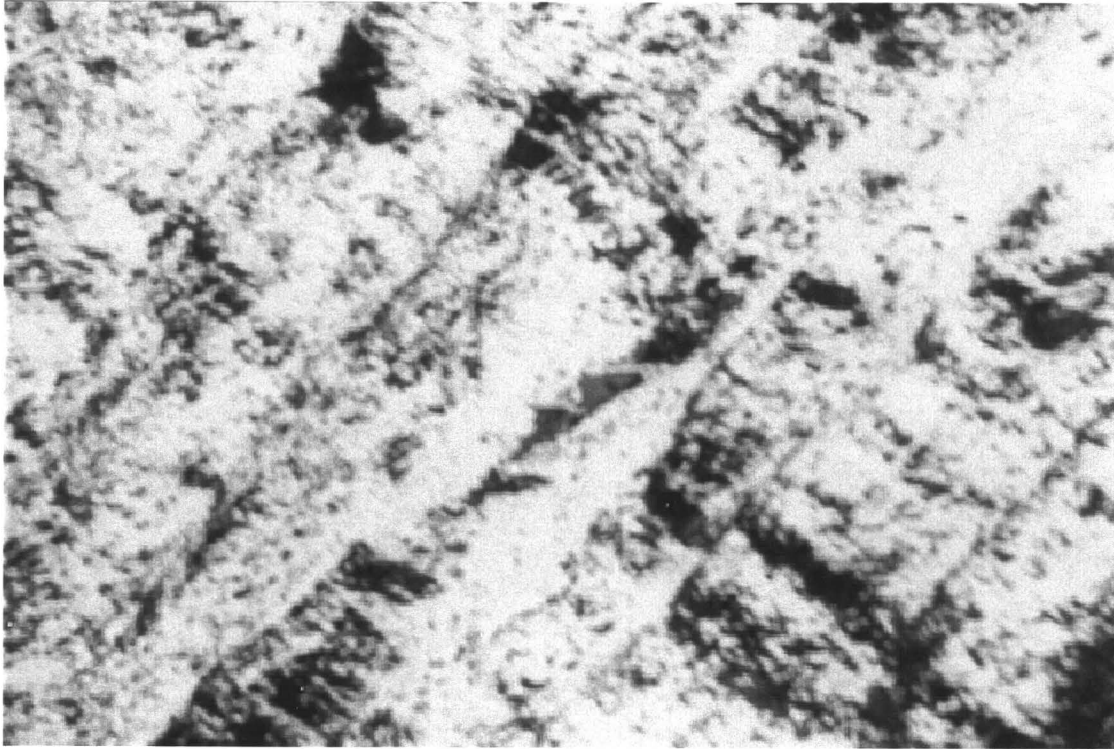
Poor flying conditions prevented access to the site and exploration of the mine workings. The minfile reports that the Mt. Hinton site has two adits and a shaft. It appears as if there is an adit at

the Northeast occurrence (photo 68-1). The Centre occurrence appears to be the site of a shaft and possibly an adit (photo 68-2). The Southwest occurrence was not observed.

Photo 68-1: Aerial photograph of Mt. Hinton Adit1 located at centre of photograph.

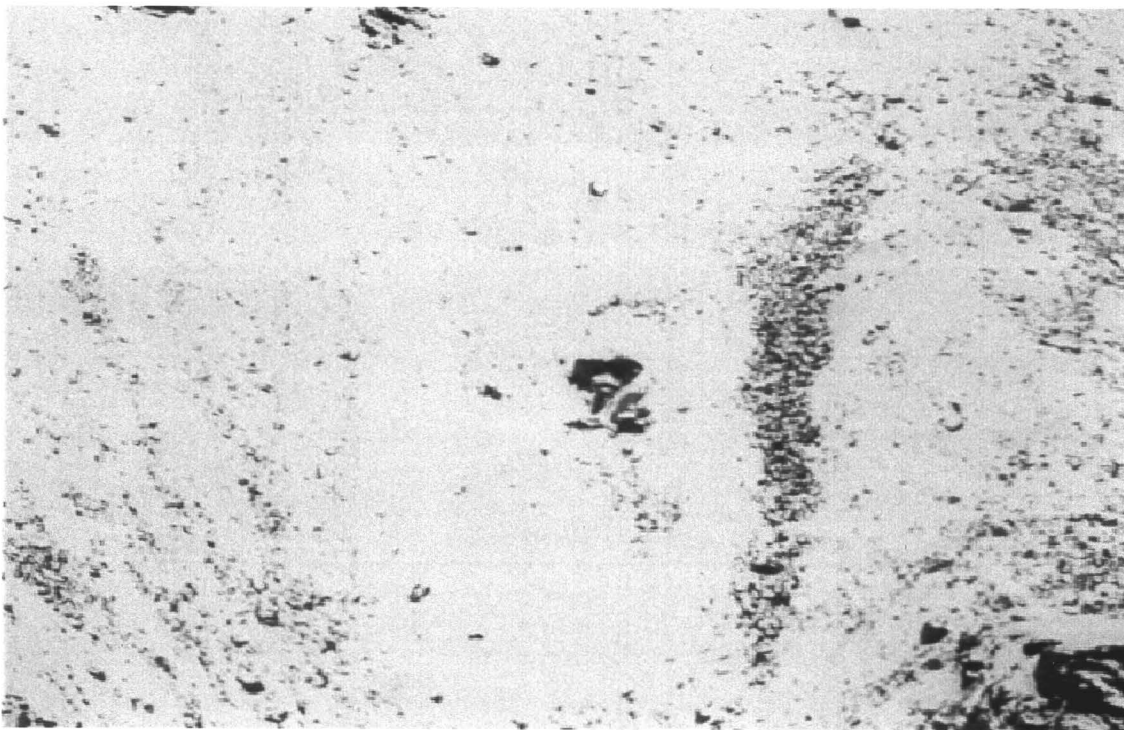
Photo 68-1: Aerial photograph of Mt. Hinton Adit2 located at centre of photograph.
