FAITH (DUNCAN)

SITE #42

MINFILE# 105M 002

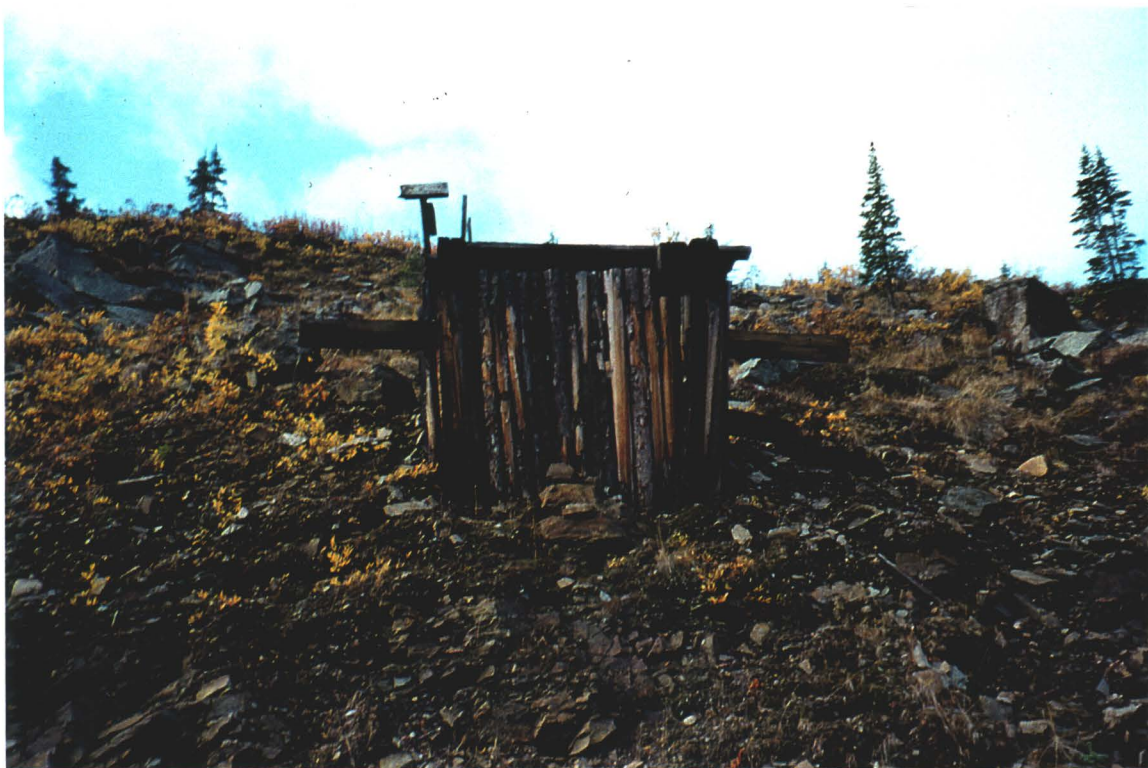
Faith Shaft (Figure 1; Photo 42-1)

The shaft is located at the eastern end of the site, roughly 100m south of Faith Gulch. The shaft is inclined at 80° to the south.

Dimensions: 2m x 2m, extending 1m above ground.

Supports: The collar is supported by timber cribbing and clad with vertical wooden poles.

Condition: The ground around the shaft appears stable.

Accessibility: The shaft is blocked 3m below the collar by collapsed rock and cannot be accessed beyond that point.

Photo 42-1 : Faith. Faith timber shaft cover building (Building 42-B). (Azimuth 200^o)

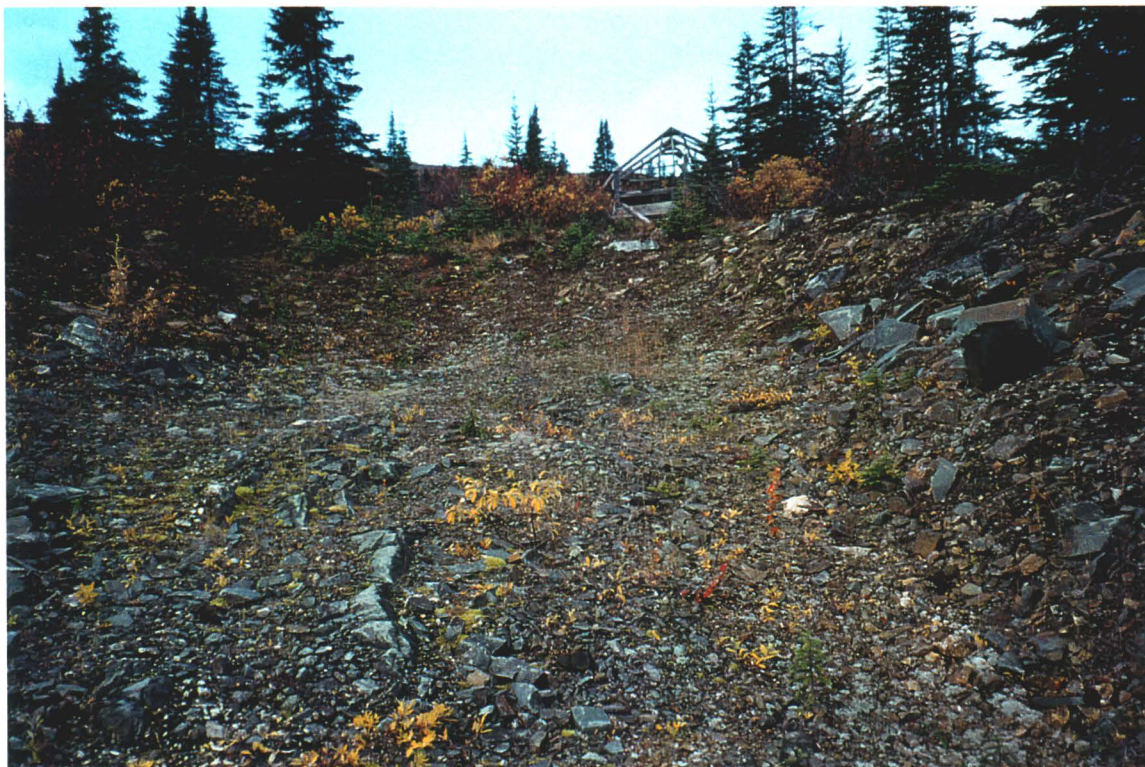
Trench #1 (Photo 42-2)

The trench is located roughly 160m southeast of the shaft, running azimuth 055° along the crest of the ridge. A small bull white quartz vein with minor limonite crosscuts the trench near the southwestern end.

Dimensions: 25m x 3m x 0.5m

Condition: There are no stability problems as the trench walls are shallow.

Accessibility: The trench can be easily accessed.

Photo 42-2 : Faith. View along trench (Trench #3) at tent brame (Building 42-A). (Azimuth 230^o)
