DUNCAN
SITE #43
MINFILE# 105M 003

Duncan Site #43
Site Assessment
 Yukon Territory

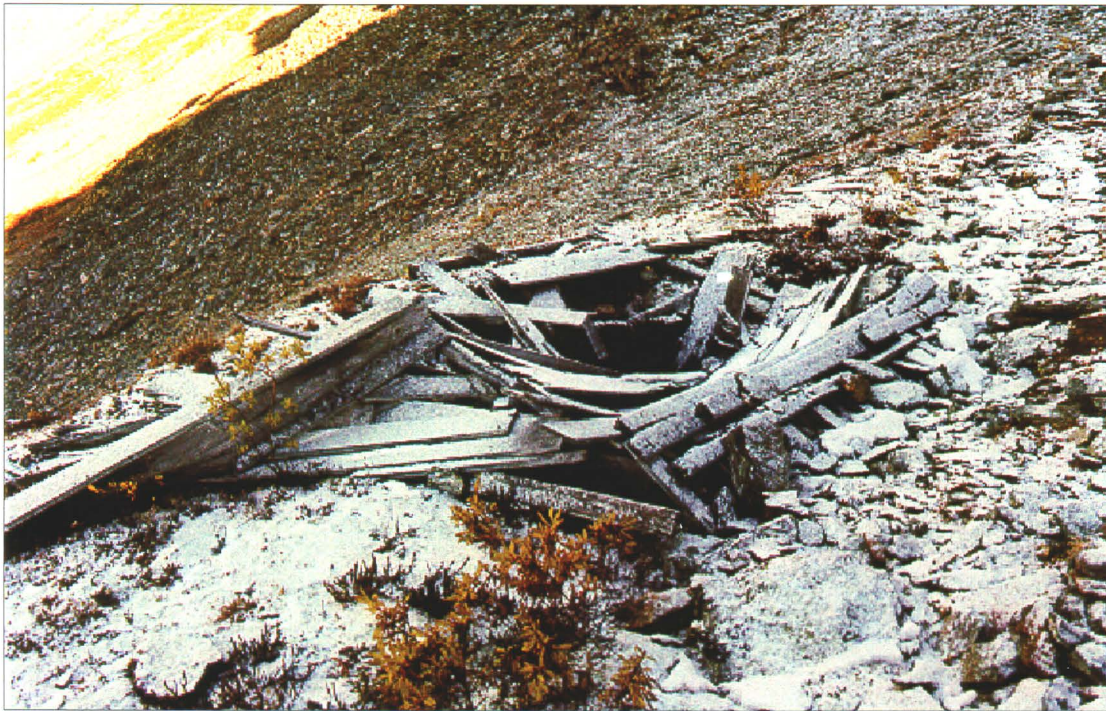
The shaft is located roughly 90m vertically below the rim of the cirque. It has collapsed approximately 1m below the collar. There is a windless and broken log cribbing at the entrance to the shaft.

Supports: The log cribbing has collapsed and blocks the entrance to the shaft.

Condition: The shaft is collapsed approximately 1m below the surface.

Accessibility: The shaft could not be accessed.

Photo 43-1 : Duncan. Collapsed shaft with windlass still in place across the top. (Azimuth $\sim 090^\circ$)

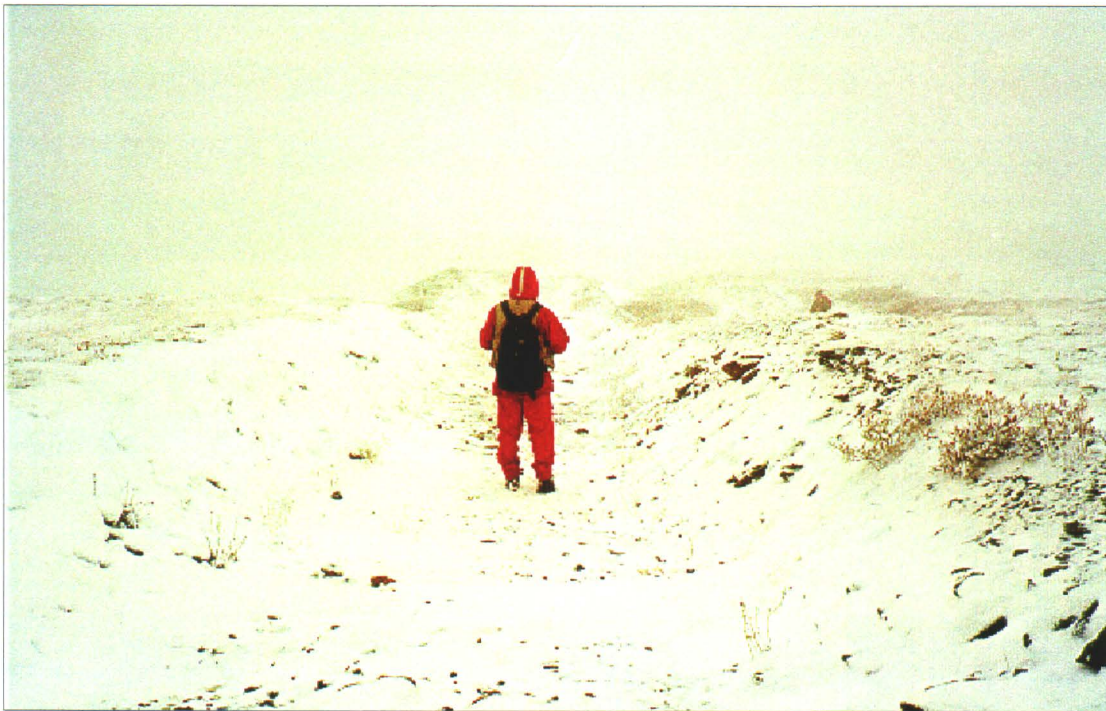
Trench #3 is 5m to the east of trench #2, immediately south of the cirque rim.

Condition: The trench appeared stable at the time of the site visit.

Photo 43-2 : Duncan. Trench #3 with waste rock pile at the end. (Azimuth 215°)

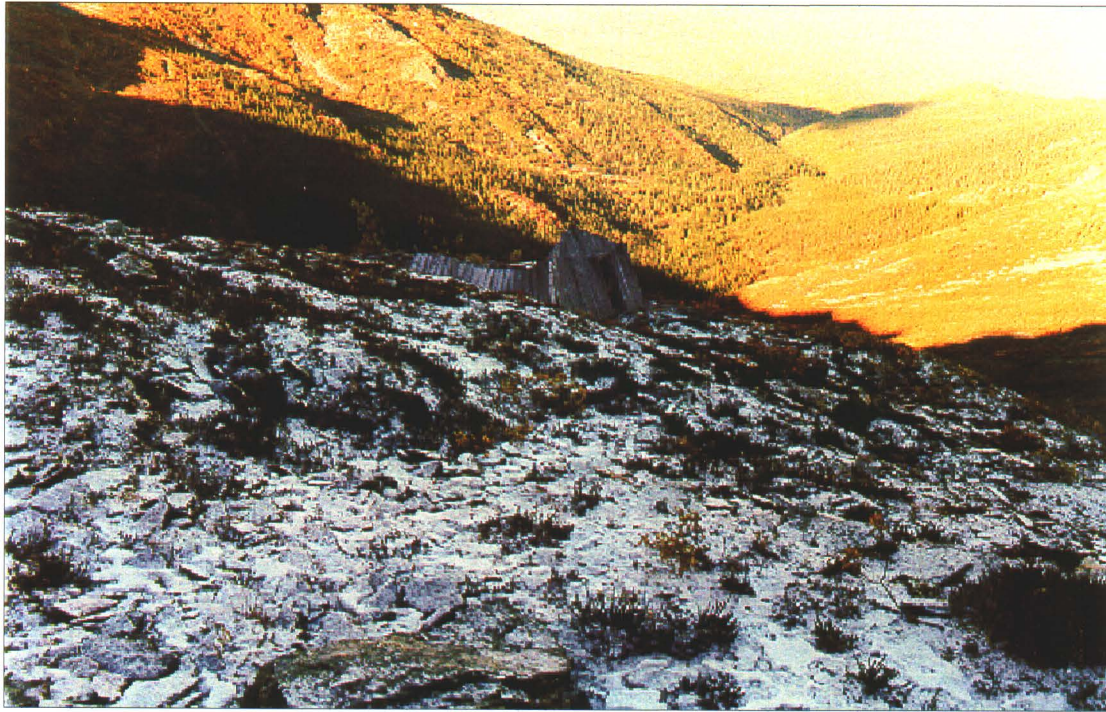
One collapsed wood frame building was noted on site located 25m northwest of the shaft.

Photo 43-3 : Duncan. View of Building 43A. (Azimuth $\sim 300^\circ$)
