SILVER BASIN
SITE #45
MINFILE# 105M 005

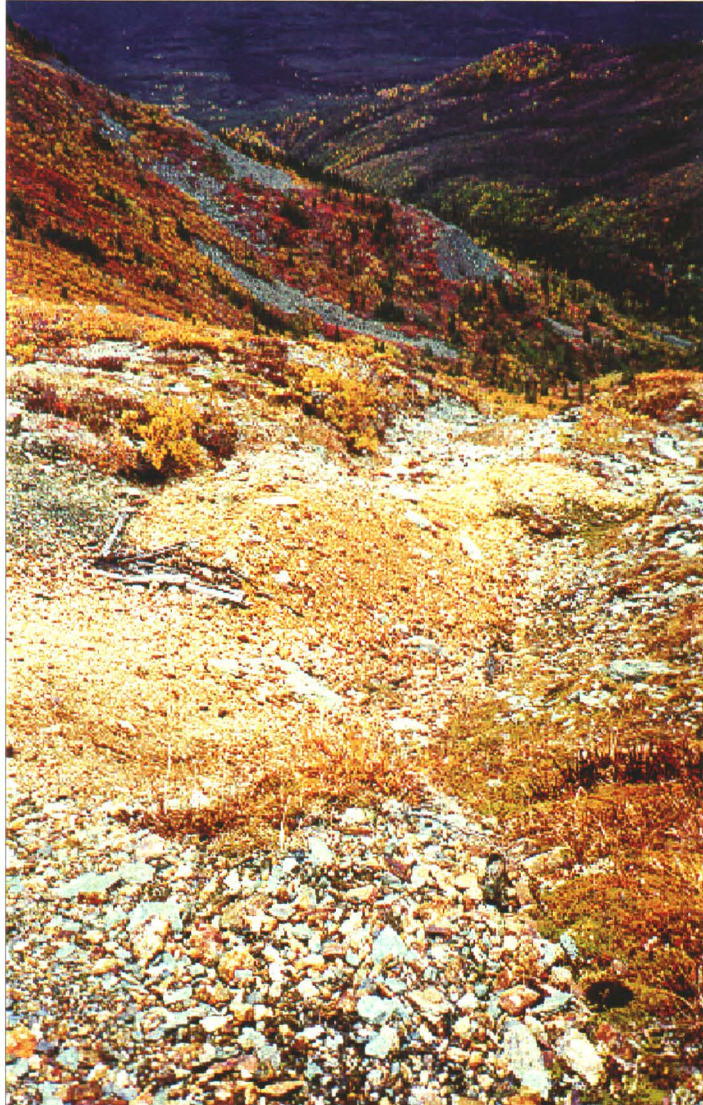
Shaft #1 (photo 45-1)

The hand shaft is collared in Keno Hill Quartzite. It has collapsed approximately 1m below the surface. From the amount of material in the waste rock pile, the shaft was originally approximately 3m deep. The shaft is located roughly 200m east of Silver Basin Gulch Trail.

Supports: The shaft is supported by log cribbing.

Accessibility: The shaft cannot be accessed.

Photo 45-1 : Silver Basin. The pile of logs is the remains of a shallow shaft, Silver Basin Gulch is in the background. (Azimuth $\sim 090^{\circ}$)

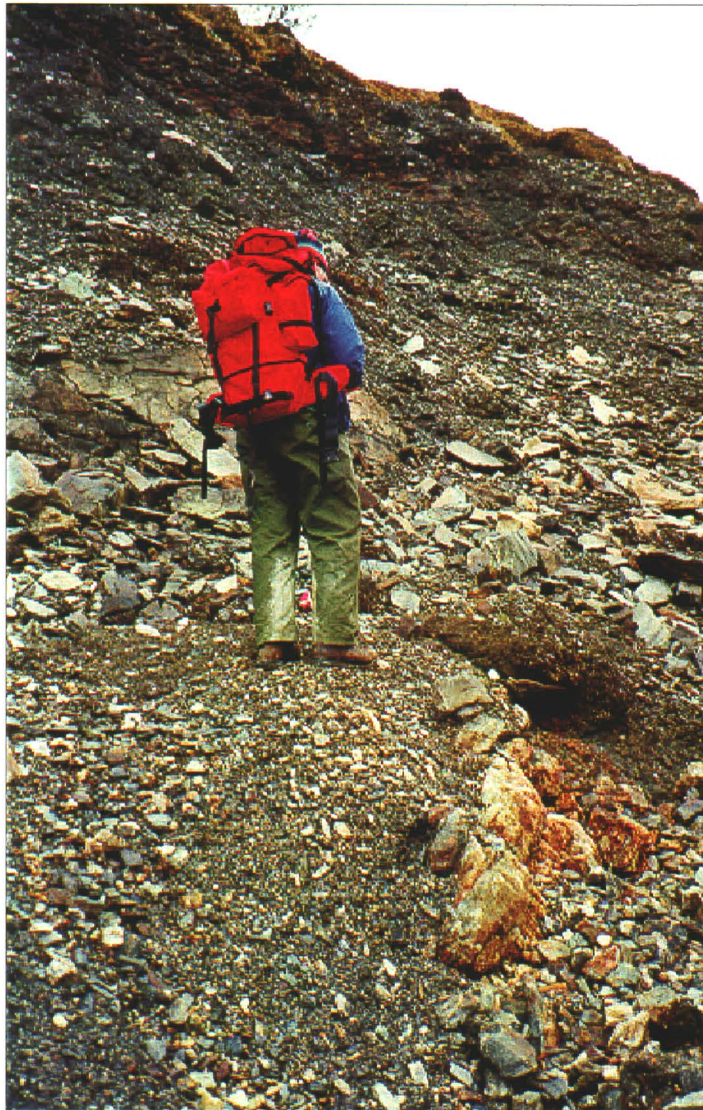
Trench #2 (photo 45-3)

The trench is located on a moderately dipping (30°) east facing slope on the southeast side of the Silver Basin Gulch Trail, 300m northeast of the shaft. A quartz vein is exposed in the upper and lower sections of the trench. There is a small trickle of water crossing the lower vein.

Condition: The trench walls are moderately steep and are composed of rock rubble and exposed bedrock. There is possibility of the walls slumping.

There is a small trickle of water flowing over the lower quartz vein in Trench #2. A water sample (Silver Basin F3 – Silver Basin – 99/09/17) was collected for analysis. The field pH was 5 and the conductivity 930µS/cm.

Photo 45-3 : Silver Basin. View of Trench #2. (Azimuth 316^o)

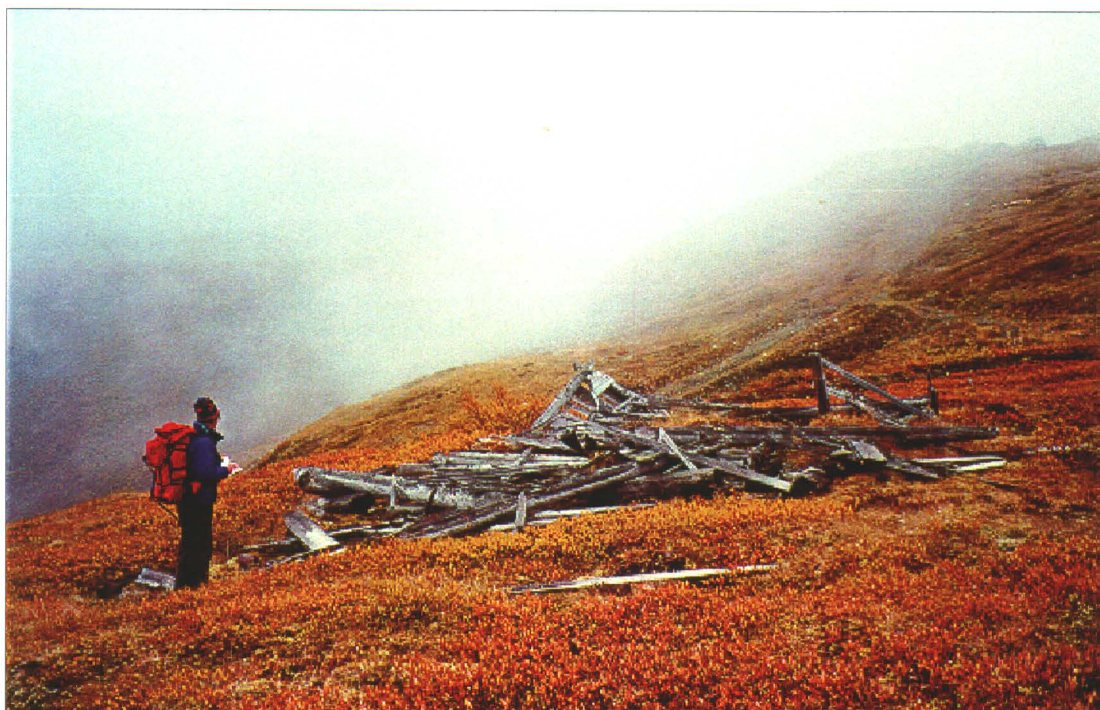
6.1 Building 45A (photo 45-4)

There is an old collapsed log and timber cabin located on the west side of Silver Gulch Trail.

Non-Hazardous Contents: A small volume of metal debris, mostly tin cans, was observed inside the cabin.

Photo 45-4 : Silver Basin. Collapsed log and timber cabin beside Silver Basin Gulch Trail.
(Azimuth $\sim 180^\circ$)
