NABOB
SITE #46
MINFILE# 105M 006

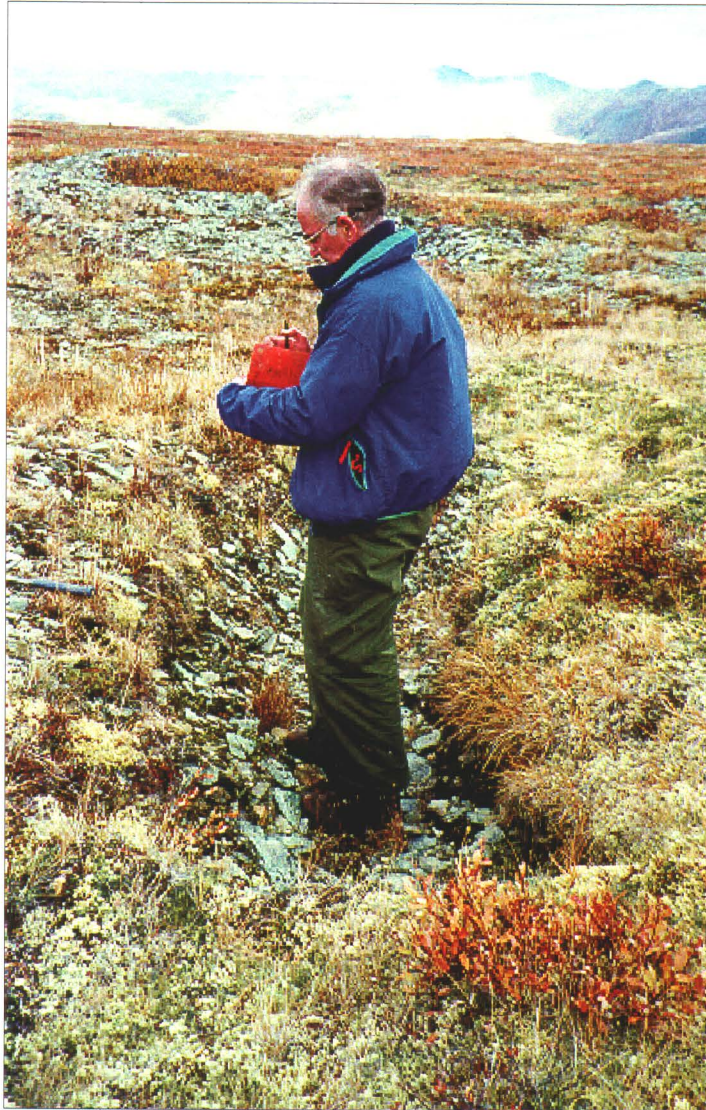
Trench #2 (photo 46-1)

This hand trench is dug into overburden. The trench is oriented at 010°.

Dimensions (L x W x H): 3m x 1m x 0.5m

Condition: The trench is very small and shallow and does not pose any stability concerns.

Photo 46-1 : Nabob. Small hand trench dug into overburden. (Azimuth 010 °)
