MONUMENT (& LADUE FRACTION)

SITE #47

MINFILE# 105M 007

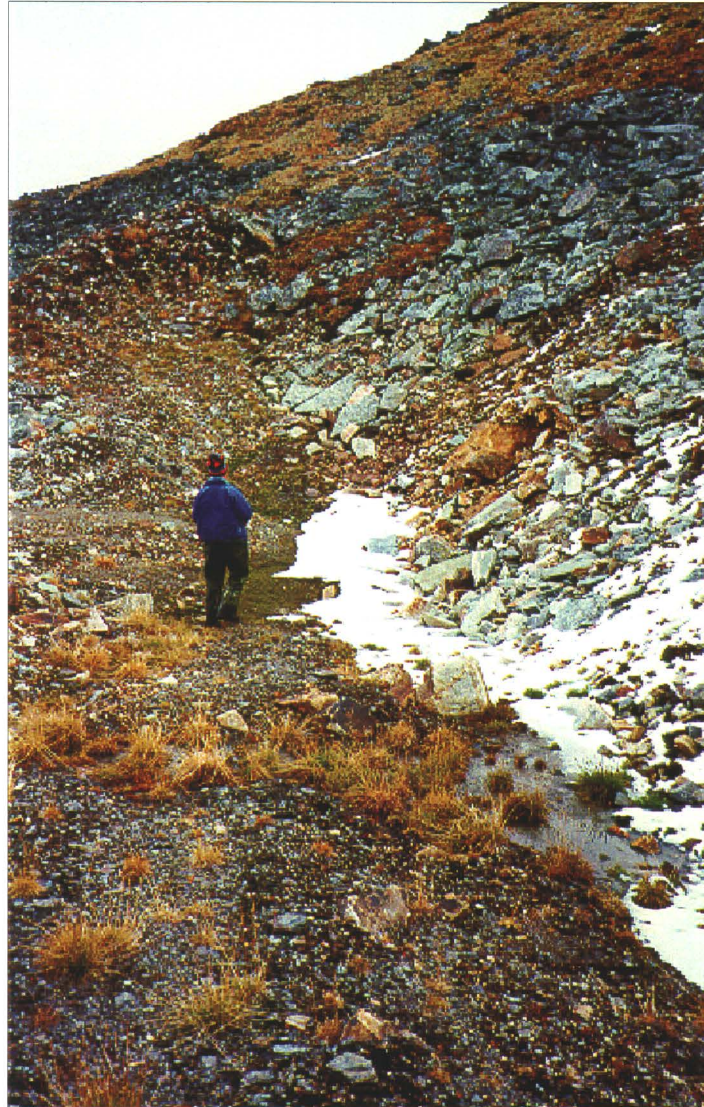
Trench #2 is located between Trench #1 and the road, at the eastern end of the site. The southern side of the trench is a moderately steep talus slope. At the time of the site visit there was a small pool of water in the bottom of the trench. A section of mud at the east end of the trench is interpreted as a fault.

Condition: The talus slope on the south side is moderately steep, but appeared stable. The wall on the north side is very low and does not pose any stability concerns.

Photo 47-1 : Monument and Ladue Fraction. View of Trench #2, note small pool of water at bottom of the trench. (Azimuth 076°)

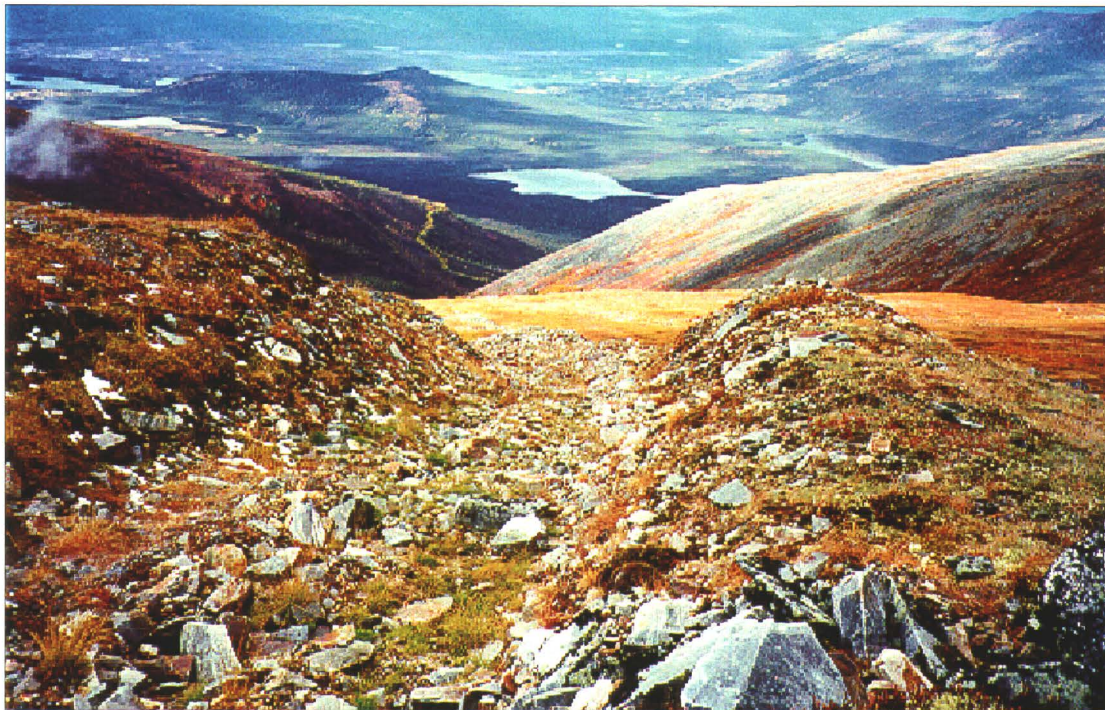
Trench #4 is 400m to the west of Trench #3, 150m from Silver Basin Gulch Trail. There is a 1m wide band of quartzite at the northwest end. The trench is oriented from 318° at the northwest end and doglegs to 342° at the south end.

Condition: The low trench walls pose no stability concerns.

Photo 47-2 : Monument and Ladue Fraction. View of Trench #4, Gambler Lake is in the background. (Azimuth 318^o)
