APEX (#48)
MINFILE# 105M 009

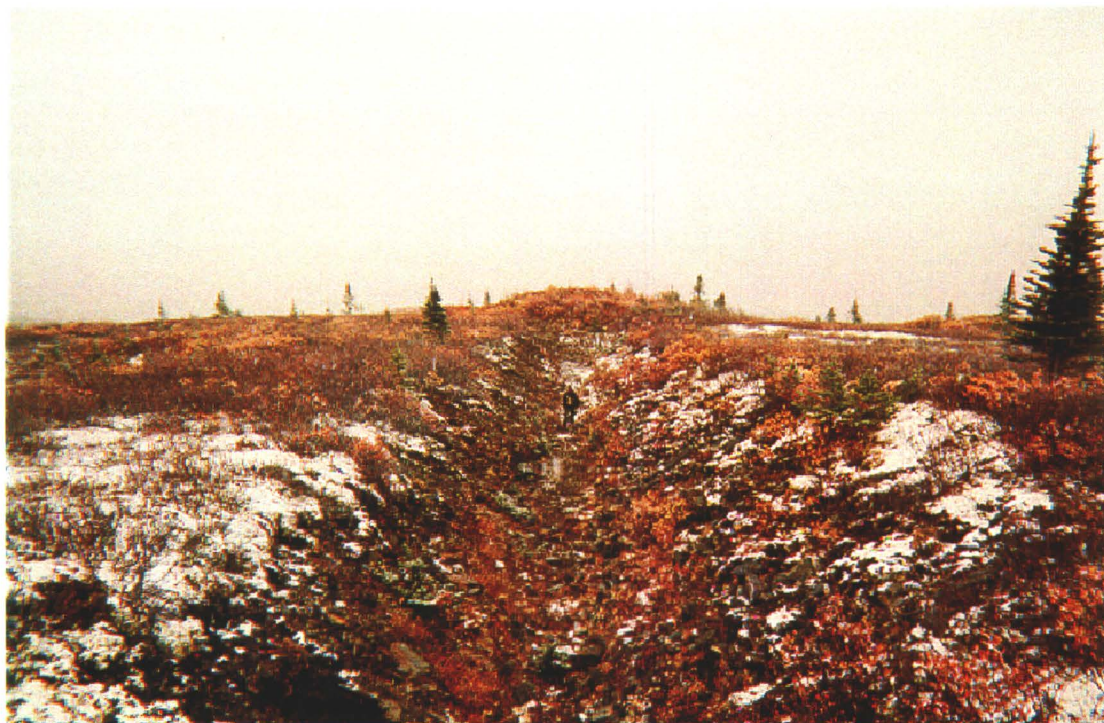
Trench 1 (photo 48-1)

Location: easternmost trench at the Apex site lying about 40 m west of Building 48A

Dimensions (L x W x H): 67 m x 4 m x 2 m - longitudinal bearing AZ 320

Condition: stable

Photo 48-1: View of Trench 1 at Apex site. (AZ 142)

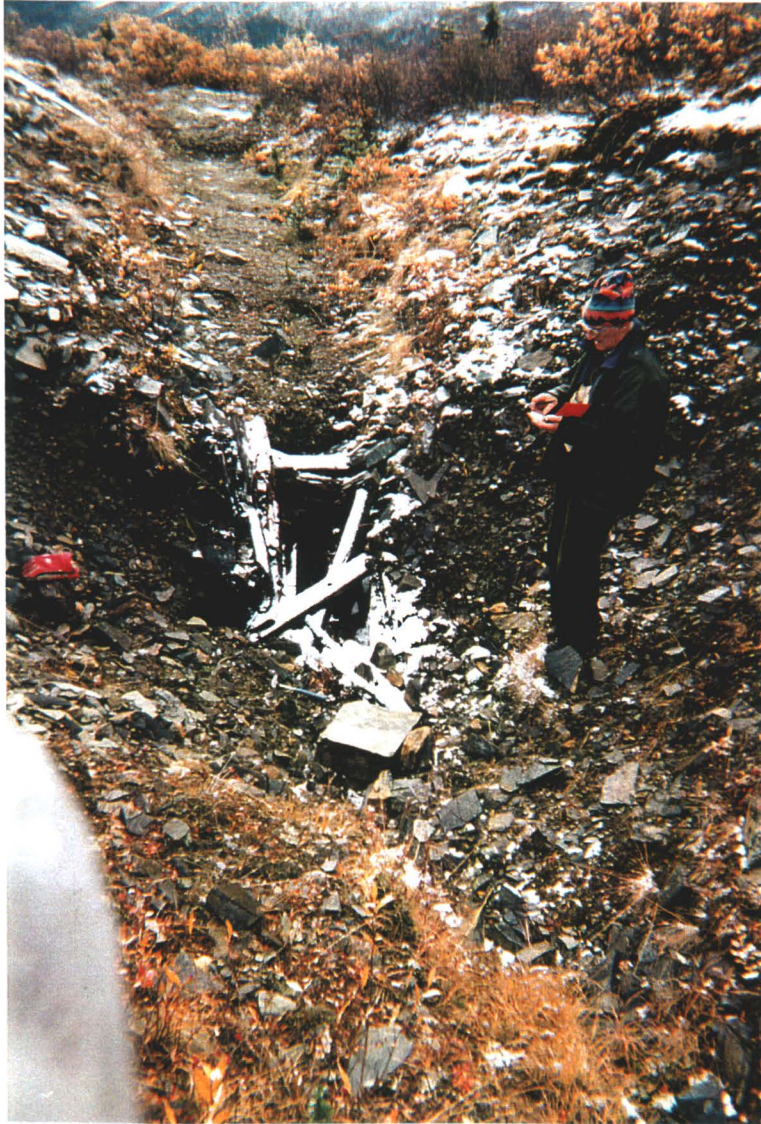
Shaft 1 (photo 48-2)

Old shaft filled in to within 5 m of surface

Location: in the bottom of Trench 3 (see description of Trench 3 below), 58 m from the waste rock dump at the south end of the trench

Dimensions (L x W): 2 m x 1.5 m

Condition: poor - caved in 5 m below surface

Accessibility: open

Photo 48-2: View of Shaft 1 in Trench 3 at Apex site. (AZ 132)

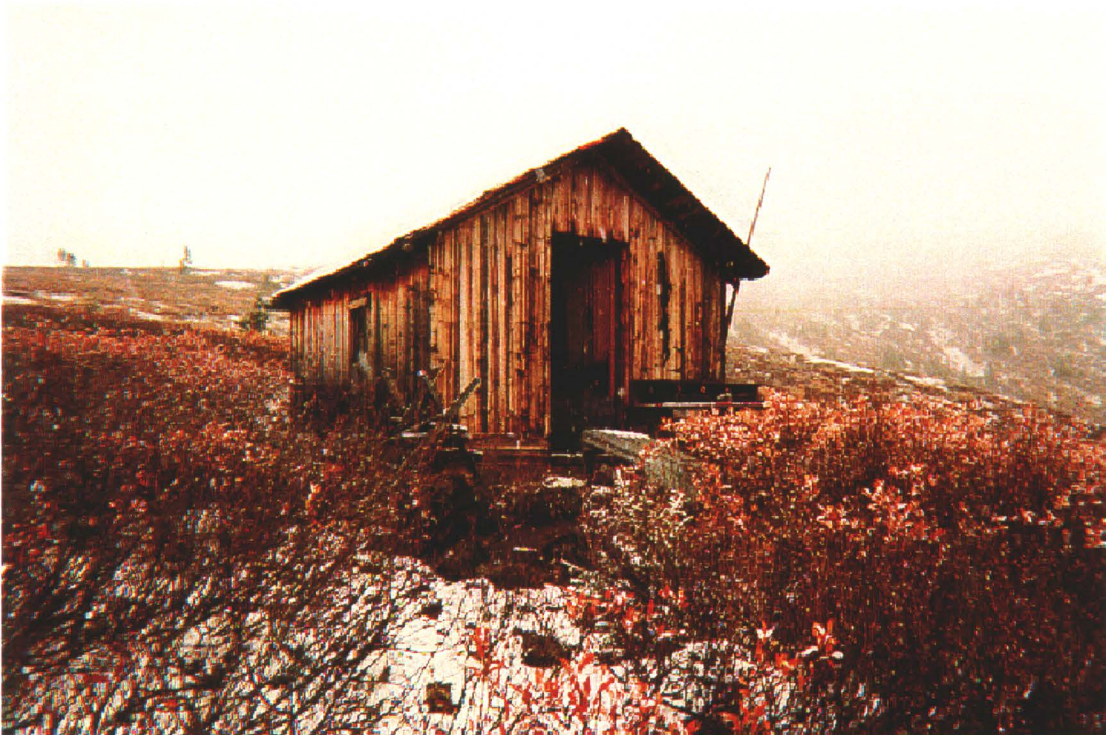
Building 48A (photo 48-3)

One level, single room freestanding wood cabin

Dimensions (L x W x H): 3.5 m x 2.5 m x 2.5 m

Construction: wood

Non-Hazardous Contents: 2 beds, utensils, firewood, and blankets are located inside. A fire pit, gas range (no fuel tank observed) and scattered debris (steel piping, cans) are located outside.

Photo48-3: View of abandoned wood cabin located at Apex site. (AZ 200)
