VANGUARD
SITE #49
MINFILE# 105M 010

The main showing with the adit, four shafts and a bulldozer trench were examined. All prospecting shafts were caved 1 - 2m below the surface. No ore was processed at the site and no tailings were encountered. There is no wastewater treatment facility at the site. Site details can be found on Figure 1; site photos are in Attachment 1 and laboratory results for samples are in Attachment 2.

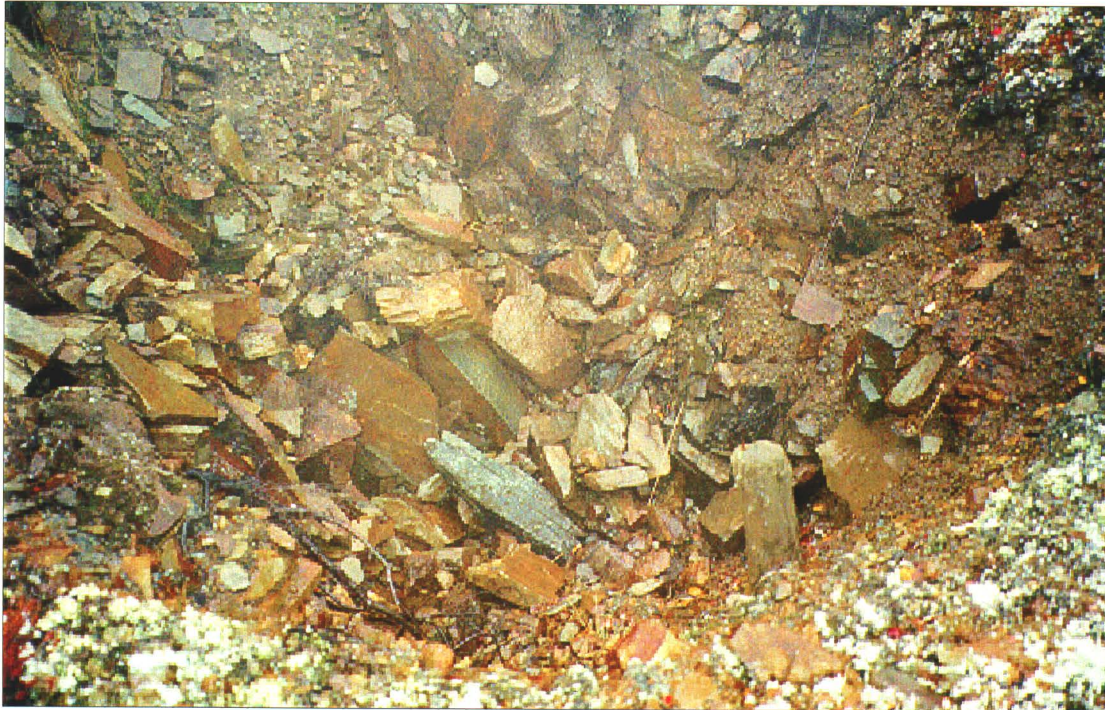
Shaft #2 (photo 49-1)

Shaft #2 is located 12m northwest of the wood framed cabin. It is likely a shallow prospecting shaft. The shaft has collapsed roughly 1m below the surface. The area of collapse is about 2m². A single log post is all that is visible of the original support structure.

Photo 49-1 : Vanguard. Shaft #2 has collapsed 1m below surface, the timber post in the bottom right hand corner is all that marks the location. (Azimuth 110^o)

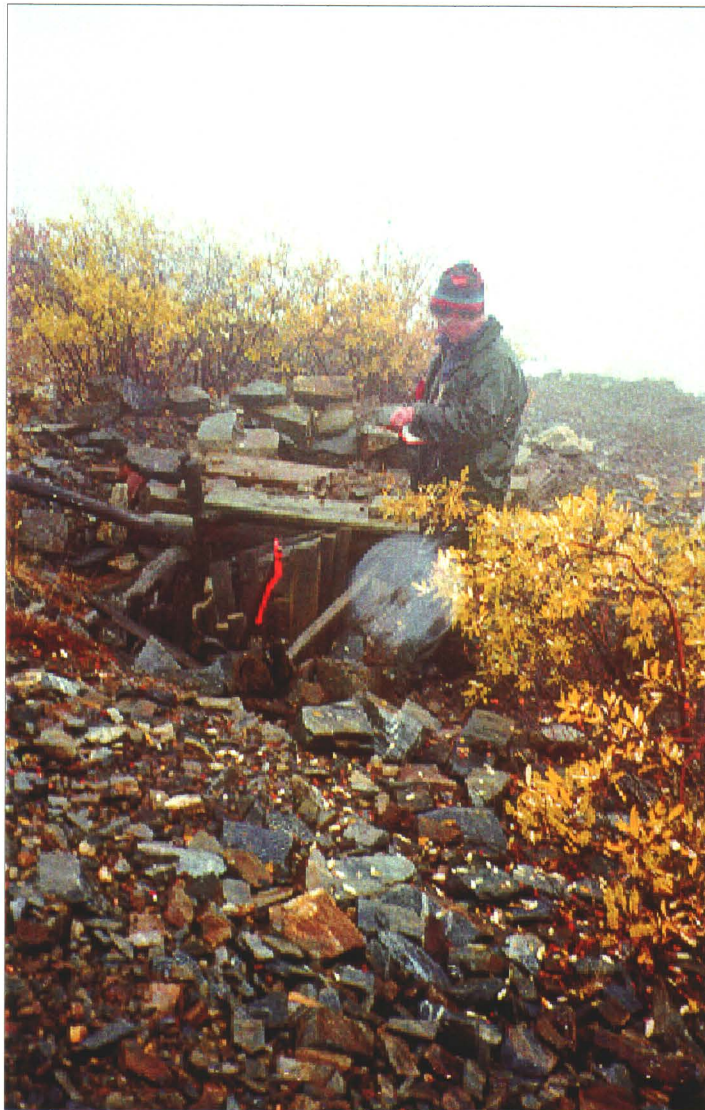
Shaft #3 (photo 49-2)

Shaft #3 is located 75m northwest of Shaft #2, 30m south of the tent frame. The collar is supported with log cribbing that measures 1.5m². The shaft has collapsed 2m below surface.

Photo 49-2 : Vanguard. The log cribbing supporting the collar of Shaft #3 is still in place but the shaft has caved 2m below surface. (Azimuth 180^o)

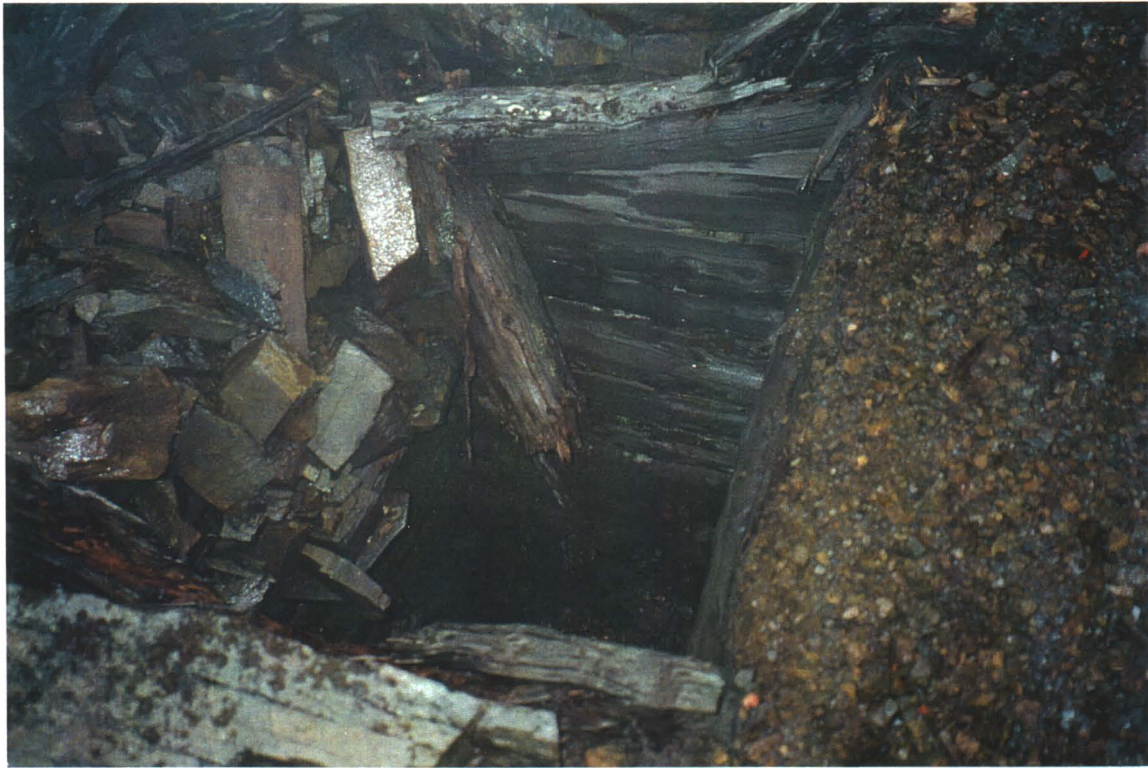
Shaft #4 (photo 49-3)

Shaft #4 is located 80m northwest of Shaft #3, 70m northeast of the adit. The shaft measures 1.5m² and is still open to about 3m down. The walls are supported with log cribbing. Three sides of the walls are still in good repair, the fourth wall is beginning to rot at the top and has partially collapsed.

Photo 49-3 : Vanguard. Shaft #4 is still open and in fairly good condition.

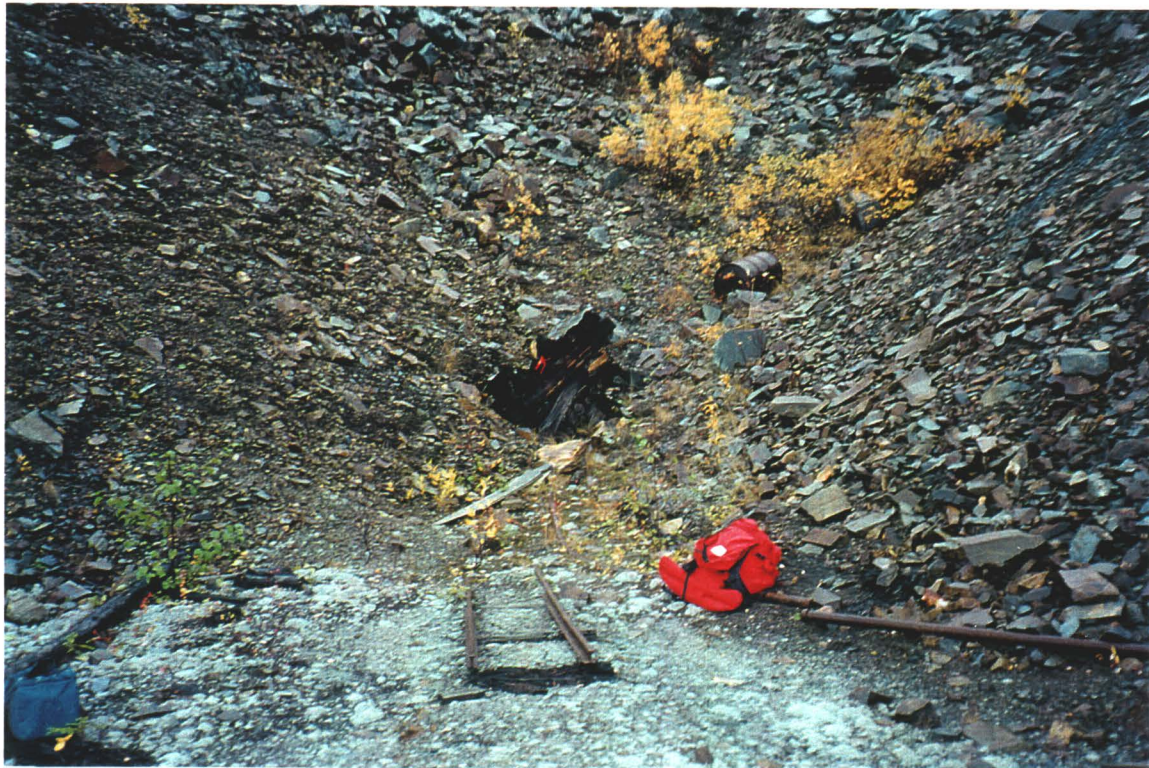
Vanguard Adit (photo 49-4)

The adit is located at the eastern edge of the site on the northern side of the road. The log cribbing that supported the portal have collapsed and the adit can no longer be accessed. Between the adit entrance and Shaft

#4, in the near bedrock talus, is an up to 3m deep depression. The collapse of the adit is the most probable explanation for the depression. According to local workers, the adit failed to intersect the mineralized vein fault.

Photo 49-4 : Vanguard. The pile of broken logs and sheet metal marks the entrance to the Vanguard Adit. The first 30m of the adit have collapsed. (Azimuth 290^o)

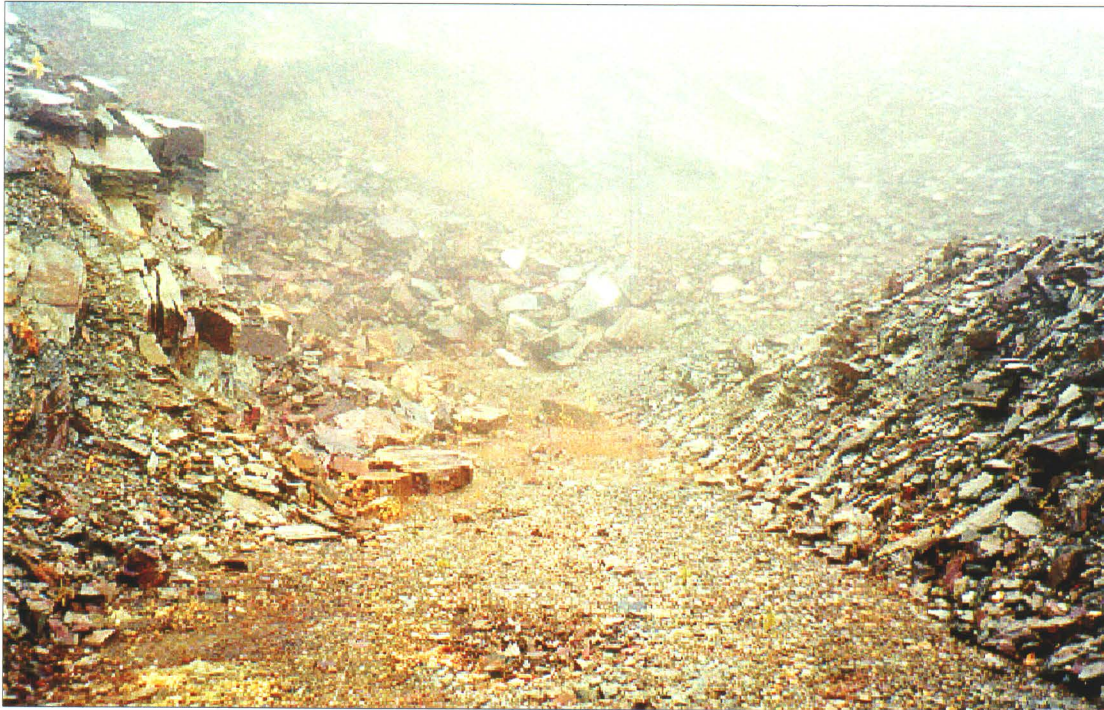
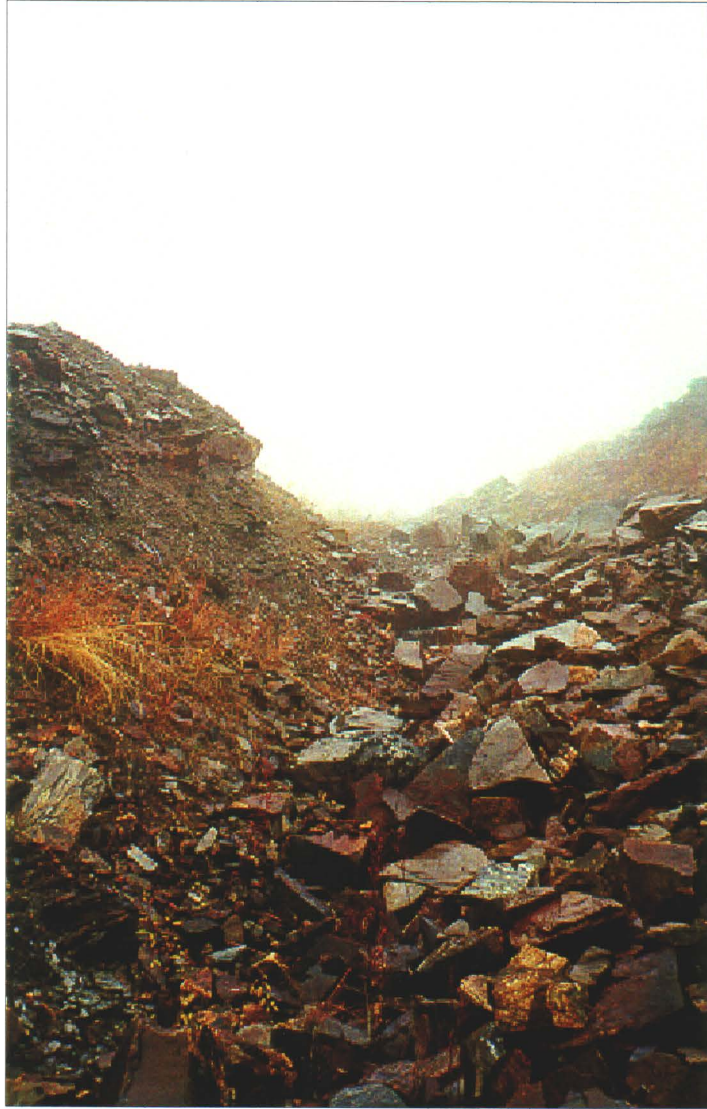
Trench #1 (photos 49-5, 49-6)

There is an 'L-shaped' bulldozer trench at the southwestern end of the site. The entire trench is 100m long, averages 7m wide and is up to 12m in height. The trench walls are composed of bedrock outcropping and quartzite float. The walls have slumped in some areas but overall seem fairly stable. The trench is easily accessible.

Photo 49-5 : Vanguard. View of Trench #1, looking to the northwest. (Azimuth 040^o)

Photo 49-6 : Vanguard. View of Trench #1, looking to the southwest. (Azimuth 320^o)

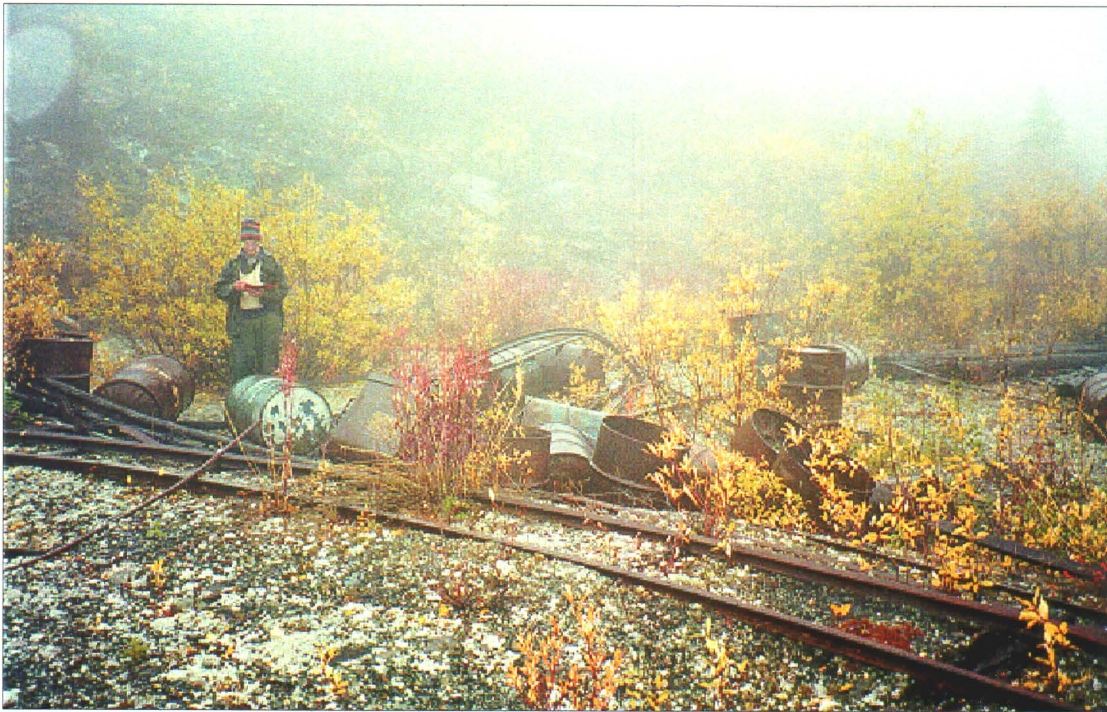
7. SOLID WASTE DUMPS (photo 49-9)

There is a fair amount of solid waste around the adit portal. There are scattered 45-gallon drums, steel rail, and various wood and metal debris. A 10cm-deep, 2.5m² hydrocarbon stain was observed.

Photo 49-9 : Vanguard. Solid waste dumped near the adit. (Azimuth 090 °)
