**CHRISTINE (#51)**  
**(MINFILE# 105M 012)**

**1. LOCATION AND ACCESS**

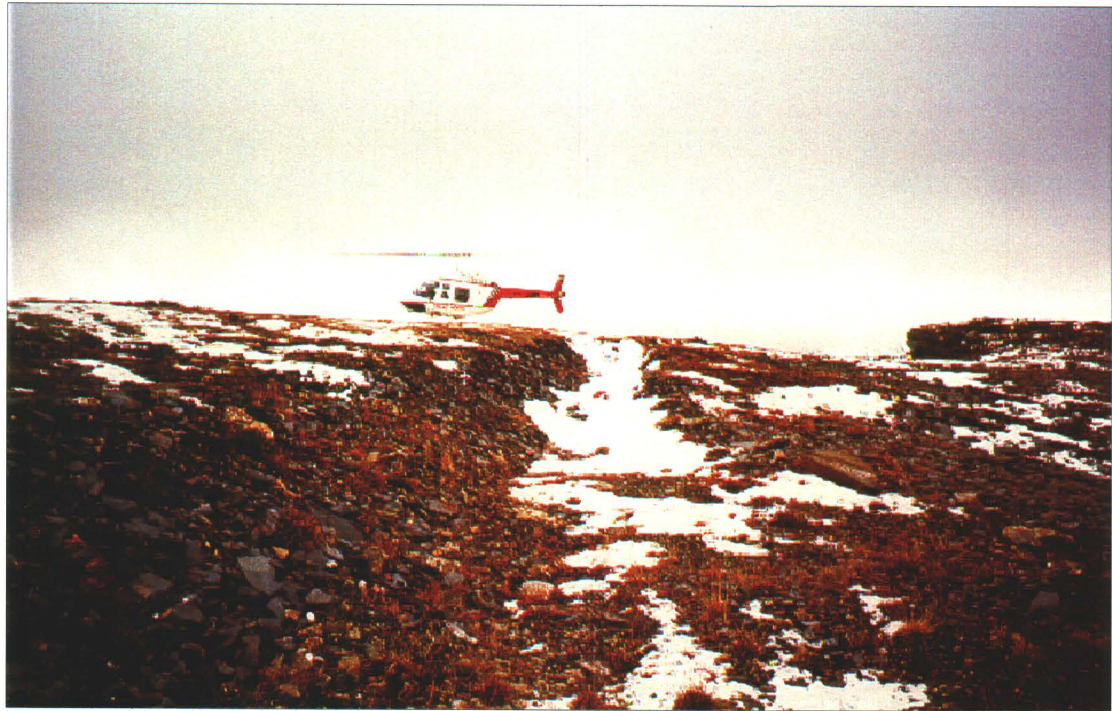
Trench 1 (photo 51-1)

Trench 1 was the only development observed at the Christine site.

Dimensions: 24 m x 2 m x 1.5 m – longitudinal bearing AZ 130

Condition: stable

Photo 51-1: View along length of Trench 1 at Christine site. (Azimuth  $130^{\circ}$ )
