MO (#52)
(MINFILE# 105M 013)

Public Works And Government Services Canada	Travaux publics et Services gouvernementaux Canada	designed by: _____ conçu par: _____	date: _____
		drawn by: C.S. dessiné par: _____	Nov. / 99
Architectural & Engineering Services Western Region		approved by: _____ approuvé par: _____	revisions: _____
Drawing title:	Titre du dessin:	project no. no. du projet:	diag. no. dessin no.:
Mo Site #52 Site Assessment Yukon Territory		125-12.01	1 of 1

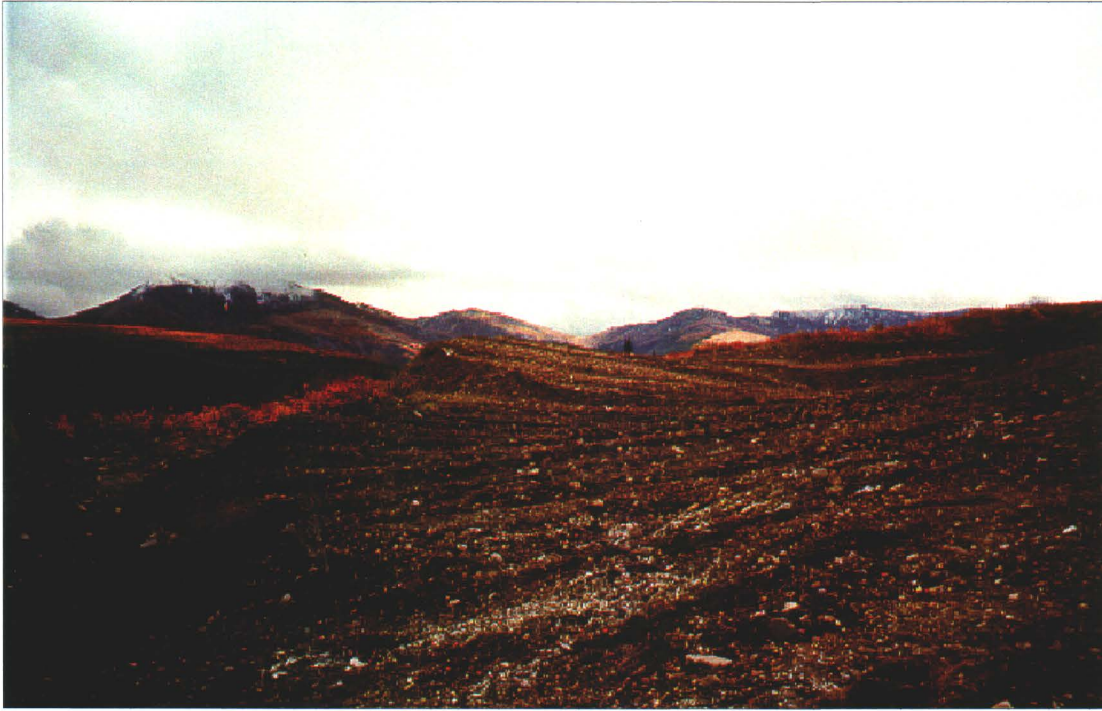
The major displacement of material from the trenching in this area has made it difficult to distinguish waste rock from overburden. Material has been piled and graded in several places to make level areas and roads (photo 52-1). Significant revegetation has occurred in the area. The extent of natural reclamation ranges from 20 to 60 percent depending on the quality of the soils.

Photo 52-1: Large area of displaced material at south end of Windy and Casy workings.

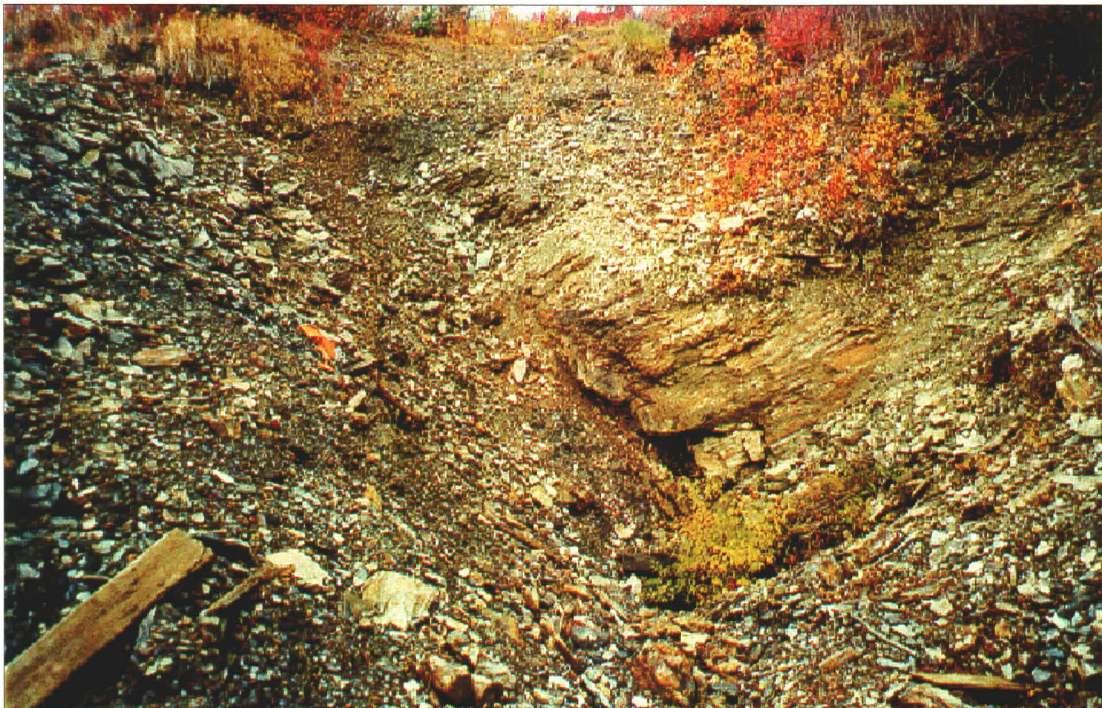
Pit 1 (photo 52-2)

Dimensions: 4 m x 3 m x 2 m

Condition: stable

Comment: potential site of former adit

Photo 52-2: View of Pit1 at Windy and Casy workings.

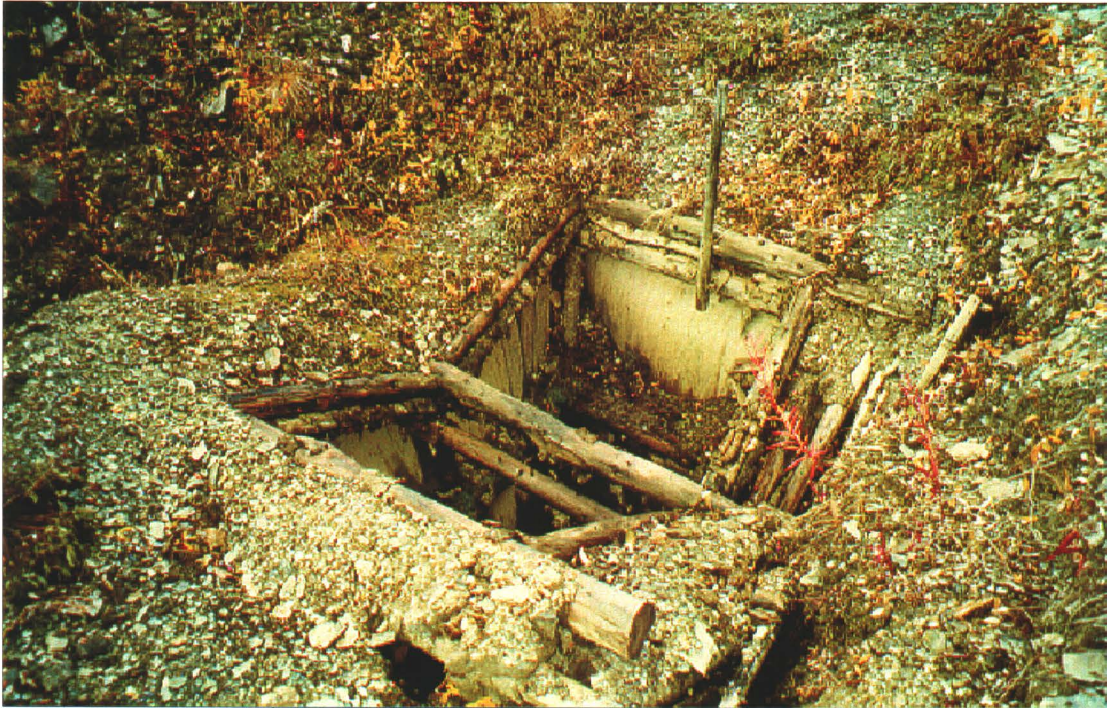
Shaft 1 (photo 52-3)

Two compartment shaft

Dimensions: 2.5 m x 2.5 m – filled to within 2 metres of trench floor

Condition: the shaft has either been filled or it has collapsed

Photo 52-3: View of Shaft 1 at Windy and Casy workings.

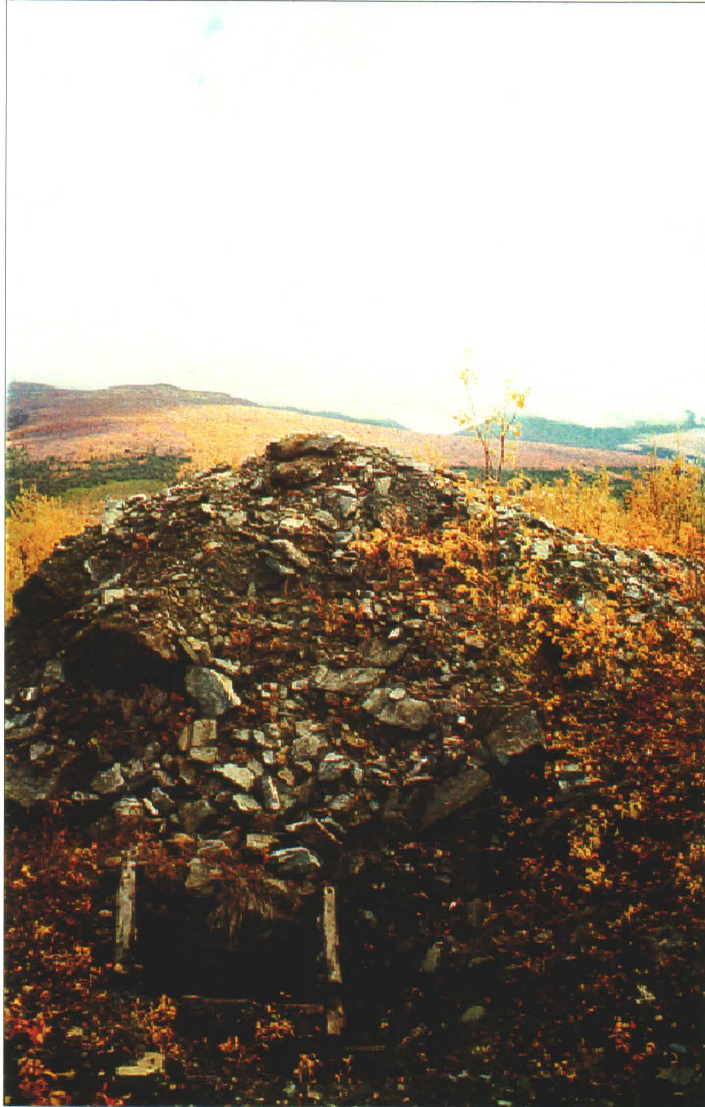
Shaft 2 (photo 52-4)

Small shaft

Dimensions: 1.3 m x 1.5 m – filled to within 3 metres of trench floor

Condition: the shaft has either been filled or it has collapsed

Photo 52-4: View of Shaft 2 at Windy and Casy workings.

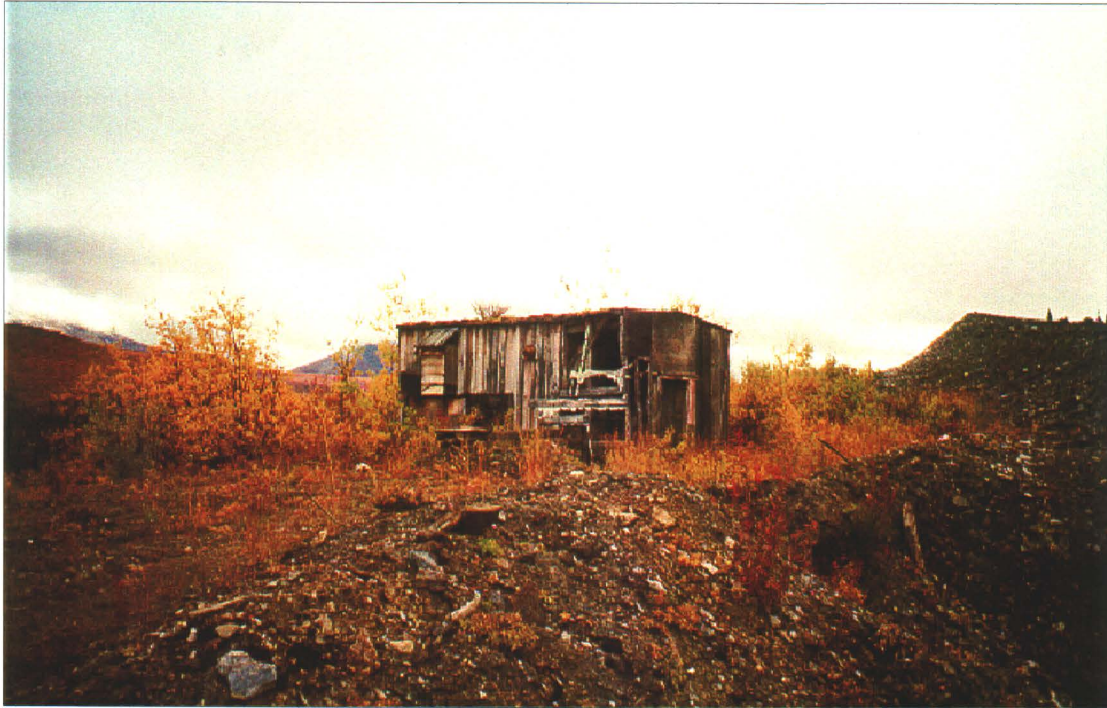
Building 52A (photo 52-5)

Wooden shack

Dimensions (L x W x H): 5 m x 3 m x 2.5 m

Construction: wood

Paint: none observed

Asbestos: none observed

Hazardous Contents: none observed

Photo 52-5: Abandoned wood shack near north end of Windy and Casy workings.

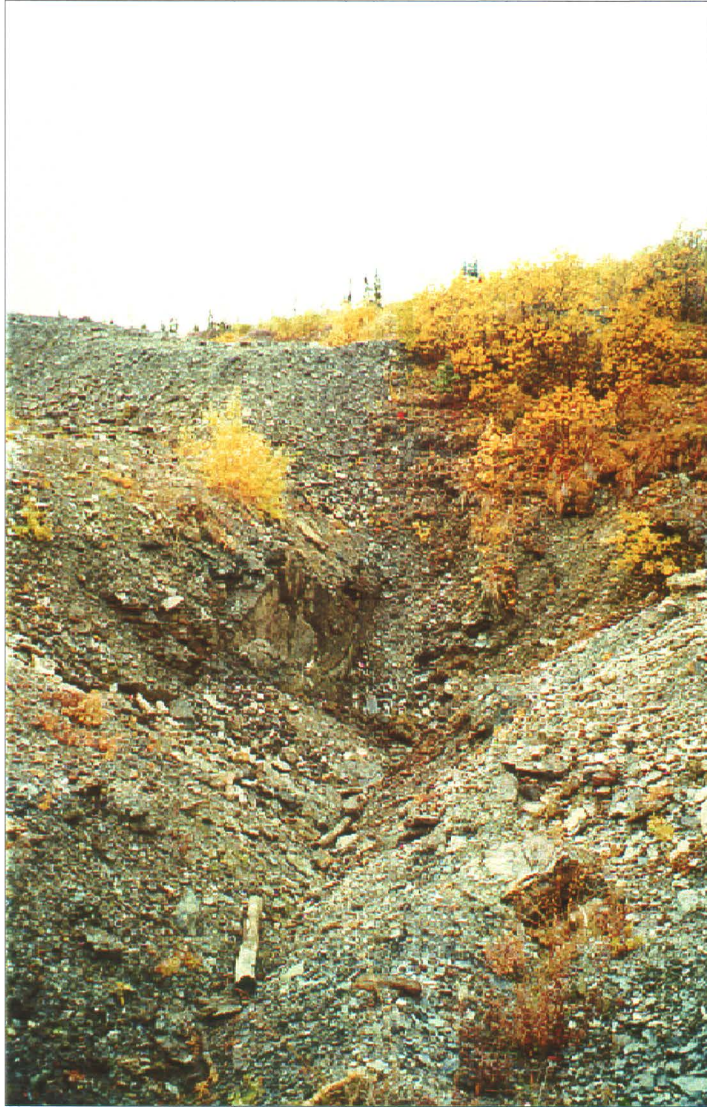
The Windy and Casy Trenches are located just off of the Sourdough Hill Trail on the Windy and Casy claims. This is a large area of trenching with small pits and two small shafts. The trenches can be accessed on foot from the Sourdough Hill Trail. One trench of particular interest shows an example of the bedrock in the area (Photo 52-6).

Photo 52-6: Deep trench showing bedrock just west of shack at Windy and Casy workings.

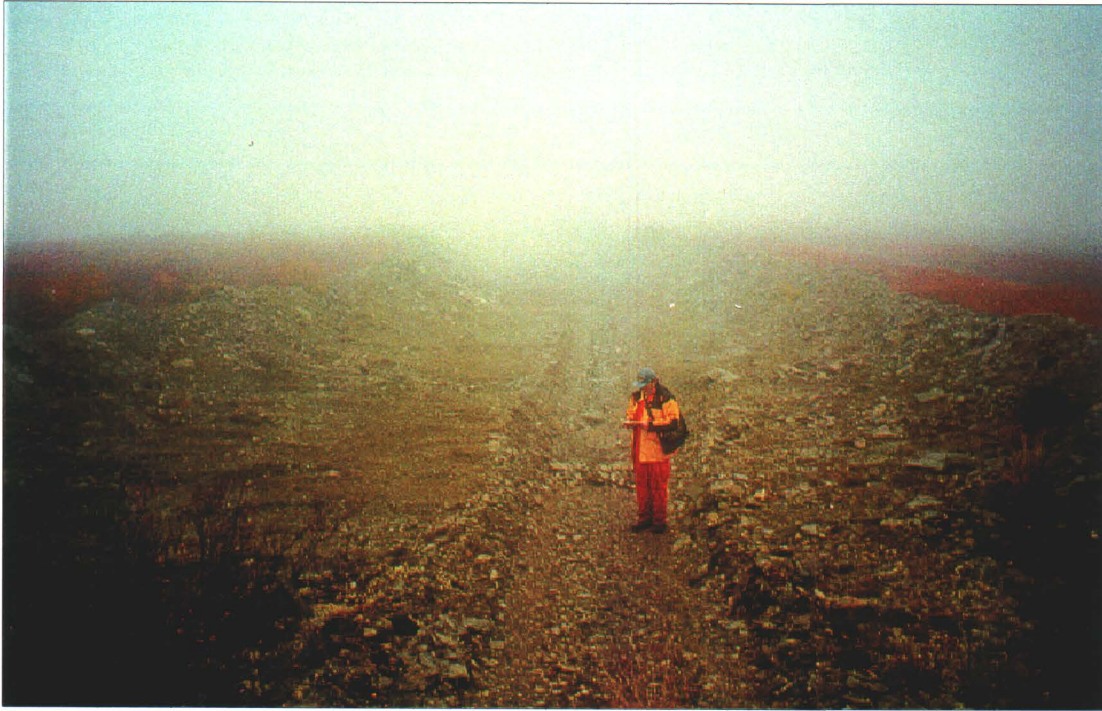
Trench 1 (photo 52-7)

Large shallow trench

Dimensions: 83 m x 12 m x 1.5 m – longitudinal bearing AZ 138

Condition: stable – no revegetation

The waste rock from Trench 1 is mostly contained in the walls of the trench. They contain a mixture of green and grey phyllite and overburden. A small waste rock pile lies at the end of a long depression at the north end of the trench. It also contains phyllite and overburden. A waste pile in the middle of the trench is composed of green phyllite from an area of digging in the trench floor. These waste rock piles show no signs of revegetation because the rock is not a suitable substrate.

Photo 52-7: View along length of large trench (Trench 1) located 2 km south of Windy and Casy workings on Bob claim. (AZ 138°)

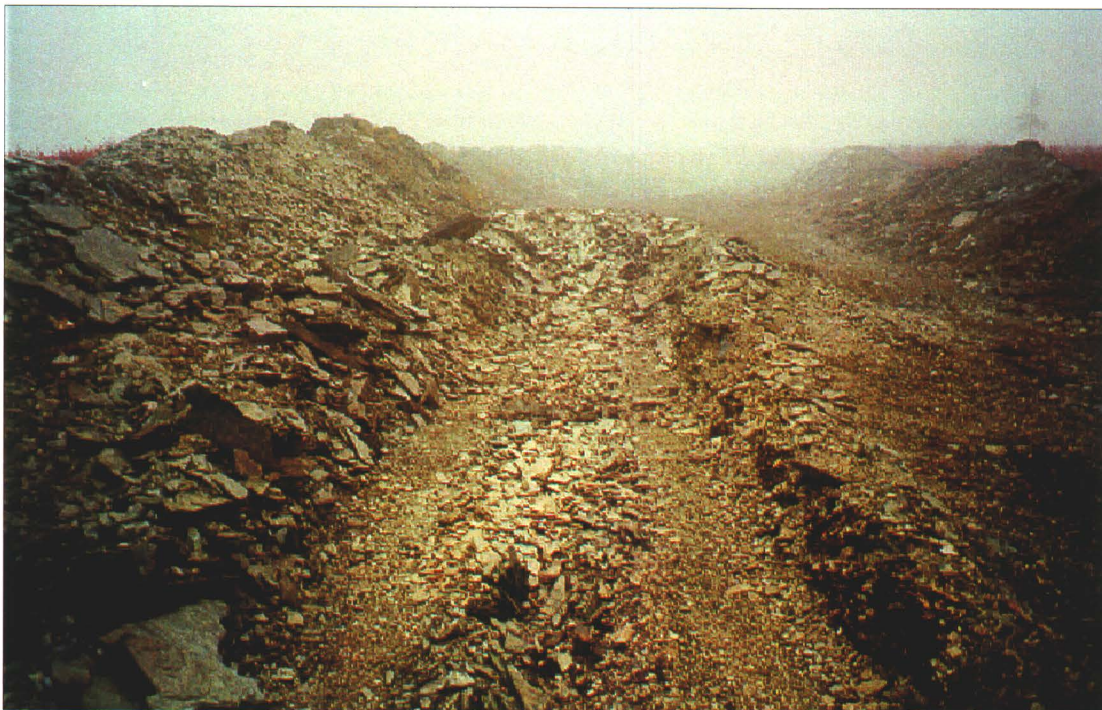
Photo 52-8: Area of digging at the bottom of Trench 1.

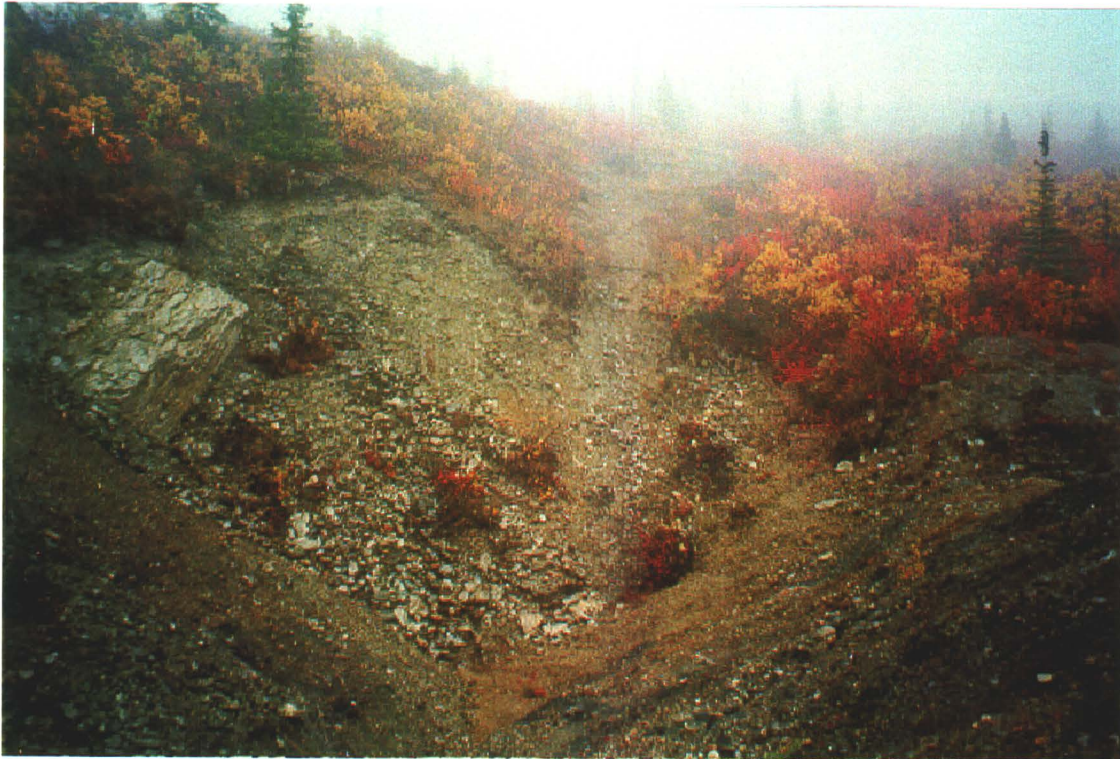
Pit 2 (photo 52-9)

Pit 2 is a deep pit with vehicle access from either side. Bedrock and overburden is dumped on the downhill side in two large piles. Bedrock is showing on the north slope of the pit.

Dimensions: 30 m x 20 m x 7 m

Condition: stable

Photo 52-9: View of Pit 2 at Boogla claim located 2.4km south of Windy and Casy workings showing exposed bedrock. (AZ 070°)

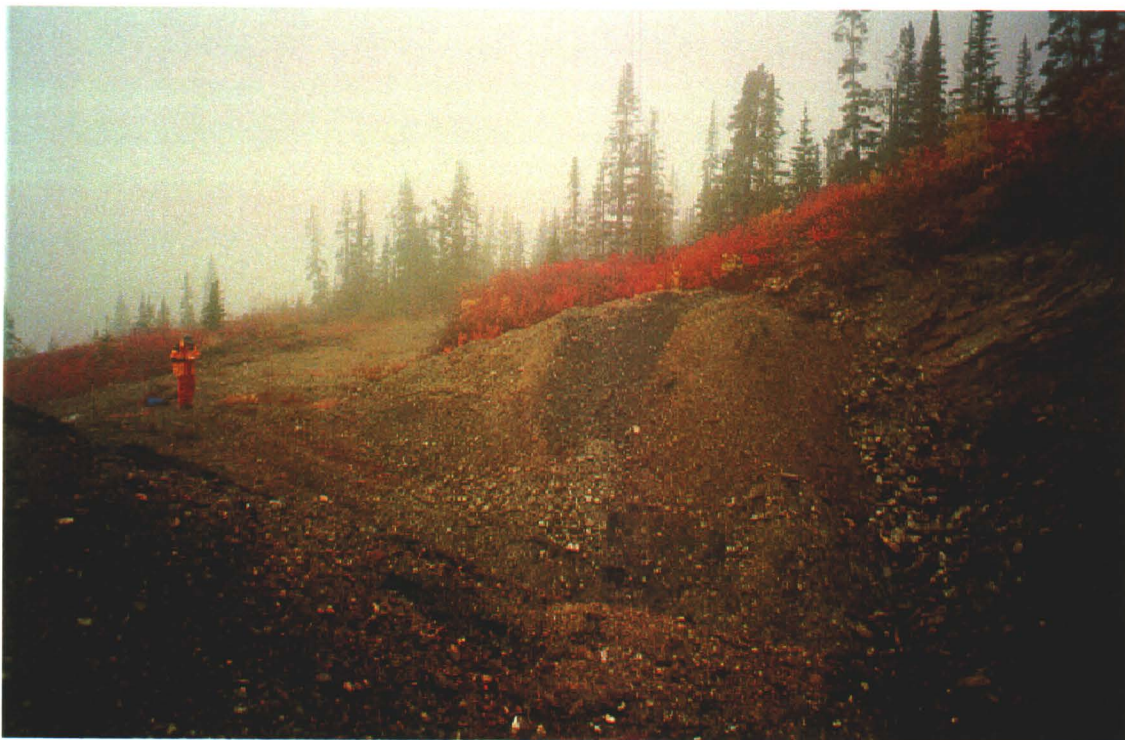
Pit 2 waste rock piles (photo 52-10)

There are two large waste rock piles located at Pit 2. They are composed of pale green and black phyllite that originated from the pit. The dimensions of the piles are 35 m x 4 m x 4 m and 10 m x 4 m x 7 m. Both waste rock piles are stable. No significant revegetation of these waste piles has occurred.

Photo 52-10: Example of waste rock piles surrounding Pit2
