MAYBRUN(#53)
(MINFILE#105M 014)

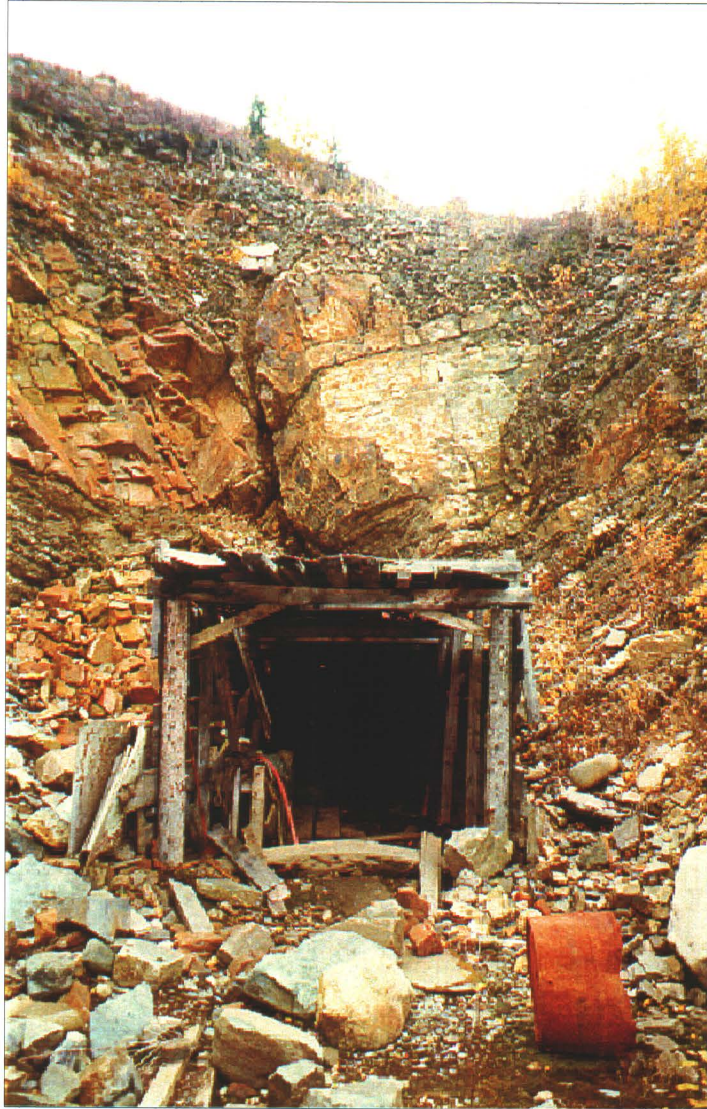
Adit 1 (photo 53-1)

Location: on the south side of Thunder Gulch behind large piles of placer tailings

Dimensions (H x W x L): 2.3 m x 2.8 m x 10 m plus drifting (about 10 m)

Supports: wood portal; underground developments appear to be unsupported

Condition: appears stable

Accessibility: open

Photo 53-1: View of Adit 1 at Maybrun site. (AZ 234)

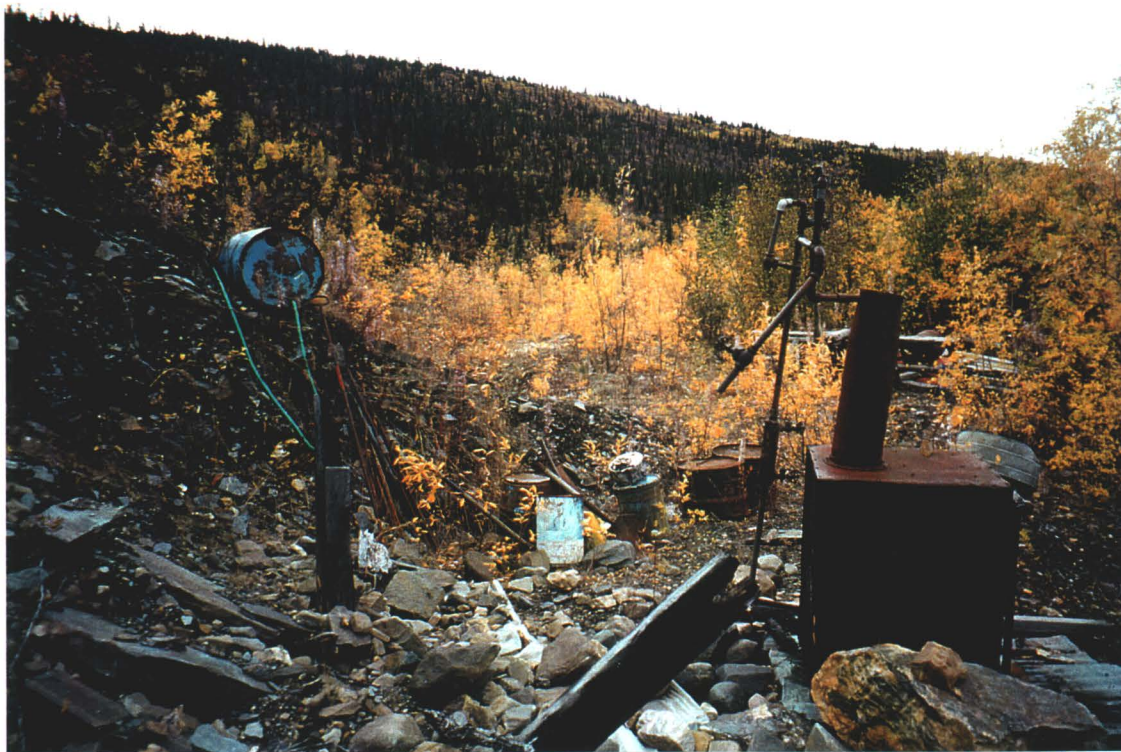
Shaft 1 (photo 53-2)

Description: collapsed shaft

Location: 50 m south of adit up a steep slope

Condition: collapsed and filled in to surface level

Accessibility: shaft site is accessible from a trail leading up the hill from Building 53A

Photo 53-2: View of Adit 1 at Maybrun site. AZ 234
Photo 53-2:View of collapsed shaft (Shaft 1) at Maybrun located above Adit 1.(AZ 300)

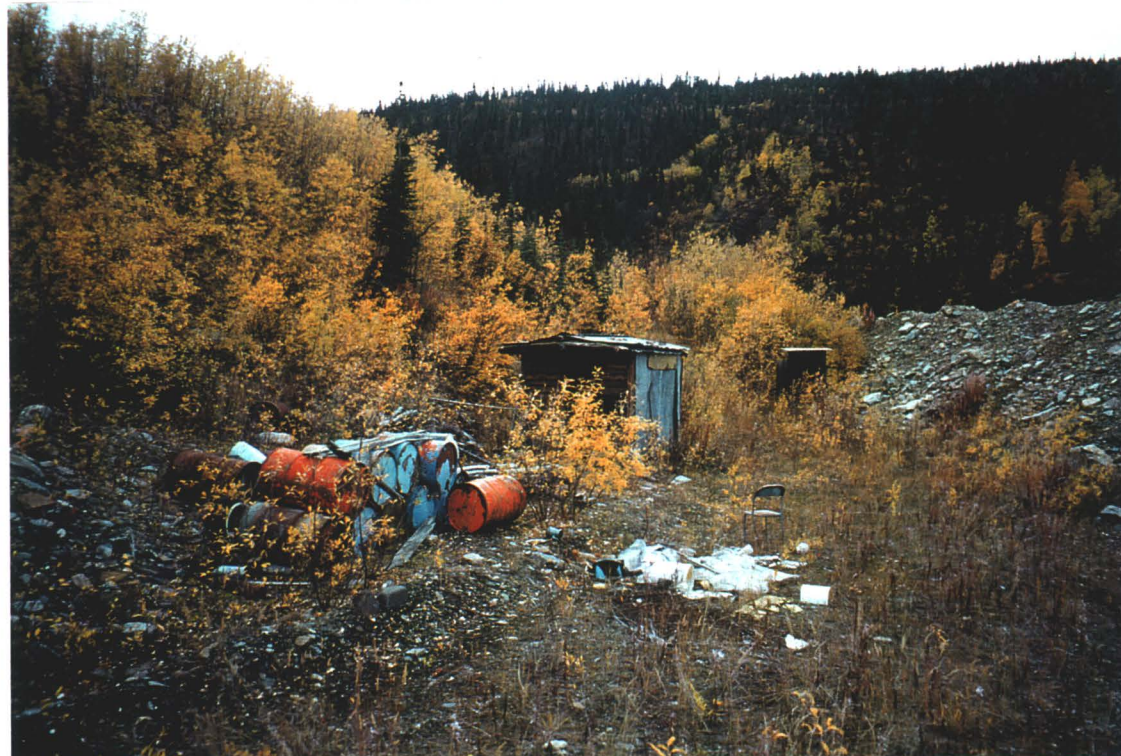
Building 53A (photo 53-3)

Dimensions (L x W x H): 2.5 m x 2 m x 2.5 m

Construction: wood and corrugated steel

Non-Hazardous Contents: bed, utensils, plateware

About a dozen empty 45 gallon drums were found at the Maybrun site.

Photo 53-3: Abandoned shack, empty barrels and scattered debris located at Maybrun.
