RUNER
SITE #55
MINFILE #105M016

Runer was the focus of a 1996 Phase II Environmental Assessment undertaken by Environmental Services, Public Works and Government Services Canada. The site was revisited in 1999, and no major changes at the site were noted. The text of this report is largely based on the PWGSC 1996 report.

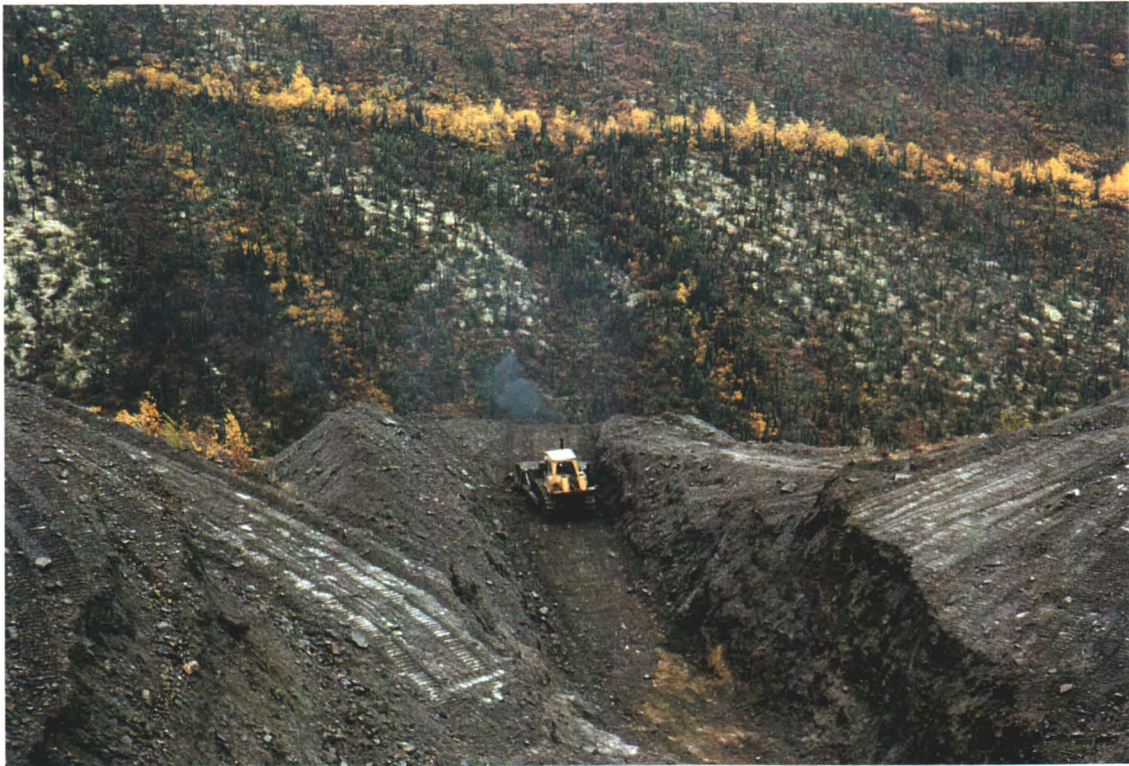
The current claim holder has undertaken further mining of an open cut in the lowest part of Runer. At the time of the site visit, a bulldozer was scraping the bedrock to expose a silver-rich galena vein (photo 55-1). The ore was hand sorted into 2L pails.

Photo 55-1: Bulldozer working at Runer site.

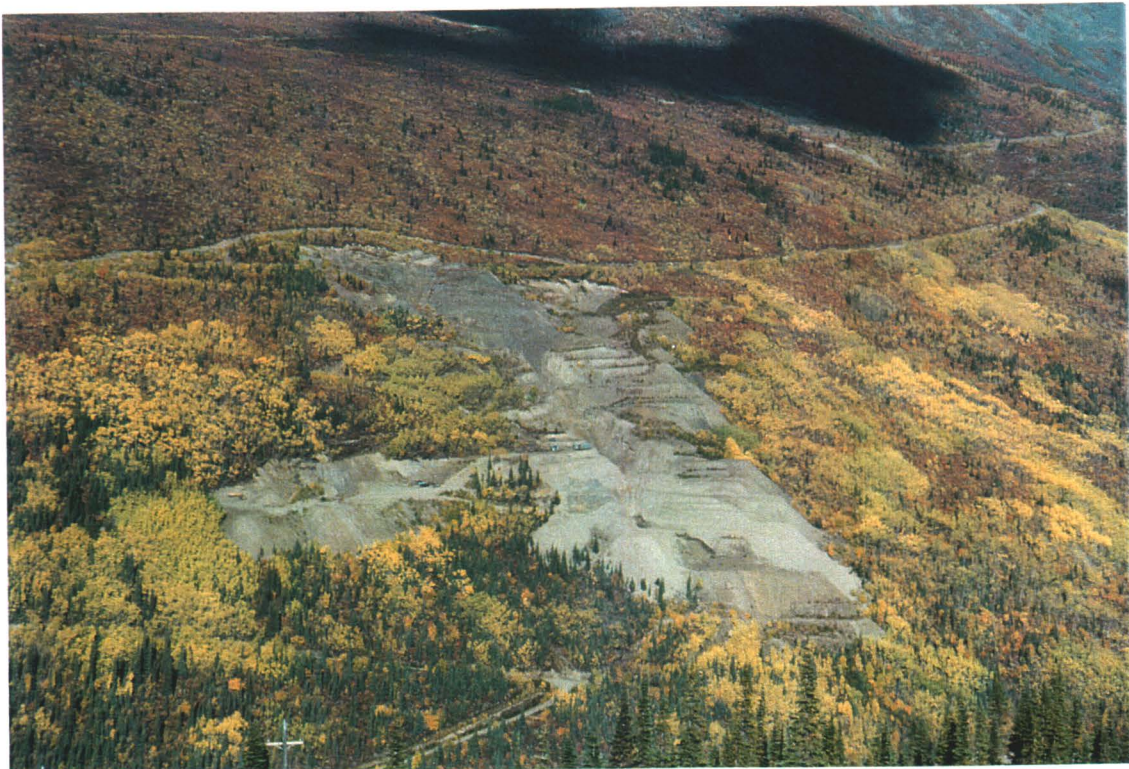
The remains of an adit (possibly the 3800-level adit) were observed high in the wall of the lower trench; a timber retaining wall above the adit and the adit entrance have been crushed by slumping overburden and bedrock.

The adit is inaccessible because of the instability of the surrounding rock. Tracks and an ore car indicate the presence of a buried adit approximately 150m west of the lower trench. No accessible underground workings were encountered during the site assessment.

It appears that the extensive trenching program conducted in the vicinity of the 3800-level and 3900-level adits have buried, caved, or removed the historical workings. The trenching in the vicinity of these adits has disturbed an area approximately 70,000m². The trenches themselves are approximately 10 m wide, cover a strike length of 300 m, and are over 30 m deep in places. The remaining area of disturbance is created by the deposition of waste rock and overburden in piles that average 5 m in height.

Because both trenches have been cut into rock, the trench wall slopes range from 40° to near-vertical. Loose waste rock or overburden piles are "perched" atop the trench walls at the trench edges. The margins of both trenches are not fenced, and no warning signs have been posted to alert site visitors of danger areas.

Photo 55-2: View of Runer site from Bunker Hill.
