Wernecke Railroad (# 56)
(MINFILE# 105M 017)

Public Works Anc. Government Services Canada	Travaux publics et Services gouvernementaux Canada	designed by:	
		conçu par:	
Architectural & Engineering Services Western Region		drawn by:	C.S. Nov. 1999
		dessiné par:	
Drawing title: Wernecke (Railroad) Site #56 Site Assessment Yukon Territory		approved by:	
		approuvé par:	
project no. no. du projet:		revisions:	
		125-12.01	
Former Building Site (Elsa)		dwg. no. dessin no.	1 of 1

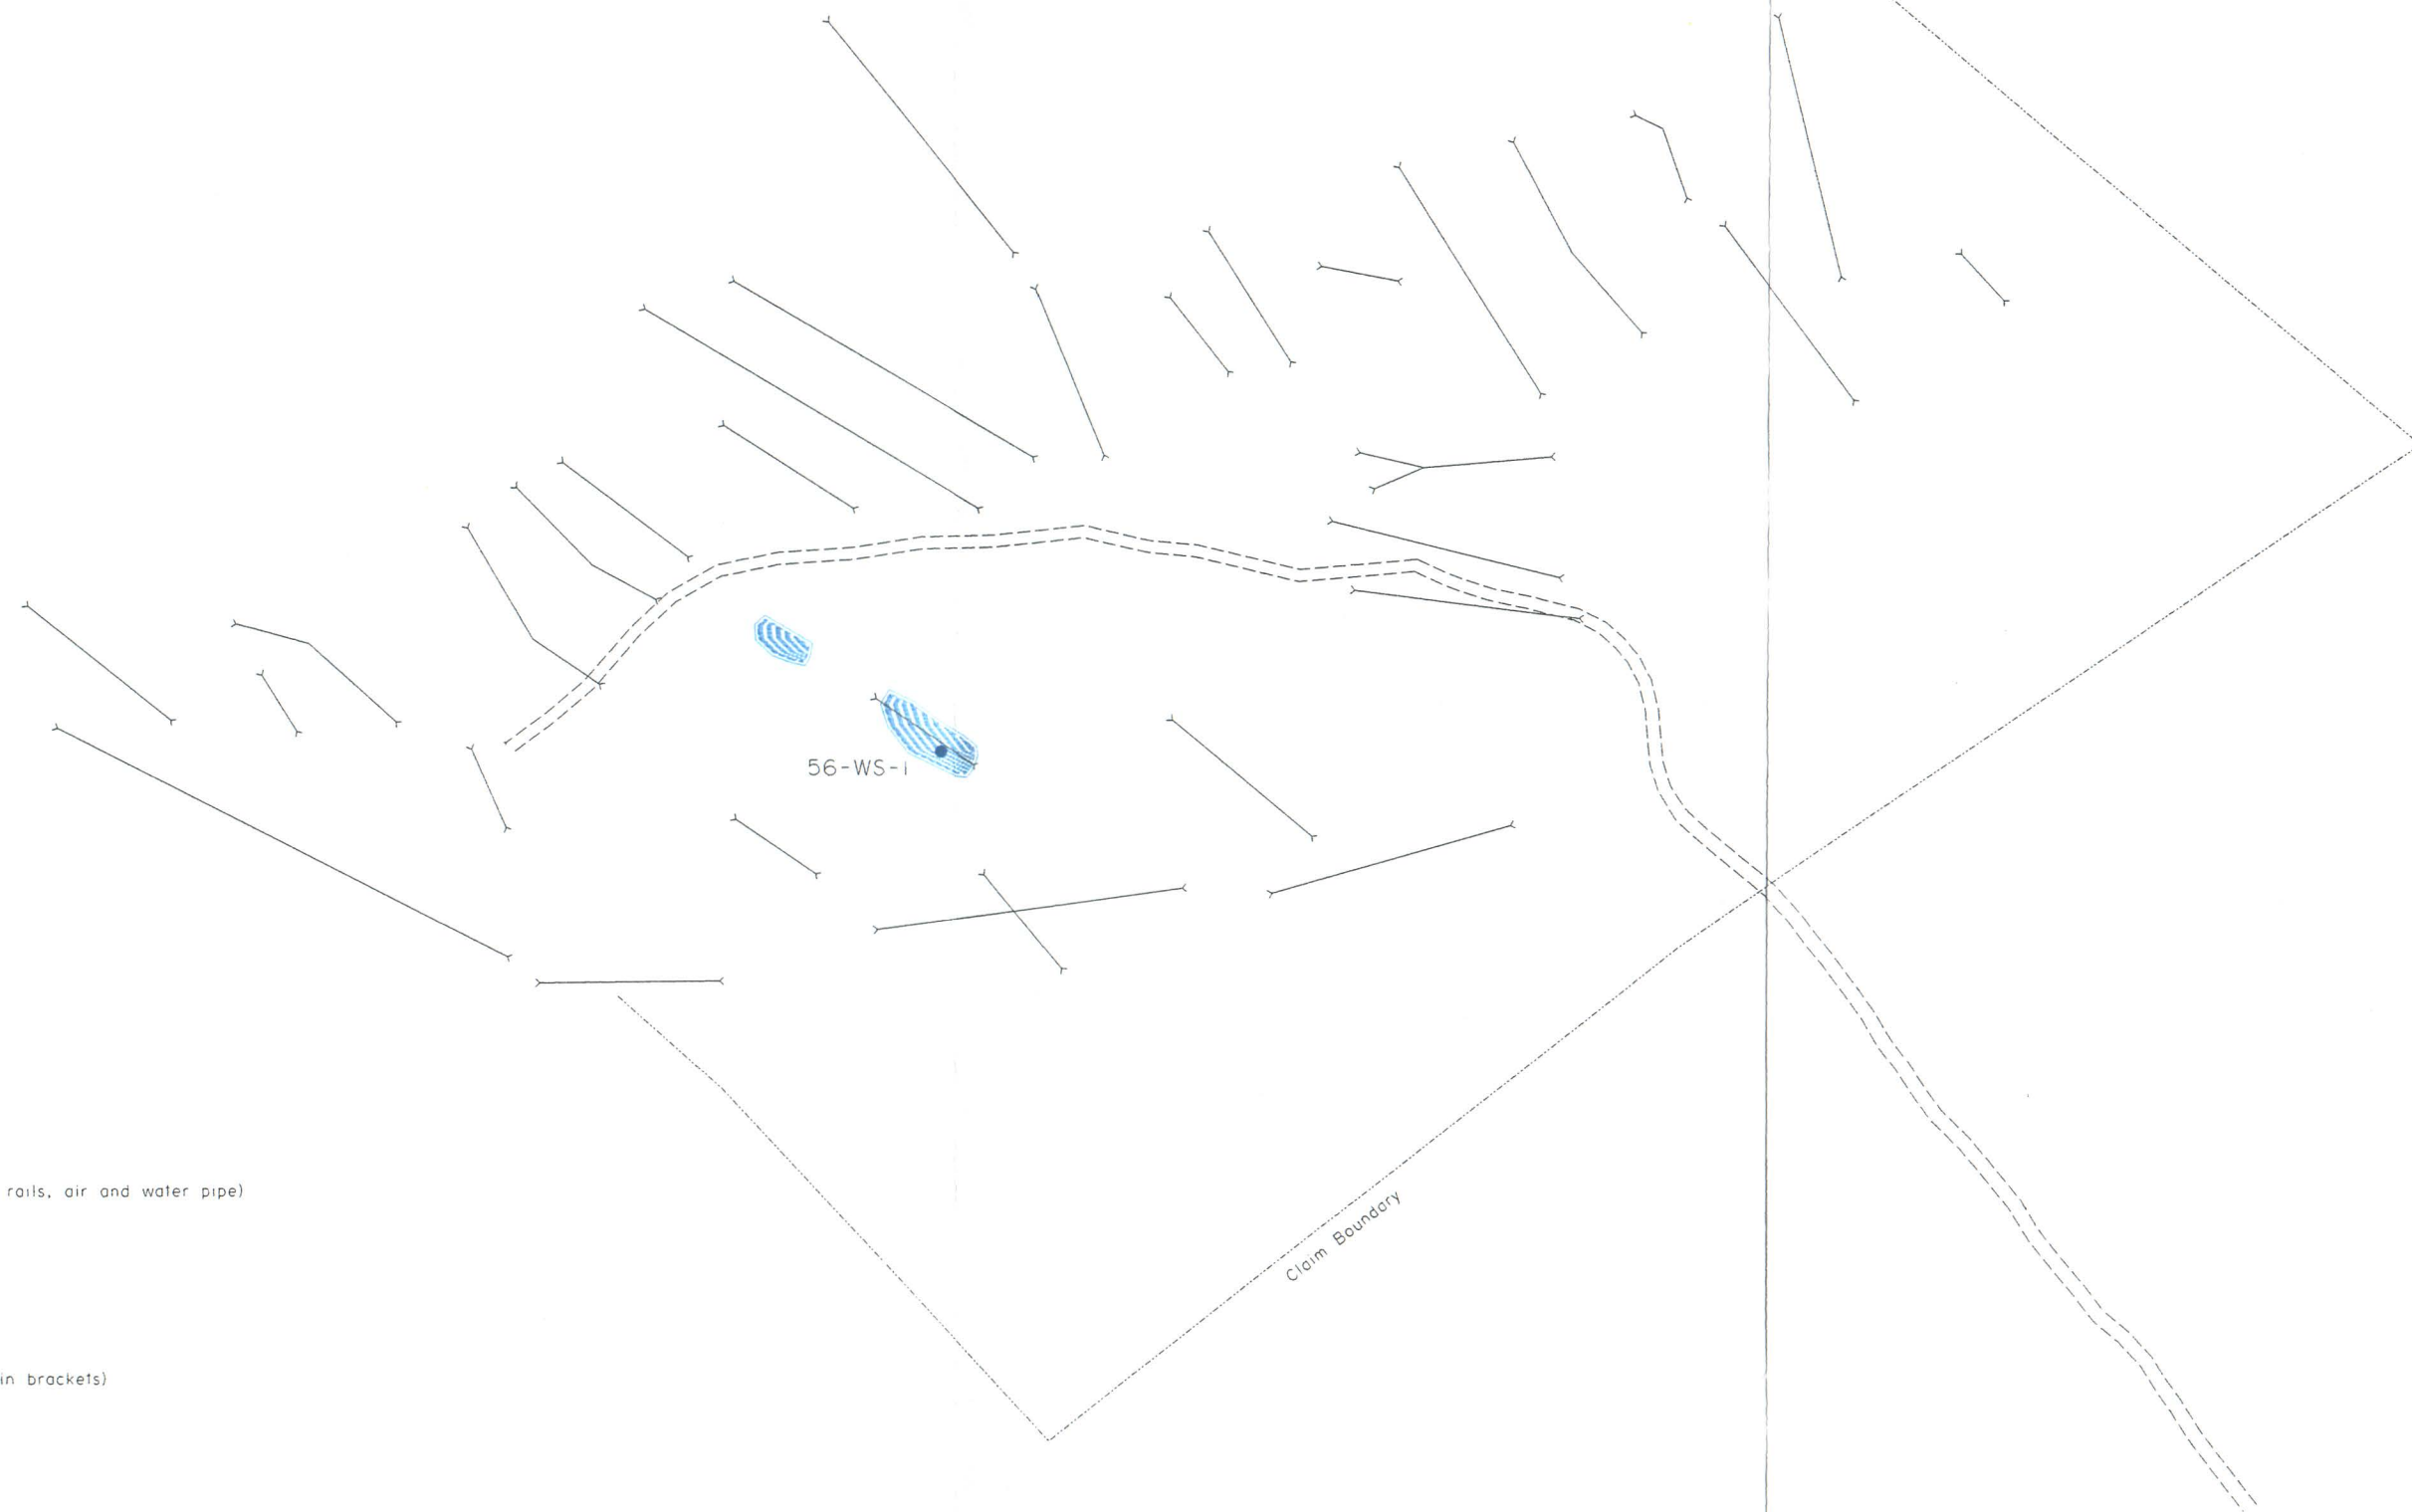
Note: Trench outlines from aerial photographs
