FORMO (# 57)
(MINFILE# 105M 018)

Public Works And Government Services Canada	Travaux publics et Services gouvernementaux Canada	designed by: conçu par: drawn by: C.S. NOV. 1999 dessiné par: approved by: approuvé par:
	Architecture & Engineering Services Western Region		Titre du dessin: Fromo Mine Site #57 Site Assessment Yukon Territory
Drawing title:		project no. no. du projet:	revisions: dwg. no. dessin no.:
		125-12.01	1 of 1

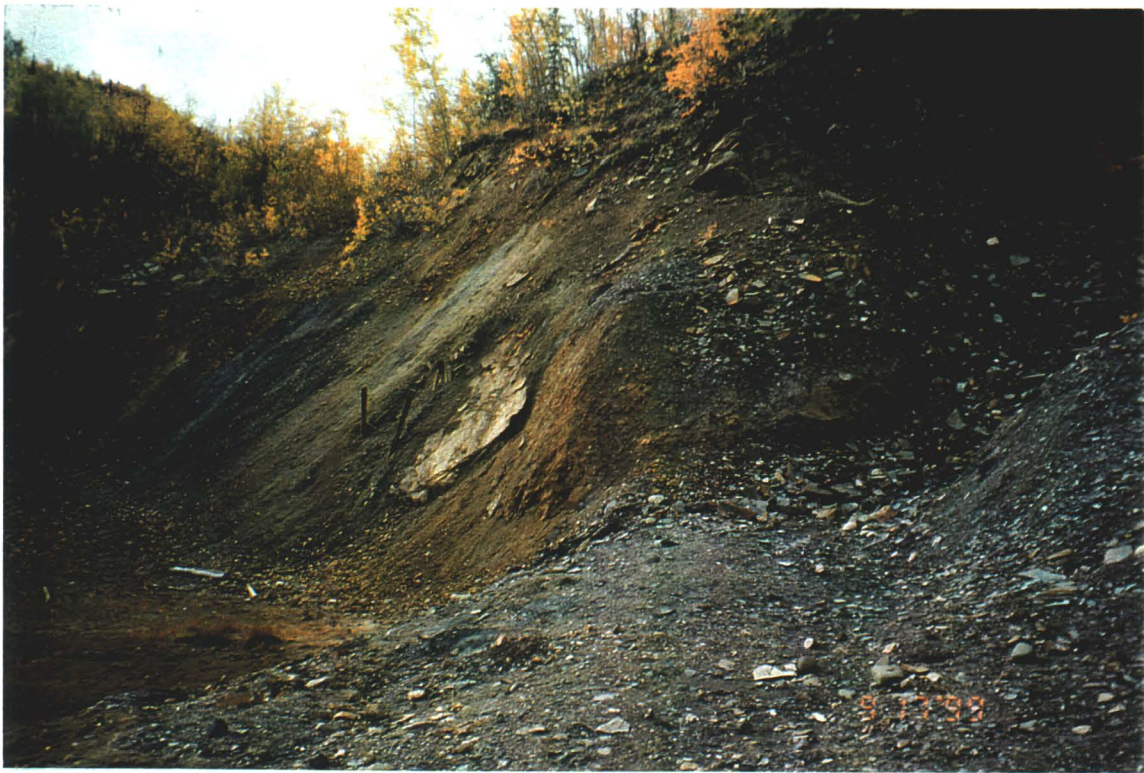
Upper shaft (photo 57-1)

Demolished during upper workings trenching. Only timbers remain at surface of site.

Photo 57-1: Remains of shaft on slope at upper workings.

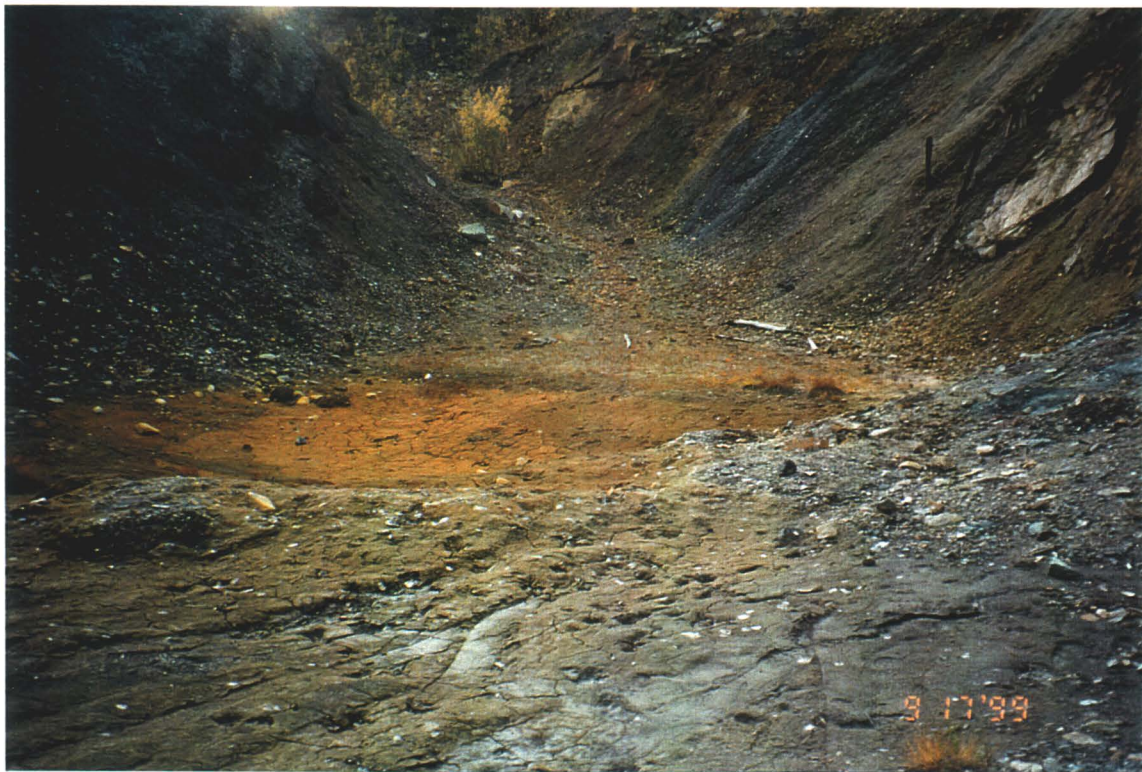
Trenches (photos 57-2 & 57-3)

Condition: Minor revegetation of the trenches, particularly at the bottom; staining at bottom of main trench appears to be result of seasonal ponding water (none at time of site visit); material sloughing off trench walls at a number of locations.

Photo 57-2: Bottom of slope at upper workings where water has ponded in past.

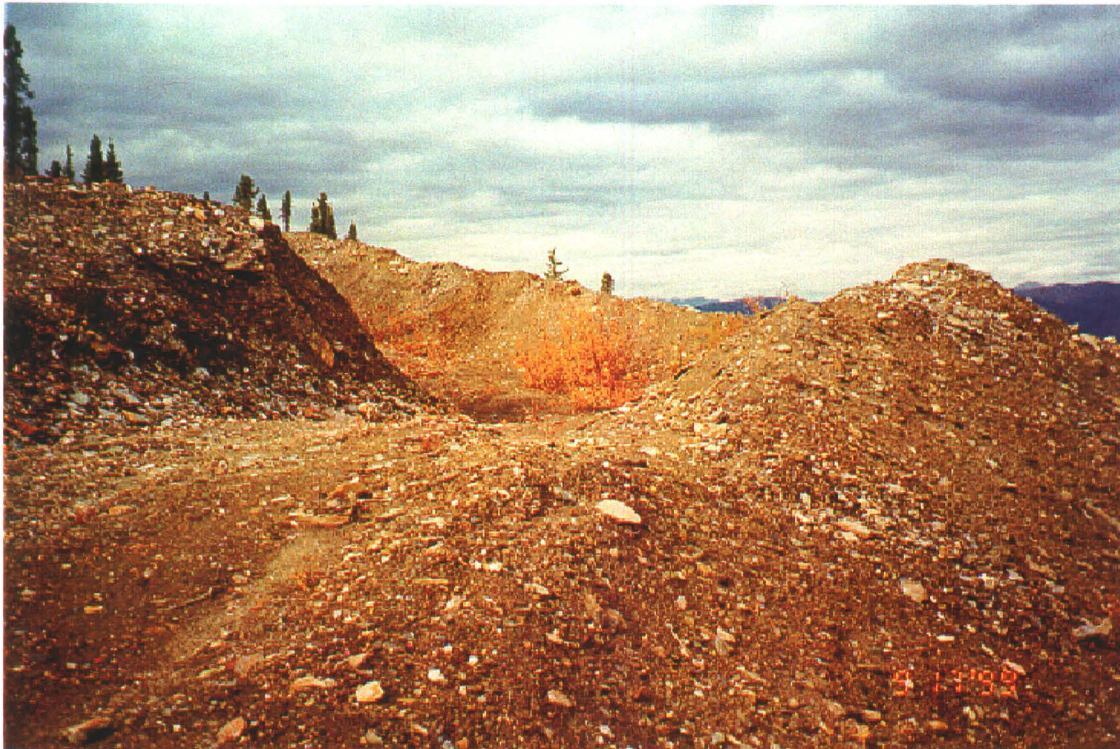
Waste rock pile – Upper workings (photos 57-2 & 57-3)

Over 6900 m³ of rock was removed from upper workings site and the waste rock was deposited on either side of the adjacent to the trenches.

Photo 57-3: Site road formed in waste rock at upper workings.

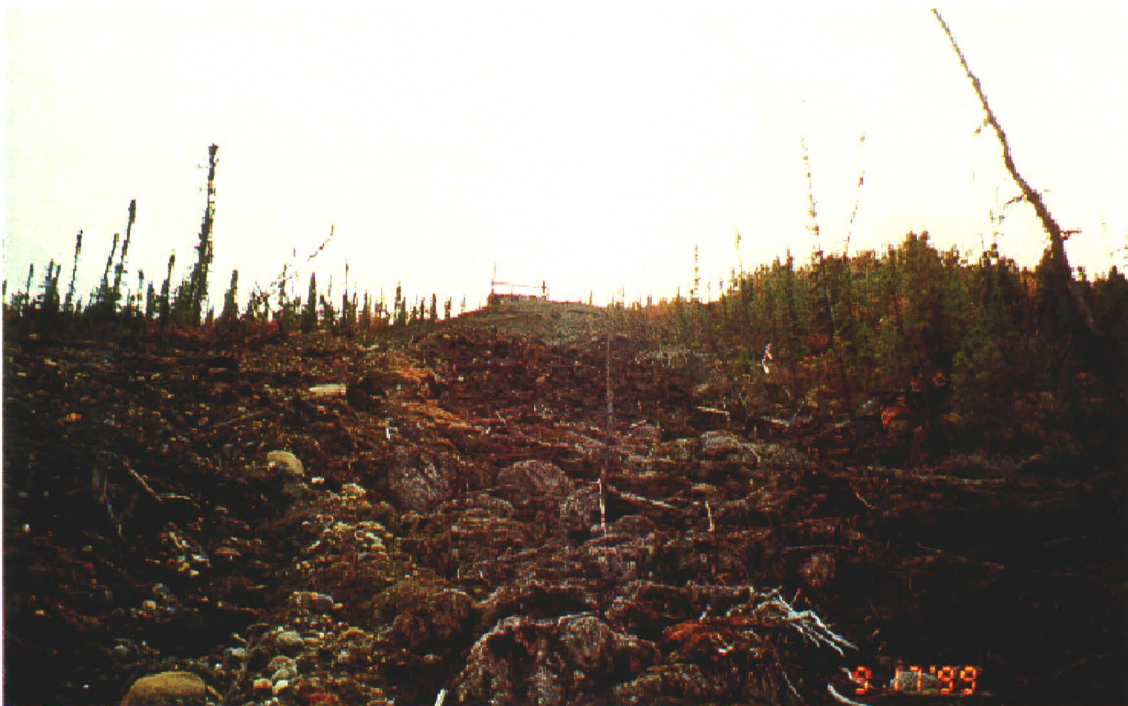
Waste rock piles (2) – Lower workings (photos 57-4 & 57-5)

An area of disturbance of approximately 6000 m² was noted at the lower workings site and the waste rock was deposited below the adit.

Photo 57-4: Waste rock below lower workings. Note extensive vegetation kill zone.

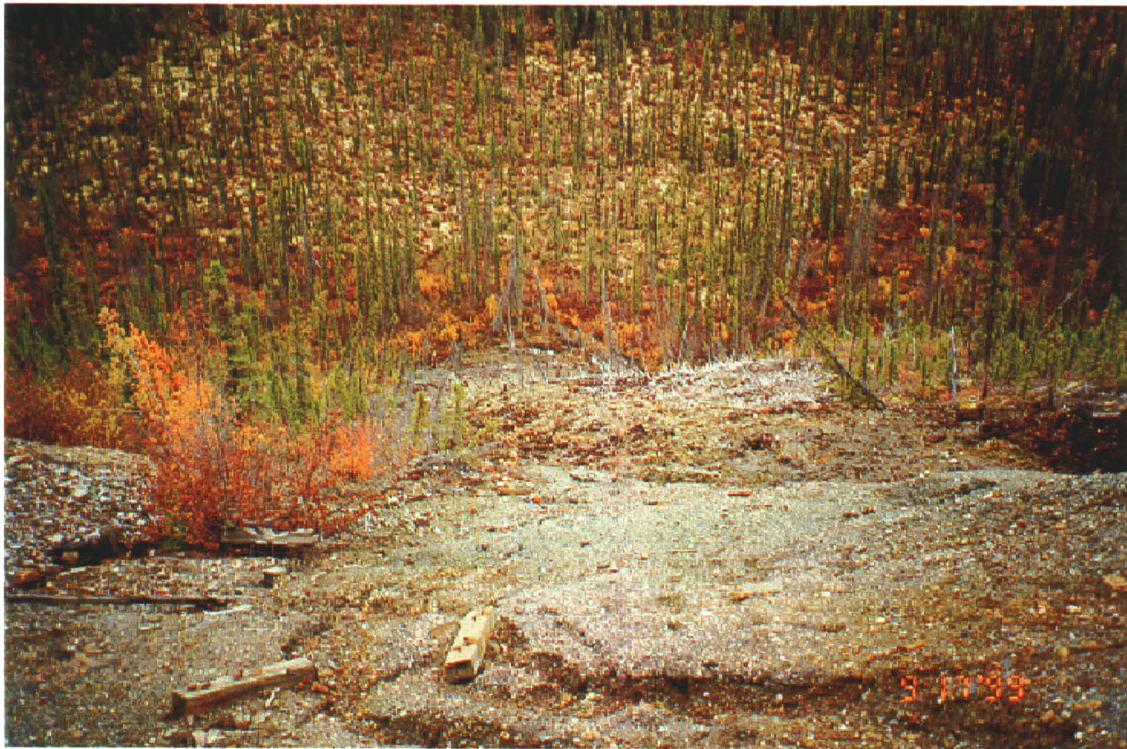
Photo 57-5: Waste rock below lower workings. Note Christal Creek at bottom.

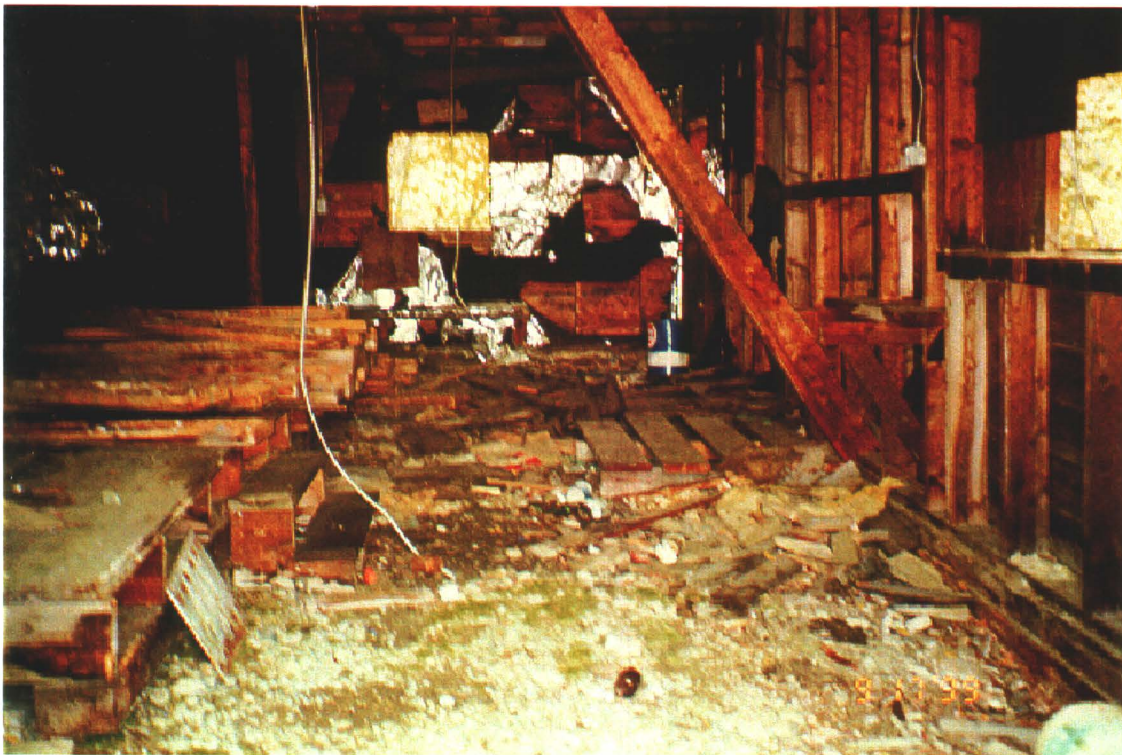
Building 57A – Core Shack (photo 57-6)

Large open wood plank building used for storage of cores. Raised wood platform for core storage.

Asbestos: Asbestos tar paper cladding.

Photo 57-6: Interior of core shack at upper workings.
