**PADDY (# 58)**  
**(MINFILE# 105M 020)**

Public Works And Government Services Canada Travaux publics et Services gouvernementaux Canada Architecture & Engineering Services Western Region	designed by: conceu par:	date: Nov. / 99
	drawn by:	C.S.
Drawing title: <b>Paddy Site #58 Site Assessment</b> Yukon Territory	approved by: approuve par:	revisions:
Title du dessin:	project no. no. du projet:	dwg. no. dessin no.:
	125-12.01	1 of 1

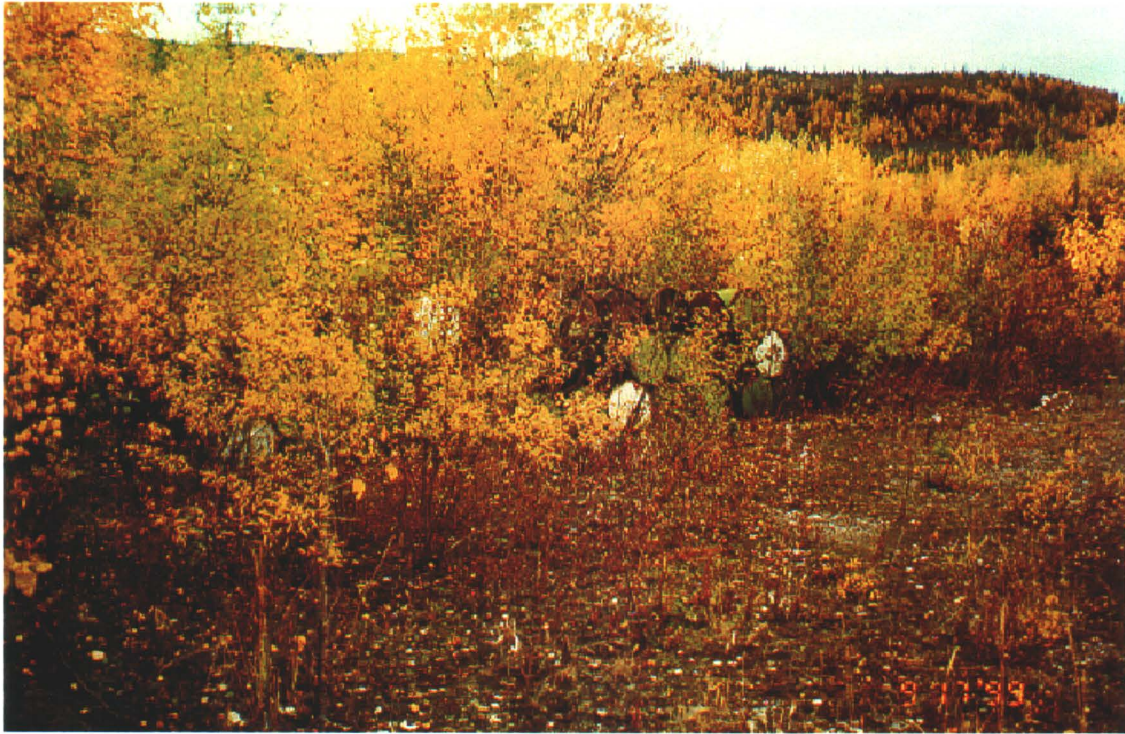
There is currently no fuel in storage at the site. Barrels at the barrel storage area were probably formerly used for high grading and are currently empty.

Photo 58-1: Barrel storage area to north of main sites.

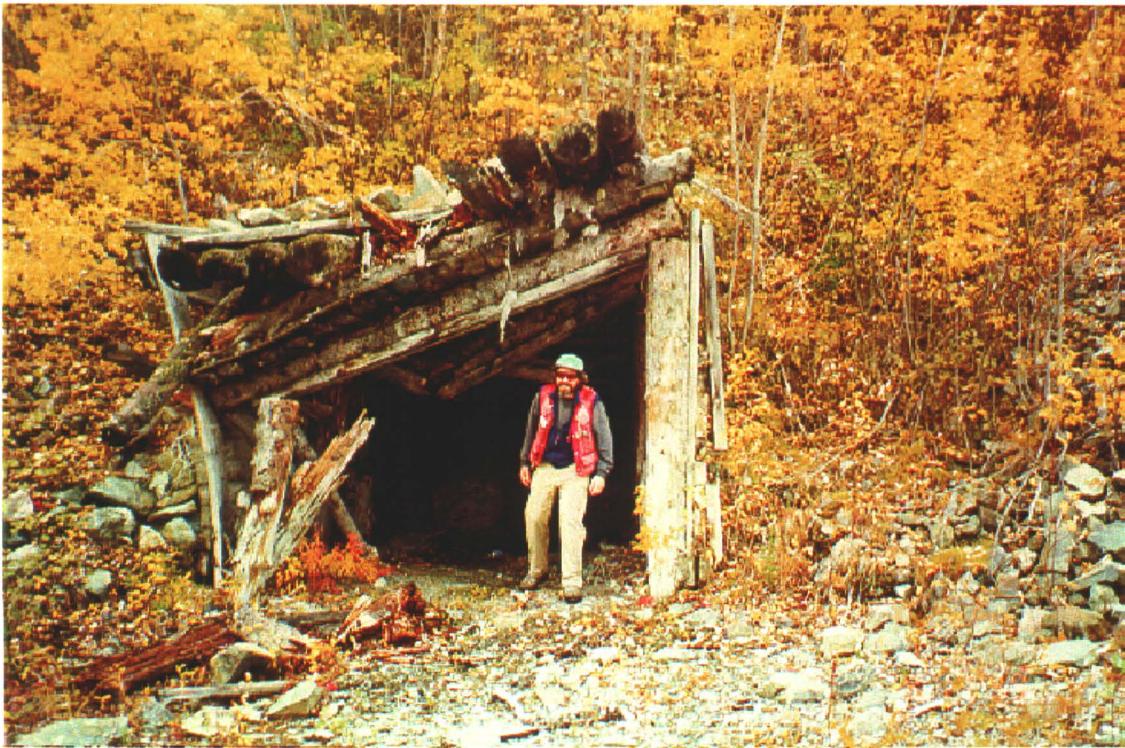
Adit (photo 58-2)

A timbered adit is present just above Christal Creek to the west.

Supports: The timbered portal is partially collapsed.

Condition: Poor condition, could collapse at any time.

Photo 58-2: Open adit.

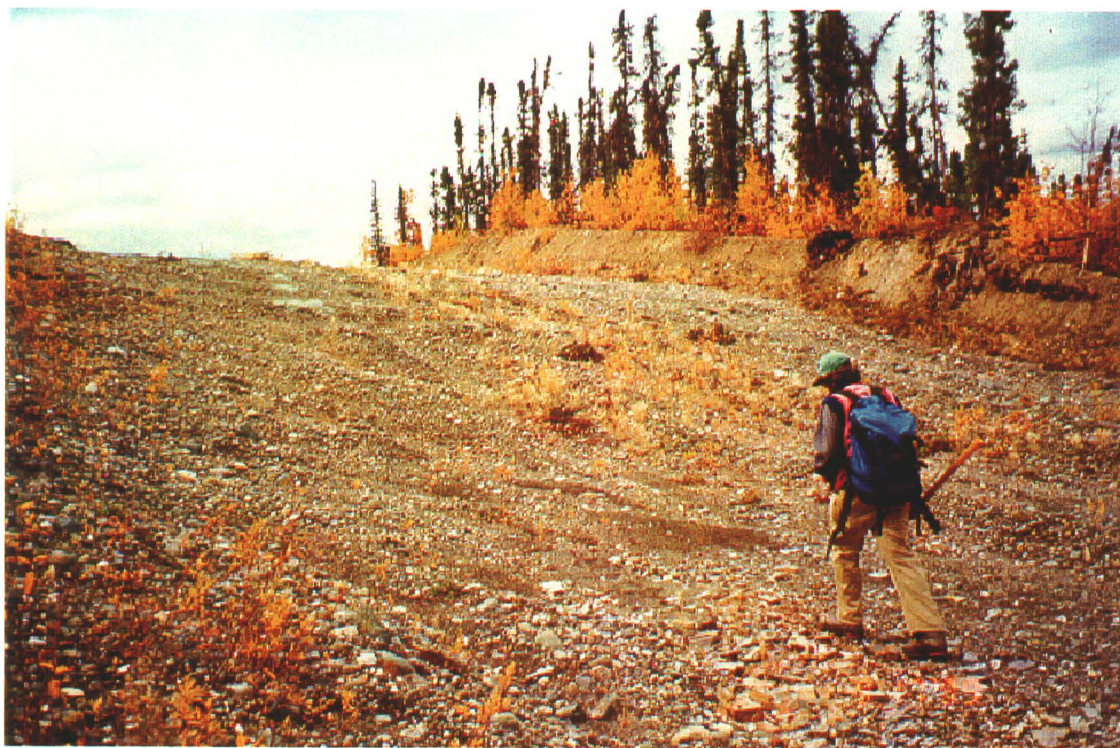
Three trenches basically parallel to each other, not previously discussed, were noted at a separate site to the south of the main (adit) site. Trenches run approximately east-west on top of knoll ending at or near cliff face. Trenches appear to be relatively recent and have had no revegetation over surface. Only a small amount of bedrock is exposed.

Condition: Two largest trenches recent and no revegetation; older trench partially reveged; material sloughing off two newer trenches into adjacent Christal Creek canyon at east end; remainder of trenches are stable.

Photo 58-3: Trenched area to north west of main site.

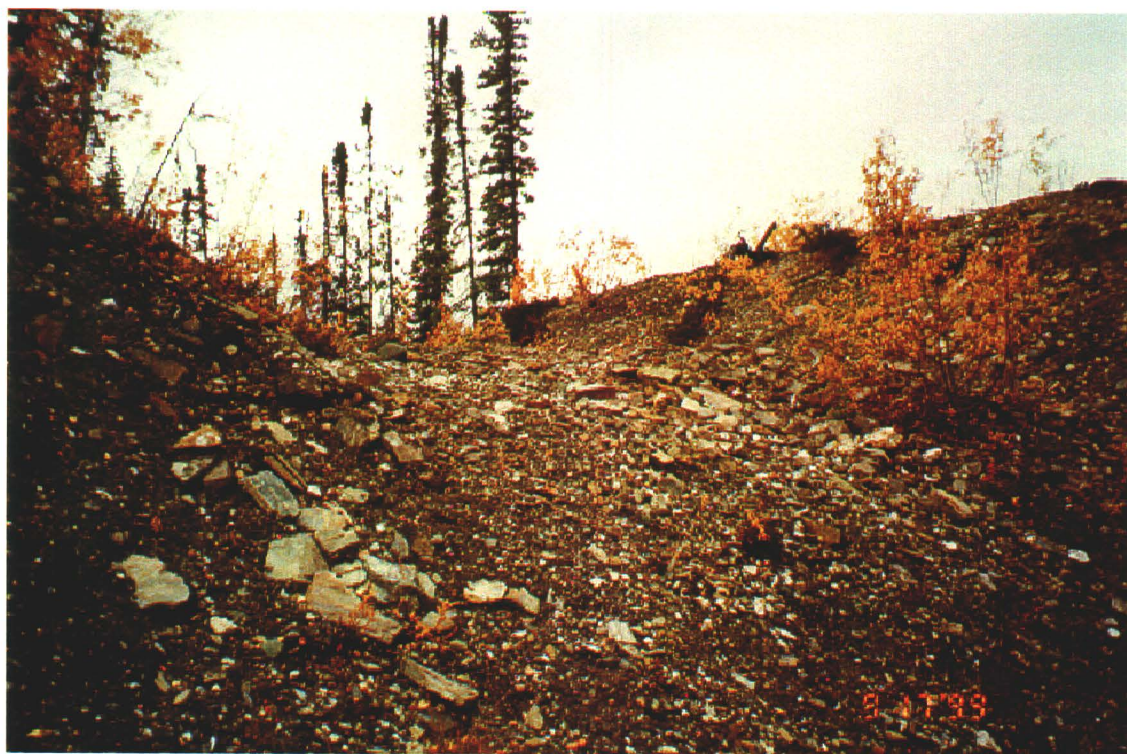
Photo 58-4: Top of knoll at newly trenched area.

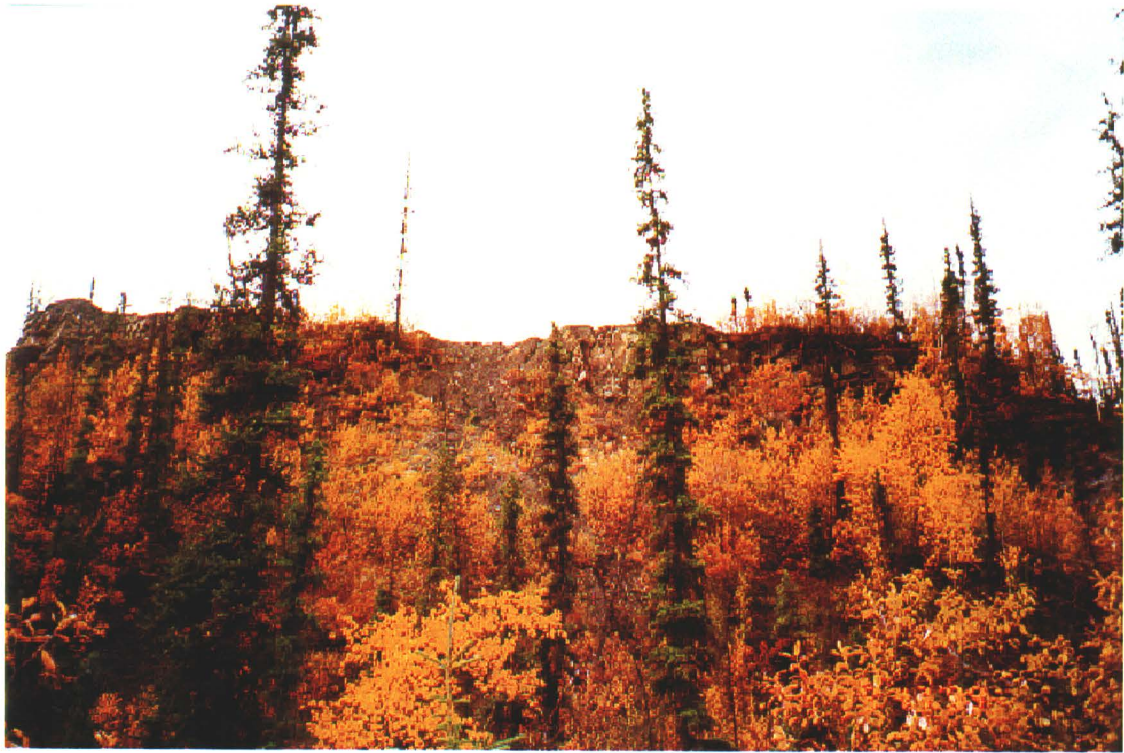
Photo 58-5: Trenched area visible from Christal Creek canyon below.

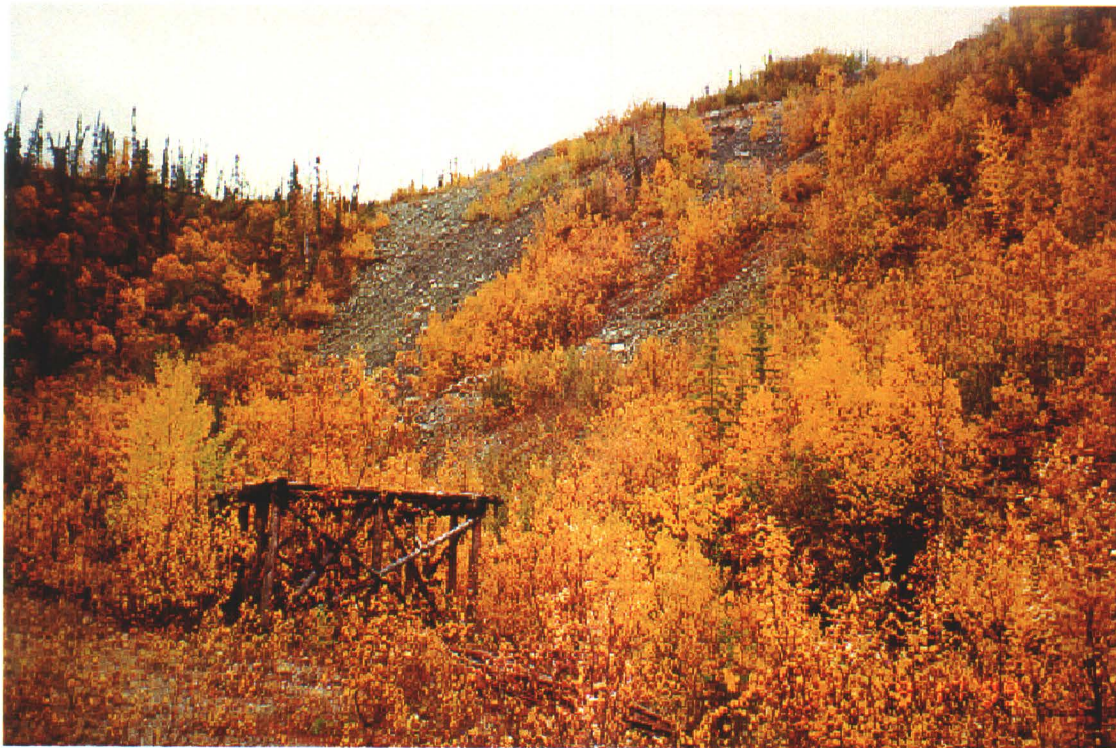
The waste rock from the adit and the excavation located above the adit was dumped down the hillside (photo 58-6). The waste rock dump below the adit extends down to Christal Creek. The rock in the upper waste rock dump has started to slump down the hillside.

Photo 58-6: Waste rock on slope adjacent to adit.

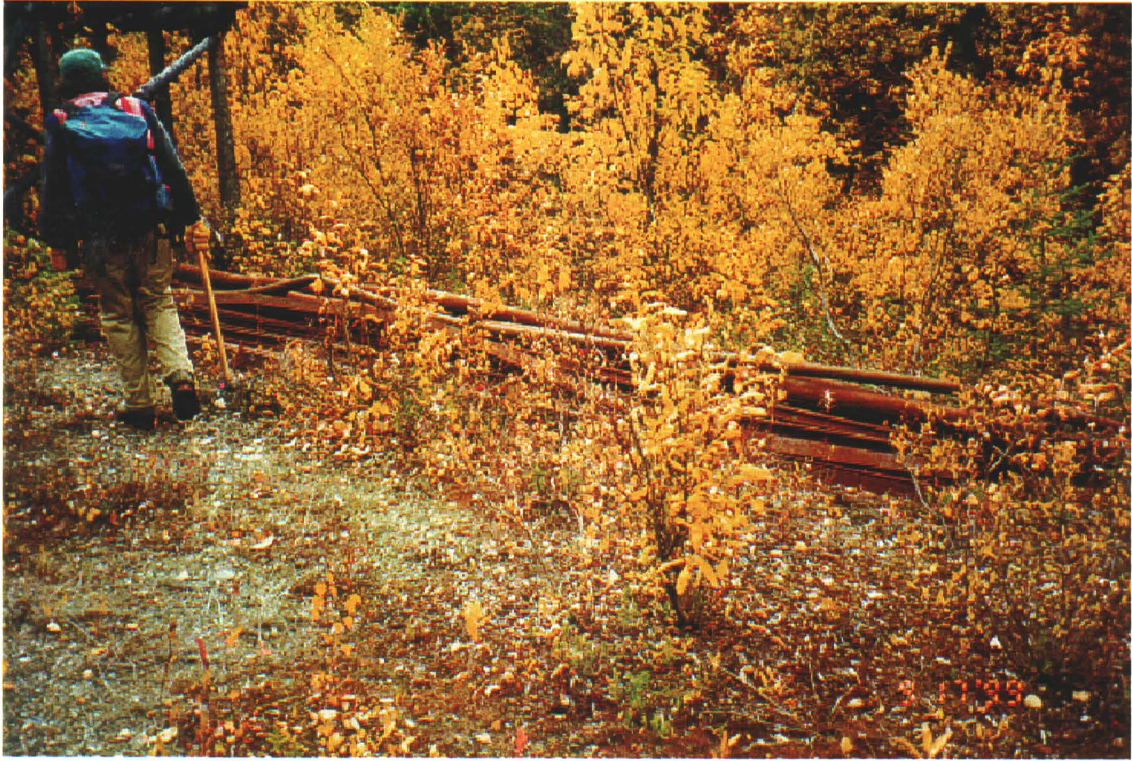
Condition: Rails are in satisfactory condition, however, they have been removed and there is no evidence of their former location.

Photo 58-7: Stockpiled rail below adit.

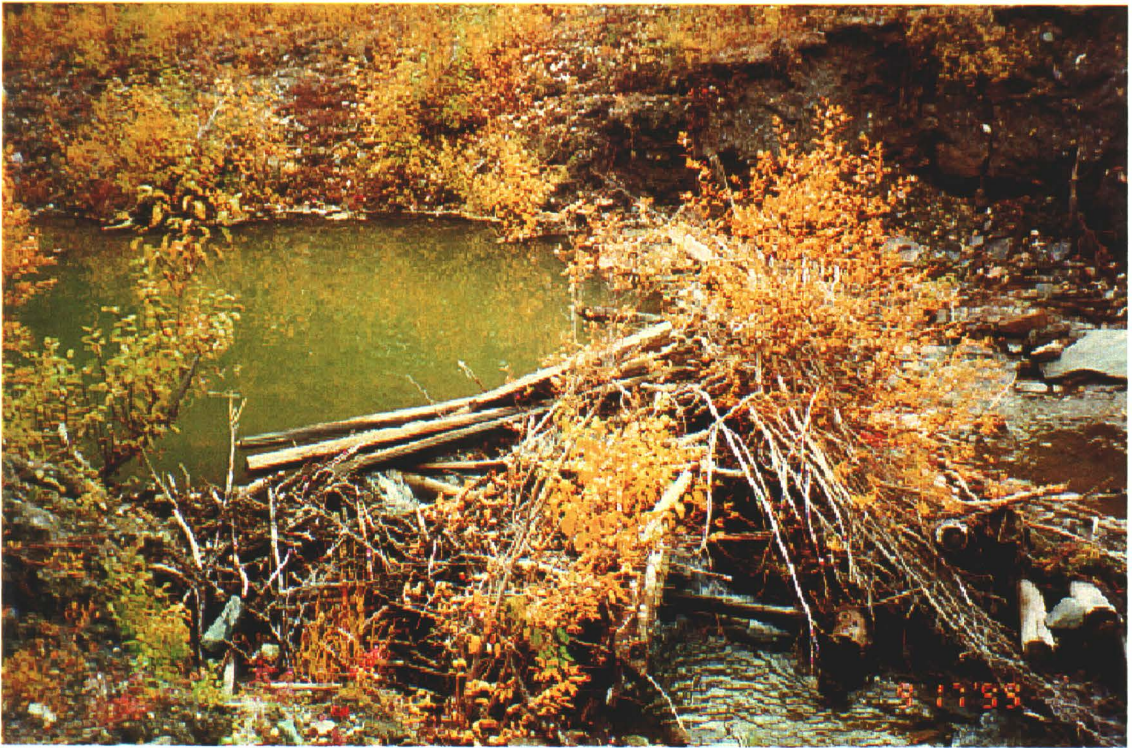
Christal Creek was sampled upstream of the site immediately upstream of a beaver dam (photo 58-8) constructed at the collapsed bridge (58-WQ-StrCD-02). The beaver dam was not identified in previous assessments and is probably of recent construction. Christal Creek was also sampled downstream of the site, immediately upstream of the north collapsed bridge (58-WQ-StrCD-01) at a location similar to previous sampling programs (photo 58-9).

Photo 58-8: Beaver dam immediately downstream of site.

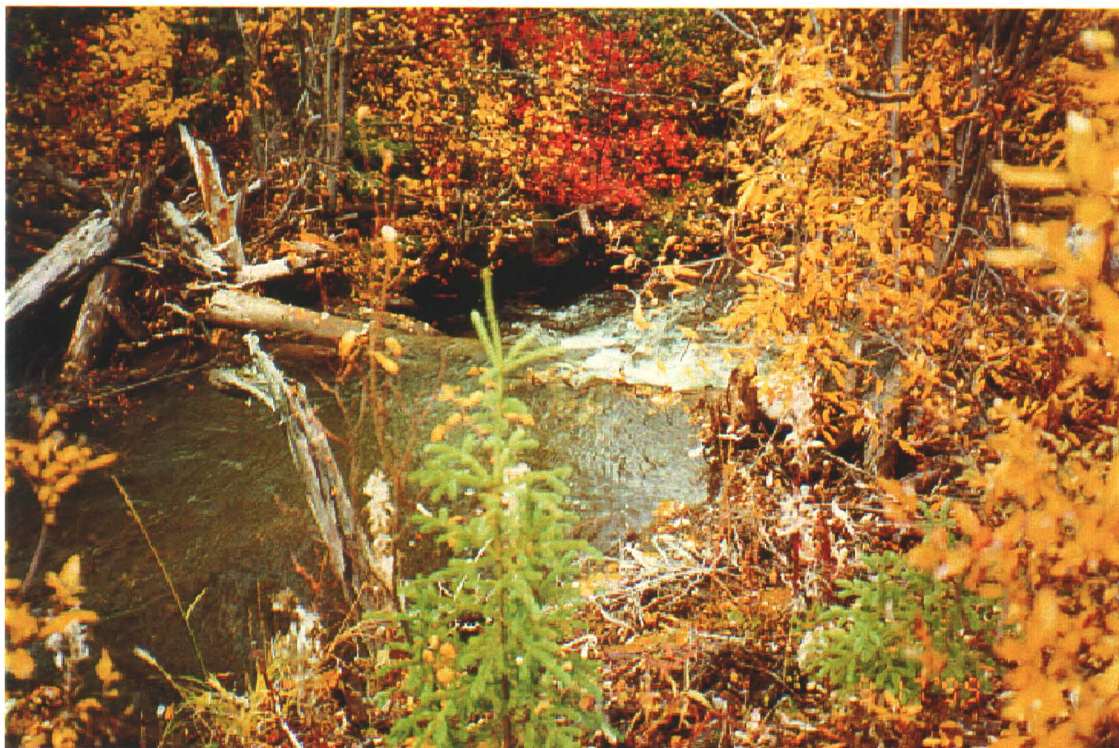
Photo 58-9: Second collapsed bridge downstream of site.
