EAGLE
Site No. 59
MINEFILE: 105M 021

Public Works And Government Services Canada	Travaux publics et Services gouvernementaux Canada	designed by: _____ date: _____ conçu par: _____
		drawn by: C.S. Nov. /99 dessiné par: _____
Architectural & Engineering Services Western Region		approved by: _____ approuvé par: _____
Drawing title:	Titre du dessin:	revisions: _____
Eagle Site #59 Site Assessment Yukon Territory		project no. no. du projet: 125-12.01
		dwg. no. dessin no.: 1 of 1

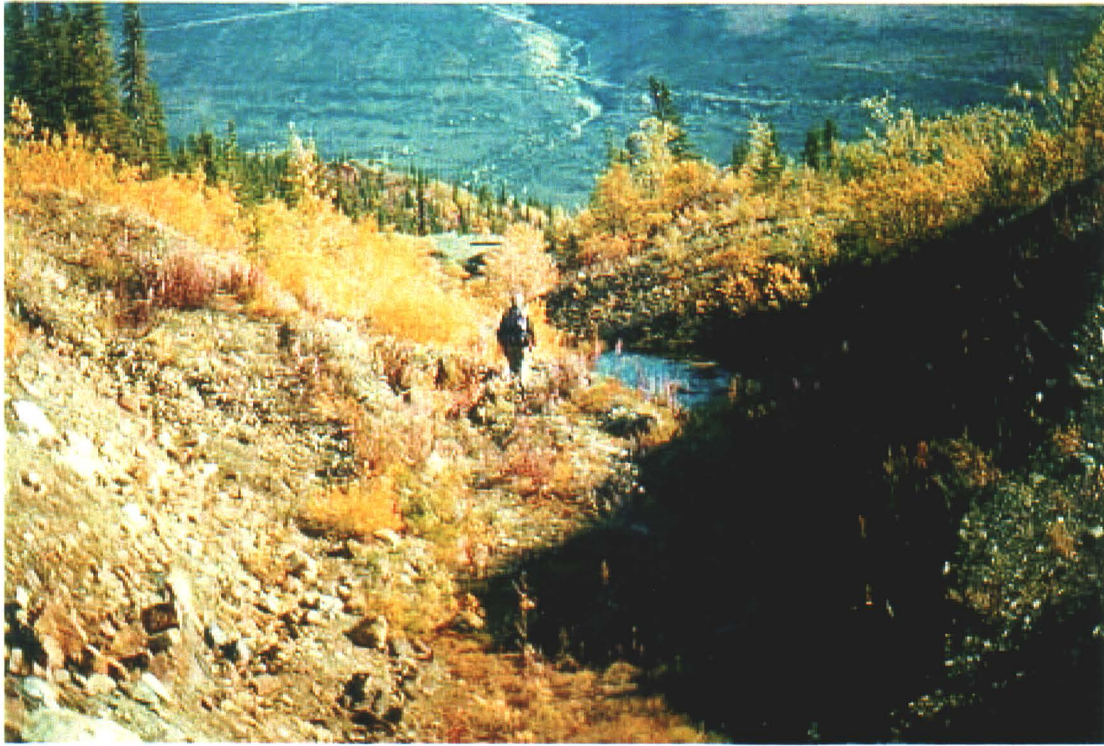
Large Trench (Photo 59-1)

Condition: The trench walls are stable.

Photo 59-1. Trench, looking eastward from below the shaft.

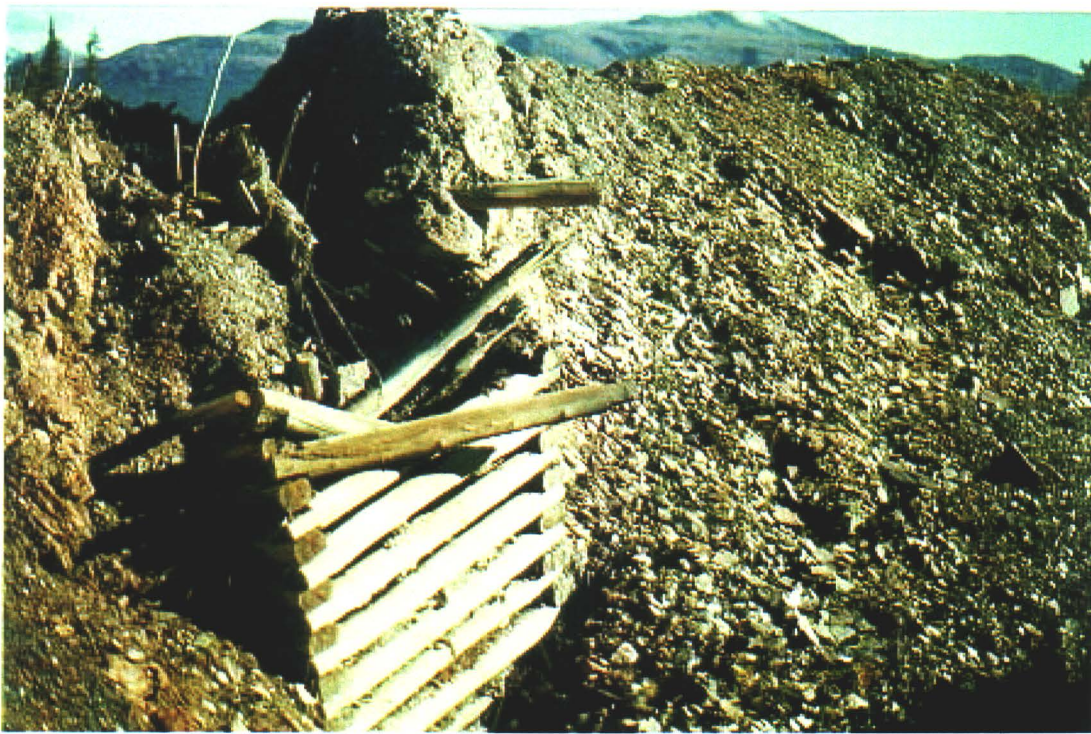
Shaft (Photo 59-2)

Condition: The shaft has completely collapsed. The trench was excavated around the shaft.

Accessibility: The shaft is inaccessible.

Photo 59-2. Collapsed shaft in center of trench.

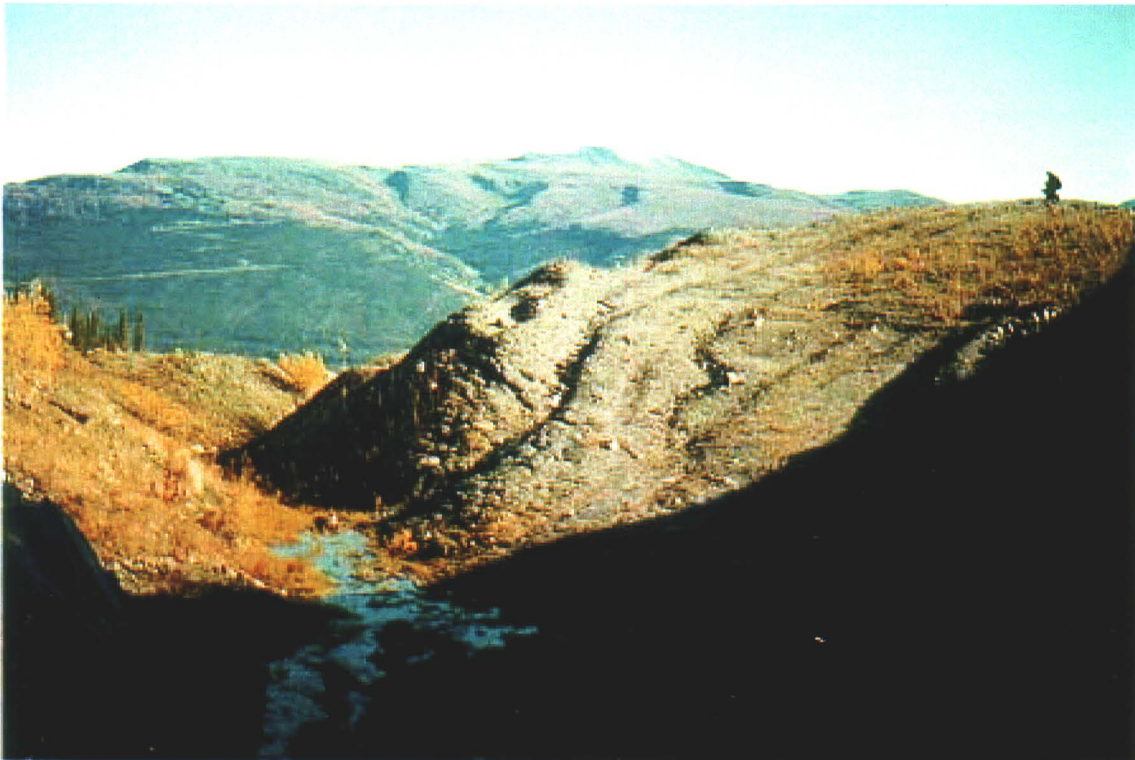
The waste rock dumps at the site were formed by pushing rock up the sides of the trench during excavation. The largest dump, located near the upper (western) end of the trench, comprises approximately 3,000 m³ of rock (Photo 59-3). Quartzite, schist, and quartz vein material make up most of the surface of the dump. All waste rock dumps appear stable.

Few sulfides and little iron staining was seen on the surface of the waste dumps. There was no evidence of seeps from the dump, and no apparent impact on the vegetation growing around it. No waste rock samples were collected from the dump.

Photo 59-3. Main waste rock pile, looking east. Note water from seep and revegetation of waste rock.

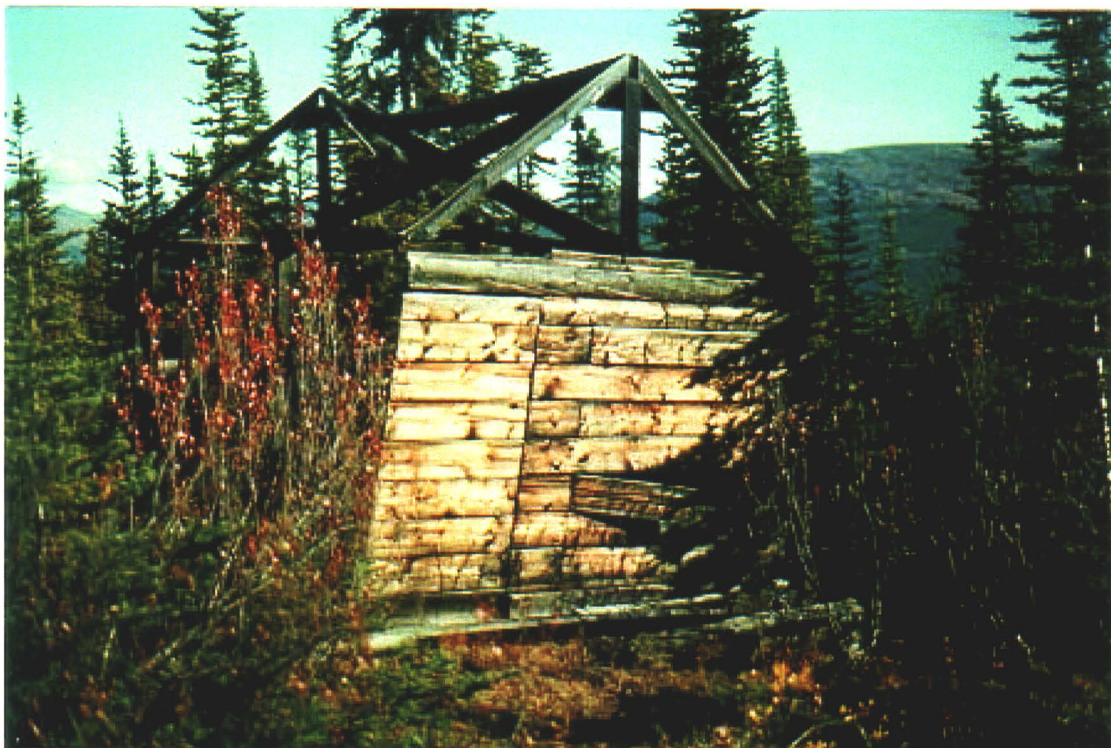
Building 59A - Cabin

Surrounding area: Two empty barrels, one tire and some pieces of metal were seen.

Photo 59-4. Wooden cabin.

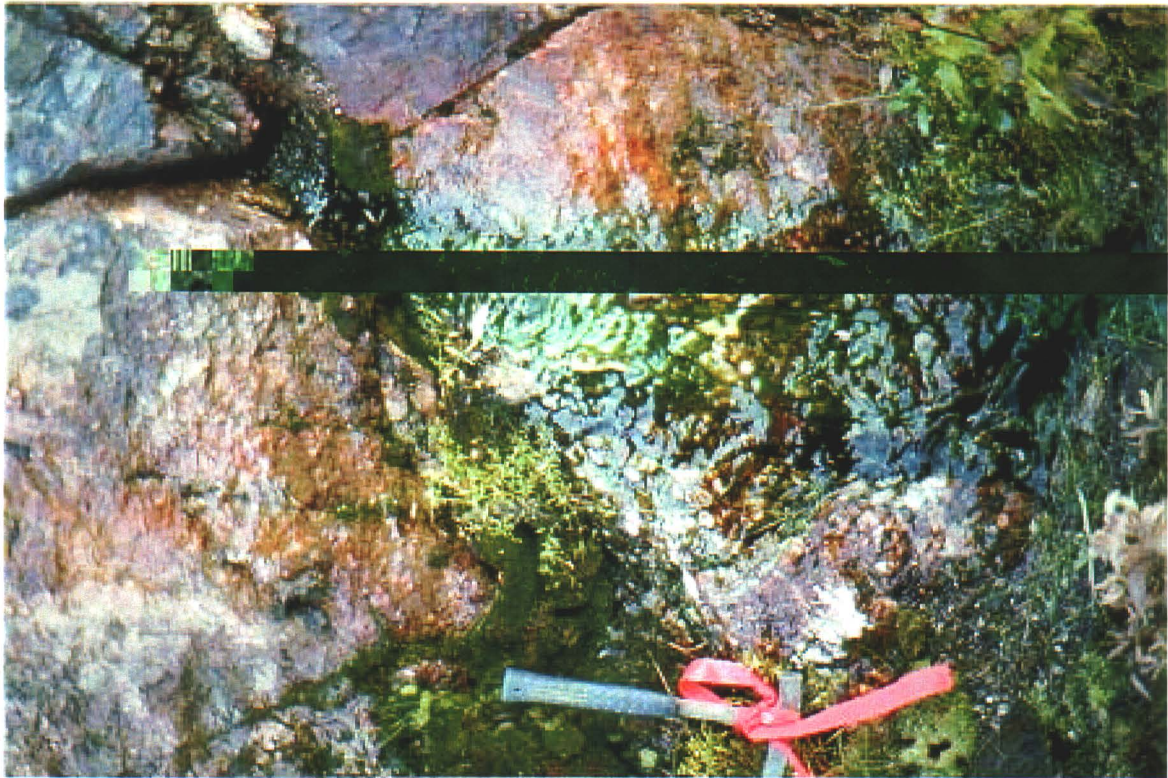
One water sample (59-01-seep) was collected near the upper (western) end of the main trench, from a seep in the footwall of the vein. The flow was < 0.5 L/s. The pH was 7.0 and the conductivity was 80 μ S. Abundant green moss was growing in the seepage. The seep water flows down the trench and then exits it before reaching the shaft. The fall water quality analysis of this sample is provided in Table 1.

Photo 59-5. Seep from the rock around the vein. Note green moss growing in water.
