FISHER
SITE #60
MINFILE# 105M022

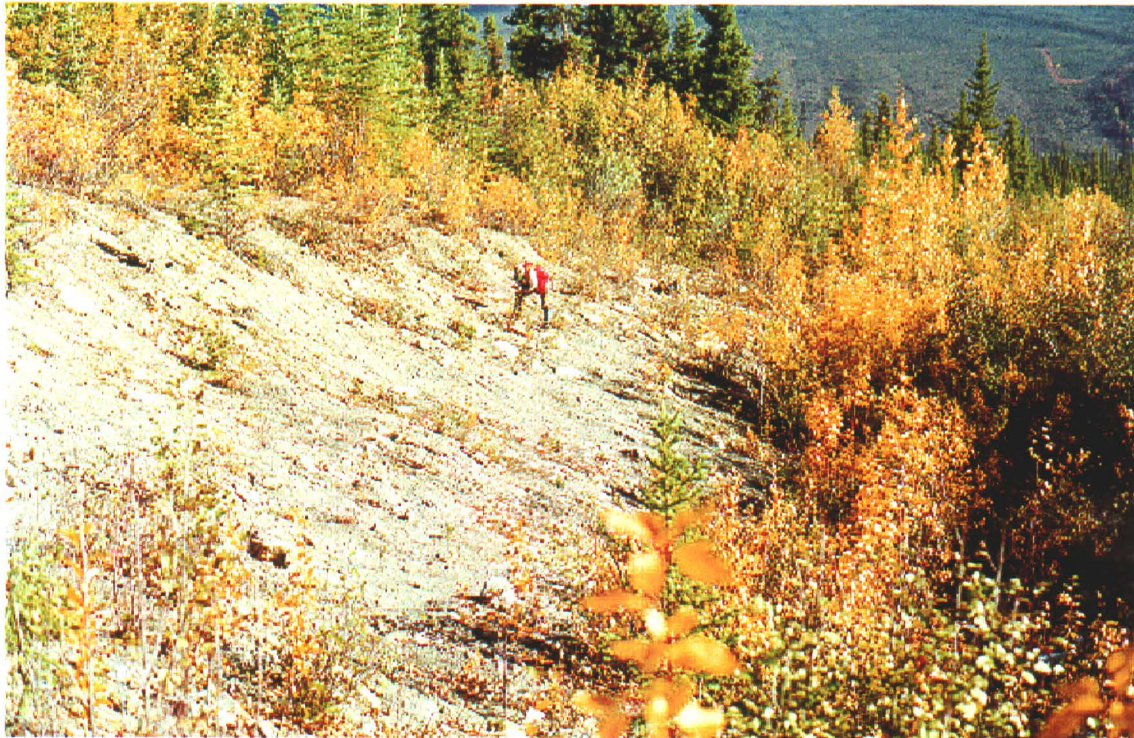
Trench (photo 60-1)

The trench was excavated in overburden creating a shallow cleared area comprised of sand, gravel and boulders. The trench is oriented at 320°. There is no visible outcropping of rock.

Dimensions (L x W x H): 60m x 20m (at rim) x 8m

Condition: There is no danger of stability problems as the trench is so shallow and the sides are gently sloped. The bottom of the trench has sparse vegetation of grasses and small bushes.

Photo 60-1: View of trench 1. (Azimuth 140°)
