CREAM & JEAN (#61)
(MINFILE# 105M 024)

Public Works And Government Services Canada Travaux publics et Services gouvernementaux Canada Architectural & Engineering Services Western Region	designed by: conçu par: drawn by: C.S. dessiné par: C.S. approved by: approuvé par:	date: Nov. / 99
	Drawing title: Cream & Jean Site #61 Site Assessment Yukon Territory	Titre du dessin: Cream & Jean Site #61 Site Assessment Yukon Territory

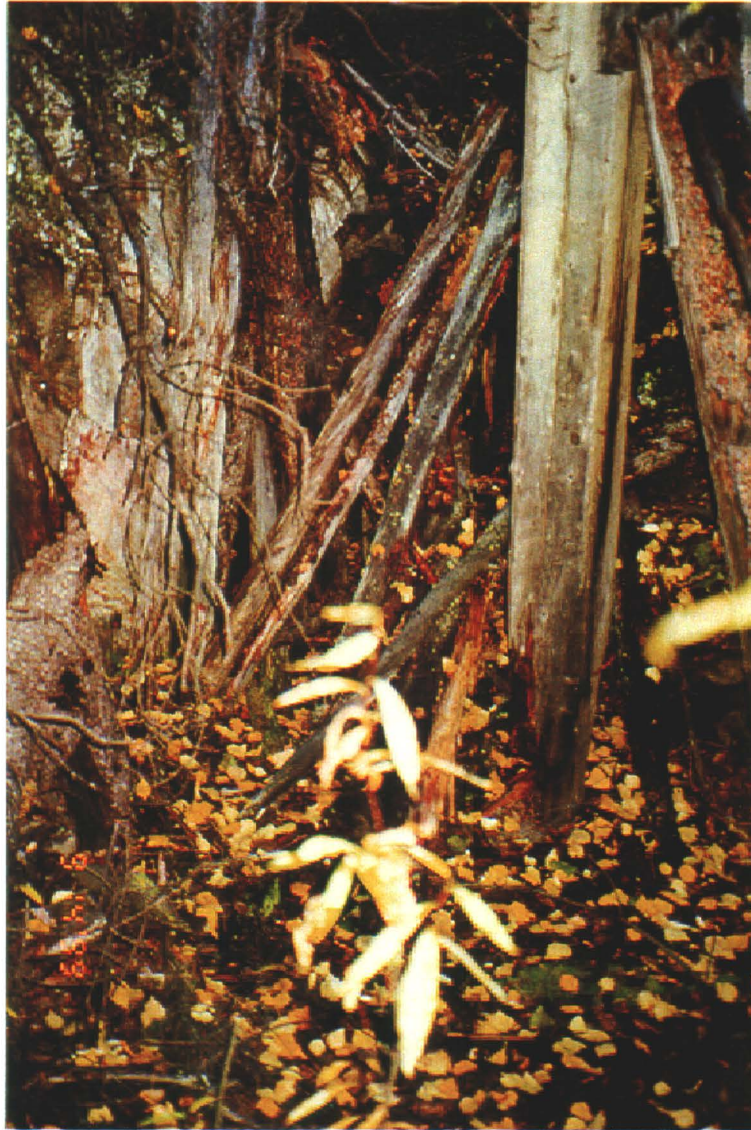
The portal has completely collapsed, and the site is overgrown with dense alders except for the steep slope of the waste dump (photo 61-2).

Supports: Wooden timbered; collapsed.

Condition: Completely collapsed; stable.

Accessibility: Inaccessible.

Photo 61-1: Timbers partially obscuring entrance to collapsed adit.

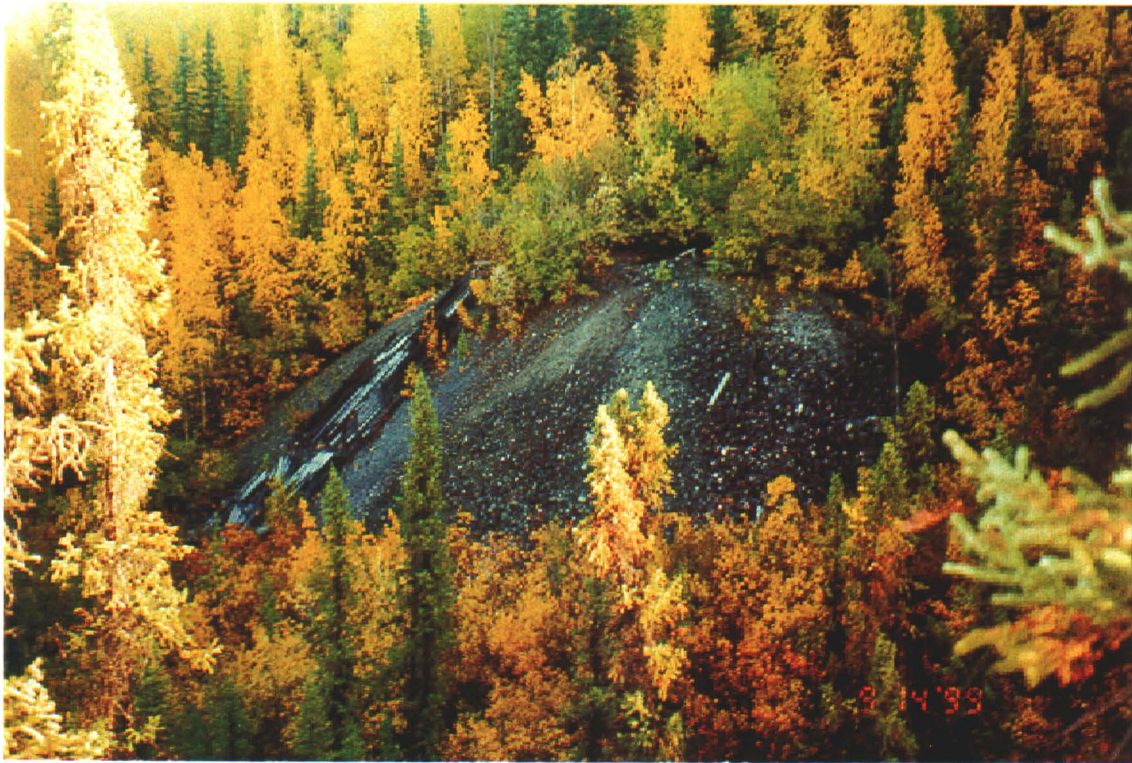
The Jean Adit dump is composed of two rock types; boulders and cobbles of dark grey-green greenstone with calcite-quartz-siderite veins and disseminated pyrite, and smaller material that is dark grey phyllite. No mineralization was observed at the Jean adit, and the high carbonate content appears to dominate the low pyrite content as no rusting was observed. No drainage was noted through the dump, although the creek does contact the toe of the dump. The dump is derived from underground development.

Location: See map. Site is immediately east of Sandy Creek. The toe of the waste dump is in the creek.

Location: There is a short rail and loadout chute immediately west of the adit leading down to a former (overgrown) road near Sandy Creek. Rails have been removed and stockpiled adjacent to the adit (photo 61-6).

Fabrication: Horizontal metal rail leading to wooden chute down the slope.

Condition: Rail has been removed and stockpiled. Wood chute has deteriorated.

Photo 61-2: Waste rock and loadout structure below adit.

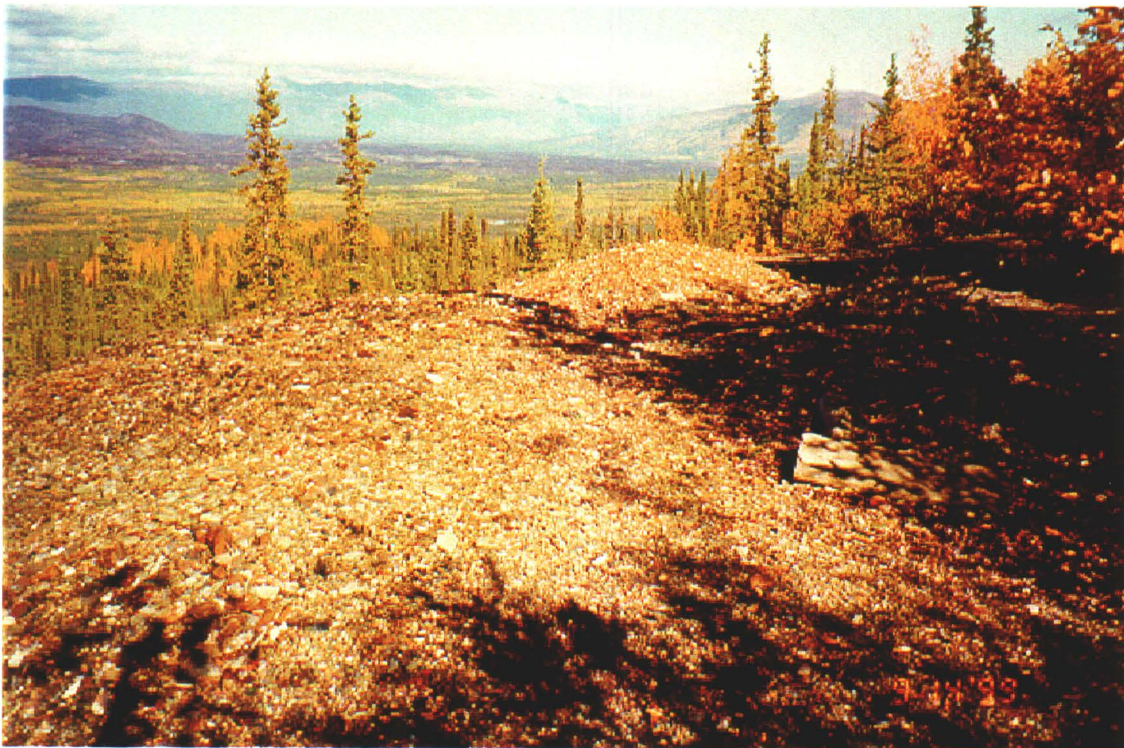
The waste rock is from the shaft development and production (photo 61-3). The bottom of the dump is likely weakly mineralized development rock, and the top is highly mineralized vein material discarded during ore production. The surface material is stained due to oxidation. No water was noted to flow over the dump. There is considerable mineralized material that occurs at the contact between quartzite and grey-brown phyllite. Quartz-siderite-calcite-limonite-pyrite-sphalerite-galena vein material is common in the dump. Minor tetrahedrite, pyrargyrite and chalcopyrite are also reported here. The material sampled is very high in sulphide sulphur (over 12%), and has a NP/AP of 0.2. There is high metal content in this dump.

Photo 61-3: Waste rock on slope adjacent to headframe.

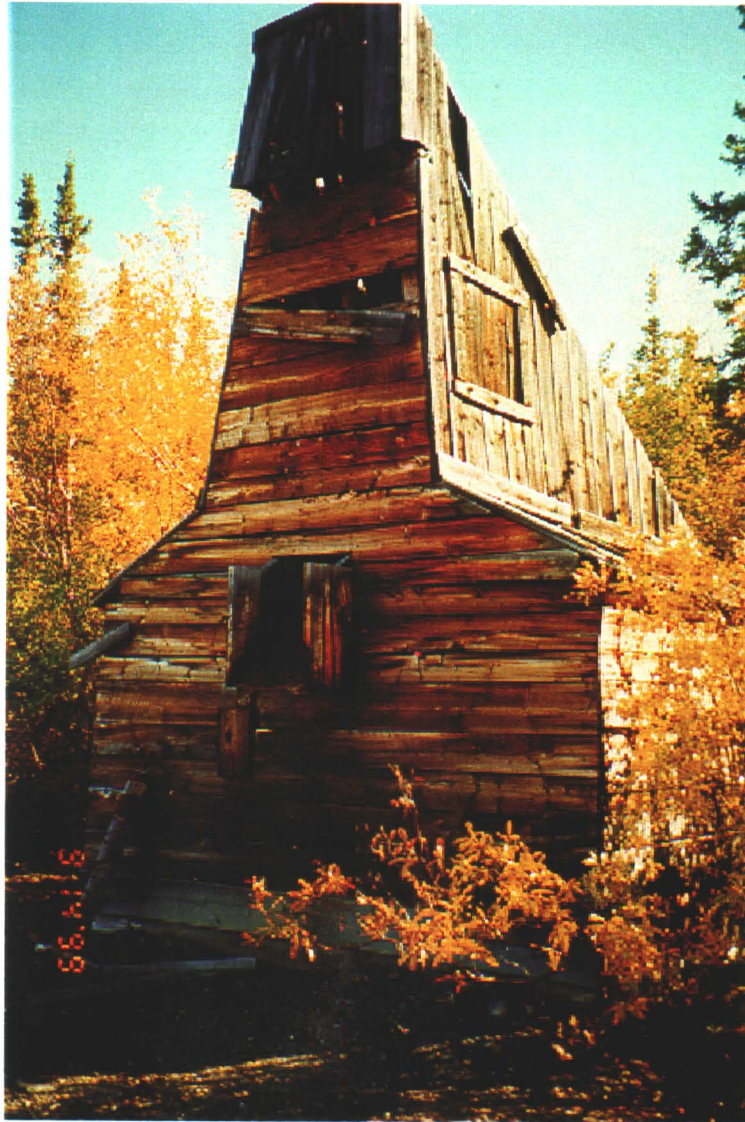
A wood headframe about 8 m high stands over the inclined shaft.

Supports: The shaft is timbered, appears to be in fair to good condition.

Condition: Shaft appears to be in good condition; stable.

Accessibility: Wooden doors cover the inclined shaft, and can be opened. Water and ice are present at a depth of approximately 2 m which prevents access to underground, and limits the hazard.

This is a small headframe with much of the original equipment remaining inside the building.

Construction: Wood frame with no floor; uninsulated.

Foundation: No foundation appeared to be present.

Photo 61-4: Wood framed headframe (61A).

Note: The headframe is photogenic, and is relatively close to the highway. It might be possible to develop this site as a tourist attraction. The mine is a good example of an underground hand-mining operation. The hand-cranked windlass is still in place, and a hoist bucket in good condition is present.

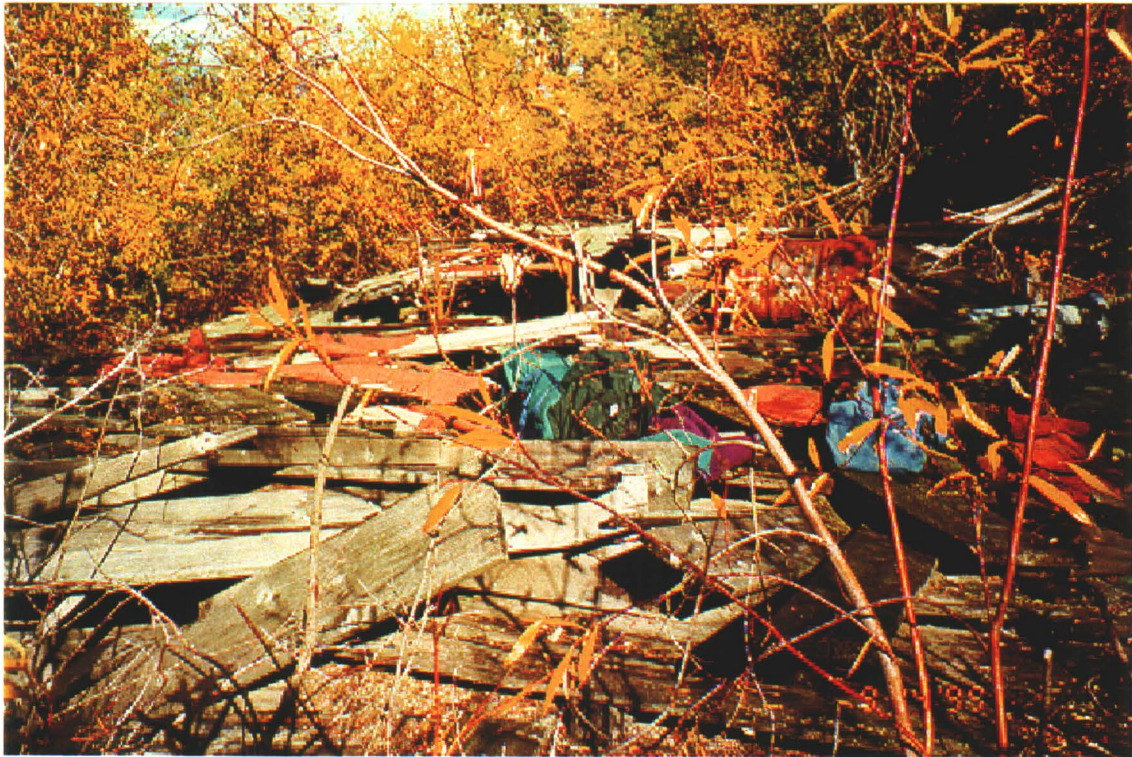
This building appears to have served as a combination bunkhouse and cookhouse. The building has collapsed and much of the building material debris is spread throughout the immediate area.

Non-hazardous contents: Stove; domestic debris; bed; asphalt sheeting; large amount of debris from collapsed building.

Photo 61-5: Wood debris at former bunkhouse/cookhouse building 61B.

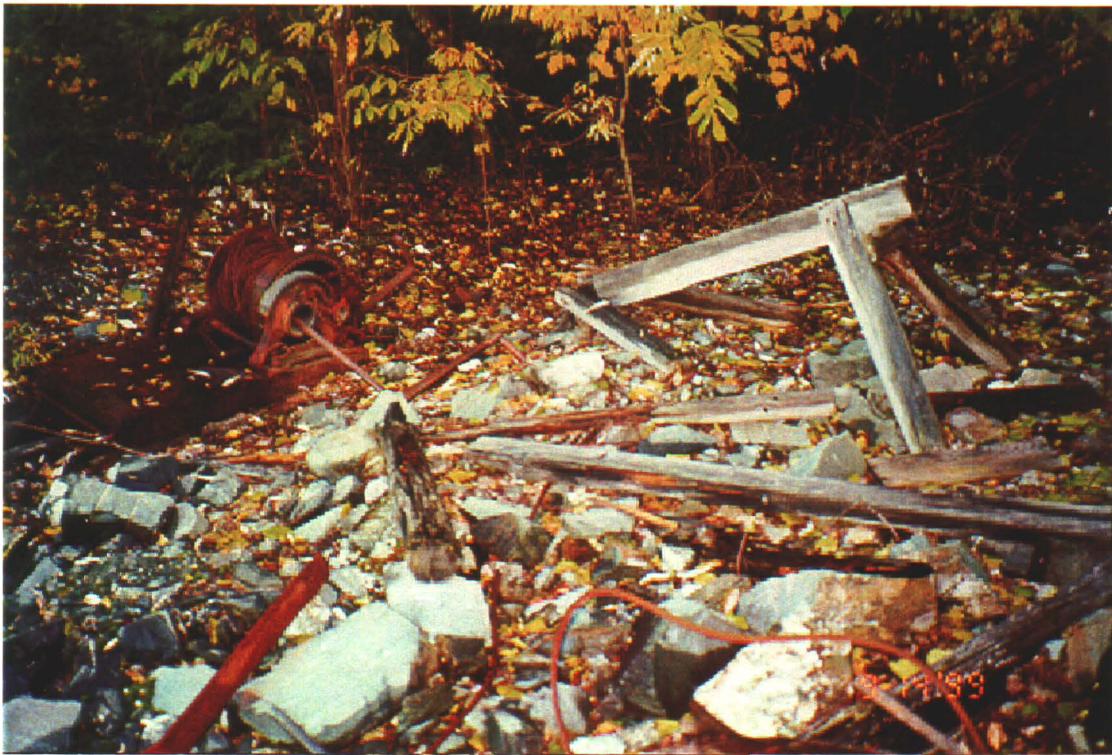
Photo 61-6: Wood and metal debris near entrance to adit.
