**NORD (#62)**  
**(MINFILE# 105M 025)**

**1. LOCATION AND ACCESS**

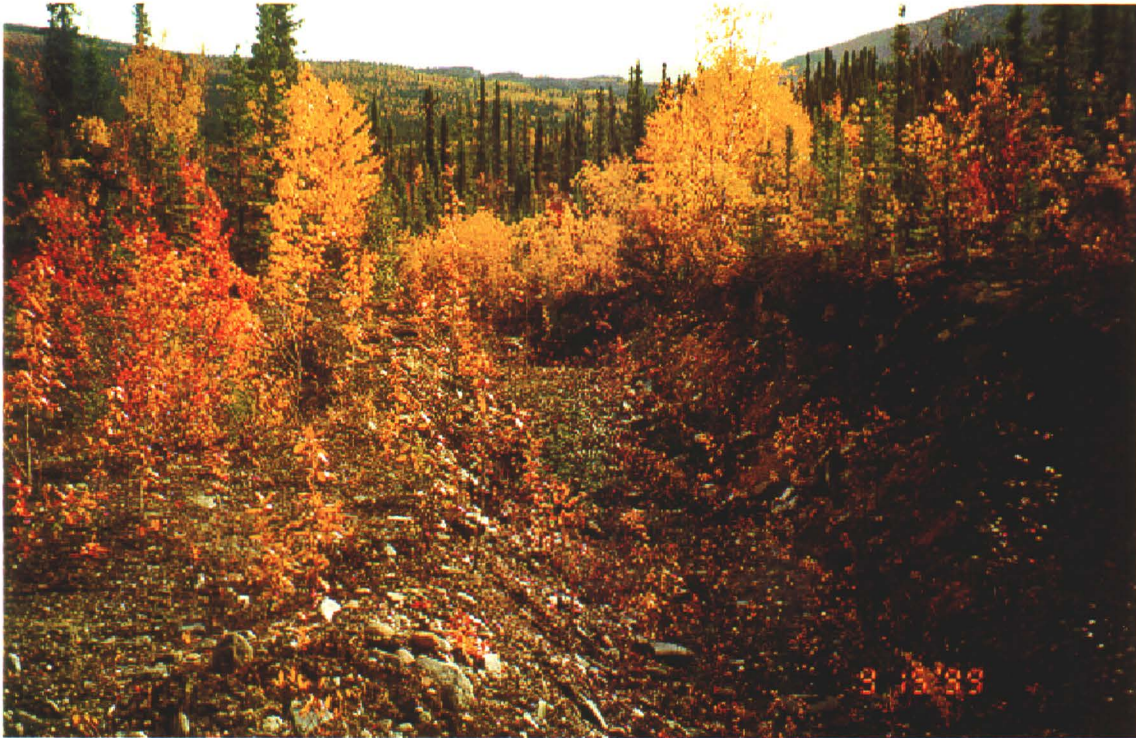
Trenches (photo 62-1)

The main vein is exposed in a bedrock sidehill trench beside the road, with a steep rock wall on the road side and material pushed downslope.

Condition: The trench is stable, with solid rock on its wall. The loose material is at a stable angle of repose, with some natural revegetation. The trench does not appear to be a hazard, except possibly to vehicles driving off the road over the steep bank.

Photo 62-1: Partially overgrown trench adjacent to road.
