**SHANGHAI**  
**SITE #65**  
**MINFILE# 105M 028**

Public Works And Government Services Canada  Architectural & Engineering Services Western Region	Travaux publics et Services gouvernementaux Canada  Architecture & Engineering Services Western Region	designed by: conçu par:	drawn by: dessiné par:
		approved by: approuvé par:	C.S. Nov. 1999
Drawing title: <b>Shanghai Site #65 Site Assessment</b> Yukon Territory		Titre du dessin: revisions: project no. no. du projet:	
		125-12.01	1 of 1

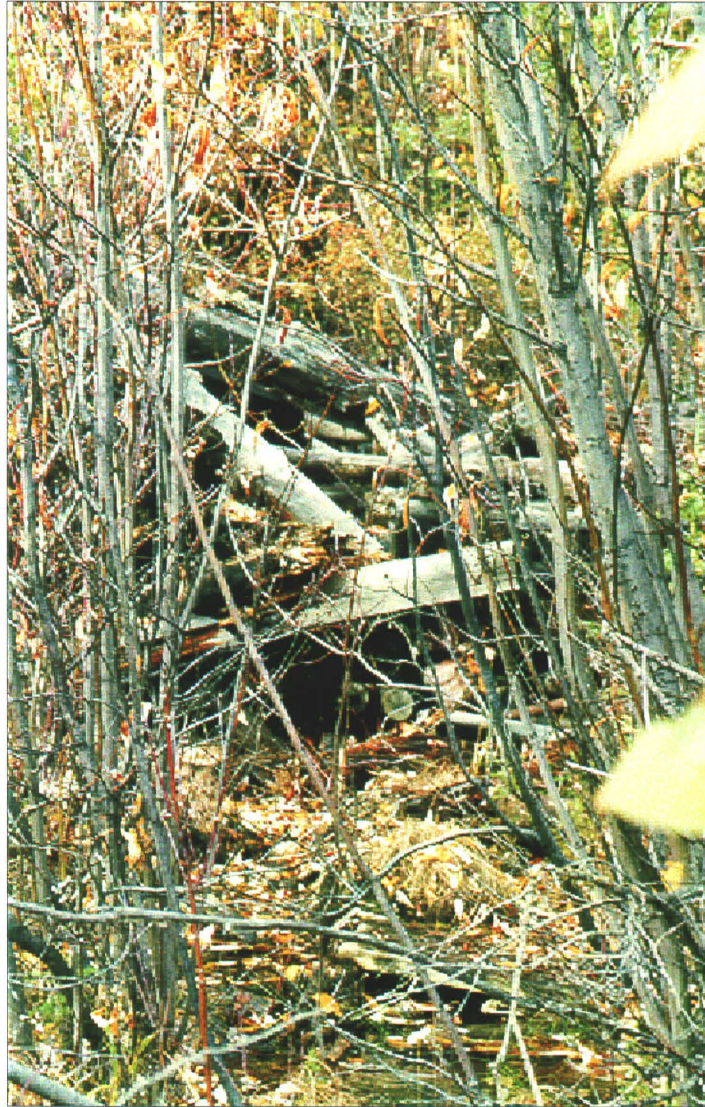
#### **Main Adit (photo 65-1)**

The main adit is located roughly 30m north of the clearing where the old camp was and where the waste rock was deposited. A 10m long log portal structure built outside of the adit has collapsed. A stream of water flows from the adit.

Dimensions (L x W x H): 835m (total length of all underground development) x 3m x 2m

Accessibility: The adit can no longer be accessed.

There is a stream of water flowing from the adit at a rate of approximately 4L/sec (visual estimation). The stream flows around the waste rock on the eastern side and presumably joins the South McQuesten River. A sample (Shanghai – 09/18/99) was collected for analysis. The field pH was 6.2 and the conductivity was 480µS/cm. Laboratory results are in Attachment 2.

Photo 65-1 : Shanghai. Collapsed Main Adit with water flowing. (Azimuth 340°)

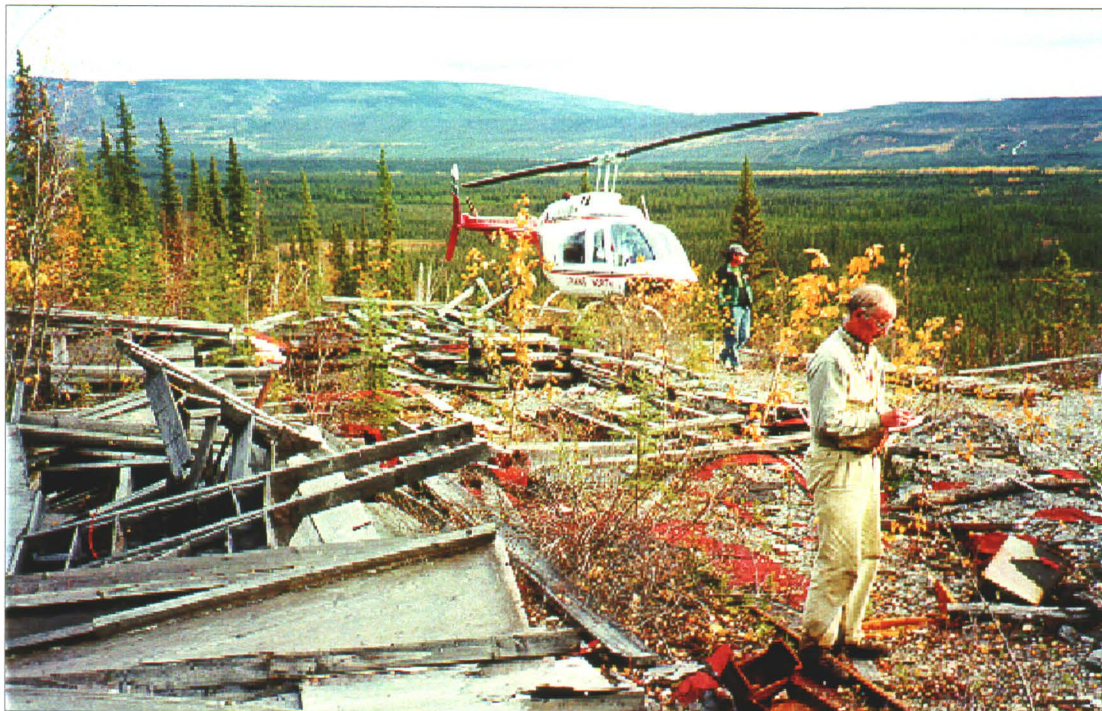
### 5.2 Waste Rock Disposal Areas (photo 65-2)

Waste rock from the adit is spread over a 48m by 34m area in front of the adit. The water flowing from the adit flows around the waste rock pile on the eastern side. No water was observed on the pile.

The face of the waste rock pile is composed of highly broken dark gray carbonaceous Keno Hill quartzite with approximately 30% of the area having patches of brown to rusty highly oxidized vein material. A sample (Shanghai-Waste Rock-Sept.18/99) of the later material gave a paste pH of 4.7 and conductivity of >1000 $\mu$ S/cm.

Most exploration adits generally have a section of the pile where low grade to high grade oreshoot vein material is stored. None was seen at any location along the dump face. It is assumed that no sorting took place.

Photo 65-2 : Shanghai. Aerial view of waste rock pile and mine site debris. (Azimuth 120°)

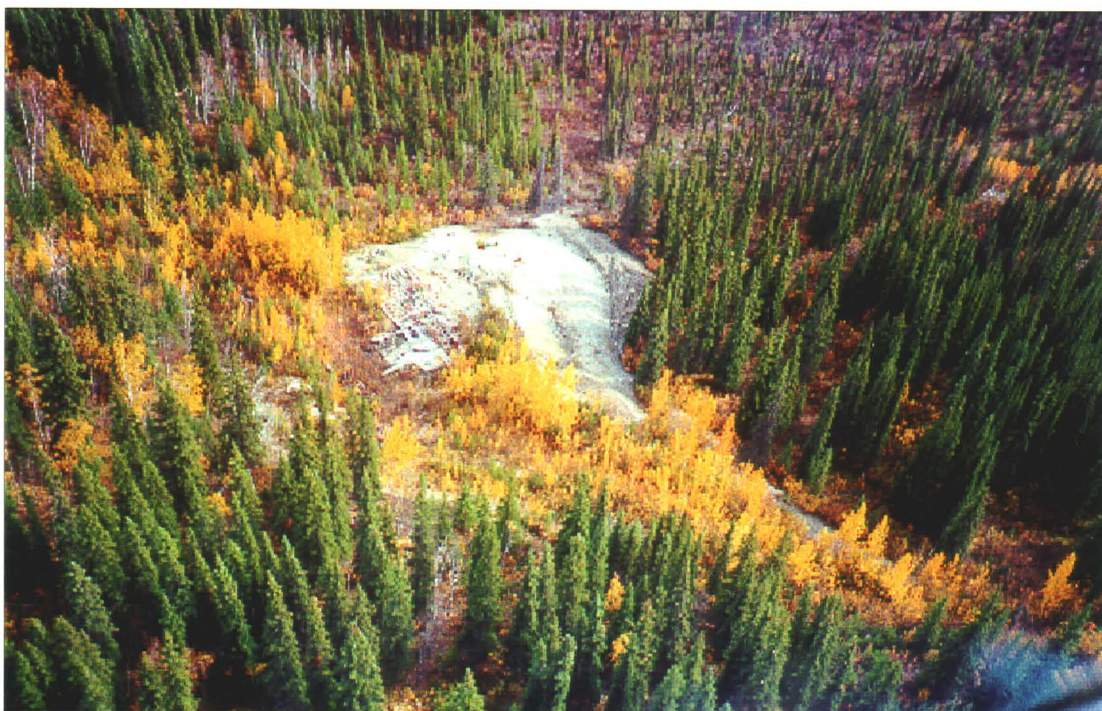
## **7. SOLID WASTE DUMPS (photo 65-3)**

There is a fair amount of waste near the collapsed building. Material observed include 10m<sup>3</sup> of wood waste, 5m<sup>3</sup> of asbestos tar paper, metal debris, 20m of water and air pipes, and a receiving air tank 0.7m in diameter and 2.4m high.

Photo 65-3 : Shanghai. Close-up of the scattered debris at the site. (Azimuth 120°)
