CHRISTAL (#71)
(MINFILE#105M 061)

Public Works And Government Services Canada Travaux publics et Services gouvernementaux Canada Architectural & Engineering Services Western Region	designed by: _____ conceu par: _____ drawn by: C.S. dessiné par: C.S.	date: _____ Nov. / 99
	approved by: _____ approuvé par: _____	revisions: _____
Drawing title: Christal Site #71 Site Assessment Yukon Territory	Titre du dessin:	dwg. no. dessin no.: 1 of 1

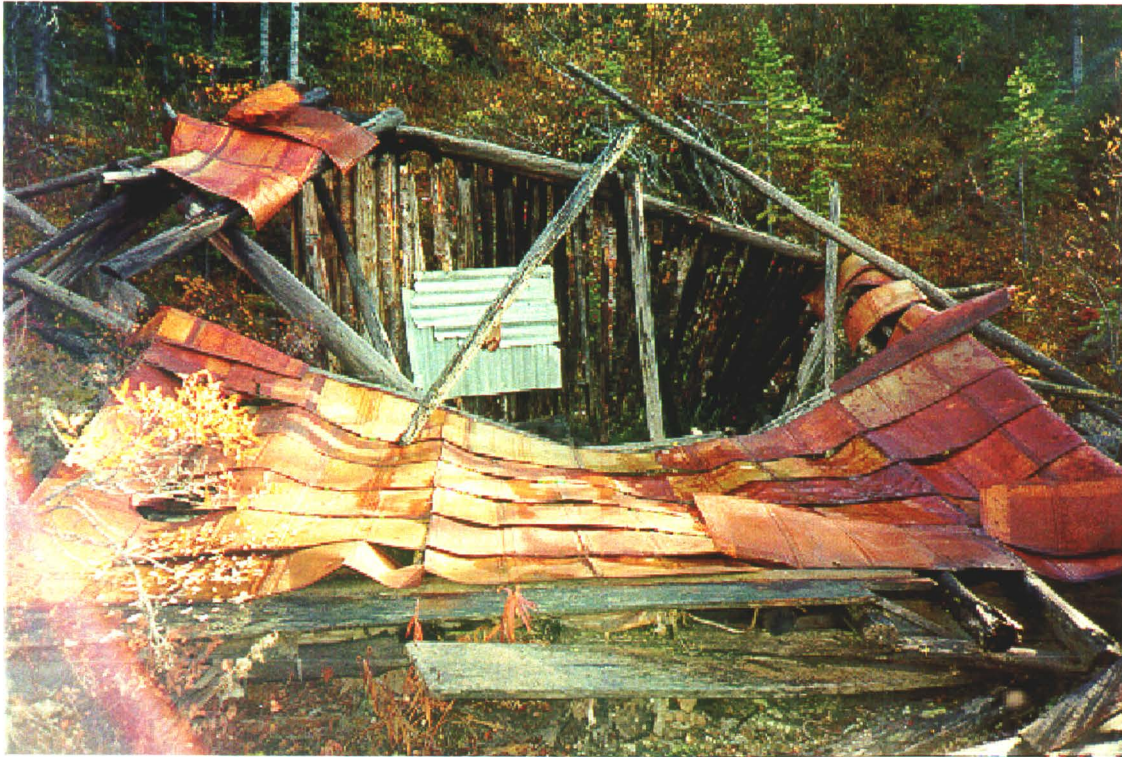
Shaft under collapsed shed (Building 71B) with water accumulated to within 1 m of surface

A wooden building (Building 71-1; photo 71-5) is located at the Christal camp site (see figure 1). Wooden debris provides evidence of other structures that used to occupy this site. A collapsed shed (Building 71-2; photo 71-1) is located over Shaft 2.

Photo 71-1: Collapsed shed building (Bldg. 71-2) over shaft A02. Note pulley on cross beam. (Azimuth 140°)

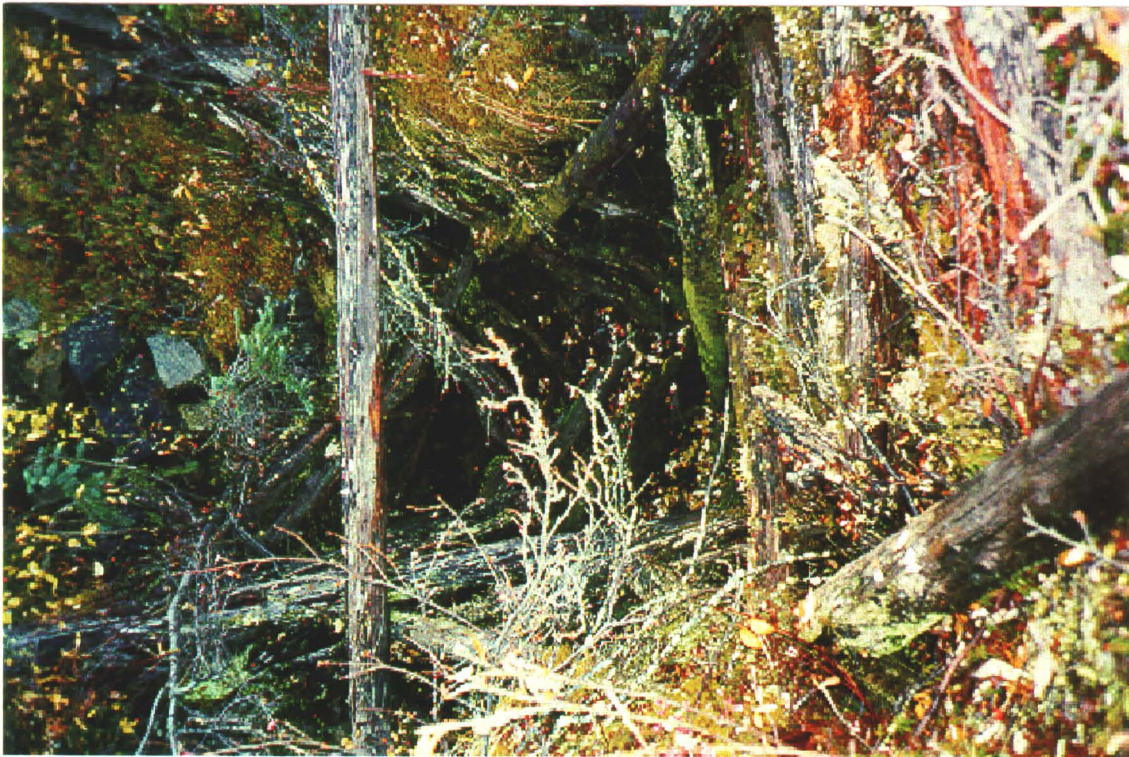
Shaft 1 (photo 71-2)

Collapsed shaft with water accumulated to within 1 m of surface

Condition: shaft is collapsed

Photo 71-2: Shaft A02. (Azimuth 150°)

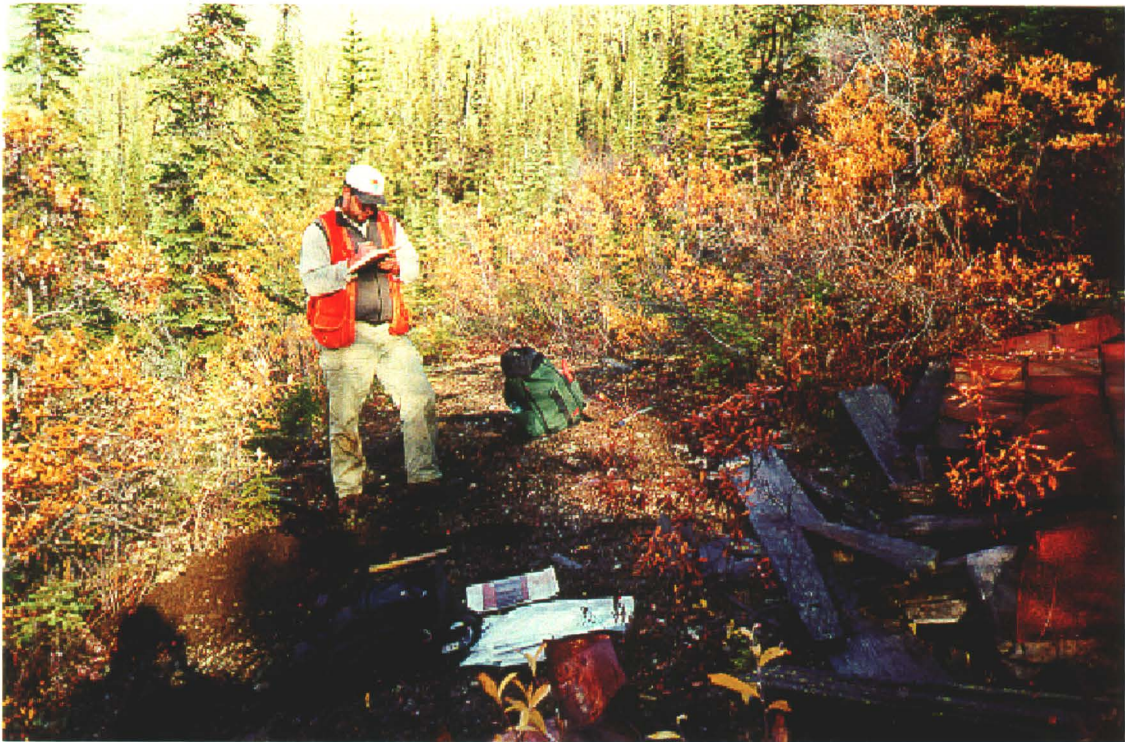
A waste rock pile was found next to Shaft 2 (photo 71-3). It was approximately 10 m long, 5 m wide and of unknown depth. This waste rock pile was almost entirely revegetated.

Photo 71-3: Waste rock dump below shafts A01 and A02. Note natural revegetation. (Azimuth 040°)

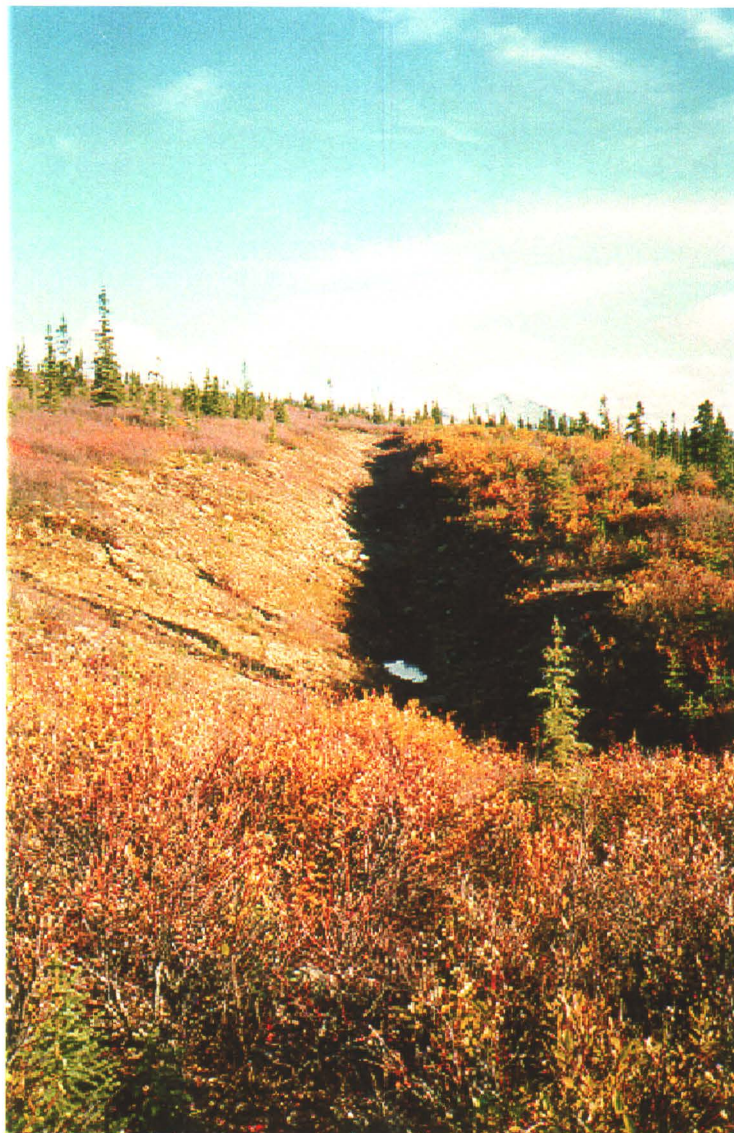
The trenches located about 500 m east of Shaft 1 can be roughly assembled into three groups based on their location, size, and orientation. Trench Group A is series of 7 trenches located almost due east from Shaft 1 (photos 71-8 and 71-9). The trenches in Group A range in length from 30m to 100 m. Trench Group B, located south of Group A, consists of 8 parallel trenches that follow the contour of Keno Hill at an elevation of about 1350 m (photo 71-10). Another trench in Group B lies perpendicular to the rest. The trenches in Group B range in length from 30 m to 60 m. Trench Group C, located east of Group B is a series of three long, deep trenches about 200 m in length (photo 71-4).

Photo 71-4: Recent cat trench; trench length 220m. (Azimuth 130°)

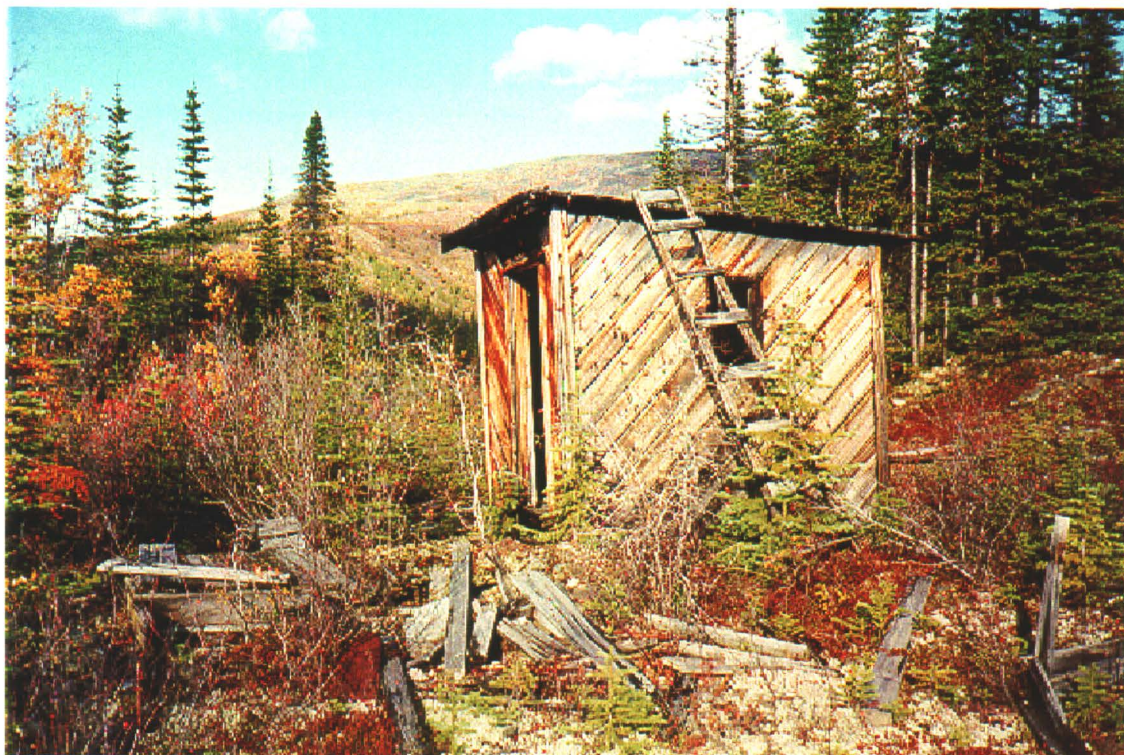
Photo 71-5: Mine shed (Bldg. 71-1). (Azimuth 000°)

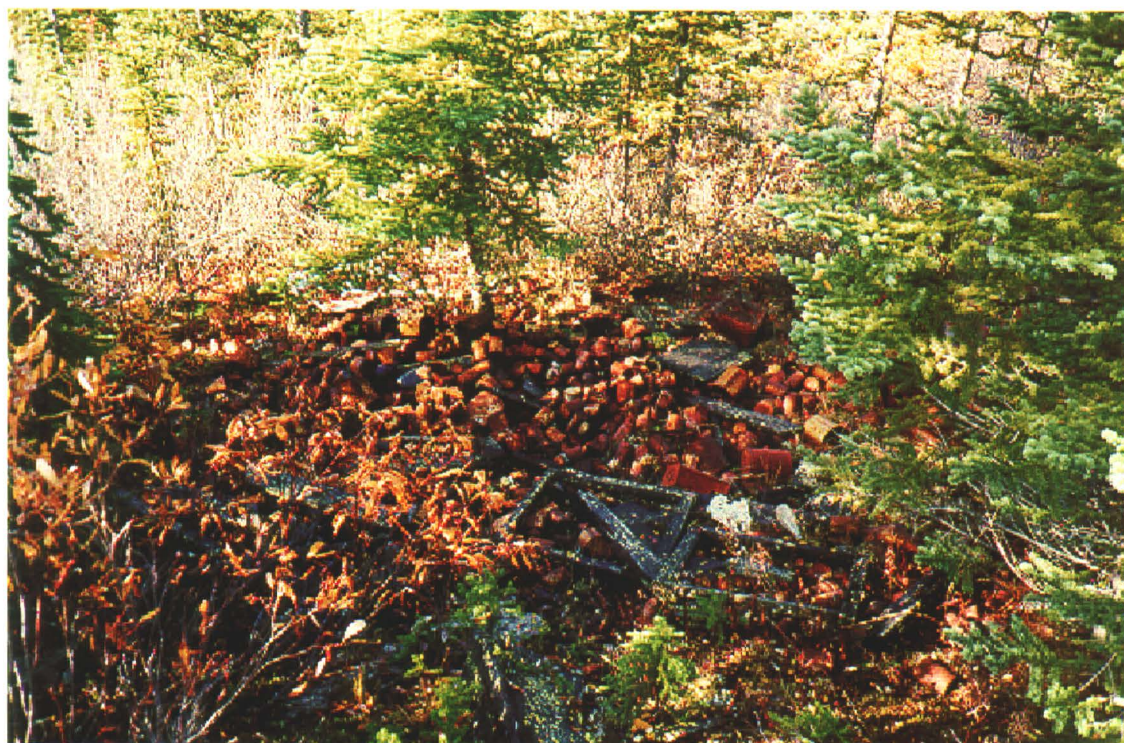
A dump of cans and other debris was observed at the Christal site about 10 m north of Building 71-1 (photo 71-6).

Photo 71-6: Camp garbage site; mostly cans and bottles. (Azimuth 280°)
